**PATERSON  
GROUP**

August 11, 2025  
File: PE4546-LET.13

Subject: **Phase I - Environmental Site Assessment Update**  
**280 Montgomery Street**  
**300 Montgomery Street**  
**2 Montreal Road**  
**3 Selkirk Street**  
**Ottawa, Ontario**

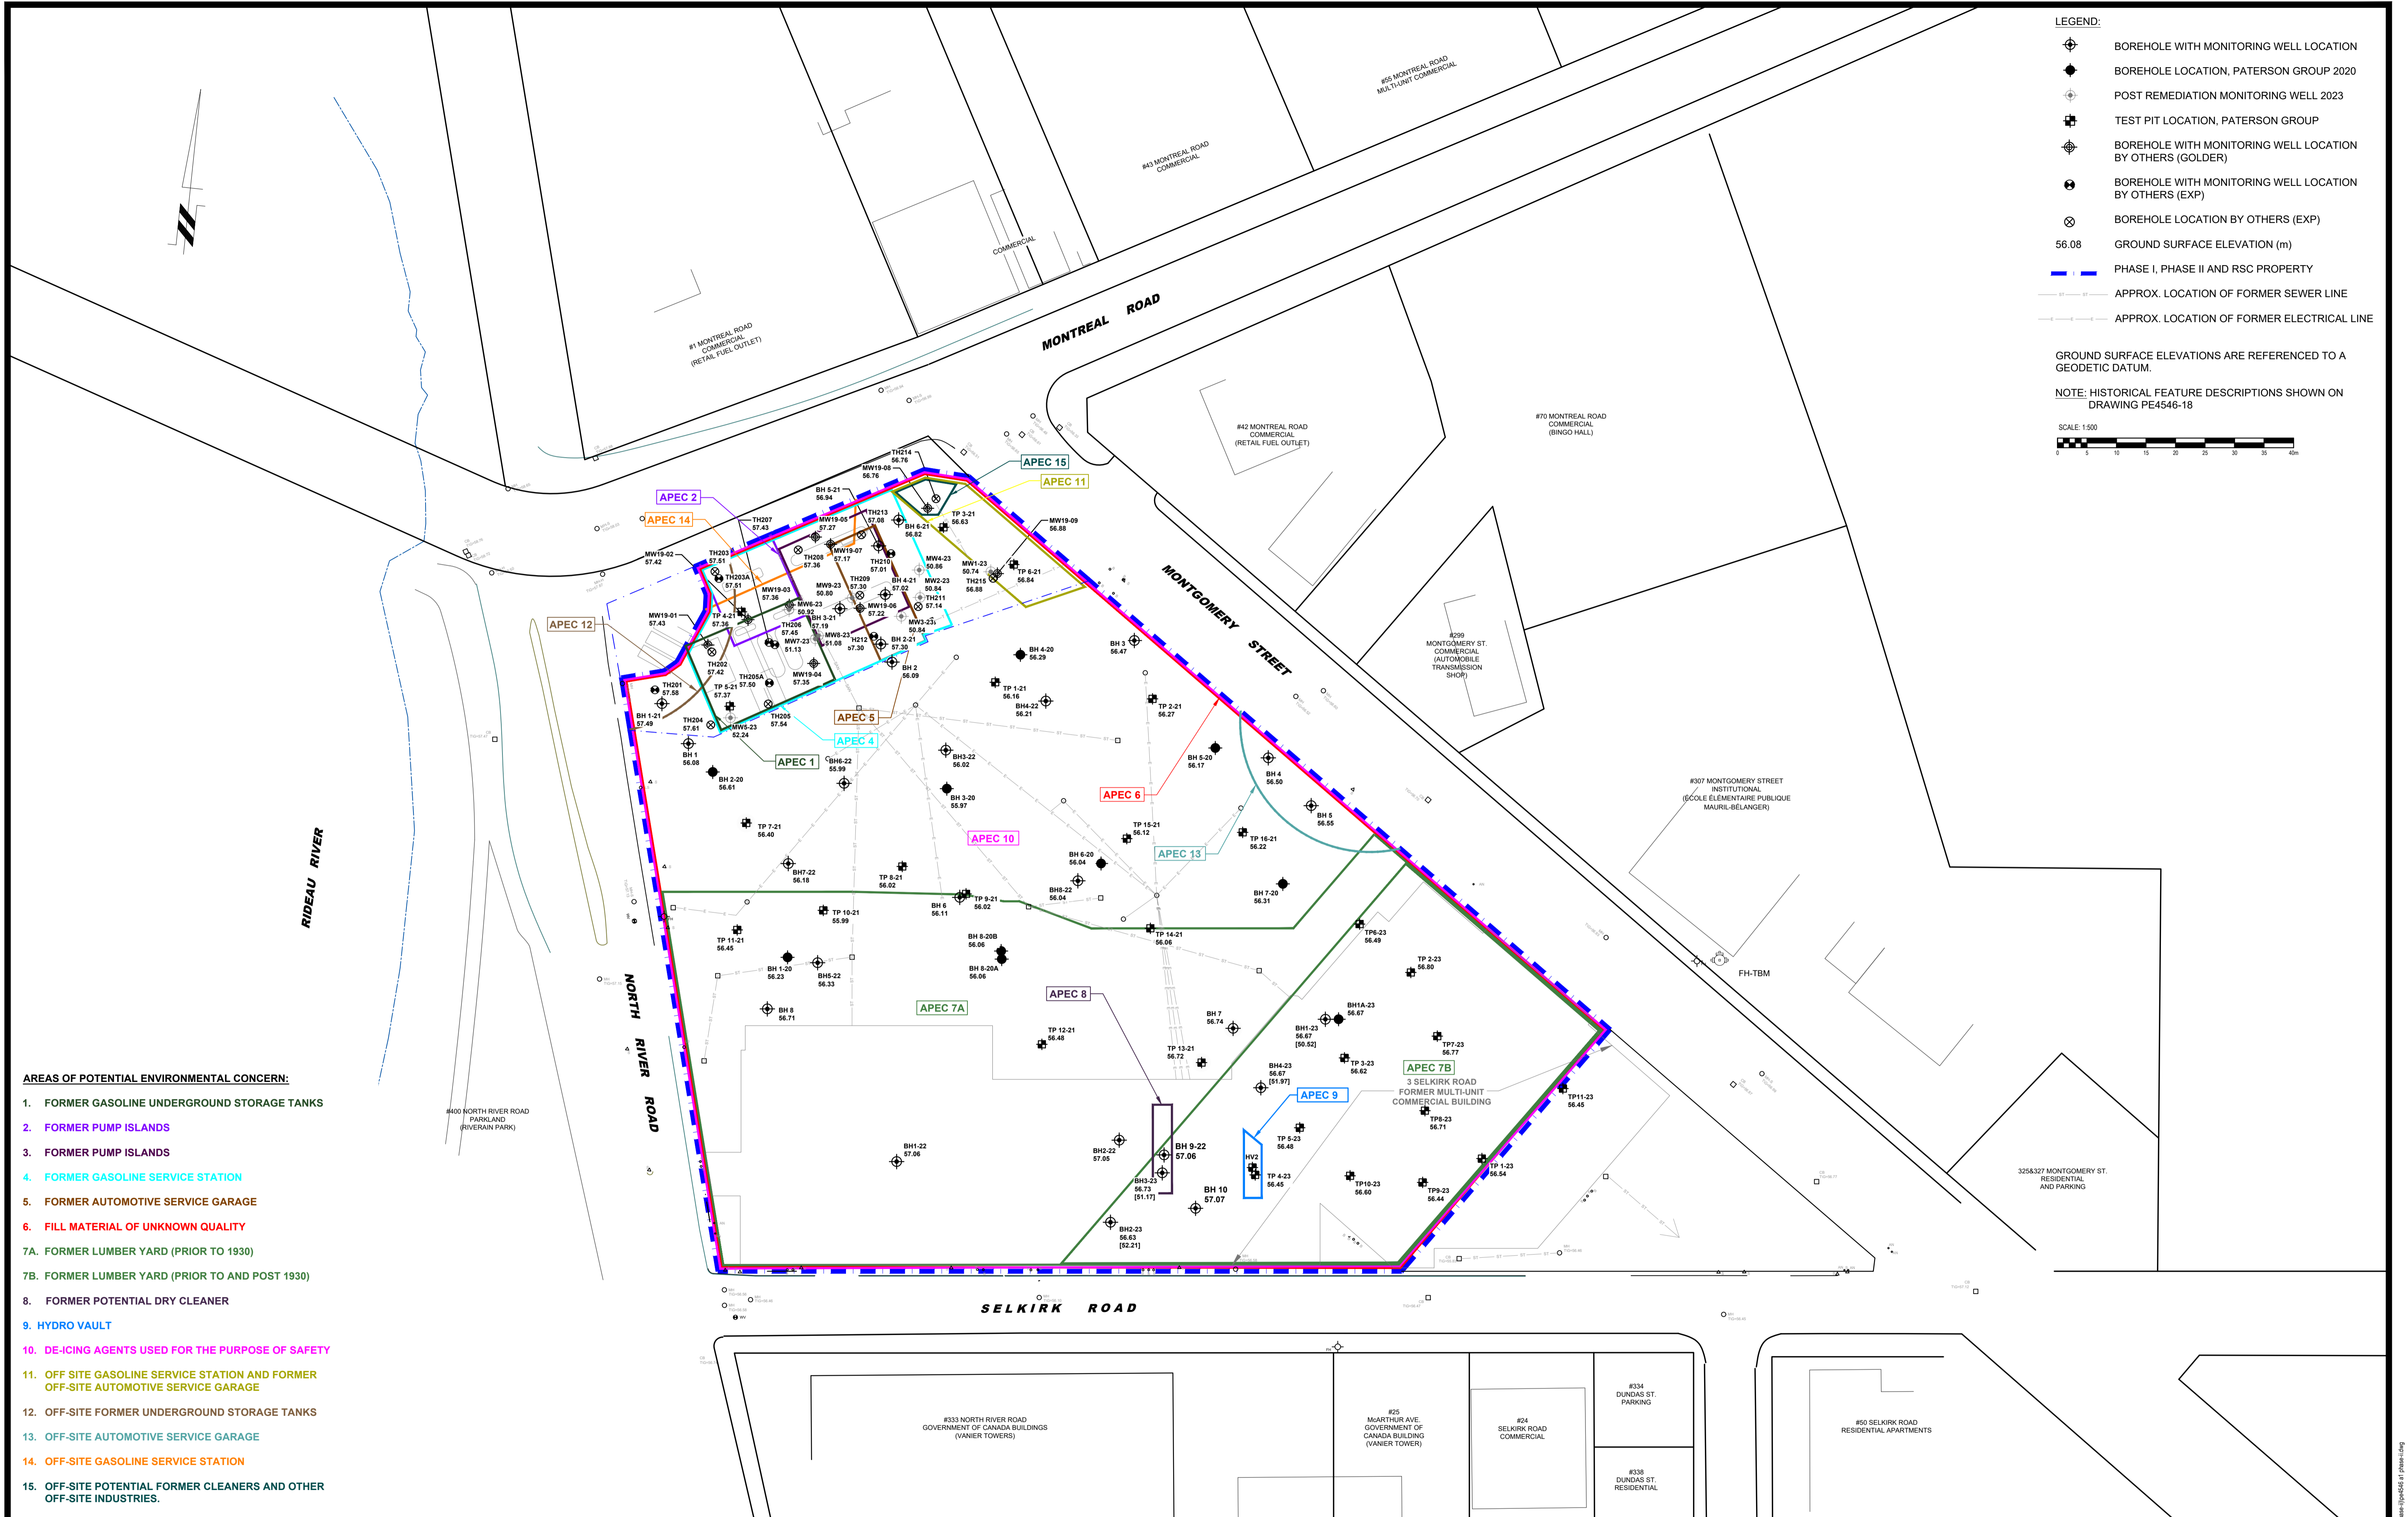
**SITE PLAN**

1. FORMER GASOLINE UNDERGROUND STORAGE TANKS
2. FORMER PUMP ISLANDS
3. FORMER PUMP ISLANDS
4. FORMER GASOLINE SERVICE STATION
5. FORMER AUTOMOTIVE SERVICE GARAGE
6. FILL MATERIAL OF UNKNOWN QUALITY
- 7A. FORMER LUMBER YARD (PRIOR TO 1930)
- 7B. FORMER LUMBER YARD (PRIOR TO AND POST 1930)
8. FORMER POTENTIAL DRY CLEANER
9. HYDRO VAULT
10. DE-ICING AGENTS USED FOR THE PURPOSE OF SAFETY
11. OFF-SITE GASOLINE SERVICE STATION AND FORMER OFF-SITE AUTOMOTIVE SERVICE GARAGE
12. OFF-SITE FORMER UNDERGROUND STORAGE TANKS
13. OFF-SITE AUTOMOTIVE SERVICE GARAGE
14. OFF-SITE GASOLINE SERVICE STATION
15. OFF-SITE POTENTIAL FORMER CLEANERS AND OTHER OFF-SITE INDUSTRIES.
