**PATERSON
GROUP**

December 19, 2025
File: PE4690-LET.08

Subject: **Phase I - Environmental Site Assessment Update
Part of 4055 Russell Road
Ottawa, Ontario**

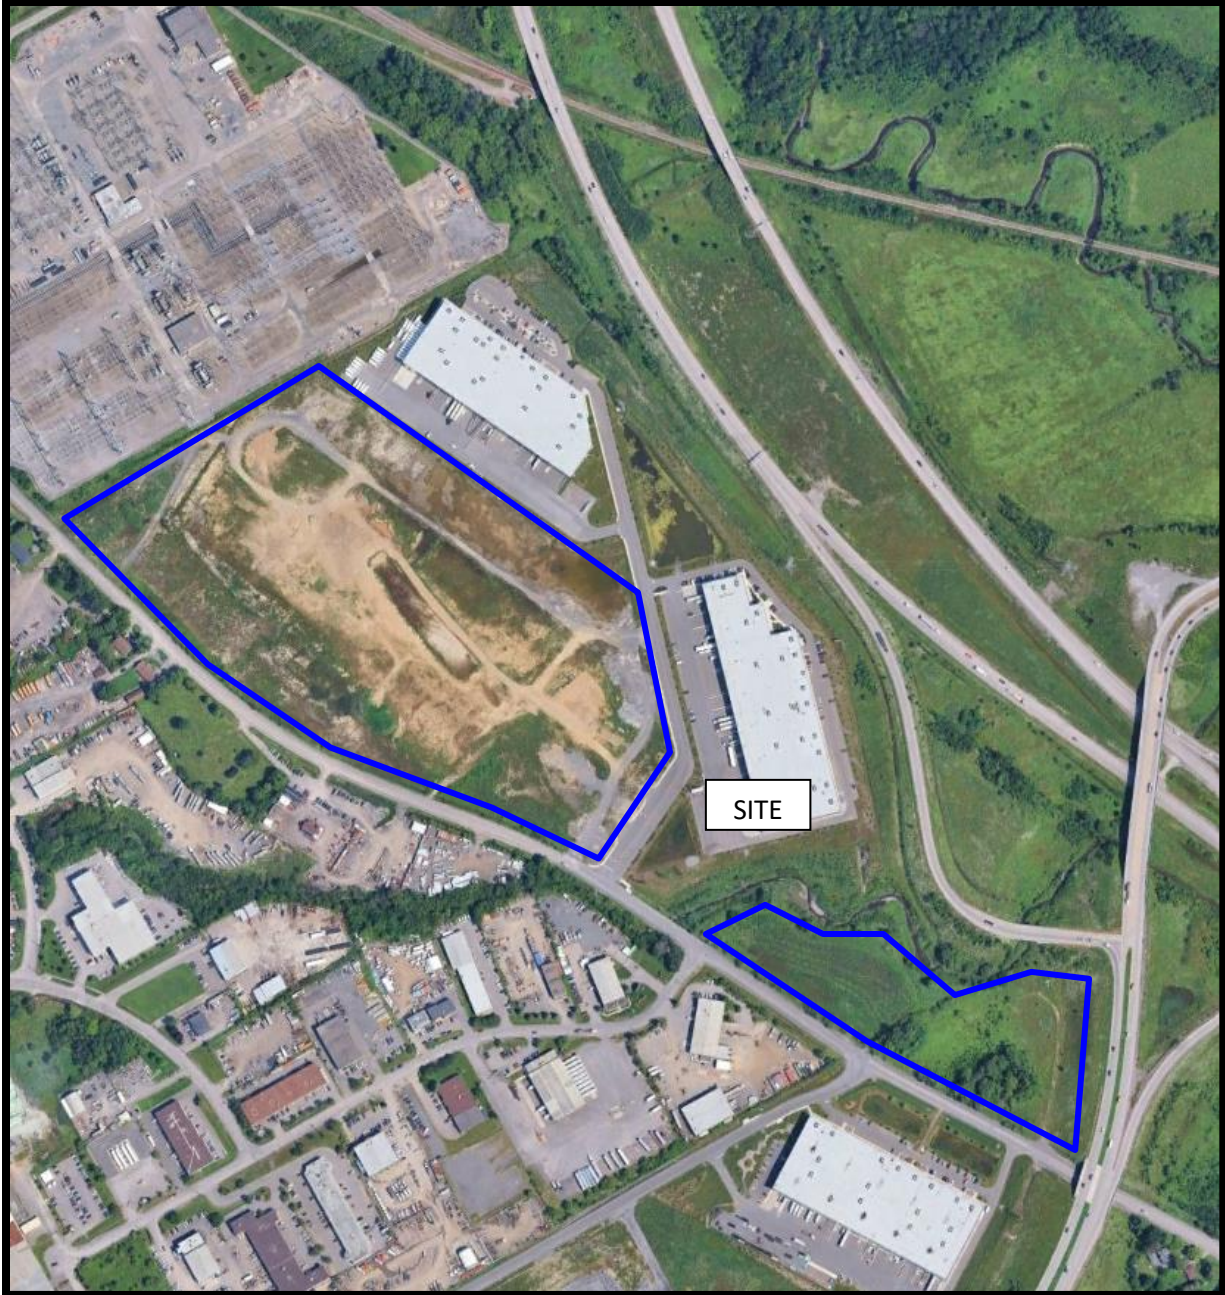
AERIAL PHOTOGRAPH
2024

In the 2024 aerial photograph, no significant changes were apparent with respect to the Phase I Property since the time of the previous 2019 aerial photograph, though much of the land has been stripped in preparation for future development. The neighbouring lands to the north and east have since been developed with commercial warehouse buildings.

The Phase I Property and the surrounding lands appear in this photograph as they exist today. A copy of the 2024 aerial photograph has been appended to this letter.

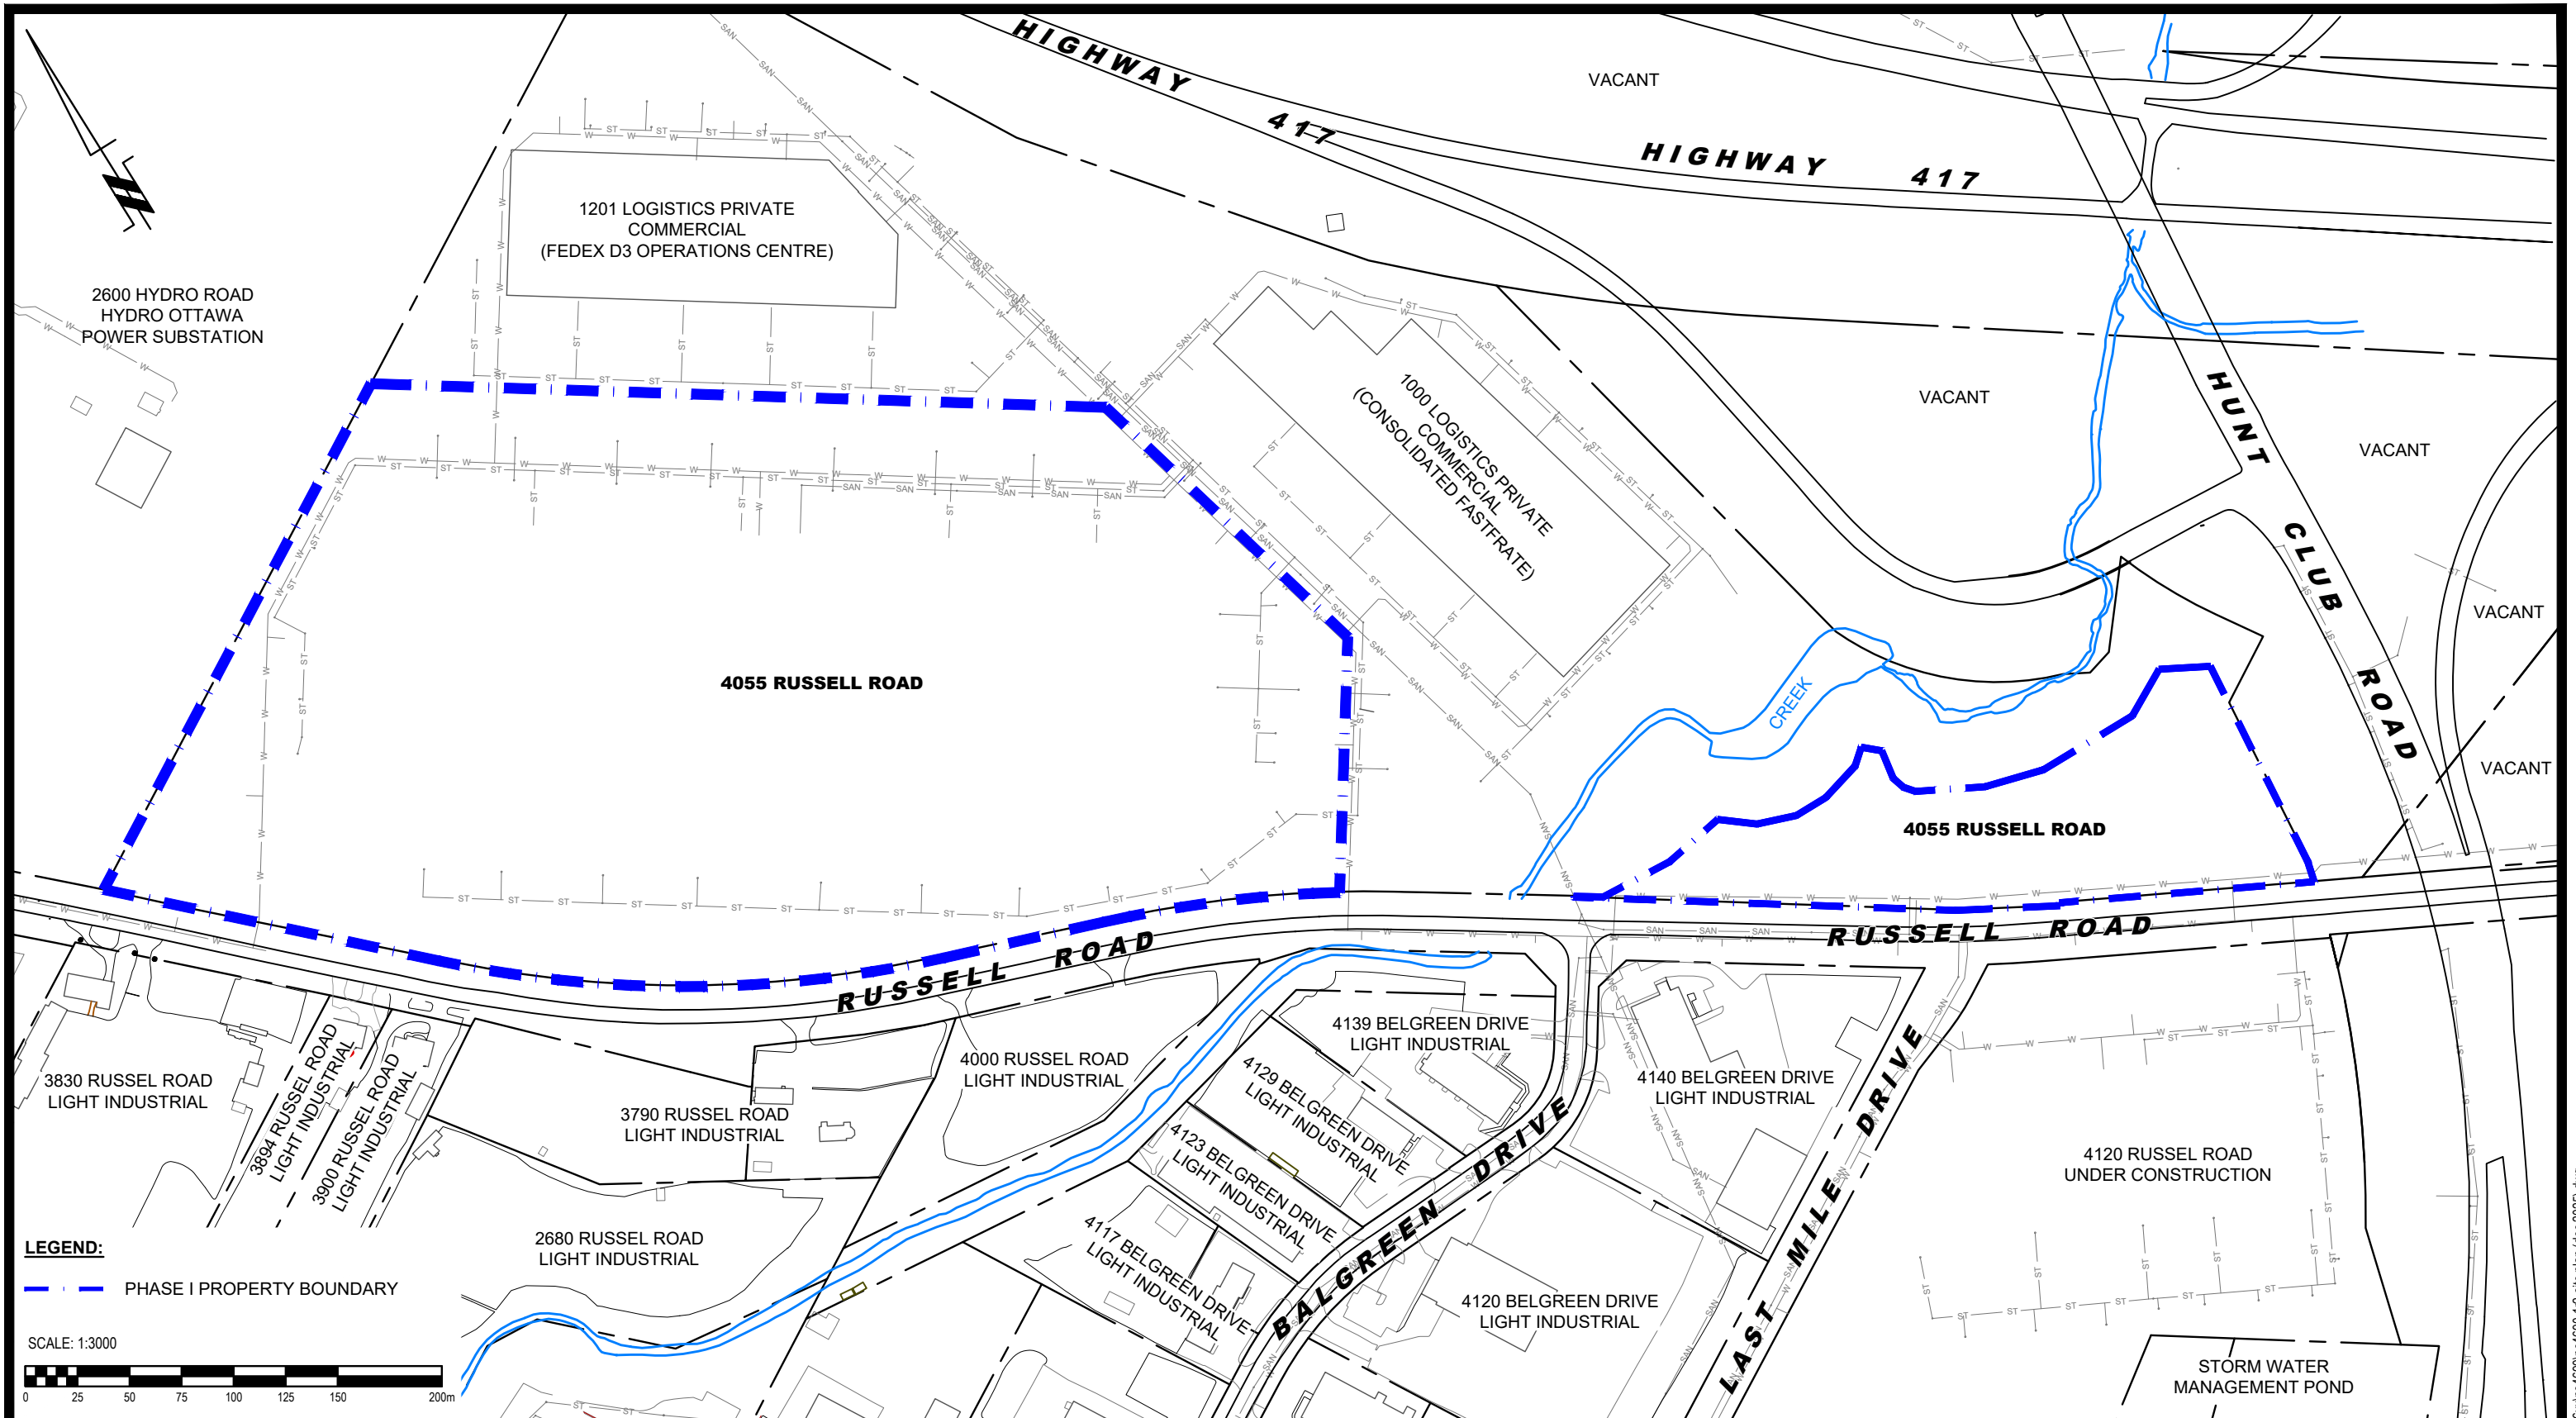
SITE PLAN

At the time of the site inspection, the Phase I Property was observed to be vacant and consisted of tall grass, light brush, and occasional mature trees. Some stockpiles of soil material were observed on the Phase I Property, though this is considered to be reworked native soil generated from the on-going developments on 4055 Russell Road and is therefore not considered to be an environmental concern to the Phase I Property.

A depiction of the Phase I Property is presented on Drawing PE4690-1R2 – Site Plan, in the Figures section of this report.

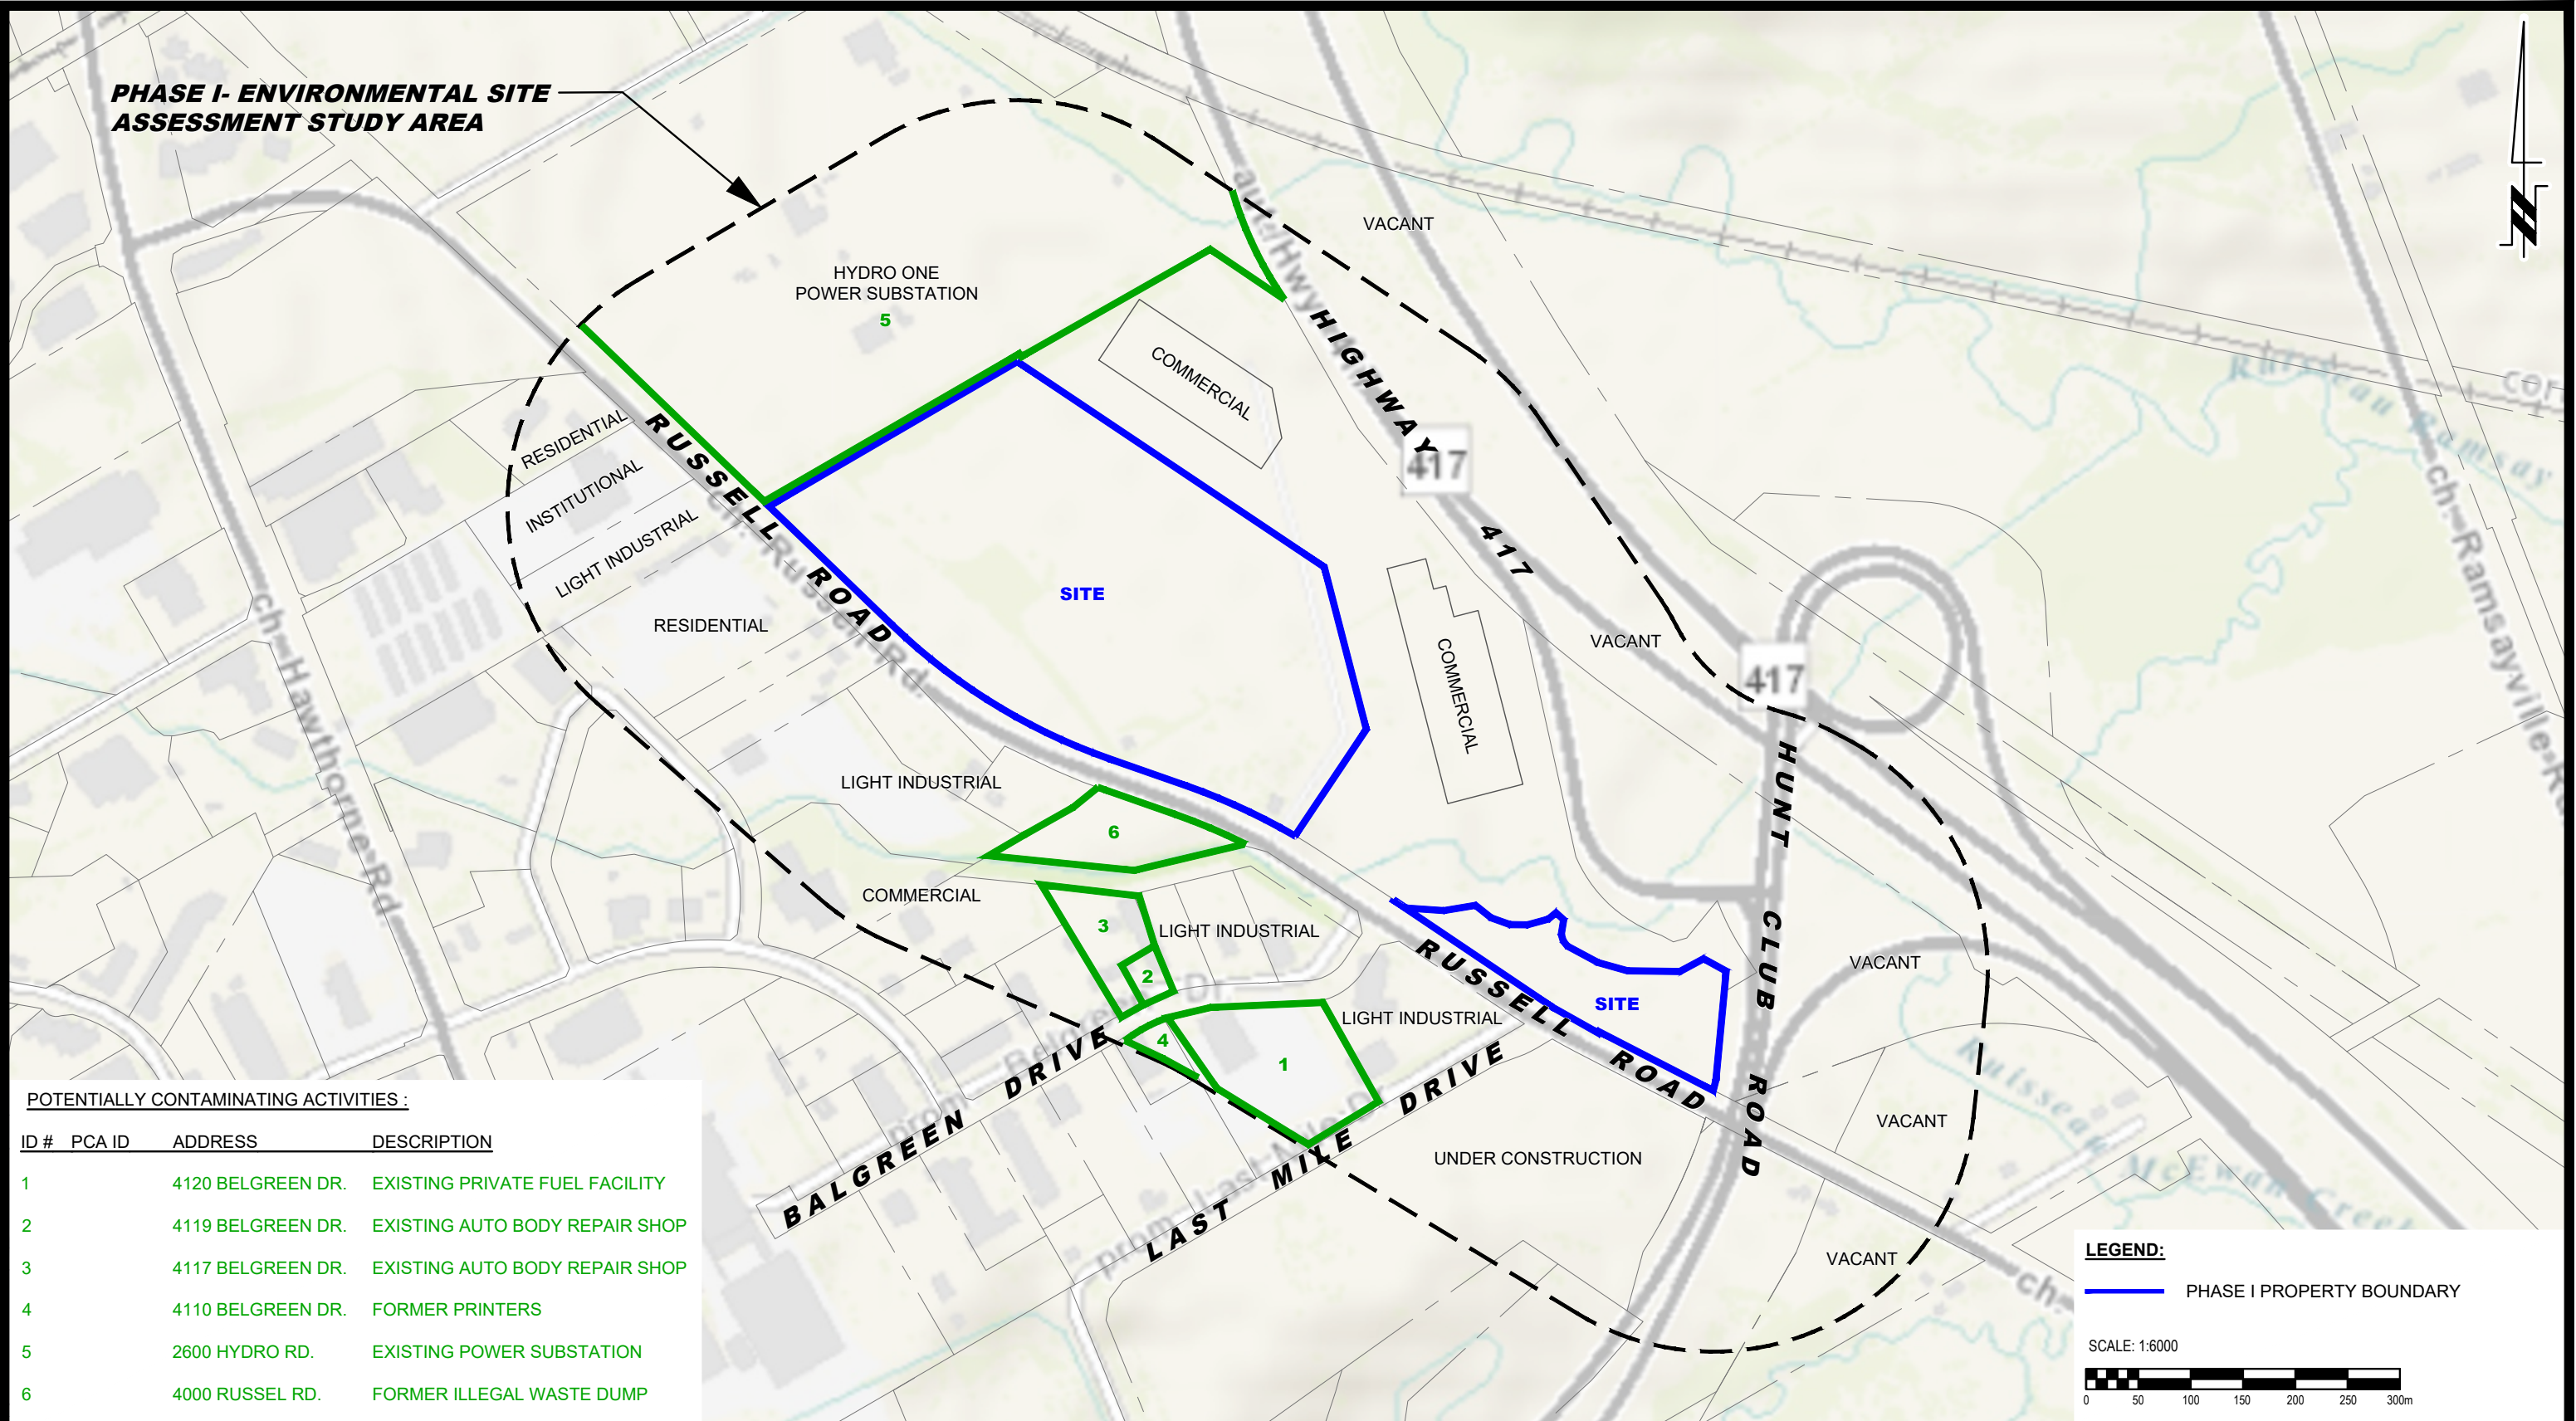
Current land use within the Phase I Study Area is illustrated on Drawing PE4690-2R2 – Surrounding Land Use Plan, appended to this letter.

The surrounding lands within the Phase I Study Area consist largely of commercial and light industrial properties. Current land use is depicted on Drawing PE4690-2R2 – Surrounding Land Use Plan, in the Figures section of this report.

ID #	PCA ID	ADDRESS	DESCRIPTION
1		4120 BELGREEN DR.	EXISTING PRIVATE FUEL FACILITY
2		4119 BELGREEN DR.	EXISTING AUTO BODY REPAIR SHOP
3		4117 BELGREEN DR.	EXISTING AUTO BODY REPAIR SHOP
4		4110 BELGREEN DR.	FORMER PRINTERS
5		2600 HYDRO RD.	EXISTING POWER SUBSTATION
6		4000 RUSSEL RD.	FORMER ILLEGAL WASTE DUMP
