# **Phase Two Environmental Site Assessment – Northeast Part of 1900 Cyrville Road, Ottawa, Ontario**

Final Report

March 18, 2026

Project No.: 121626297.300

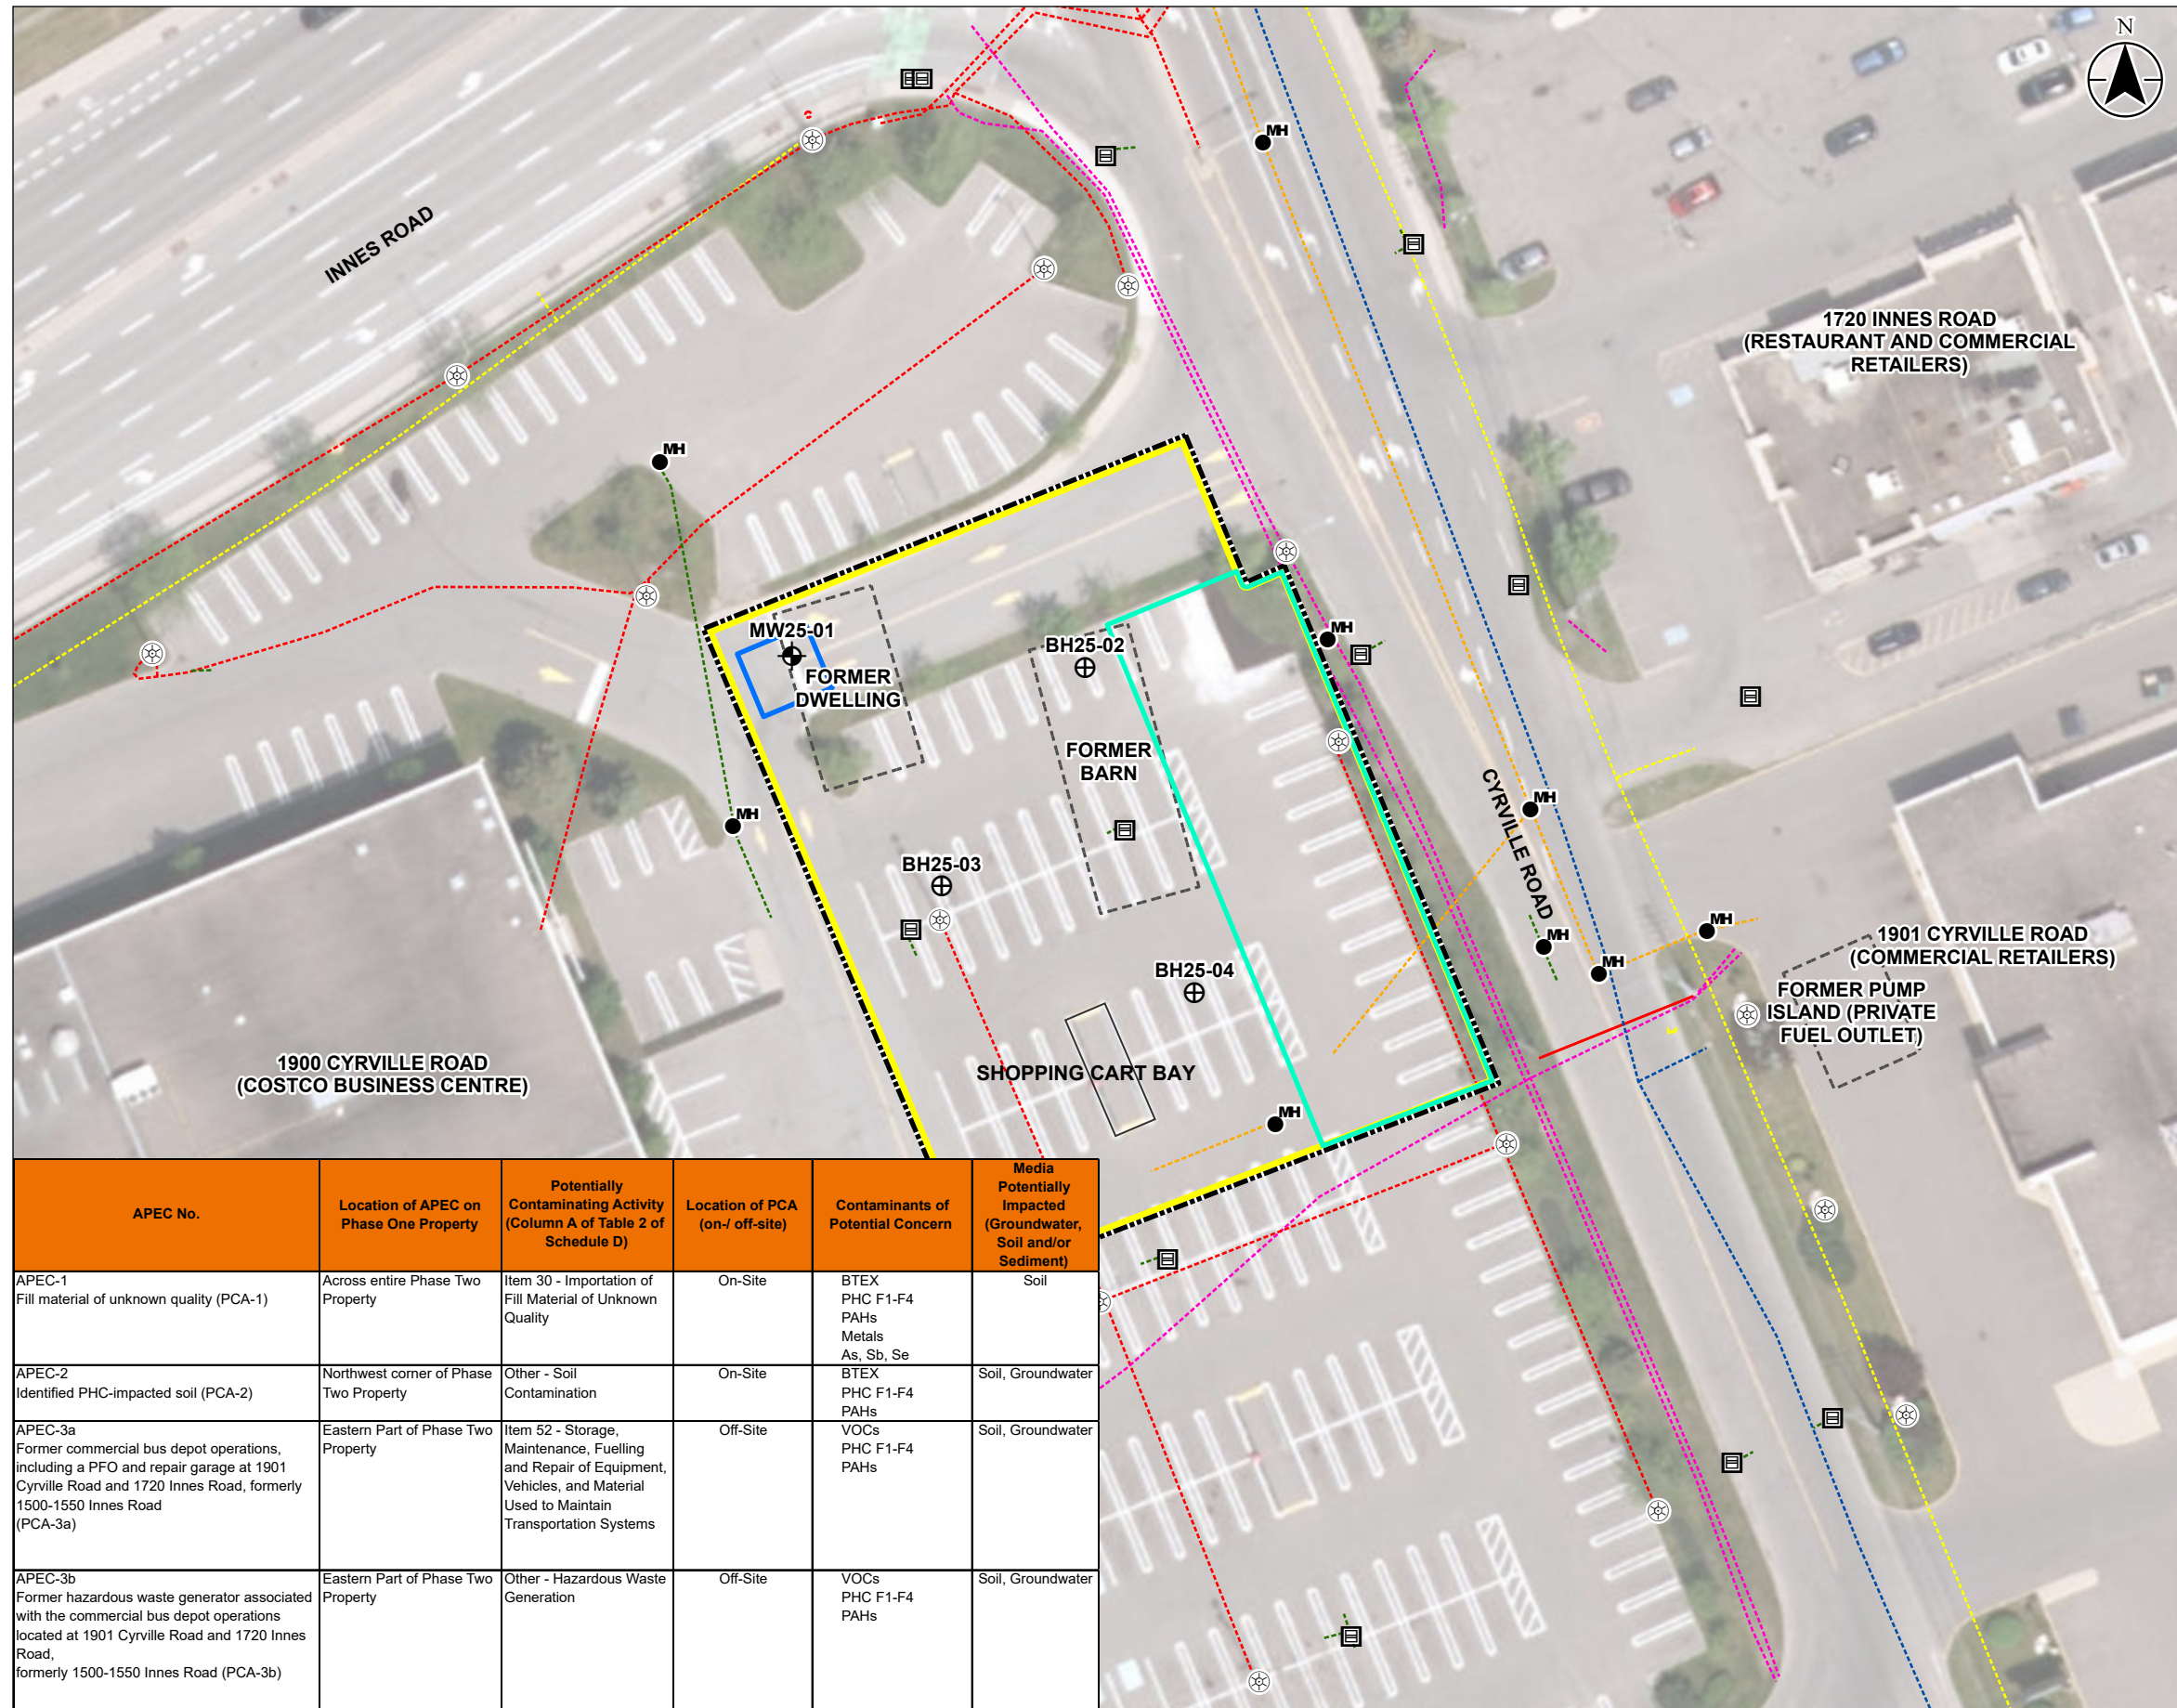
**Site Plan Showing Areas of Potential Environmental Concern and Sampling Locations**

APEC No.	Location of APEC on Phase One Property	Potentially Contaminating Activity (Column A of Table 2 of Schedule D)	Location of PCA (on-/ off-site)	Contaminants of Potential Concern	Media Potentially Impacted (Groundwater, Soil and/or Sediment)
APEC-1	Across entire Phase Two Property	Item 30 - Importation of Fill Material of Unknown Quality	On-Site	BTEX PHC F1-F4 PAHs Metals As, Sb, Se	Soil
APEC-2	Northwest corner of Phase Two Property	Other - Soil Contamination	On-Site	BTEX PHC F1-F4 PAHs	Soil, Groundwater
APEC-3a	Eastern Part of Phase Two Property	Item 52 - Storage, Maintenance, Fuelling and Repair of Equipment, Vehicles, and Material Used to Maintain Transportation Systems	Off-Site	VOCs PHC F1-F4 PAHs	Soil, Groundwater
APEC-3b	Eastern Part of Phase Two Property	Other - Hazardous Waste Generation	Off-Site	VOCs PHC F1-F4 PAHs	Soil, Groundwater

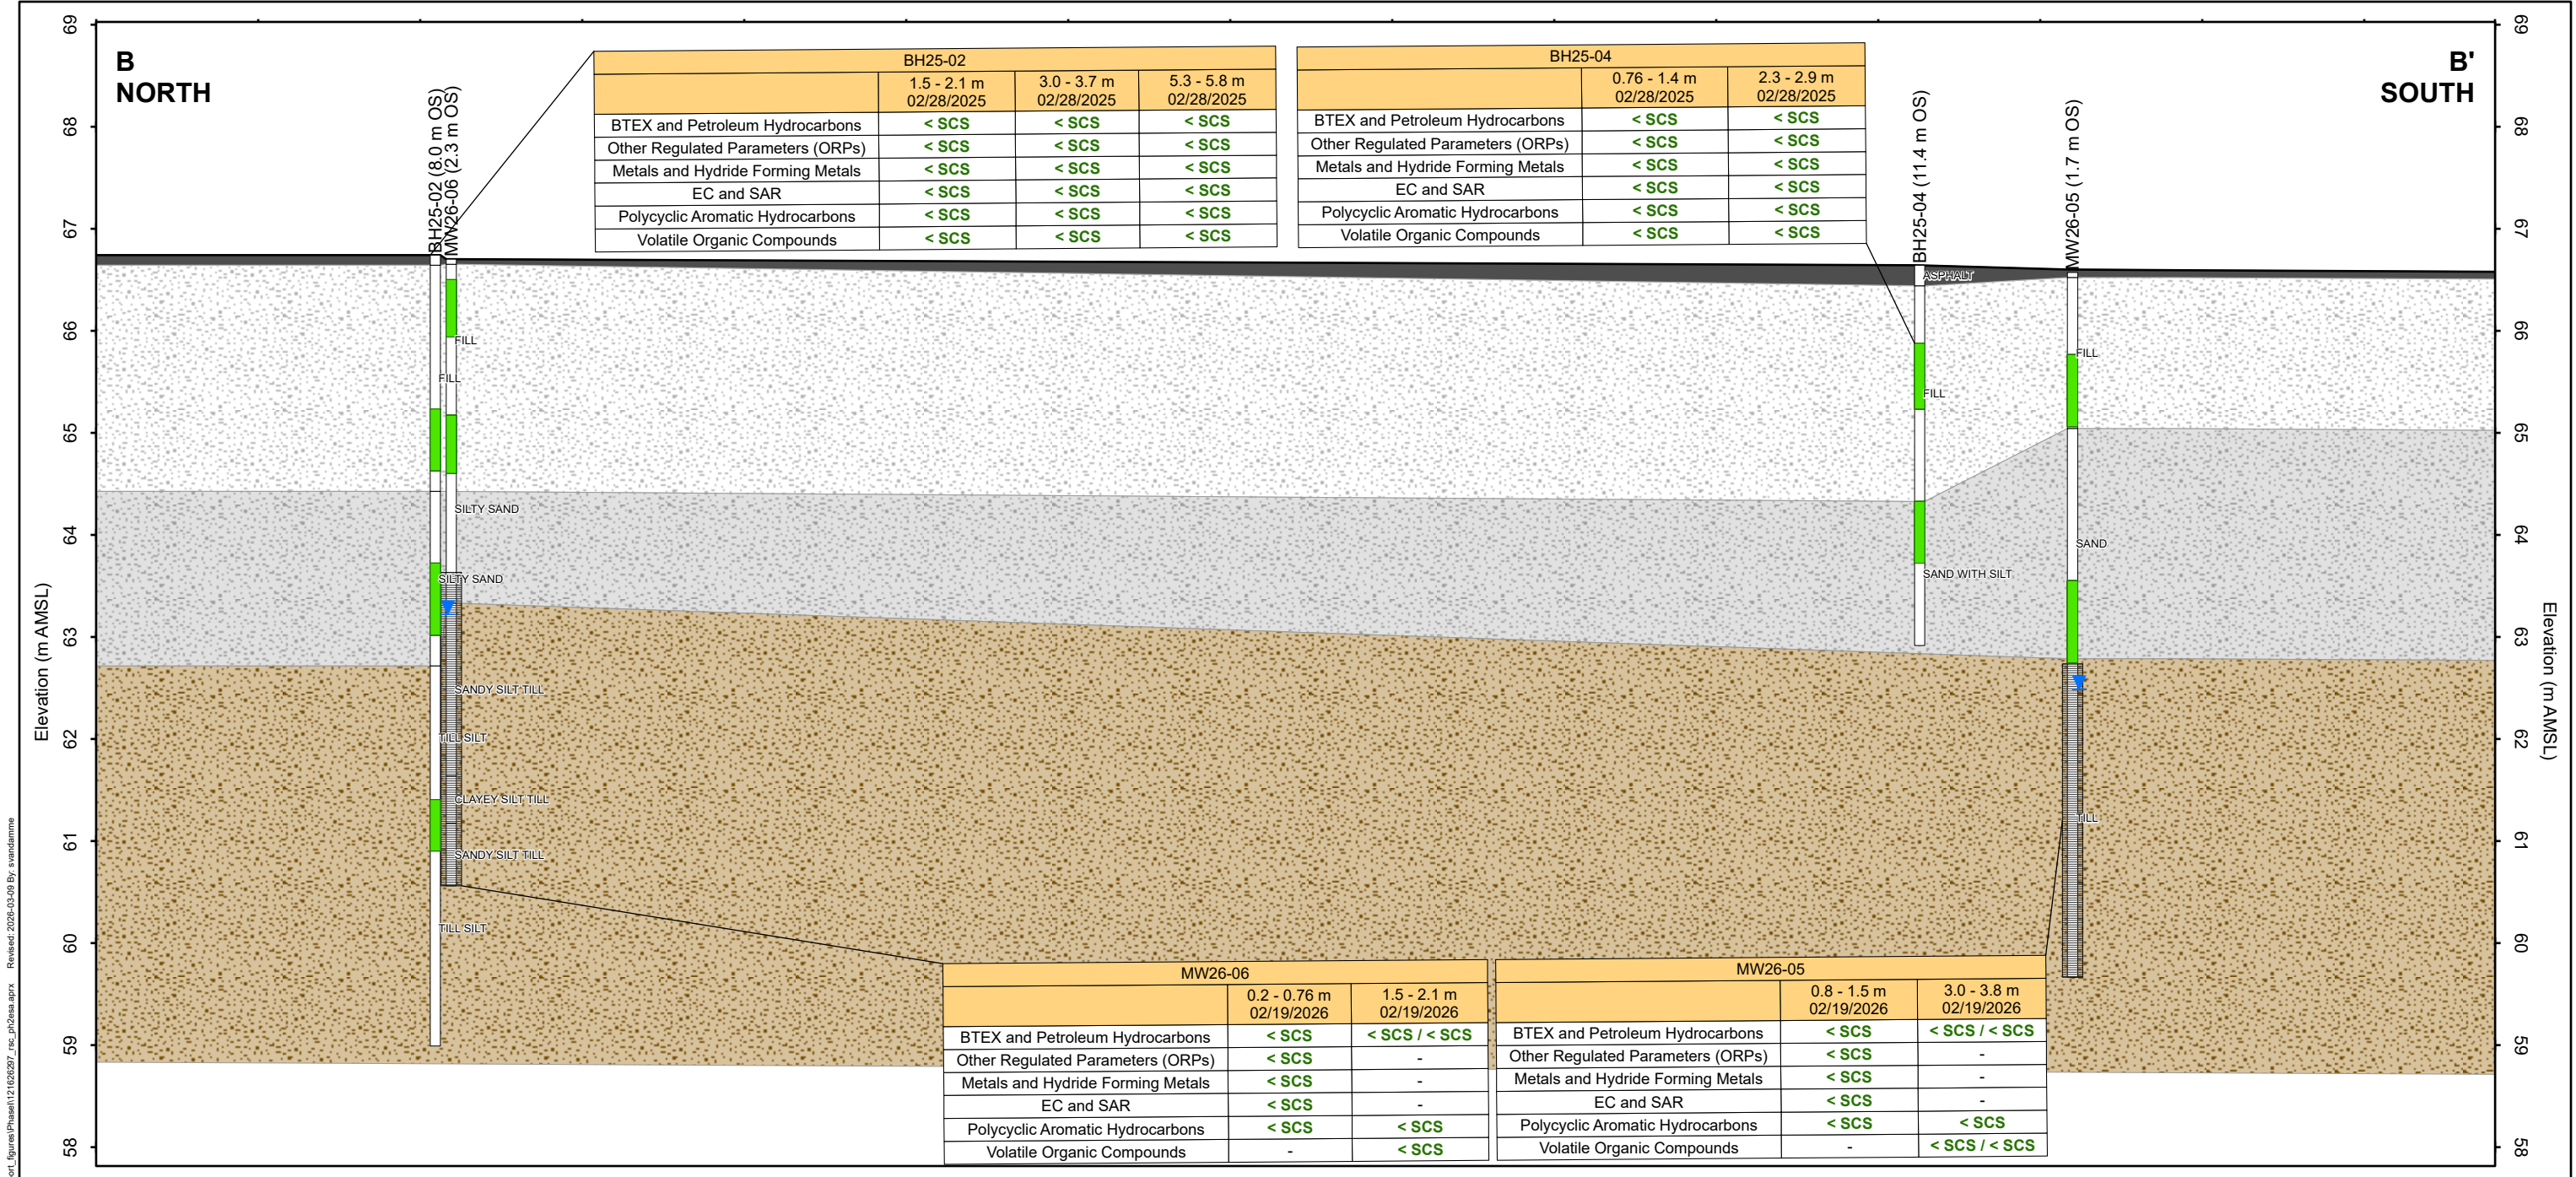
Figure No. **6b**  
 Title: **Cross-Section A-A' - Summary of Soil Analytical Results**

- Legend**
- Approximate Ground Surface
  - Soil Parameters Met Regulatory Standards (2011 MECP Table 3 SCS)
  - Asphalt
  - Fill
  - Silty Sand/Sand
  - Till

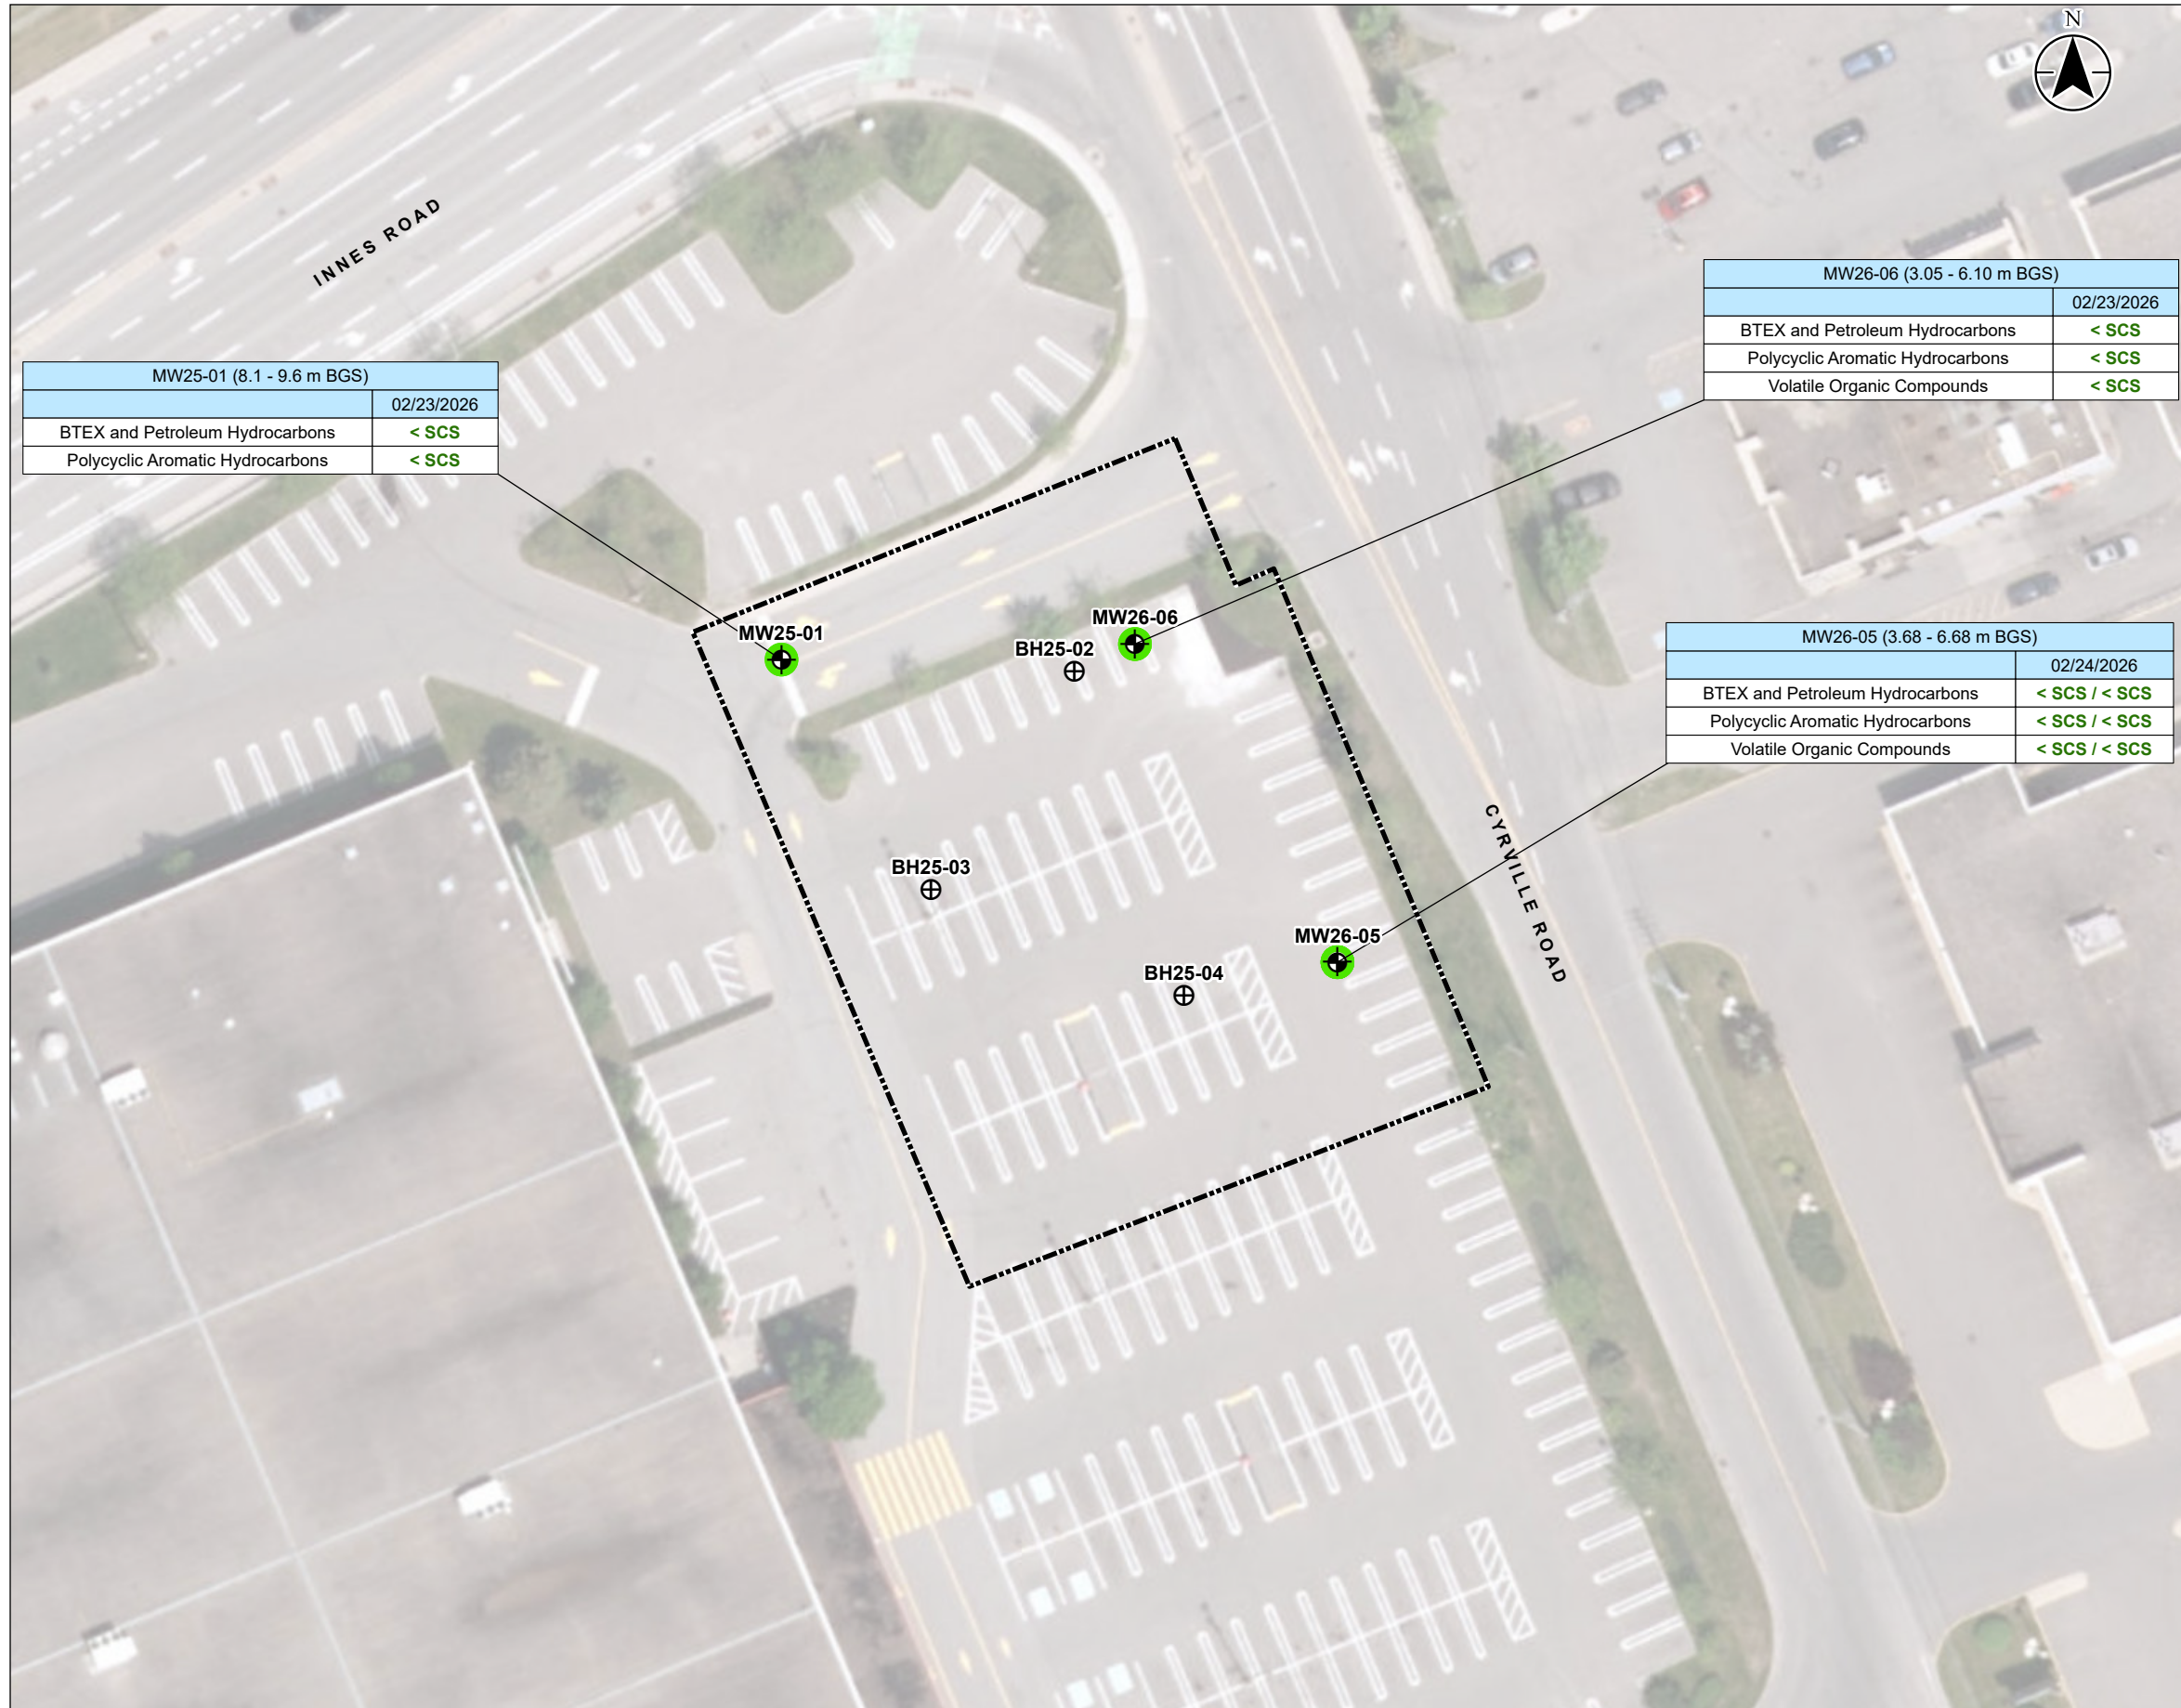
Figure No. **7a**  
 Title: **Summary of Groundwater Analytical Results**

MW25-01 (8.1 - 9.6 m BGS)	
	02/23/2026
BTEX and Petroleum Hydrocarbons	< SCS
Polycyclic Aromatic Hydrocarbons	< SCS

MW26-06 (3.05 - 6.10 m BGS)	
	02/23/2026
BTEX and Petroleum Hydrocarbons	< SCS
Polycyclic Aromatic Hydrocarbons	< SCS
Volatile Organic Compounds	< SCS

Groundwater monitoring and sampling of the three monitoring wells (MW25-01, MW26-05 and MW26-06) were conducted on February 24, 2026. No signs of contamination were observed during this event. Groundwater samples from the three monitoring wells were analyzed for BTEX, PHC F1–F4, VOCs, and/or PAHs. Laboratory results for all analyzed groundwater samples reported concentrations below the applicable Table 3 SCS.

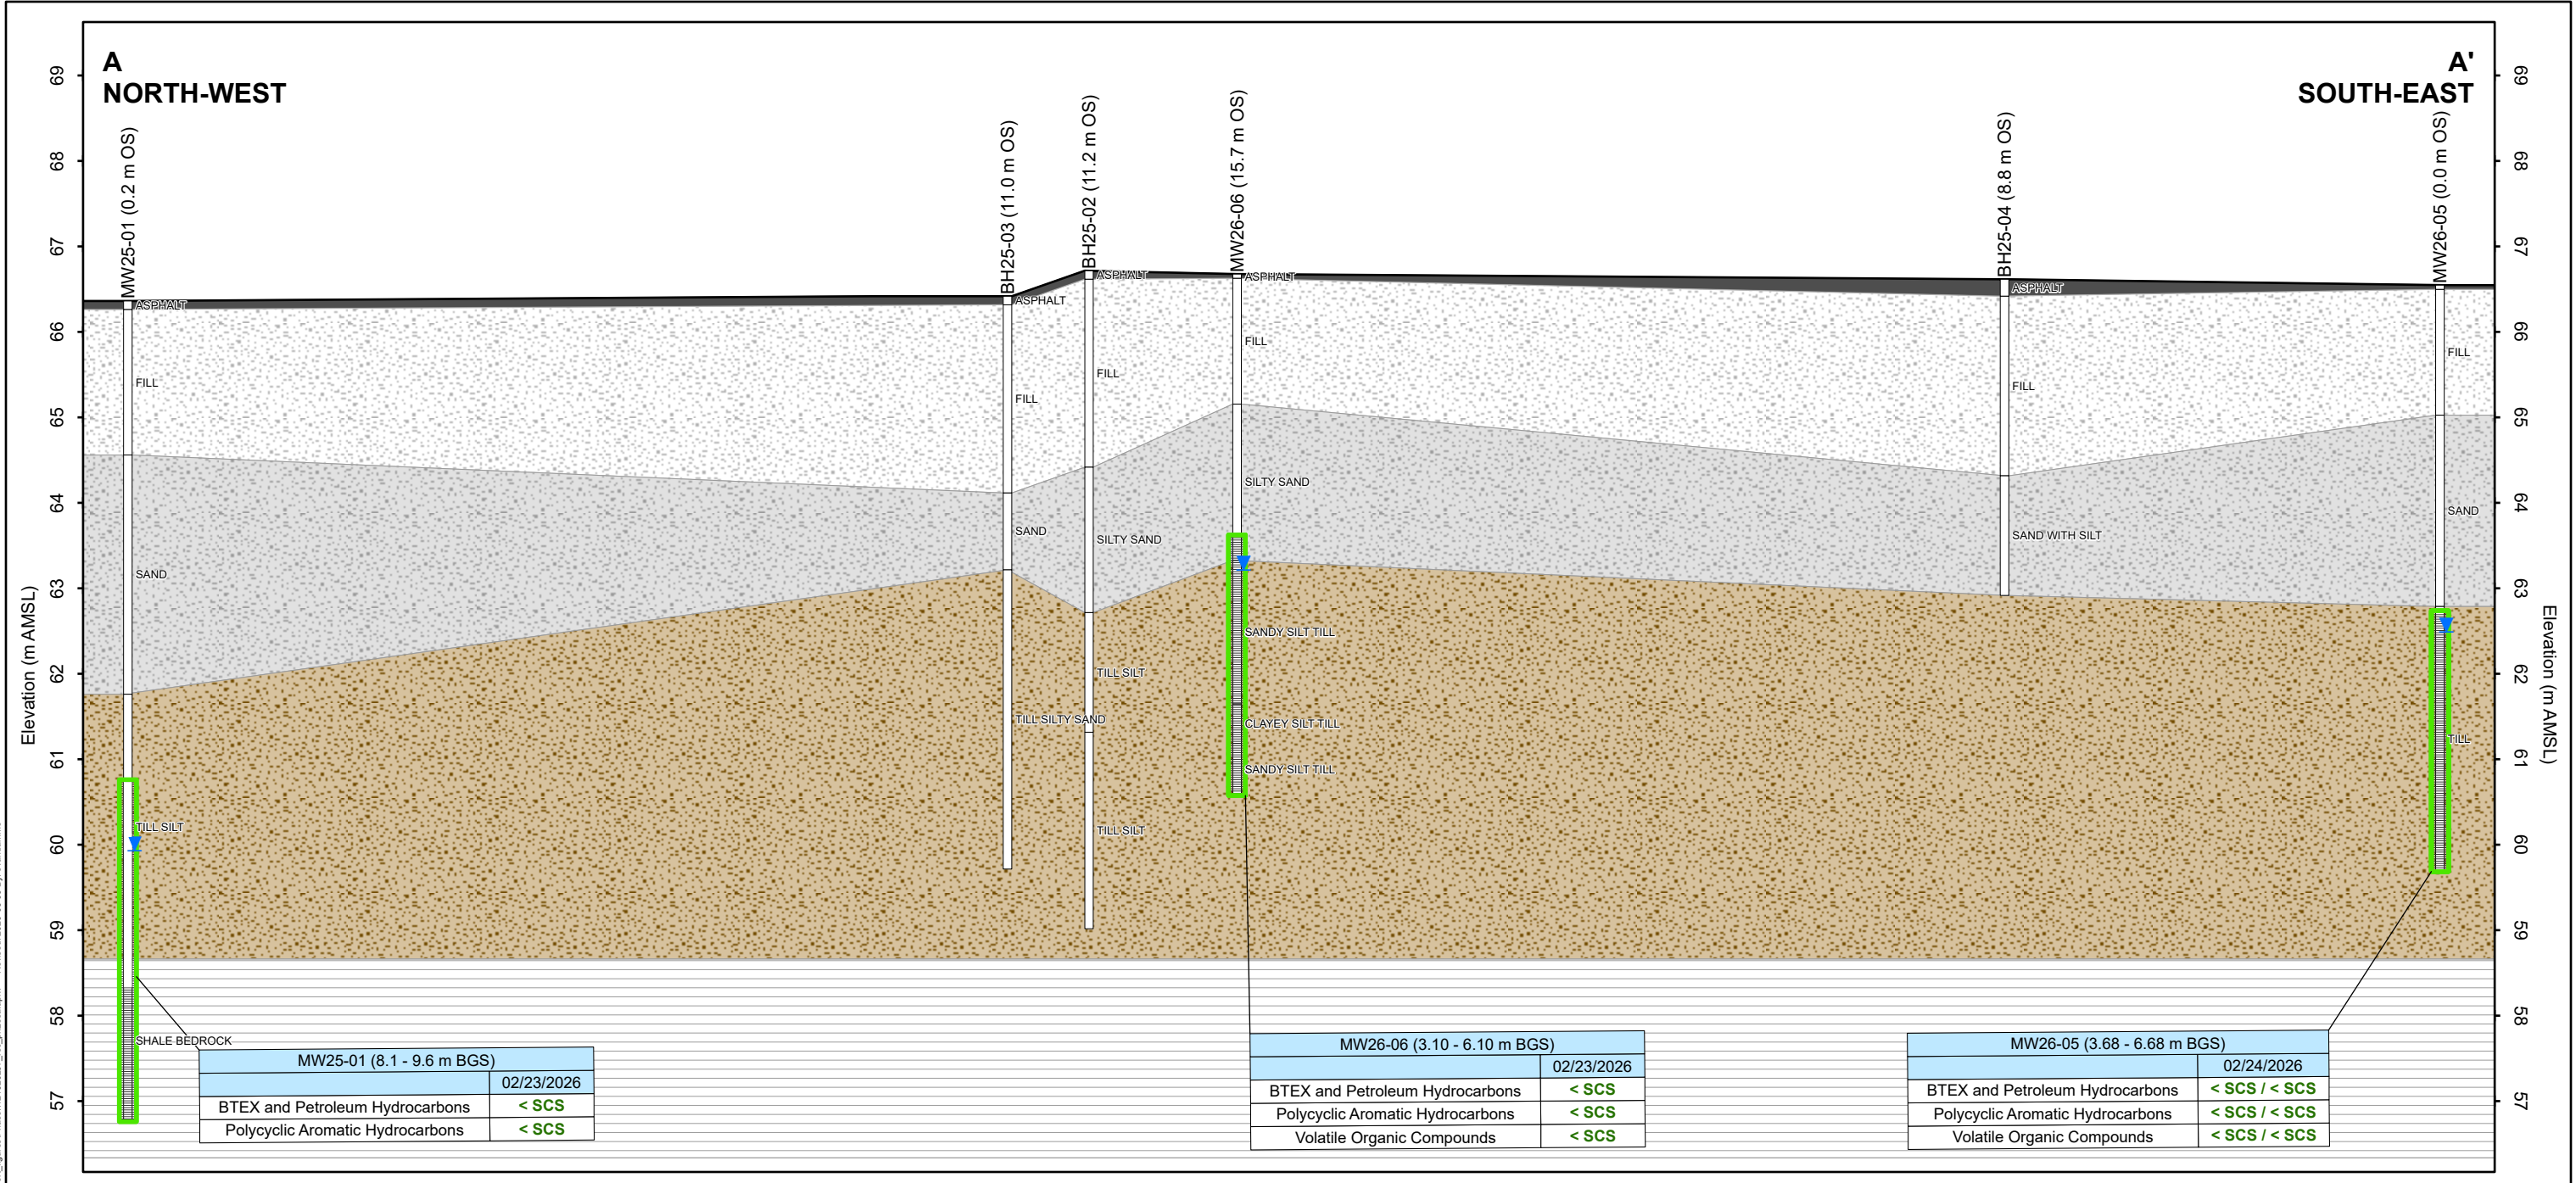
Figure No. **7b**  
 Title: **Cross-Section A-A' - Summary of Groundwater Analytical Results**

- Legend**
- AA\_Strata**
- DESC**
- Asphalt
  - Fill
  - Silty Sand/Sand
  - Till
  - Shale Bedrock
  - Approximate Ground Surface
  - Groundwater Parameters Met Regulatory Standards (2011 MECP Table 3 SCS)

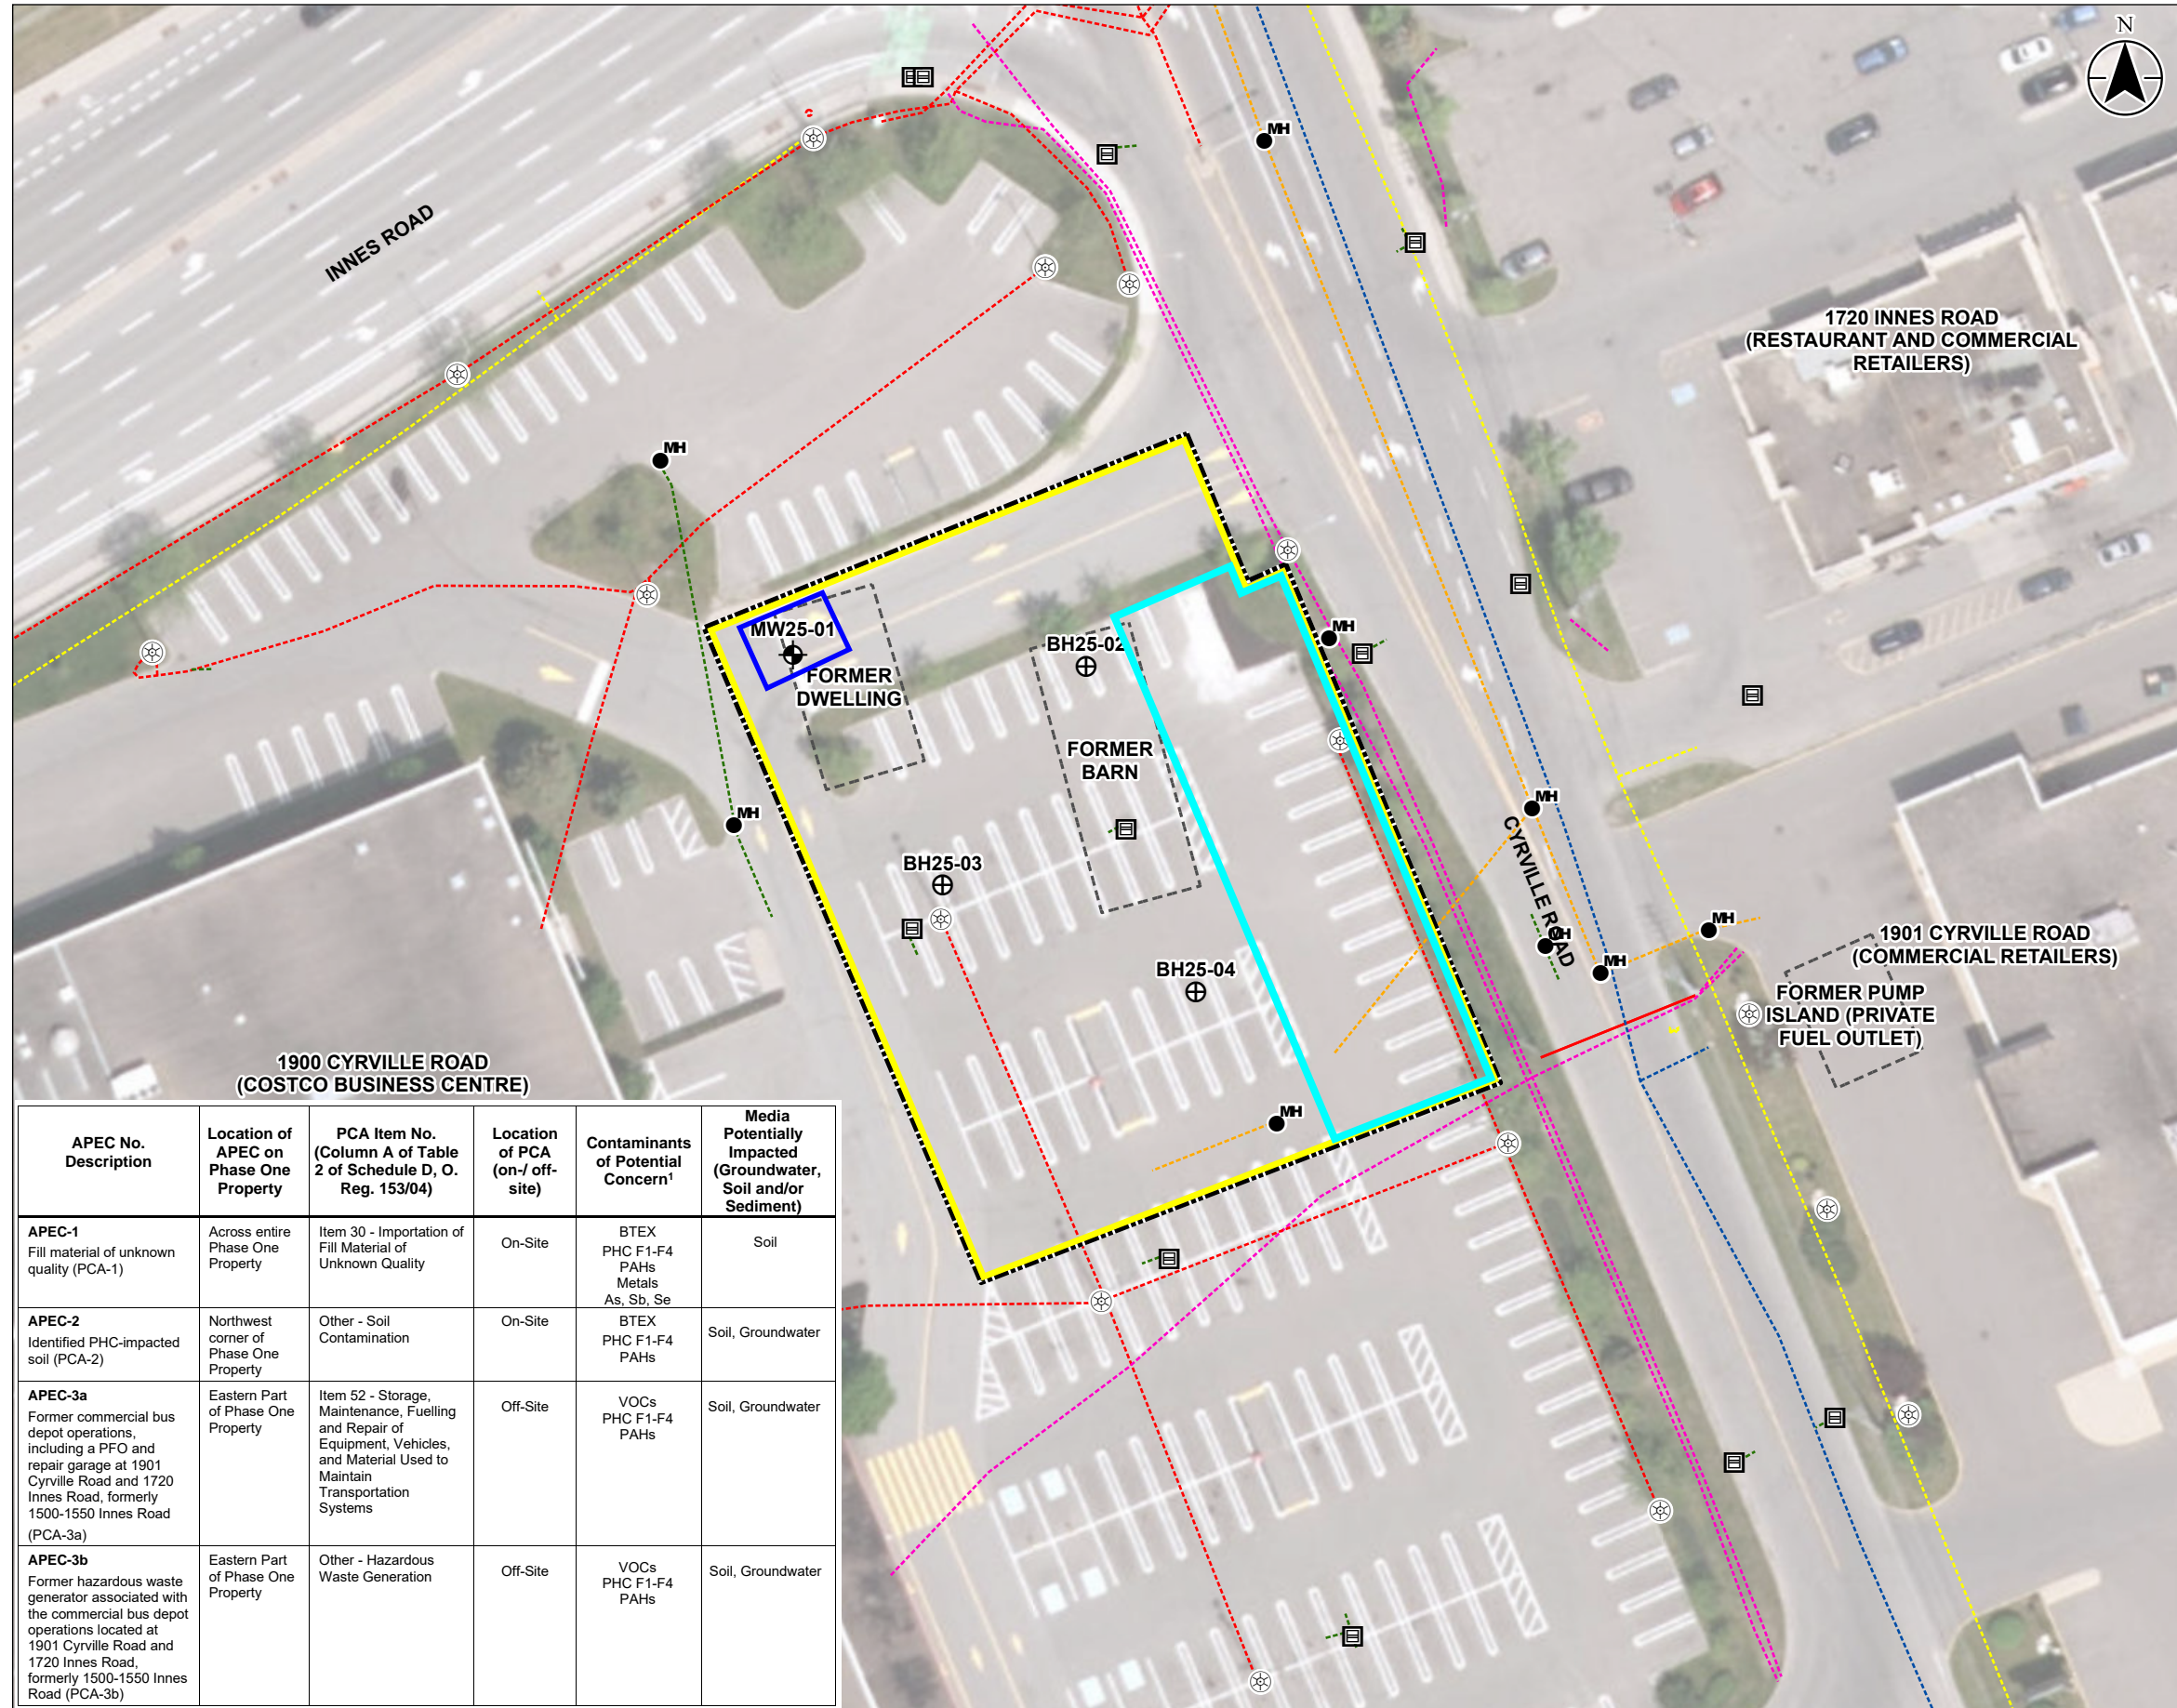
Figure No.: **3**  
 Title: **Areas of Potential Environmental Concern (APECs)**

APEC No. Description	Location of APEC on Phase One Property	PCA Item No. (Column A of Table 2 of Schedule D, O. Reg. 153/04)	Location of PCA (on-/ off-site)	Contaminants of Potential Concern <sup>1</sup>	Media Potentially Impacted (Groundwater, Soil and/or Sediment)
<b>APEC-1</b> Fill material of unknown quality (PCA-1)	Across entire Phase One Property	Item 30 - Importation of Fill Material of Unknown Quality	On-Site	BTEX PHC F1-F4 PAHs Metals As, Sb, Se	Soil
<b>APEC-2</b> Identified PHC-impacted soil (PCA-2)	Northwest corner of Phase One Property	Other - Soil Contamination	On-Site	BTEX PHC F1-F4 PAHs	Soil, Groundwater
<b>APEC-3a</b> Former commercial bus depot operations, including a PFO and repair garage at 1901 Cyrville Road and 1720 Innes Road, formerly 1500-1550 Innes Road (PCA-3a)	Eastern Part of Phase One Property	Item 52 - Storage, Maintenance, Fuelling and Repair of Equipment, Vehicles, and Material Used to Maintain Transportation Systems	Off-Site	VOCs PHC F1-F4 PAHs	Soil, Groundwater

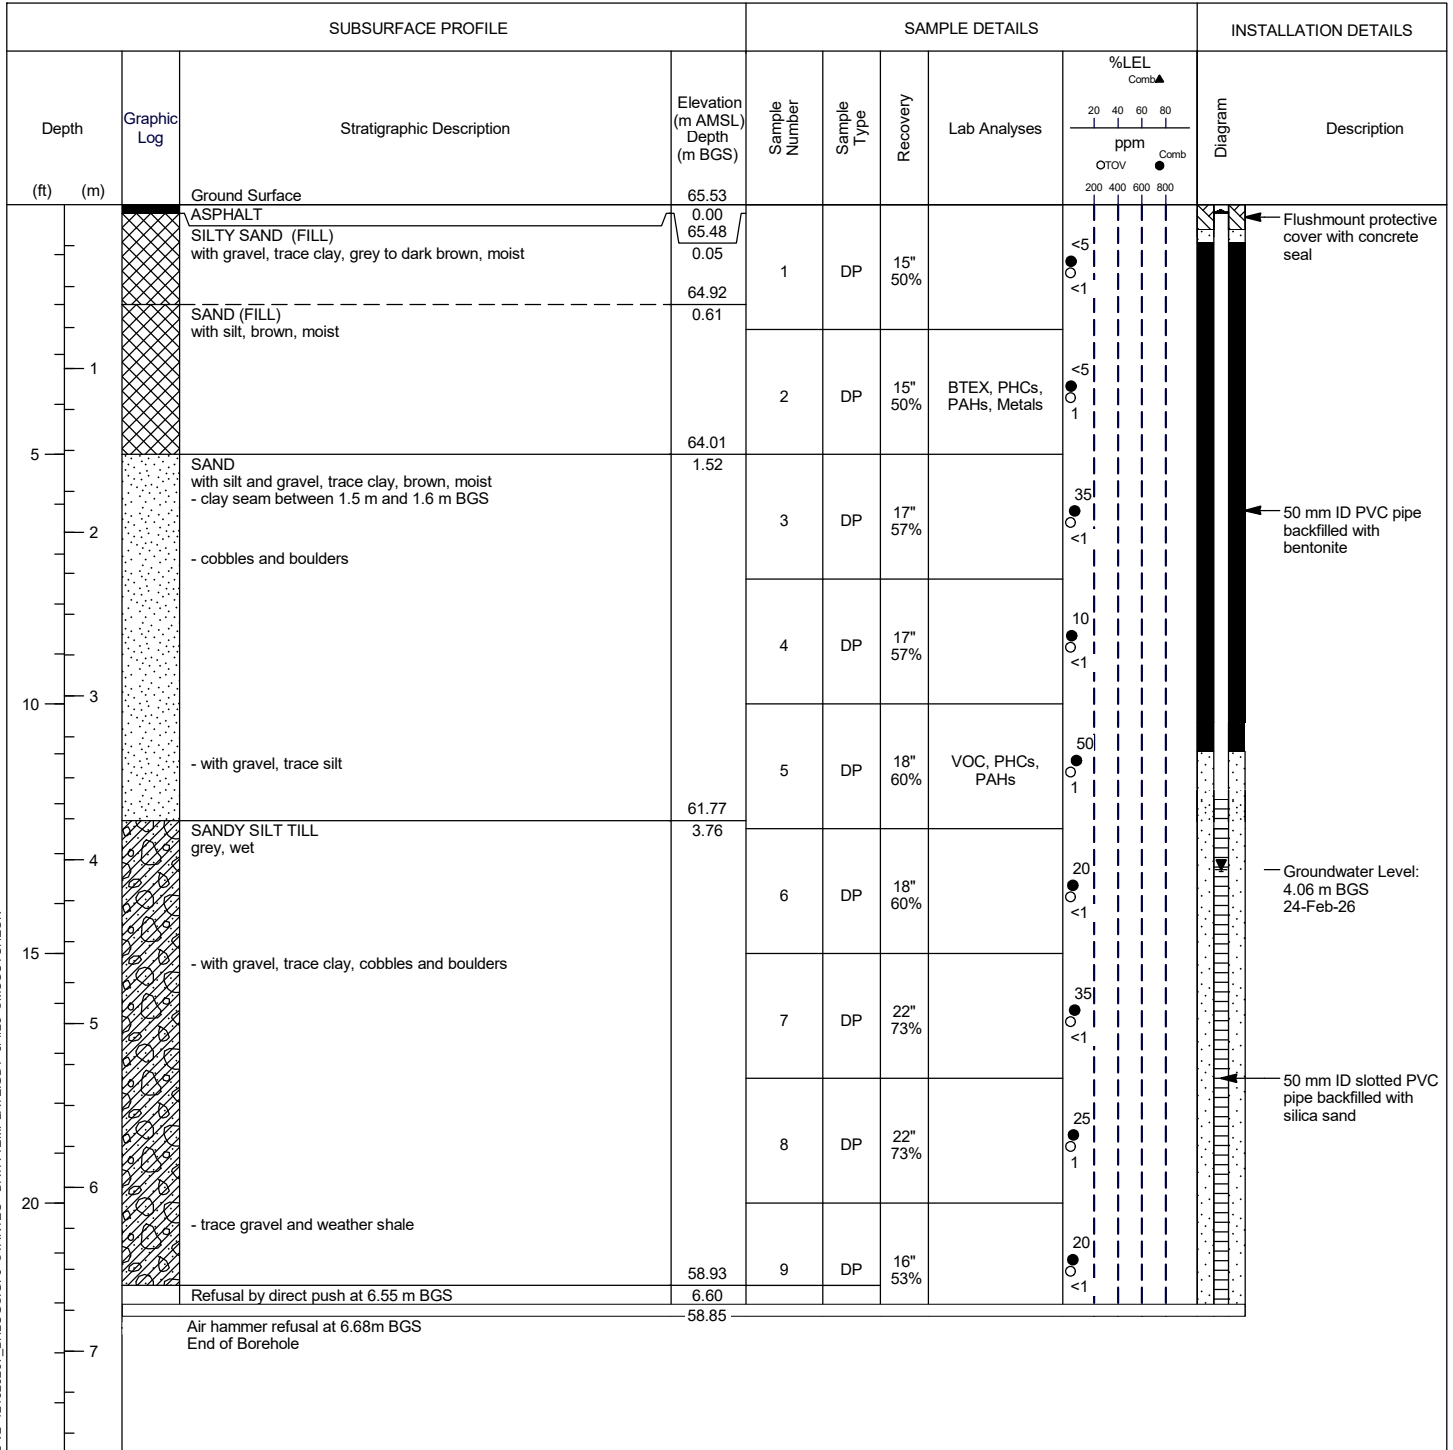
Screen Interval: 3.68 - 6.68 m BGS  
 Sand Pack Interval: 3.35 - 6.68 m BGS  
 Well Seal Interval: 0.23 - 3.35 m BGS
