PH5103-LET.01-REV.01

Subject: **Hydrogeological Assessment and Terrain Analysis
Re-zoning Application
2966-2978 Carp Road
Ottawa (Carp), Ontario**

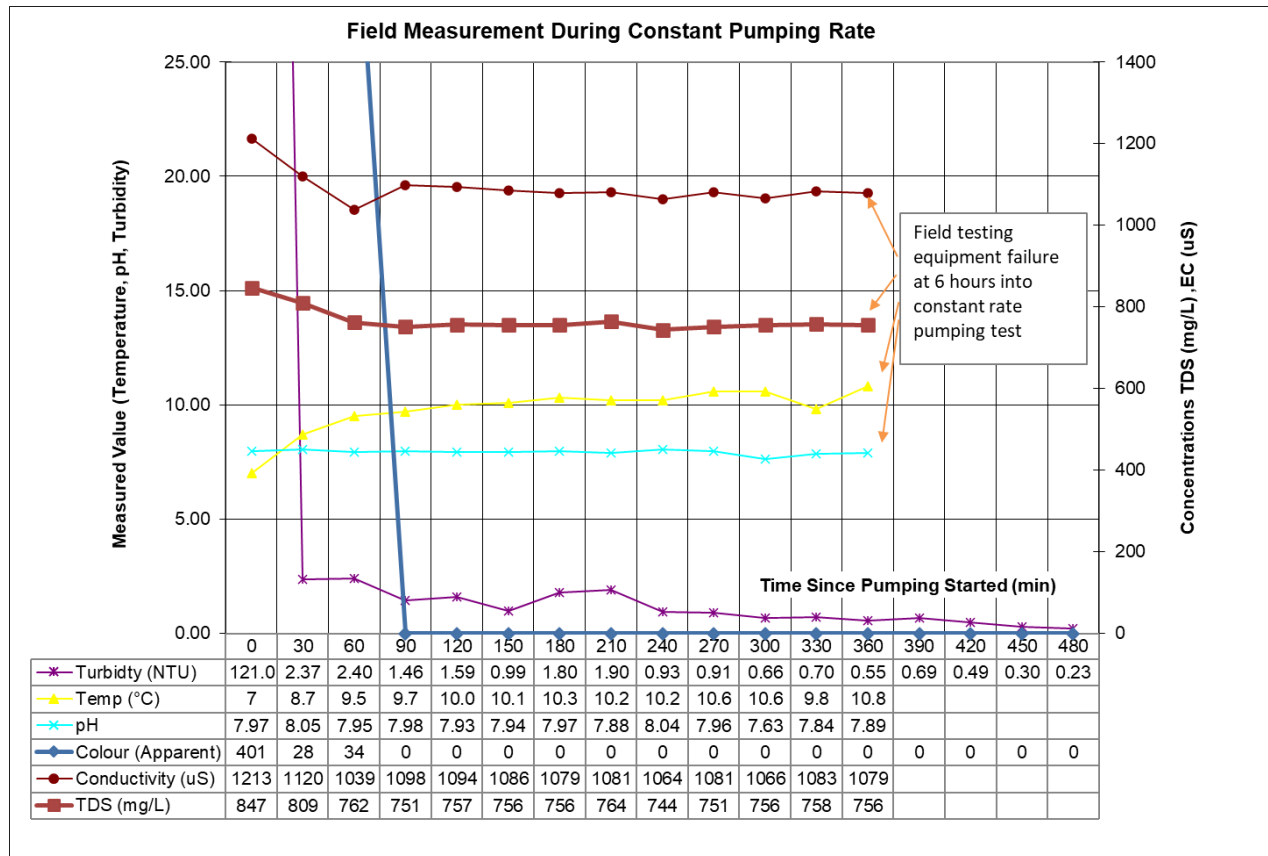
Turbidity, electrical conductivity, total dissolved solids (TDS), pH, true color and temperature were measured at the wellhead during the pumping test. The measurements and time intervals for each of these parameters are summarized on the graphical representation below. In addition, a HACH Pocket Colorimeter II chlorine reader was used to measure the free chlorine residual level. No chlorine residual was detected in the discharged water prior to the collection of the water samples. During the constant rate pumping test, the field-testing equipment which tests for pH, TDS, EC, and temperature malfunctioned at the 6-hour point. These parameters were noted to have stabilized prior to the malfunction of the equipment.

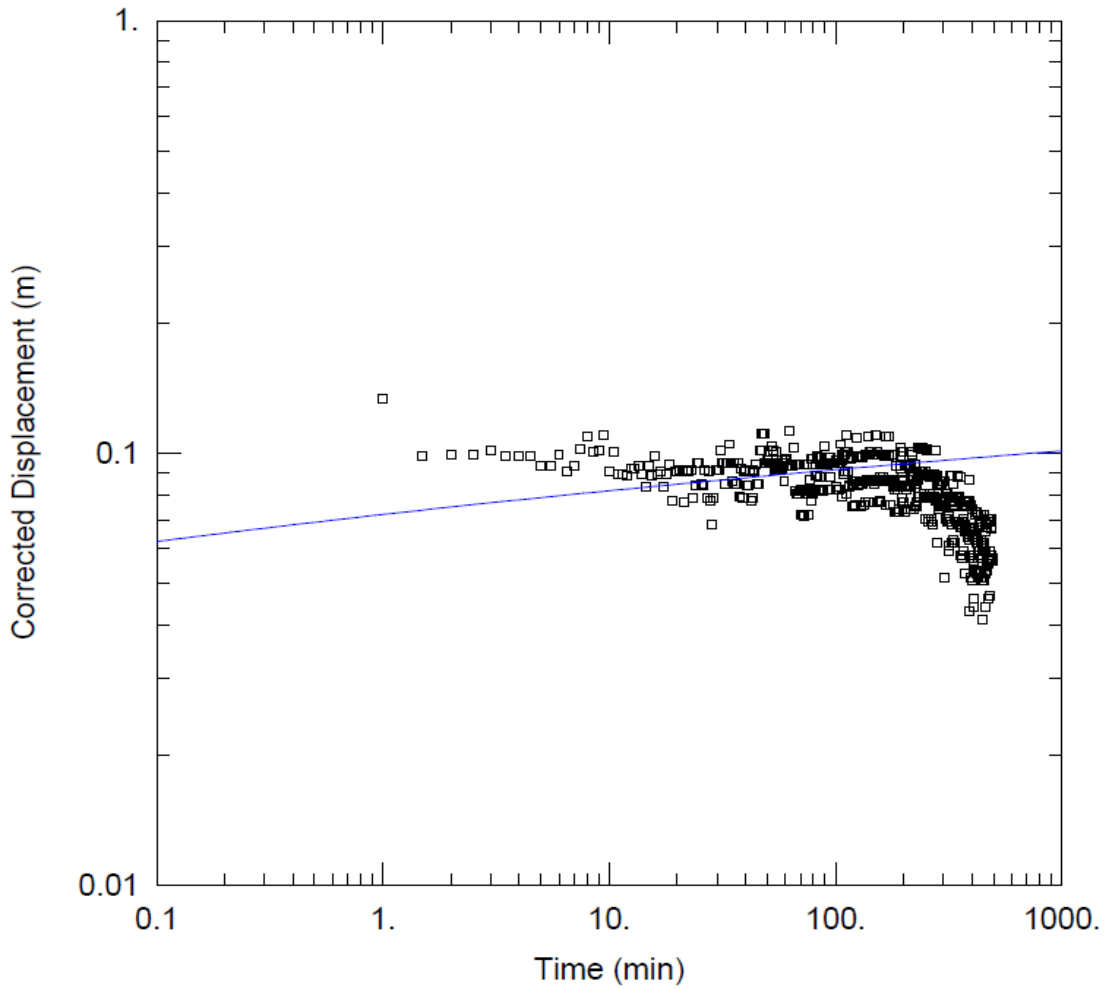
Pumping Test Analysis Report

File No.	PH4484	Well ID:	TW1
Date:	April 13, 2022	Solution Method:	Theis
Client:	Nautical Lands Group	Transmissivity (m ² /day):	1224.1
Site Address:	2966 Carp Road, Ottawa	Discharge Rate (L/min)	45
Project:	Site Plan Application	Analysis performed by:	EA

The pumping test results show that TW1 has a high yield to support the water demands that may be required. Overall maximum drawdown at a constant pumping rate for a period of 8 hours was approximately 0.14 m (0.3% of the available drawdown), but only 0.06 m at the end of the test period. 95% recovery was achieved approximately one minute after the end of pumping. It should be noted that the water level was measured to be increasing throughout the 8-hour constant rate pumping test.

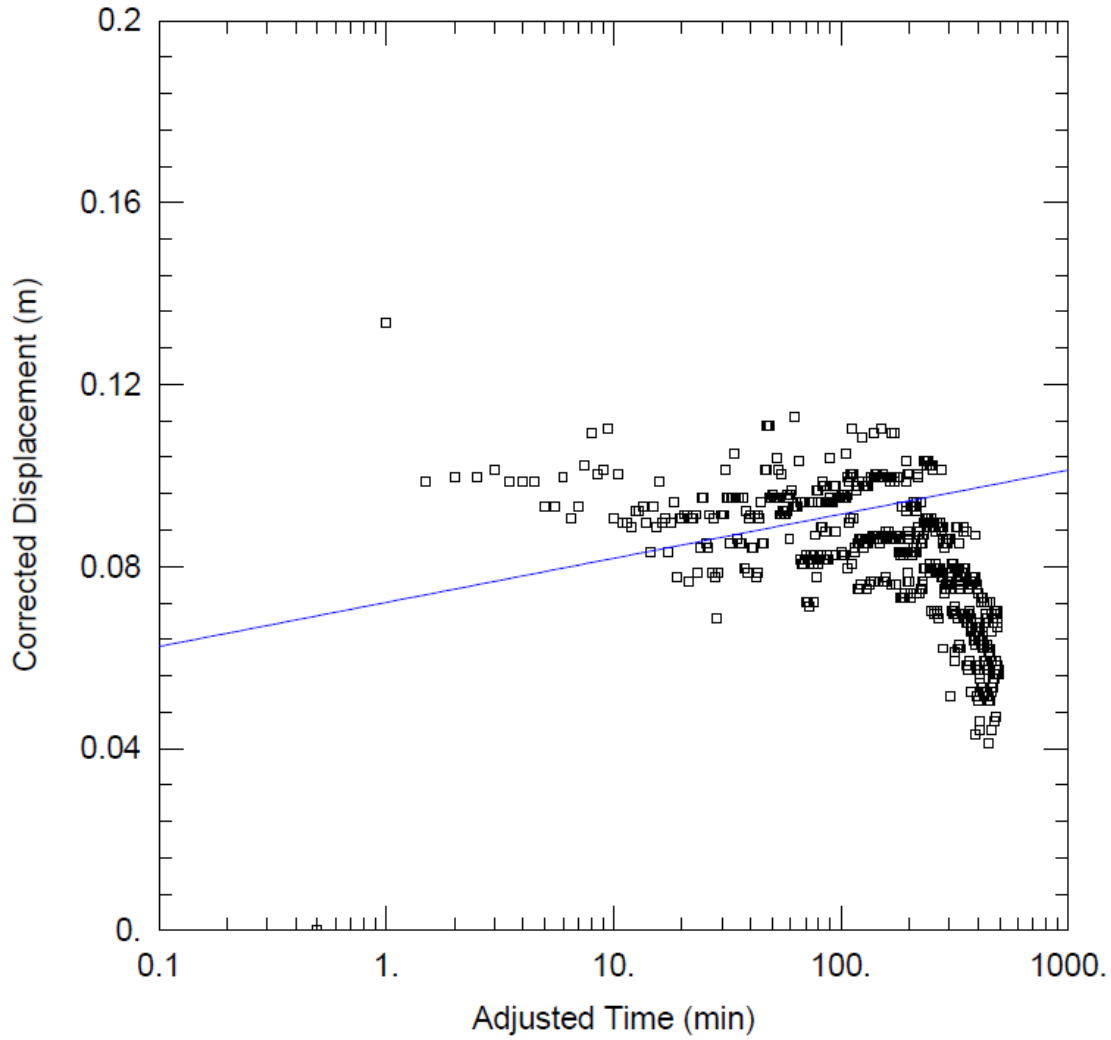
Pumping Test Analysis Report

File No.	PH4484	Well ID:	TW1
Date:	April 13, 2022	Solution Method:	Cooper-Jacob
Client:	Nautical Lands Group	Transmissivity (m ² /day):	1224.1
Site Address:	2966 Carp Road, Ottawa	Discharge Rate (L/min)	45
Project:	Site Plan Application	Analysis performed by:	EA
