**Phase One Environmental Site Assessment**  
**Alexander Community Centre and Alexander Park**  
**960 Silver Street, Ottawa, Ontario**

Phase One Environmental Site Assessment

OTT-23011957-Q0

*City of Ottawa  
Phase One Environmental Site Assessment  
960 Silver Street, Ottawa, Ontario  
OTT-23011957-Q0  
March 2, 2026*

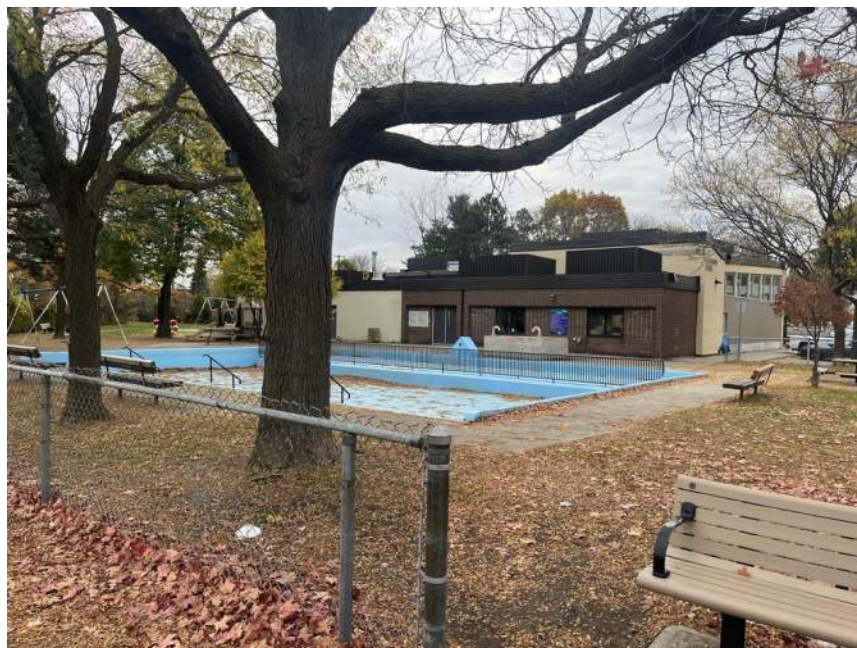
**Photograph No. 3**

View of the wave pool at the rear of the building.

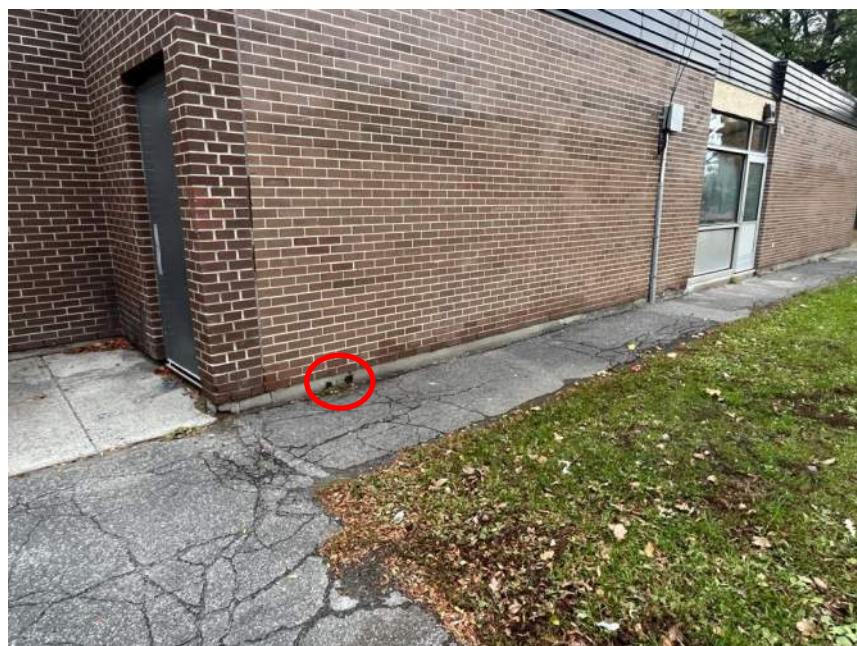
**Photograph No. 4**

EXP did not observe any evidence of above storage tanks (ASTs) during the site reconnaissance. Historic building drawings show that two ASTs (**PCA 5**) were located in the northeast corner of the basement. These were used to store furnace oil for boilers used to heat the building. Holes from the vent/fill pipes were observed in the parking at the base of the north wall of the community building.

The location of the former vent/fill pipes was observed on the north wall of the building during the site visit (**PCA 5**). The transformer on the east side of the site building is a PCA (**PCA 23**). As these PCAs are located on the Phase One property, they are considered to contribute to an APEC.

View of the north building wall and suspected vent/fill pipes.

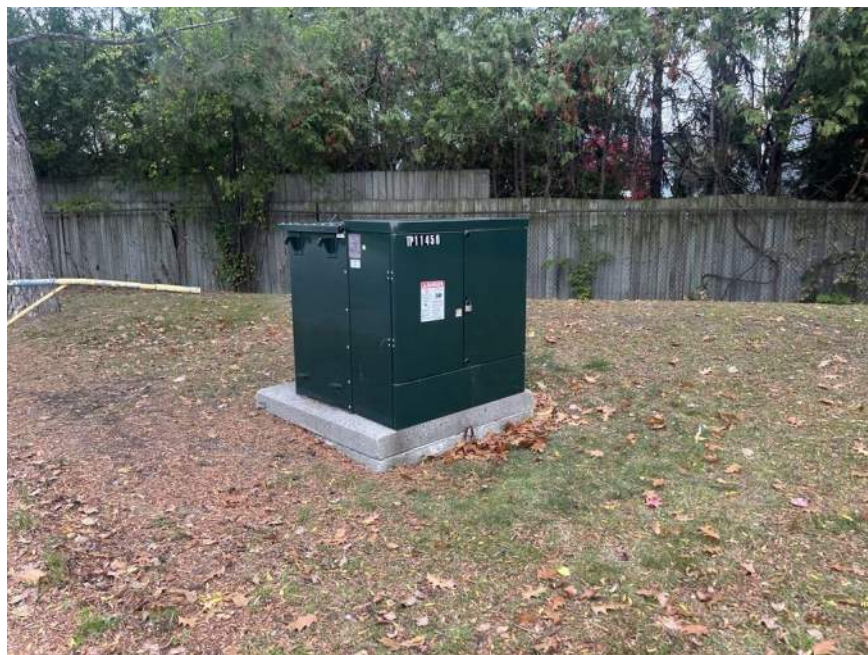
**Photograph No. 6**

A pad mounted transformer was present on the east side of the site building. The label on the transformer indicated that it contained < 2ppm of PCB. The transformer is **PCA 23: PCA #55** – Transformer manufacturing, processing, and use. It is noted that the transformer was sitting on a concrete pad, which appear to be in good condition. No staining was observed.

View of the transformer to the northeast of the site building.

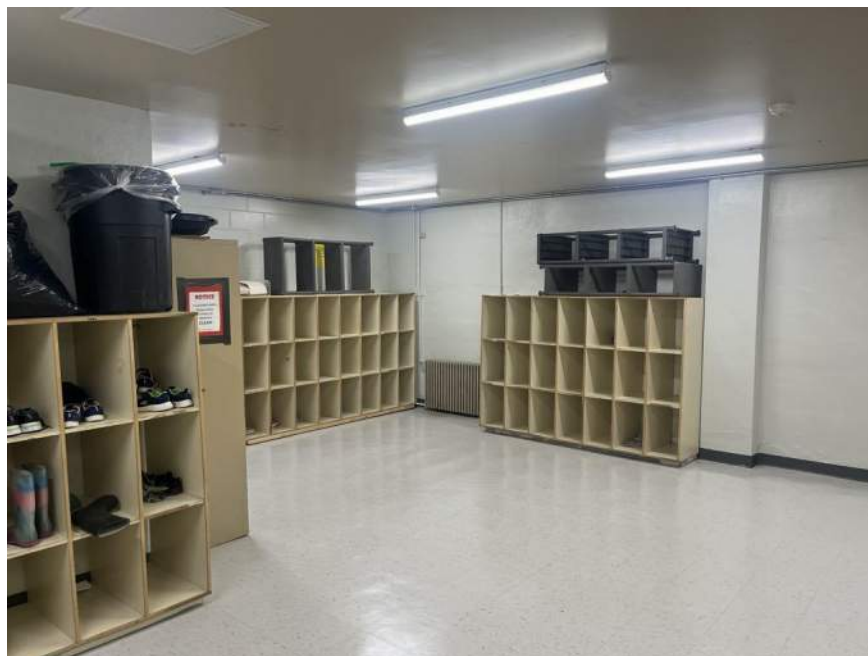
**Photograph No. 7**

The building is heated and cooled by roof-top natural gas fired furnaces/air conditioning units. There were also hot water radiators observed in the basement of the building.

View of the basement of the site building.

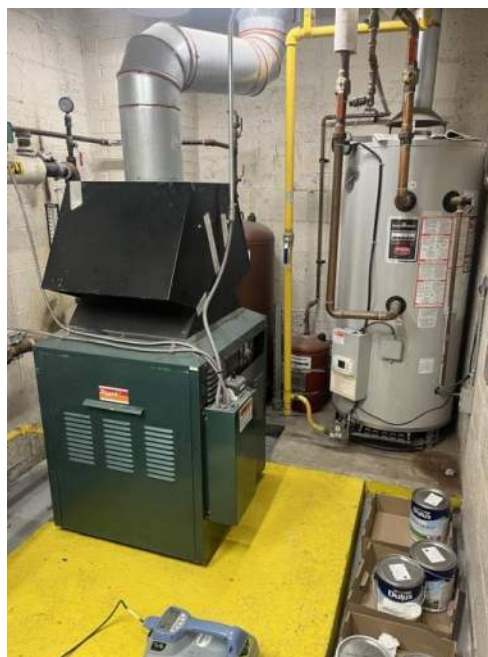
**Photograph No. 8**

The City also provided several historic drawings showing the site building layout. An as-built drawing 573/M-1 from 1965 shows two 250 gallon above ground storage tanks (ASTs) located in the northeast corner of the basement (**PCA 5: PCA #28 – Gasoline and associated products storage in fixed tanks**). Drawing M-1 from 1984 showed renovations to the community centre, including the removal of the ASTs, and the replacement of the oil fired boiler with a natural gas fired boiler.

View of the natural gas fired boiler in the basement mechanical room.
