**RE: Environmental Impact Statement and Tree Conservation Report Update  
319 Huntmar Drive  
Southeast Portion of Taggart's Palladium Drive Kanata West Development**

26-6019A  
HUNTMAR DRIVE  
CITY OF OTTAWA

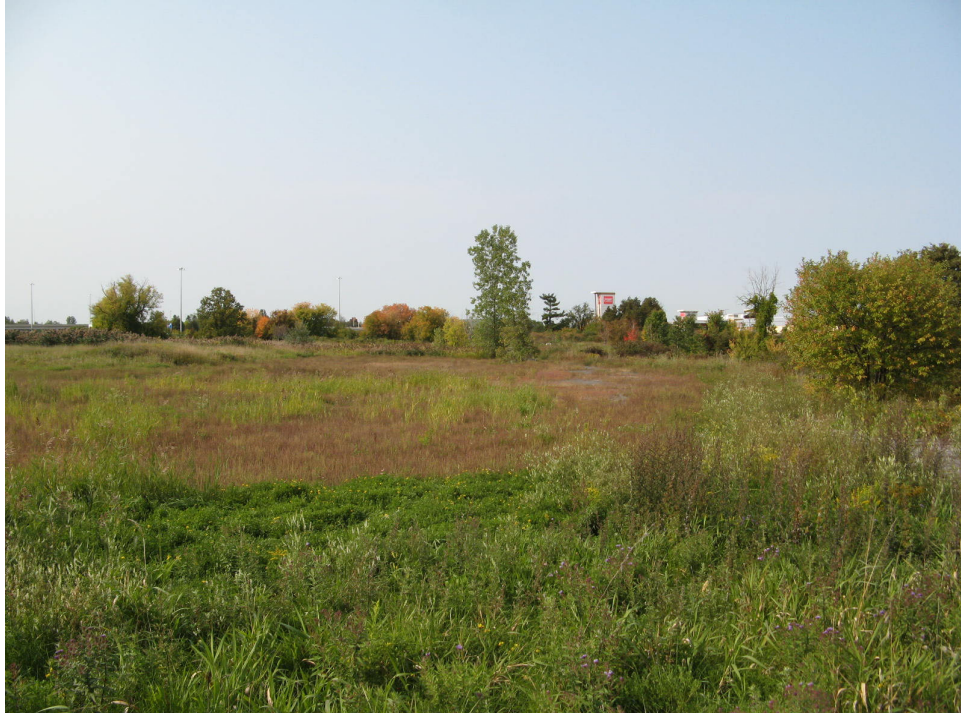
*Photo 1 – Meadow habitat dominates the current site. This is the west and central portions of the site, with view looking west from Huntmar Drive*

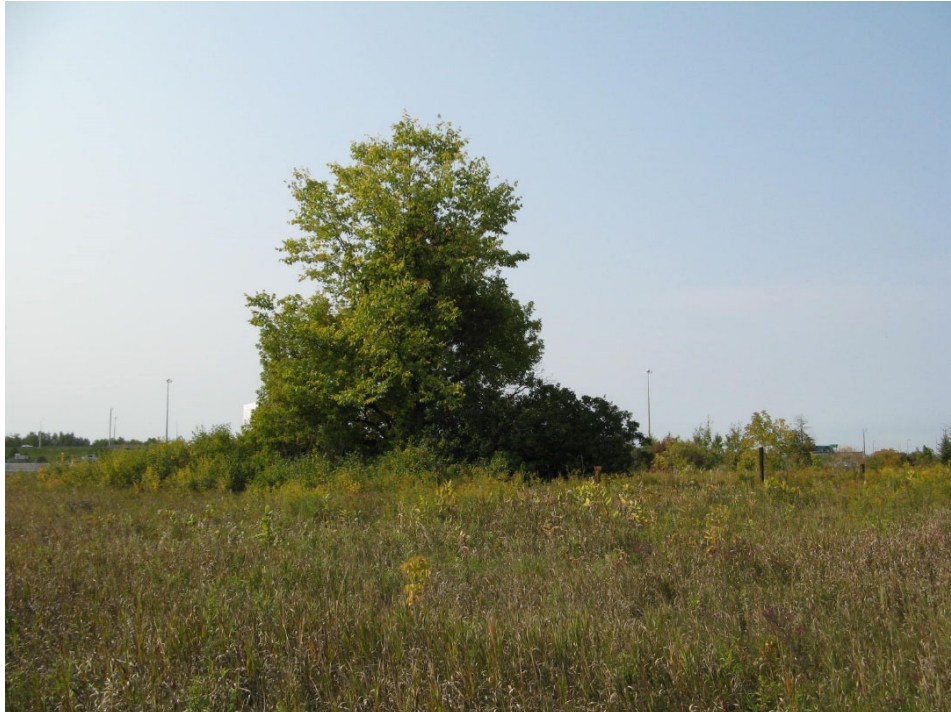
*Photo 2 – Meadow habitat in the west portion of the site. View looking east to south end of intermittent deciduous hedgerow in the central-west portion of the site.*

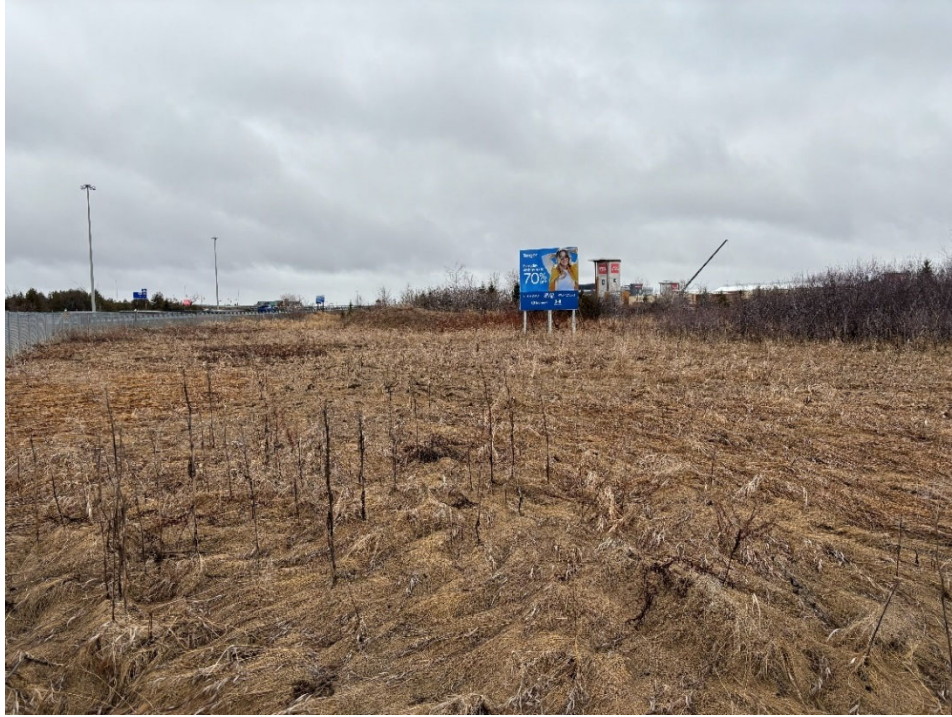
*Photo 3 – Meadow habitat in the west portion of the site. View looking west in the central-west portion of the site. Photo taken April 1, 2026.*

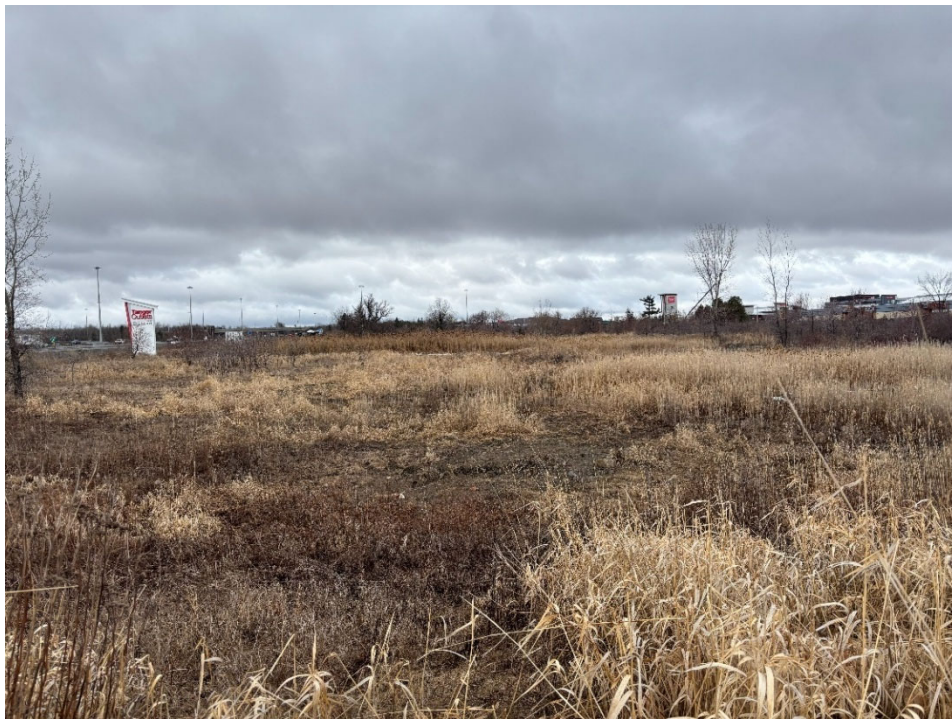
*Photo 4 – Meadow habitat in the east portion of the site. View looking west near Huntmar Drive. Photo taken April 1, 2026.*

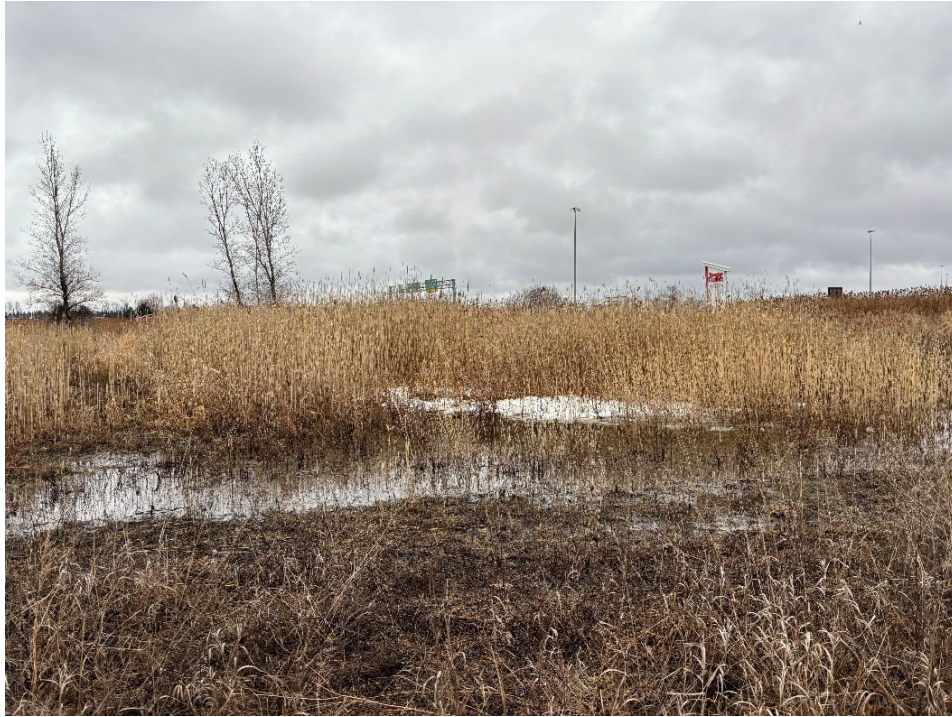
*Photo 5 – Meadow habitat with some standing water in the east/central portion of the site. View looking south from the north portion of the site. Photo taken April 1, 2026.*

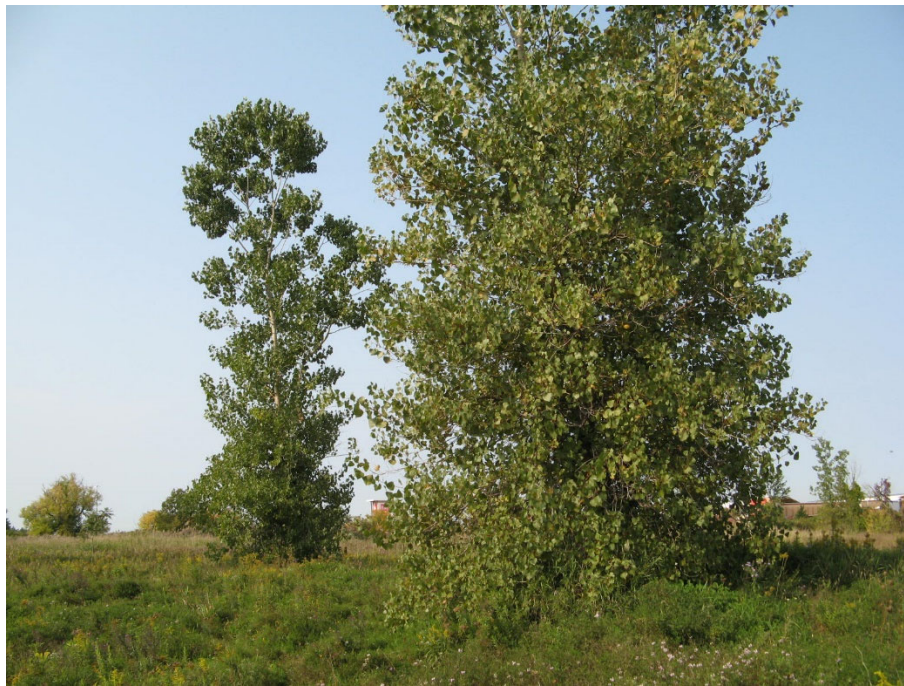
A few trembling aspens up to 38cm diameter at breast height (dbh) are in the meadow habitat in the southeast portion of the site (Photo 6). Fungal growth was extensive on the poplar trunks. Staghorn sumac shrubs are among the poplar trees. Trembling aspen and Manitoba maple stems up to 25cm dbh are also along portions of the north site boundary (Photo 7). Regenerating white cedar and Manitoba maple stems up to 10cm dbh are scattered in the west meadow habitat, along with serviceberry, red raspberry, and staghorn sumac shrubs.

*Photo 6 – Scattered trembling aspen in the southeast portion of the meadow habitat. View looking northwest.*

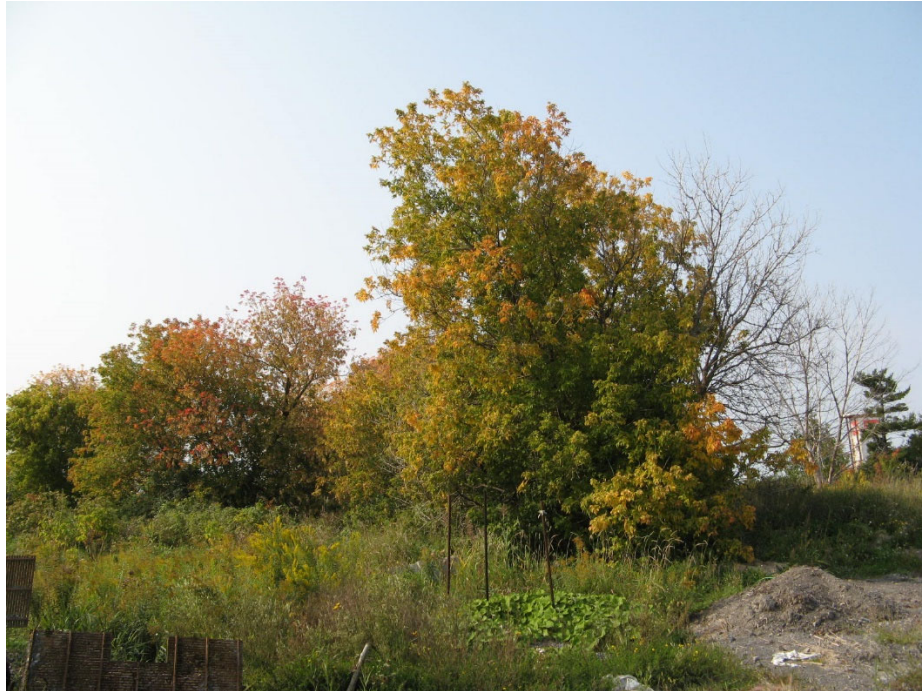
*Photo 7 – Manitoba maple and dead white ash in the north-central portion of the current site.  
View looking west.*

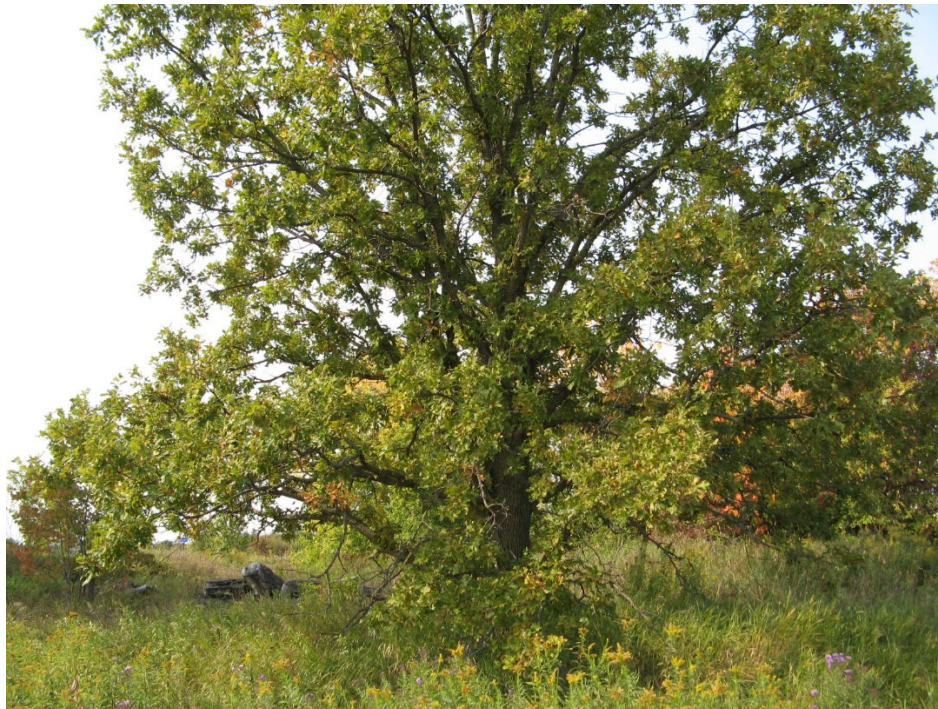
*Photo 8 –Mature bur oak in the intermittent deciduous hedgerow in the central -west portion of the  
current site. View looking west.*

No tree retention was identified on or adjacent to the current site in the 2015 Tree Conservation Report. Other than the mature bur oak in the central-west portion of the site, no prime candidate trees for retention (due to species and/or condition) were observed on the current site. There are no co-owned trees or adjacent trees with critical root zones extending onto the site due to adjacent roadways and generally open Feedmill Creek corridor to the north.

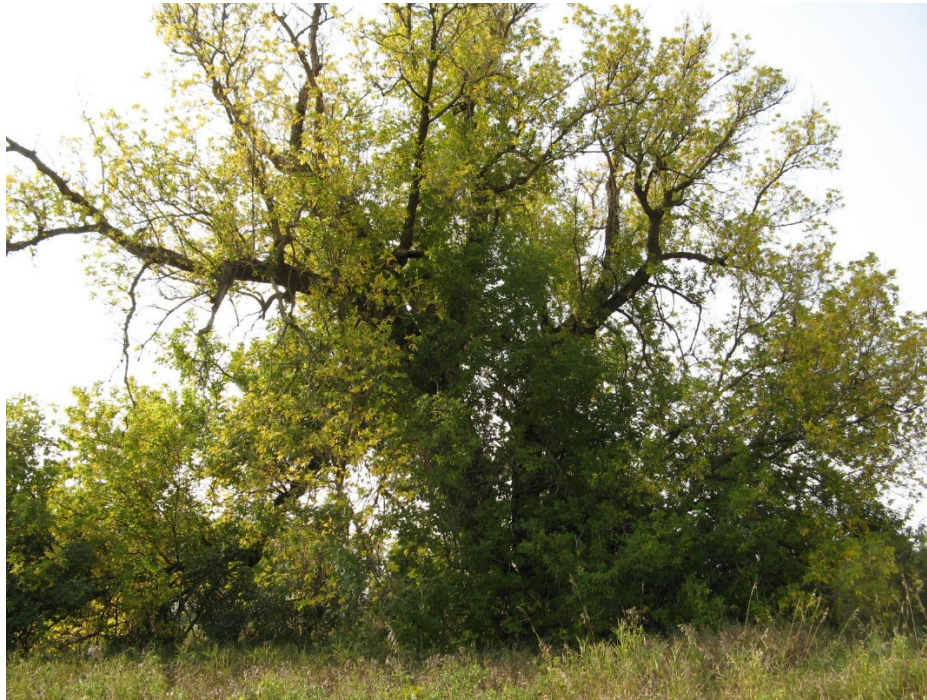
*Photo 9 –Mature Manitoba maple in the intermittent deciduous hedgerow. View looking southwest.*

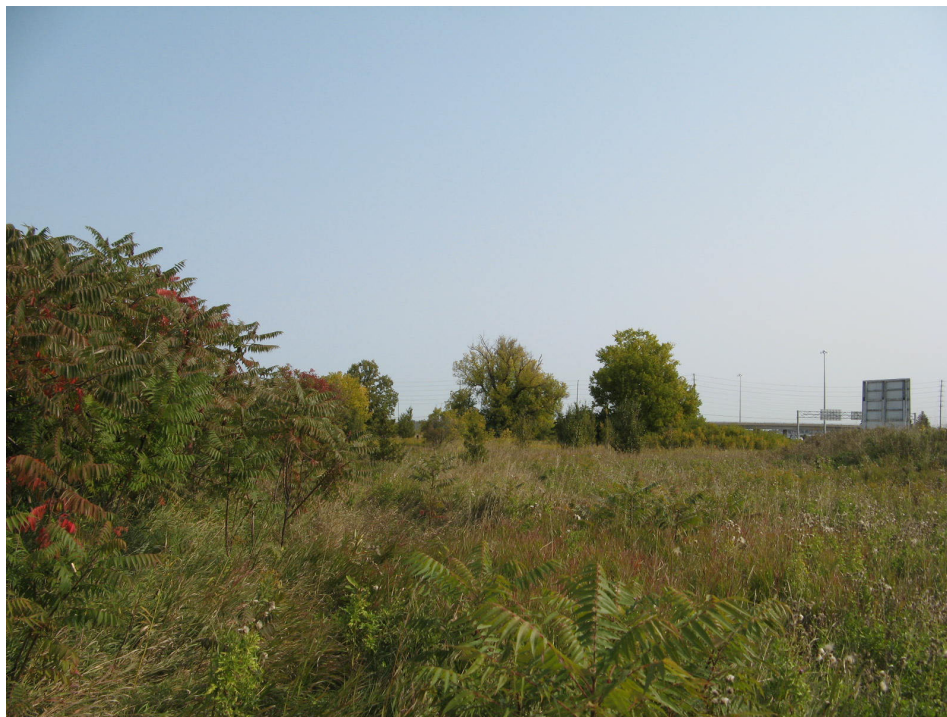
Where the shrub coverage is greater than 25 percent, the vegetation community is identified on Map 1 as cultural thicket. In addition to the well-represented red raspberry and staghorn sumac, common buckthorn, tartarian honeysuckle, red-osier dogwood, and nannyberry shrubs are also present in the thicket habitat, along with regenerating Manitoba maple, white birch, and trembling aspen stems (Photos 10 and 11).

*Photo 10 –Cultural thicket (left) and meadow (right) habitat in the central -west portion of the site.  
View looking east.*

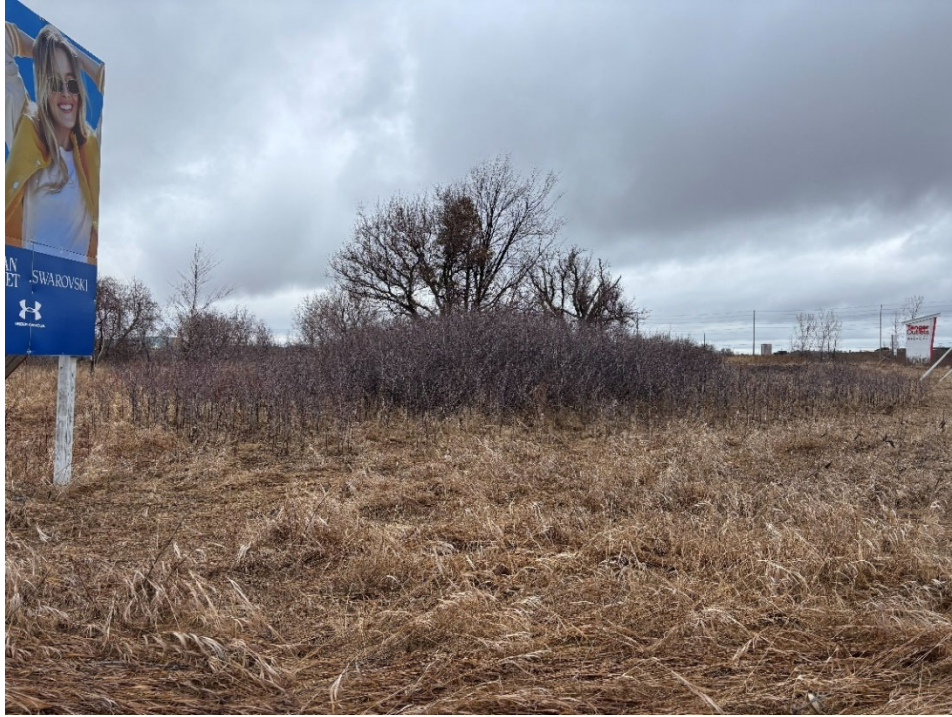
*Photo 11 –Cultural thicket (background) and meadow (foreground) habitat in the central -west portion of the site. View looking east. Photo taken April 1, 2026.*

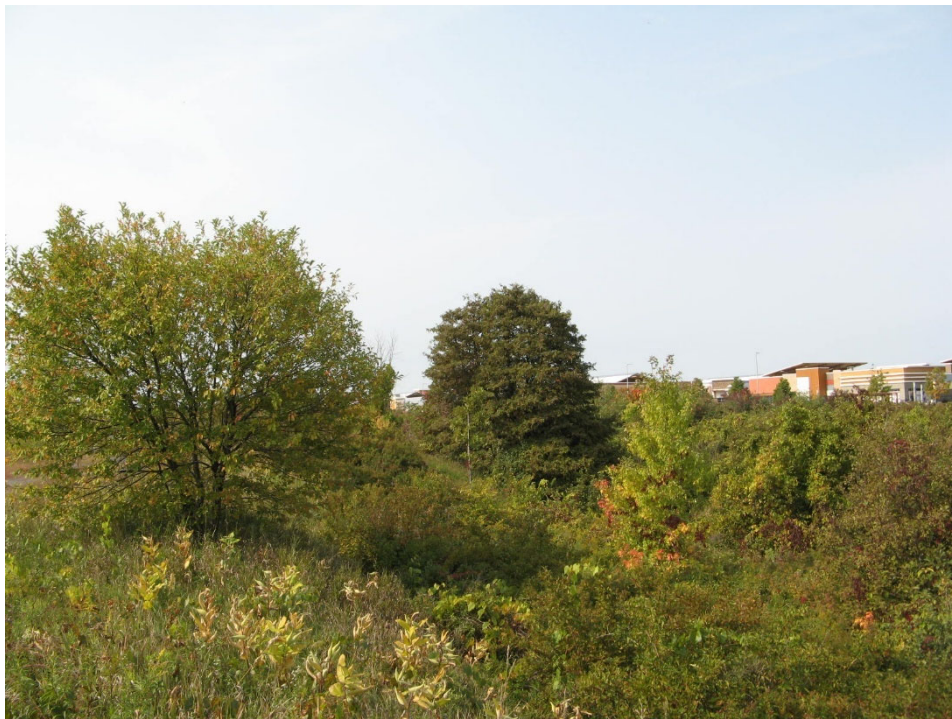
The Feedmill Creek corridor to the north of the site (Photos 12 & 13) contains mature white cedar and white pine. Manitoba maple, green ash, and white elm are common, as are common buckthorn, red raspberry, staghorn sumac, speckled alder, and red-osier dogwood shrubs. Many plantings including white spruce and red maple, with white cedar, ash, and Manitoba maple regenerating stems also present.

*Photo 12 –Feedmill Creek corridor to the north of the current site. View looking northwest.*

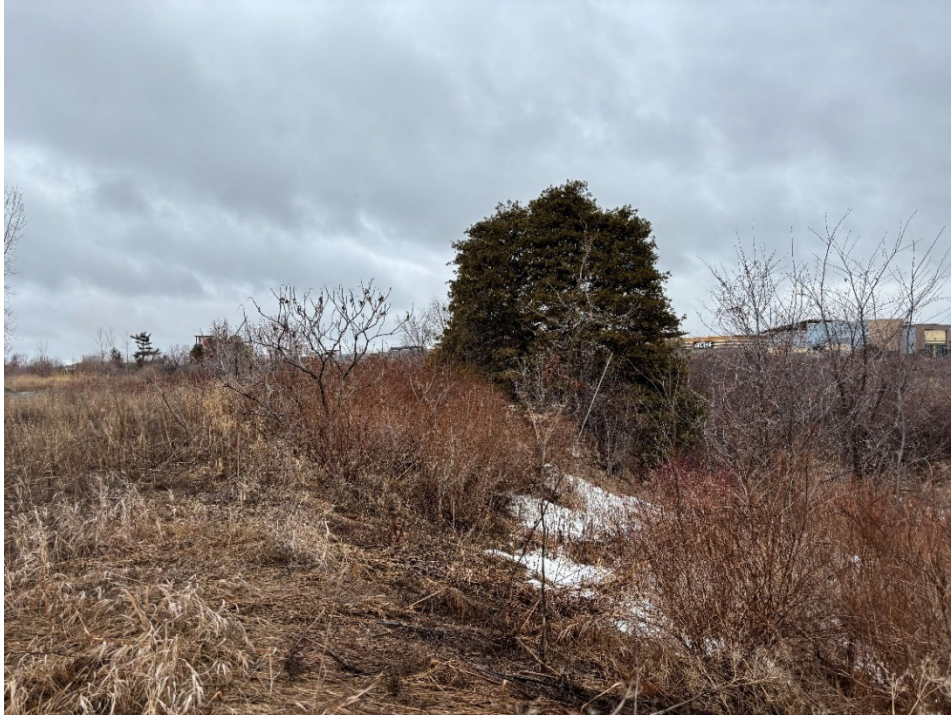
*Photo 13 –Feedmill Creek corridor to the north of the current site. View looking southwest.  
Photo taken April 1, 2026.*

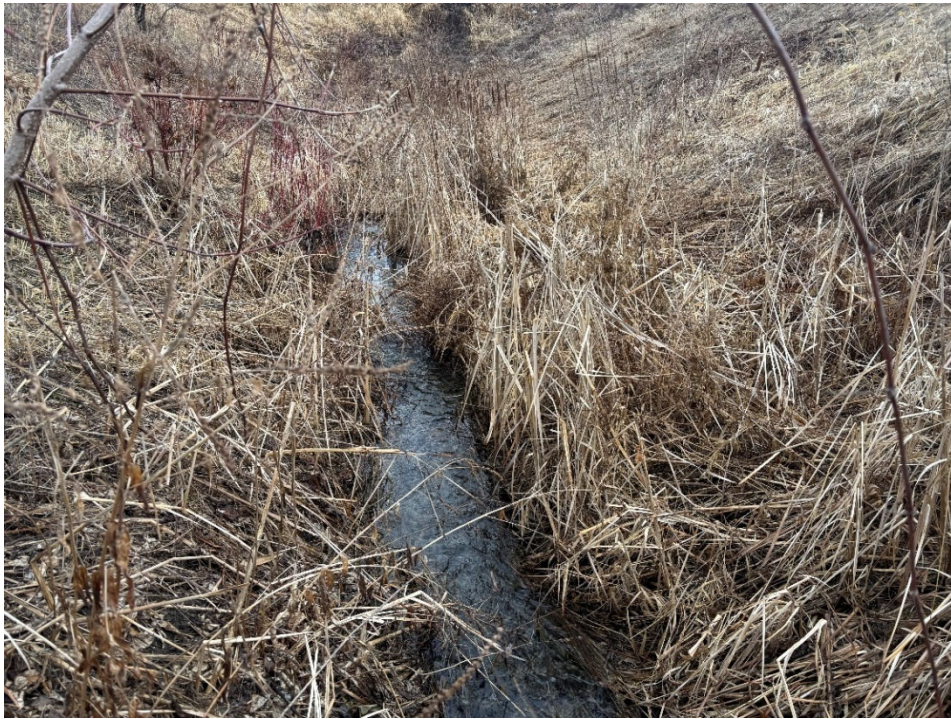
*Photo 14 – Ditch along eastern property line. View looking northwest from south of existing access  
from Huntmar Drive. Photo taken April 1, 2026.*

Direct fish habitat is also considered to be present in the lower reach of the ditch (immediately adjacent to Feedmill Creek), along the eastern property line, which conveys water from a stormwater pond on the south side of Highway 417, as illustrated on Map 3. This ditch contained clear, flowing water at the time of the April 1, 2026 site visit, and two barriers were observed in the ditch at the locations shown on Map 3, which would prevent any fish movement further upstream and therefore the majority of this ditch is considered to be indirect fish habitat. In order to protect the potential downstream fish habitat utilization within this ditch and Feedmill Creek, all development will be located at least 10 metres from the ditch, with the exception of the extension of an existing culvert under the access road from Huntmar Drive in order to provide for a new access road, as well as some site grading.

1. A 10 metre wide buffer area from the highwater mark of the existing ditch, shall be maintained in a natural vegetated state and be re-vegetated with native species.
2. Prior to any works related to the construction of a new stormwater outlet to the Creek or the extension of the existing culvert under the access road from Huntmar Drive, a Request for Review form will need to be submitted to the Department of Fisheries and Oceans (DFO) for review and any recommendations from DFO are to be properly implemented.
3. Permits from the Mississippi Valley Conservation Authority for the works within their regulated areas, will also need to be obtained.
