| To: | Ashbury College<br>362 Mariposa Avenue | From: | Stantec Consulting Ltd.<br>1331 Clyde Avenue |
| Project/File: | Ashbury College – Supplementary<br>Geotechnical and Hydrogeological<br>Investigation | Date: | August 19, 2025 |

**Reference: Ashbury College – Supplementary Geotechnical and Hydrogeological Investigation in Support of the Redevelopment of the Outdoor Field**

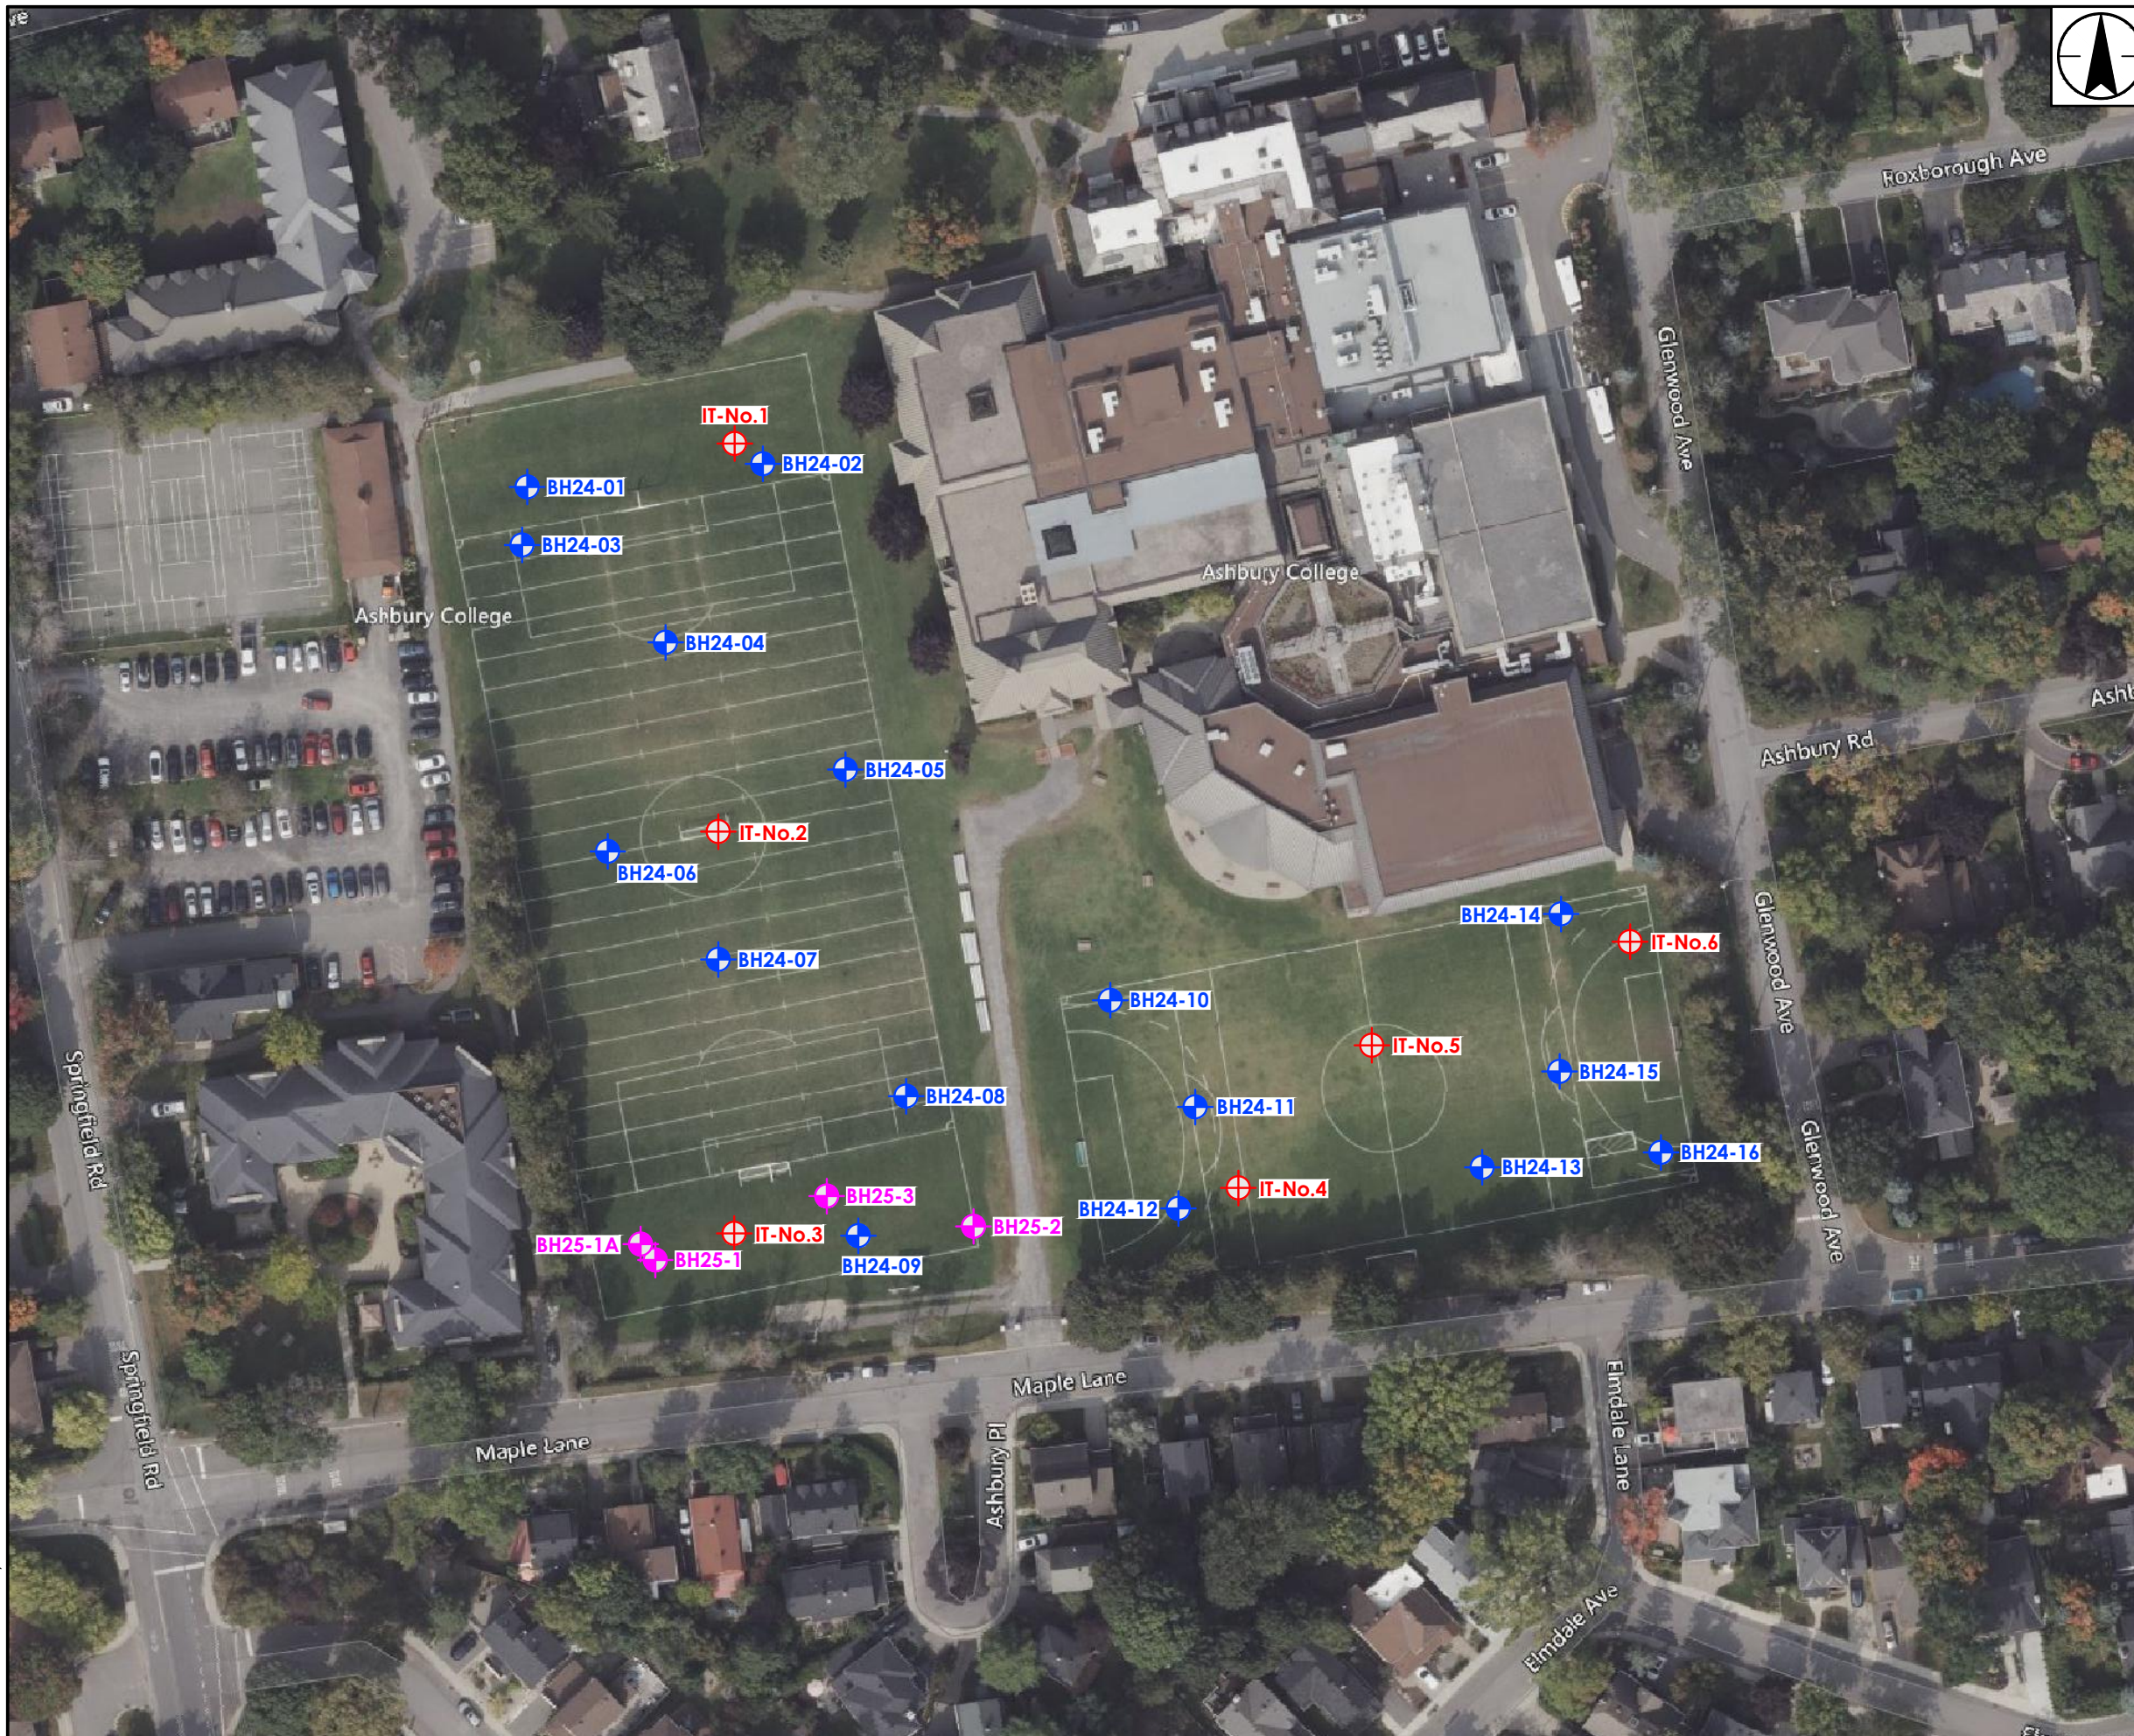
### **B.1 Borehole Location Plan**

The supplementary investigation program consisted of advancing three boreholes identified as BH25-1, BH25-2, and BH25-3 to depths ranging from 3.4 m to 9.2 m below the existing ground surface. An alternate borehole, identified as borehole BH25-1A, located approximately three meters north of BH25-1, was augured to the top of the bedrock to install multi-level monitoring well at this location (i.e., one in the overburden at BH251A and one in the bedrock at BH25-1). Two boreholes (BH25-1, and BH25-2) were located at the proposed stormwater tank, and one borehole (BH25-3) was located near the sprint track. Their locations are shown in Drawing No.1 presented in **Appendix B**.

INFILTRATION TEST (STANTEC 2024)
-

BOREHOLE (STANTEC, 2025)

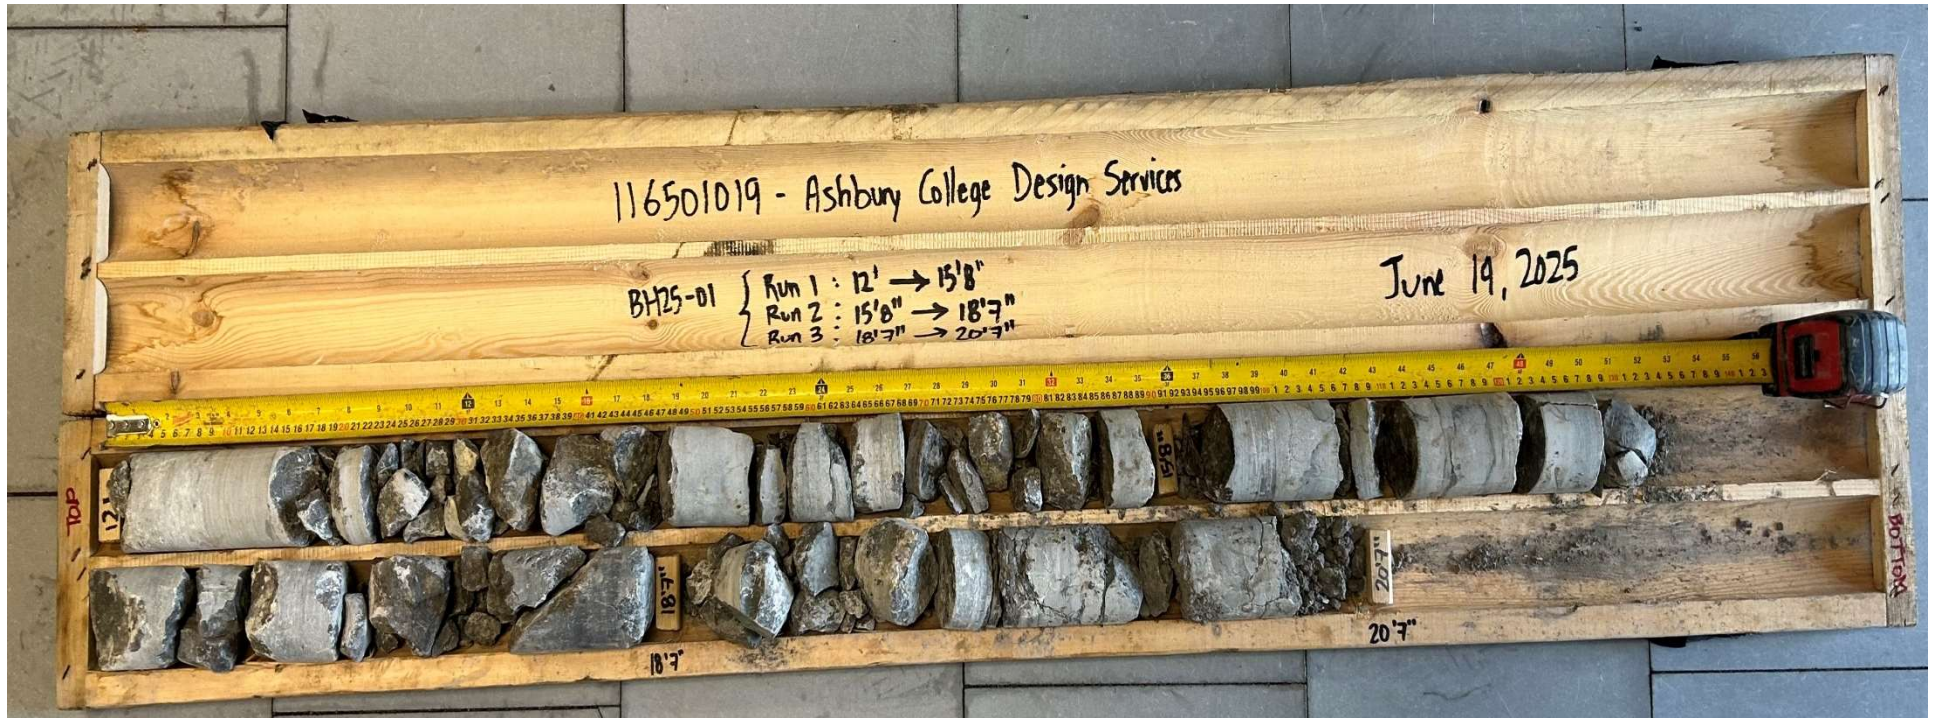
Rock Core Photo No.: 1

Rock Core Photograph

Borehole: BH25-1

The sampled bedrock consisted of grey to black limestone with shale interbeds. The rock has been noted as highly to slightly weathered near the surface and becomes fresh at depth. The Rock Quality Designation (RQD) value ranged from 0% to 31%, indicating a very poor to poor quality rock.

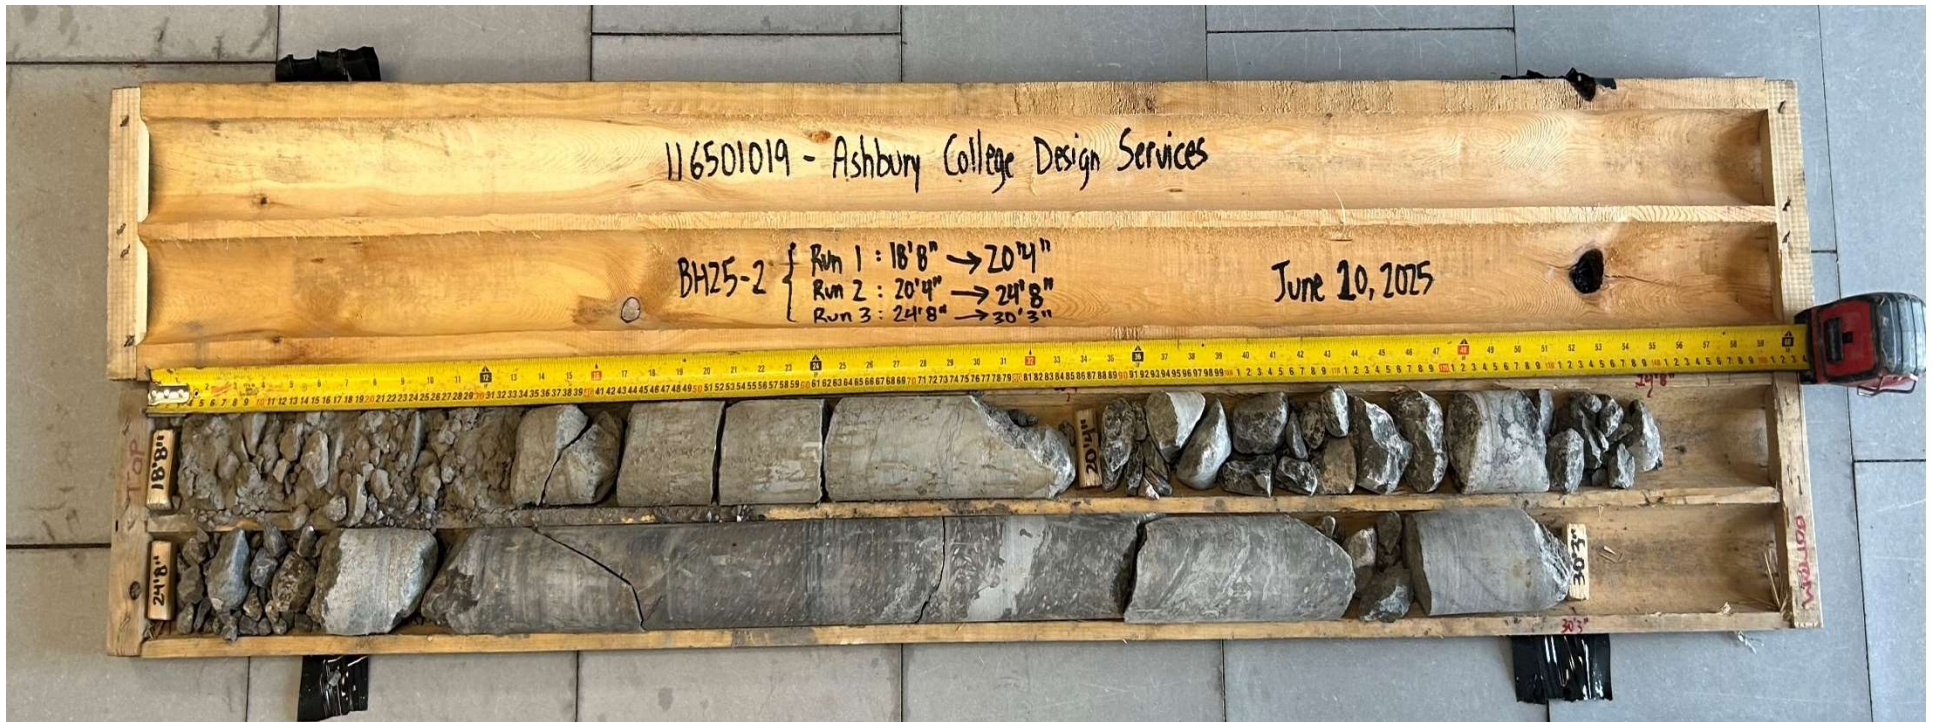
Rock Core Photo No.: 2

Borehole: BH25-2

The strength of the intact rock core was determined by conducting Unconfined Compressive Strength (UCS) testing on a select rock core sample. A summary of the results of the laboratory testing carried out on the bedrock is presented in Table 4 below. Based on the UCS test findings, the bedrock was found to be strong.

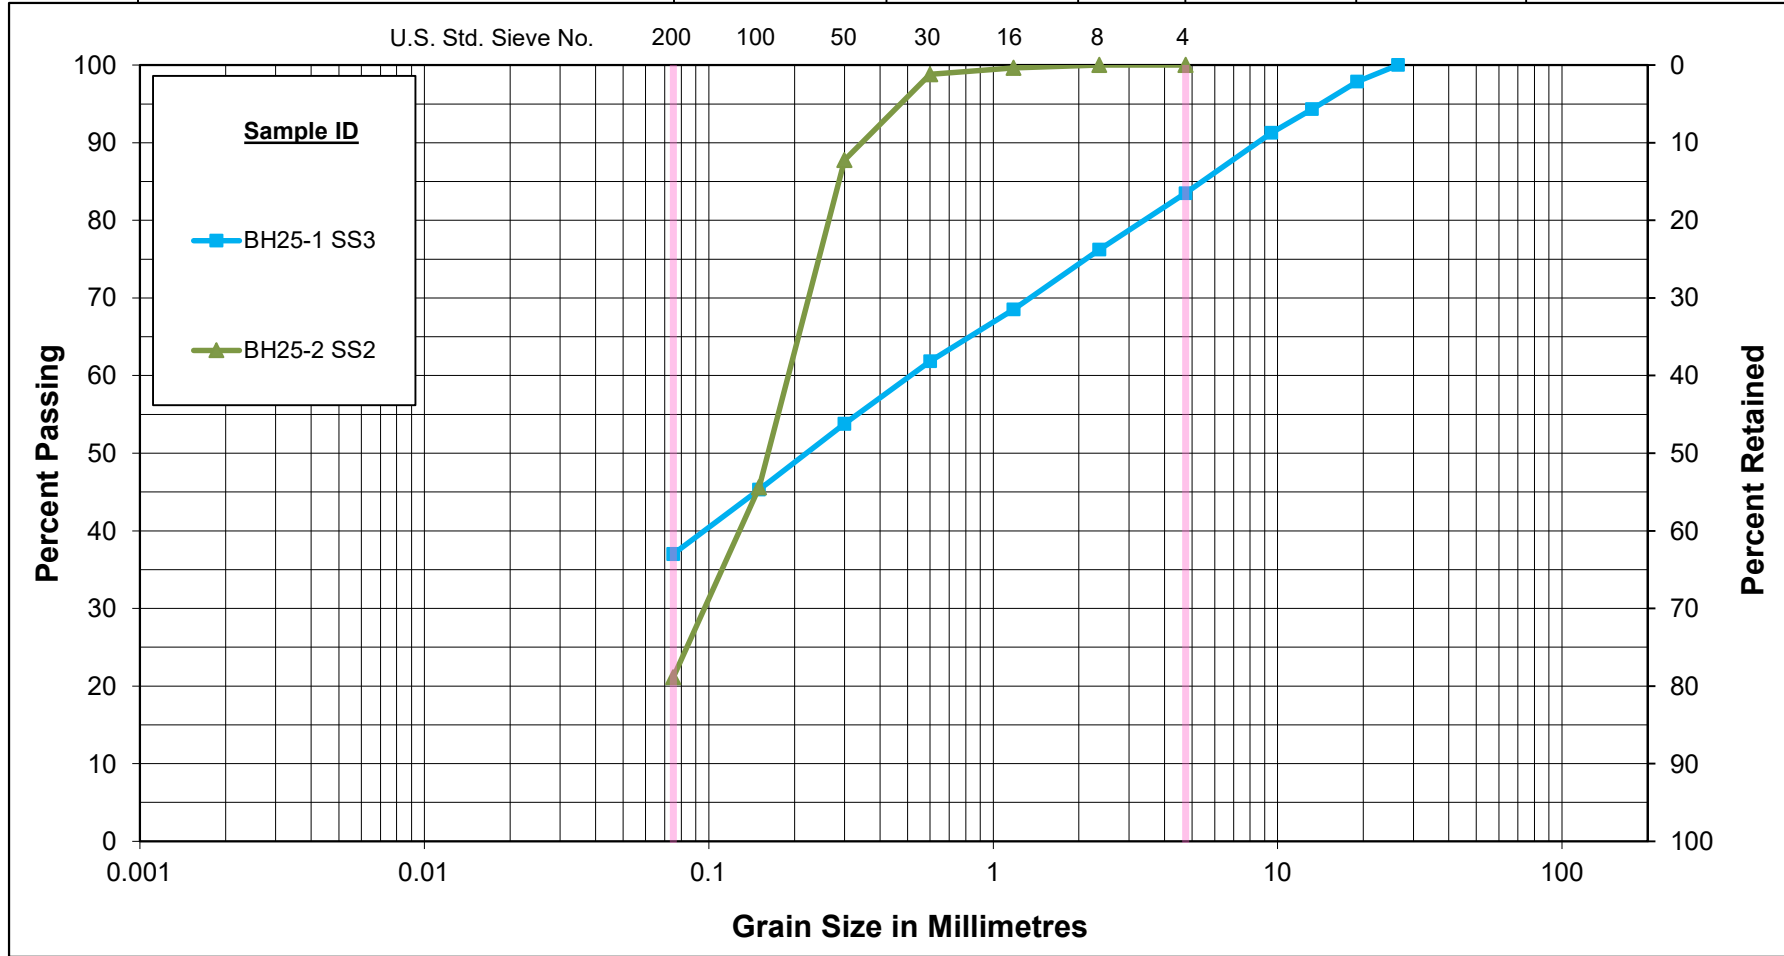
## GRAIN SIZE DISTRIBUTION

Fill Material

Two (2) samples of fill were selected for grain size distribution testing. The grain size distribution curve for the fill is provided in Figure D1 in **Appendix D**, and a summary of the test results is provided in Table 2 below.

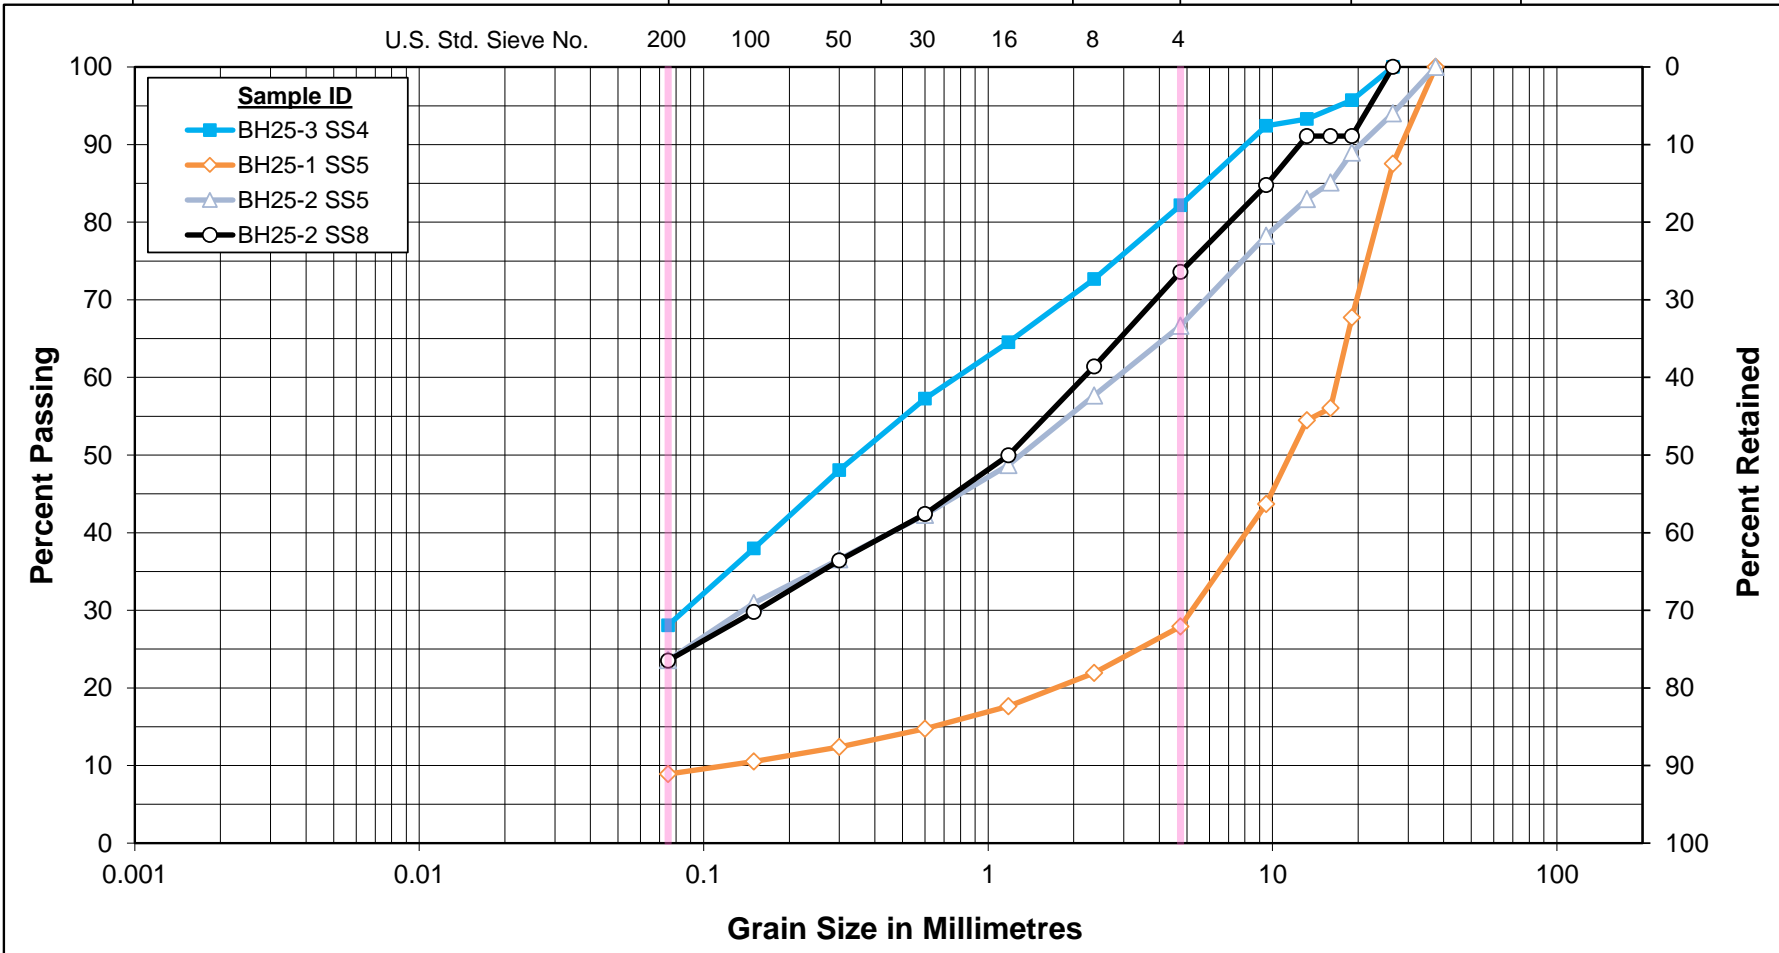
## GRAIN SIZE DISTRIBUTION

Glacial Till  
Ashbury College

Four (4) samples of till were selected for grain size distribution testing. The grain size distribution curve for the till is provided in Figure D2 in **Appendix D**, and a summary of the test results is provided in Table 3 below.

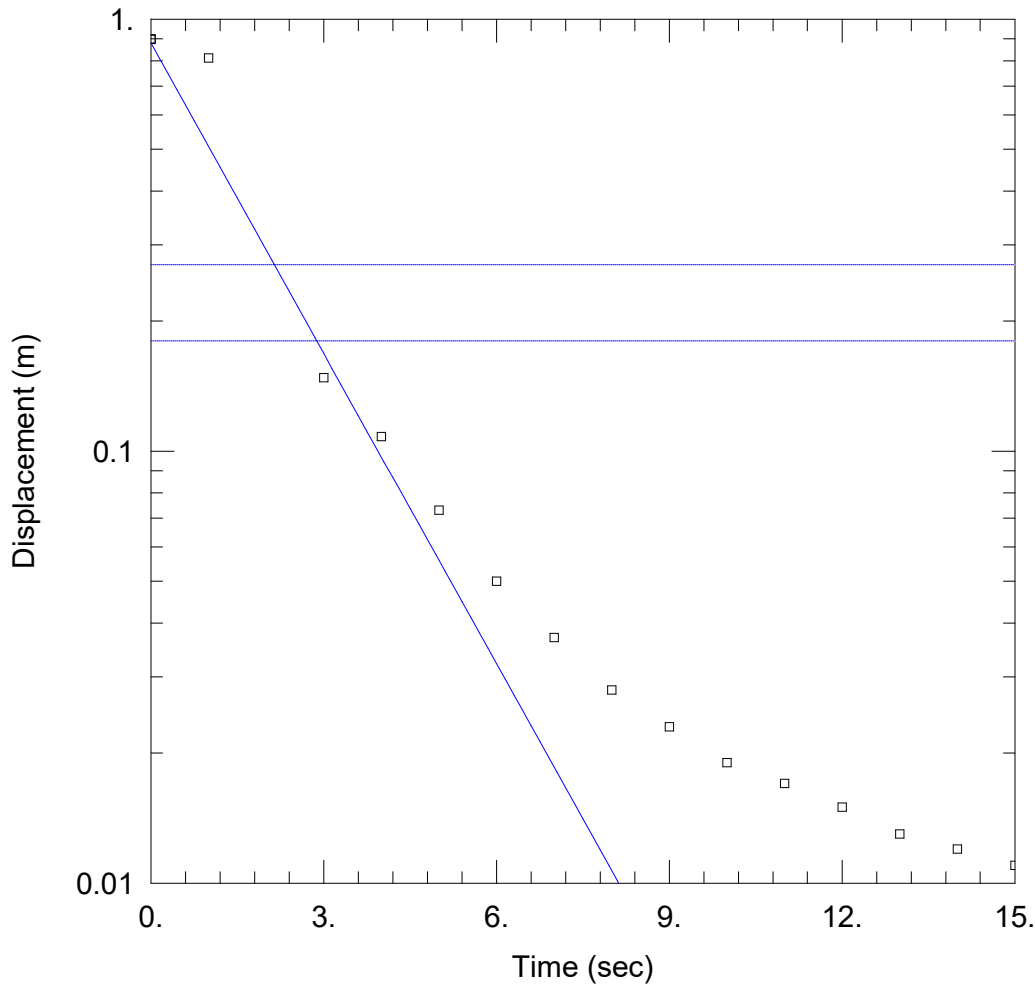
BH25-01 - FALLING HEAD TEST

K = 0.00041 m/sec

y0 = 0.8799 m

Stantec performed in-situ hydraulic response testing on BH25-1 and BH25-2, which are screened at elevations ranging between 65.6 to 61.4 m AMSL in slightly to moderately weathered limestone. The tests consisted of creating an instantaneous change in each monitoring well water level by introducing a slug into the well below the static water level (i.e., falling head test), followed by recording the time taken for the resulting water level to return to its static condition using a combination of manual and continuous (i.e., data logger) water level measurements. After the water level returned to static conditions, the slug was then

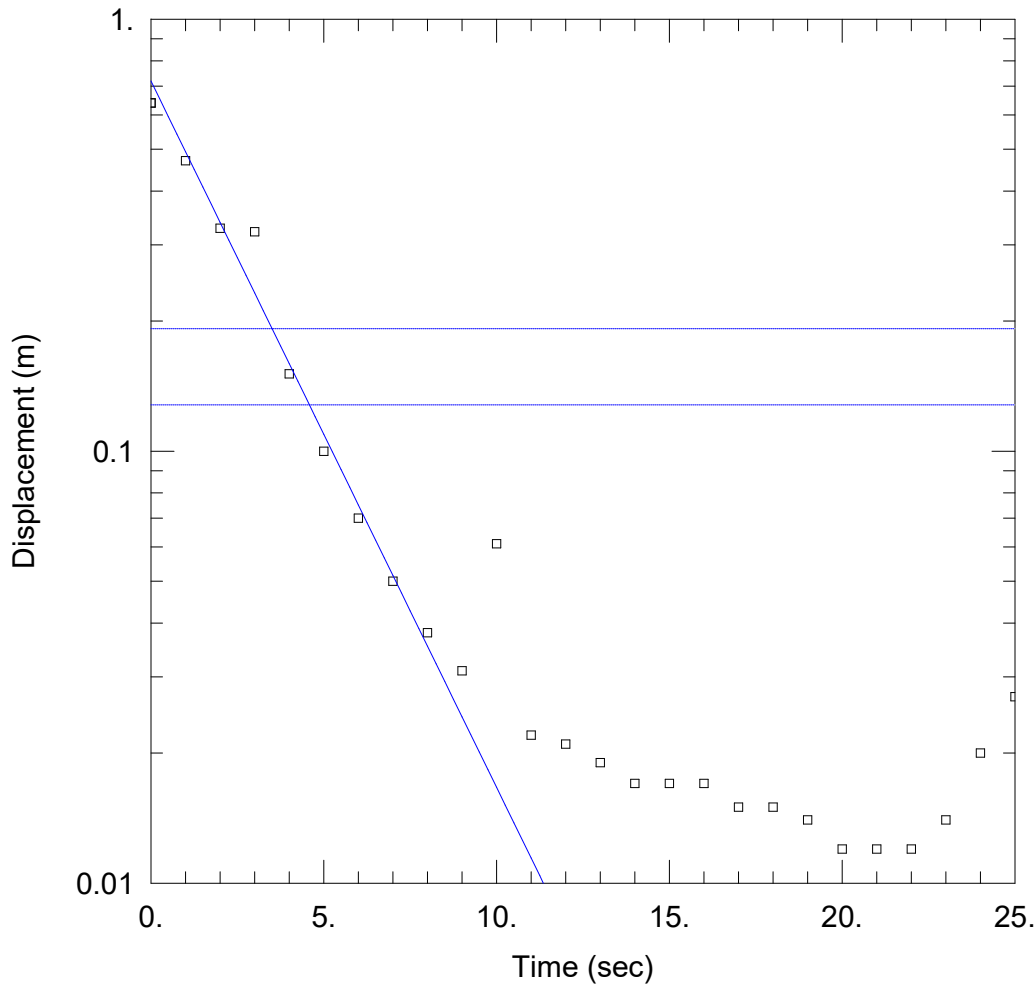
BH25-01 - RISING HEAD TEST 2

K = 0.00028 m/sec

y0 = 0.7187 m

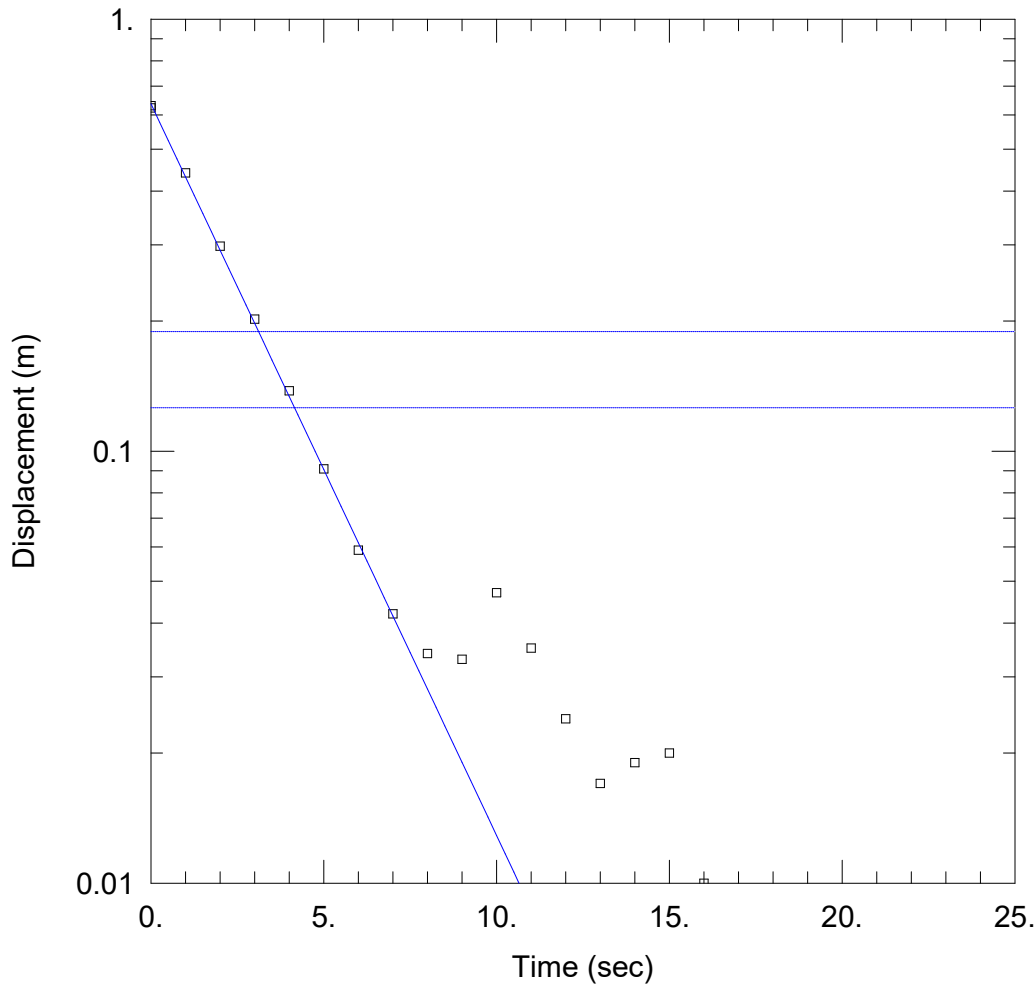
**BH25-01 - RISING HEAD TEST 3**

K = 0.00029 m/sec

y0 = 0.6365 m

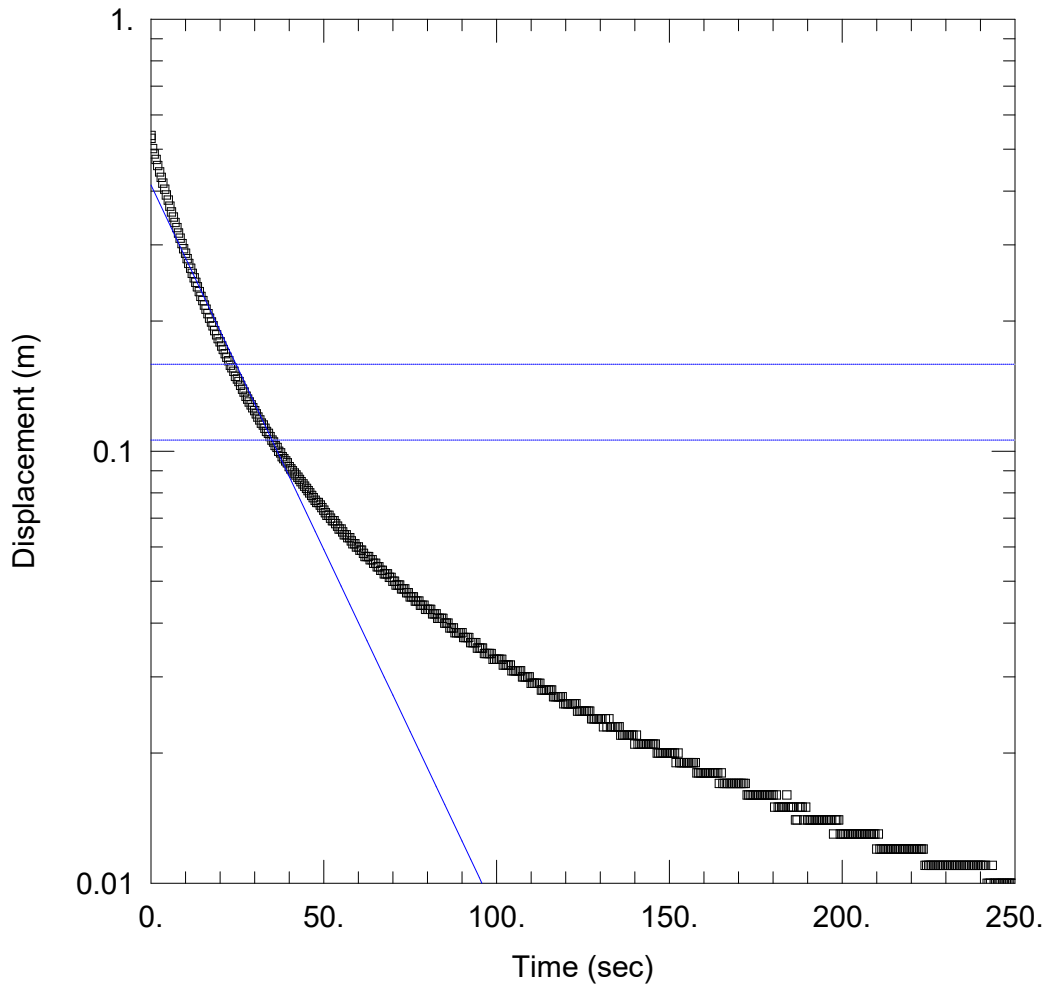
BH25-02 - FALLING HEAD TEST 1

K = 3.2E-5 m/sec

y0 = 0.4129 m

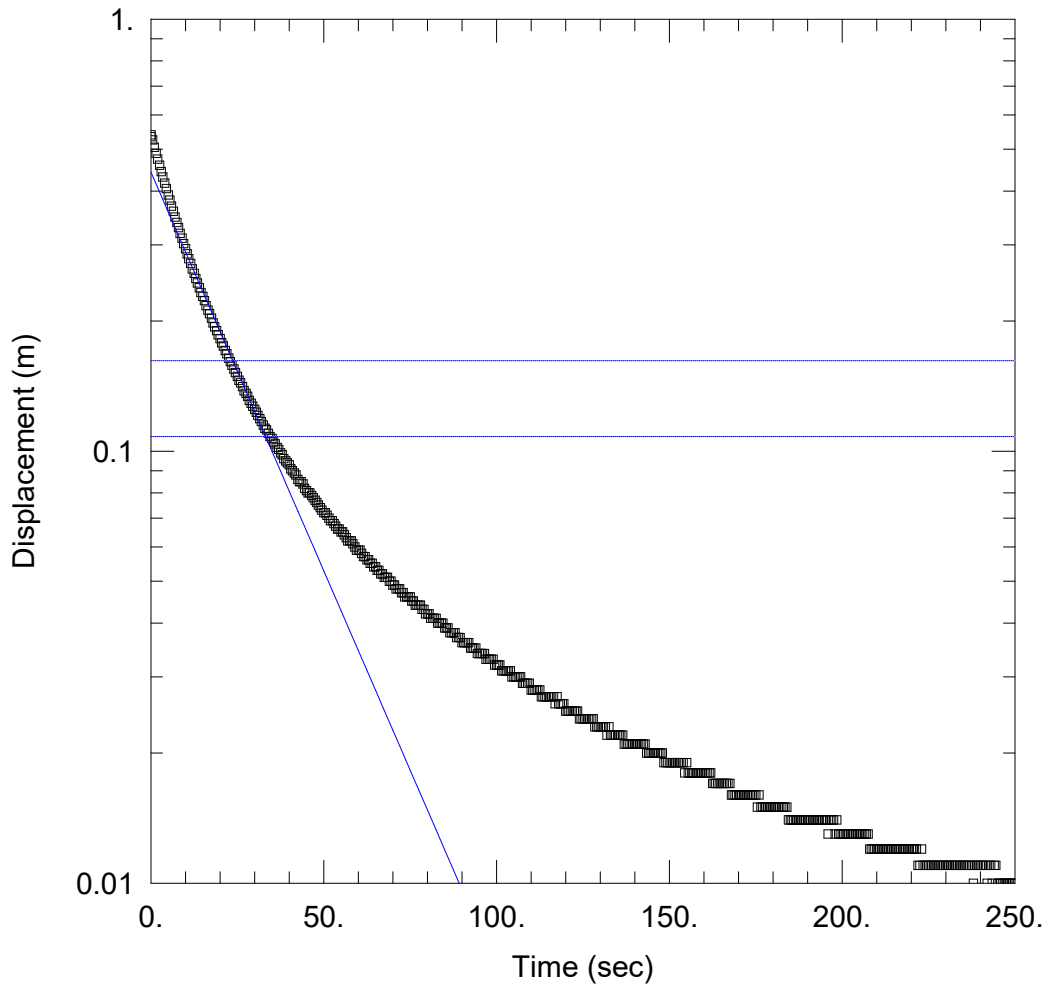
BH25-02 - FALLING HEAD TEST 2

K = 3.5E-5 m/sec

y0 = 0.4421 m

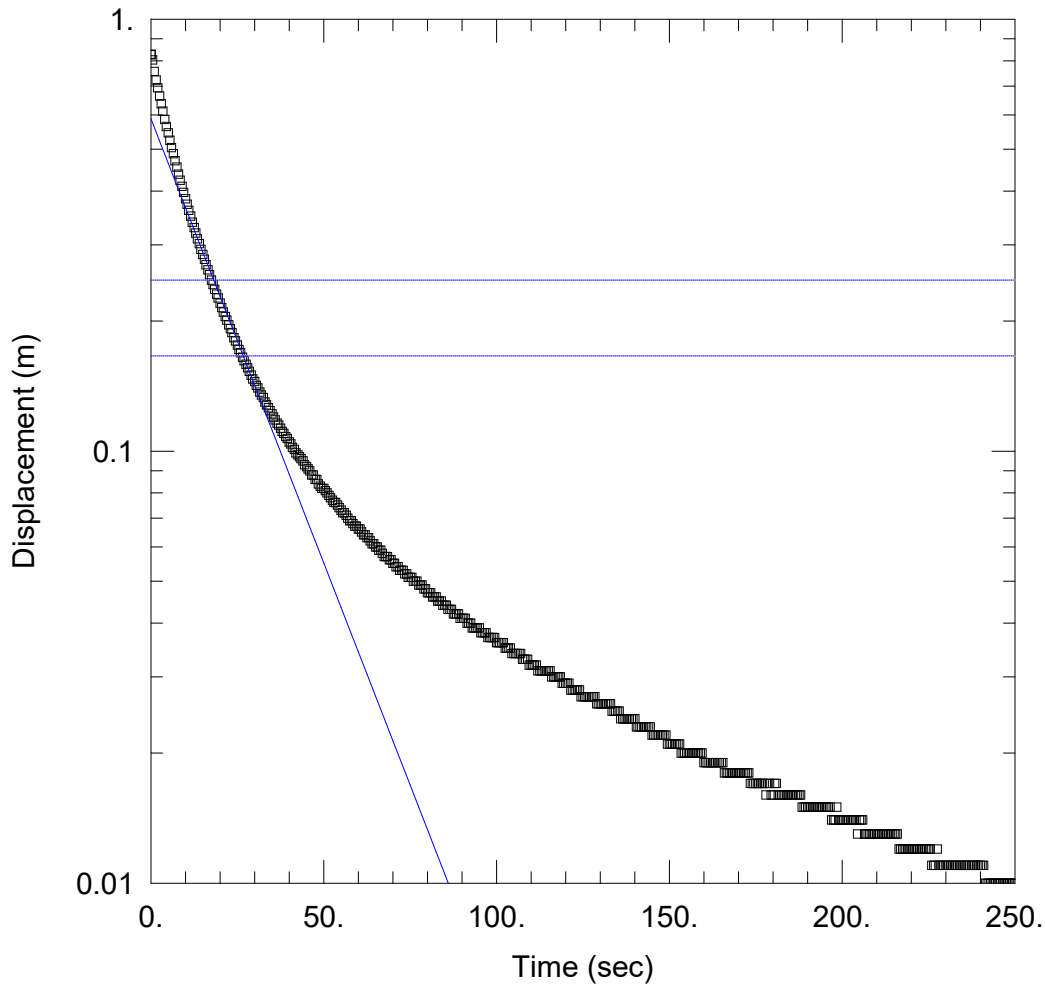
BH25-02 - RISING HEAD TEST 1

K = 3.9E-5 m/sec

y0 = 0.5874 m
