Phase One Environmental Site Assessment – Ashbury College, Portion of 362 Mariposa Avenue, Ottawa, Ontario

Final Report

October 10, 2025

Project/File:
116581700.400.200

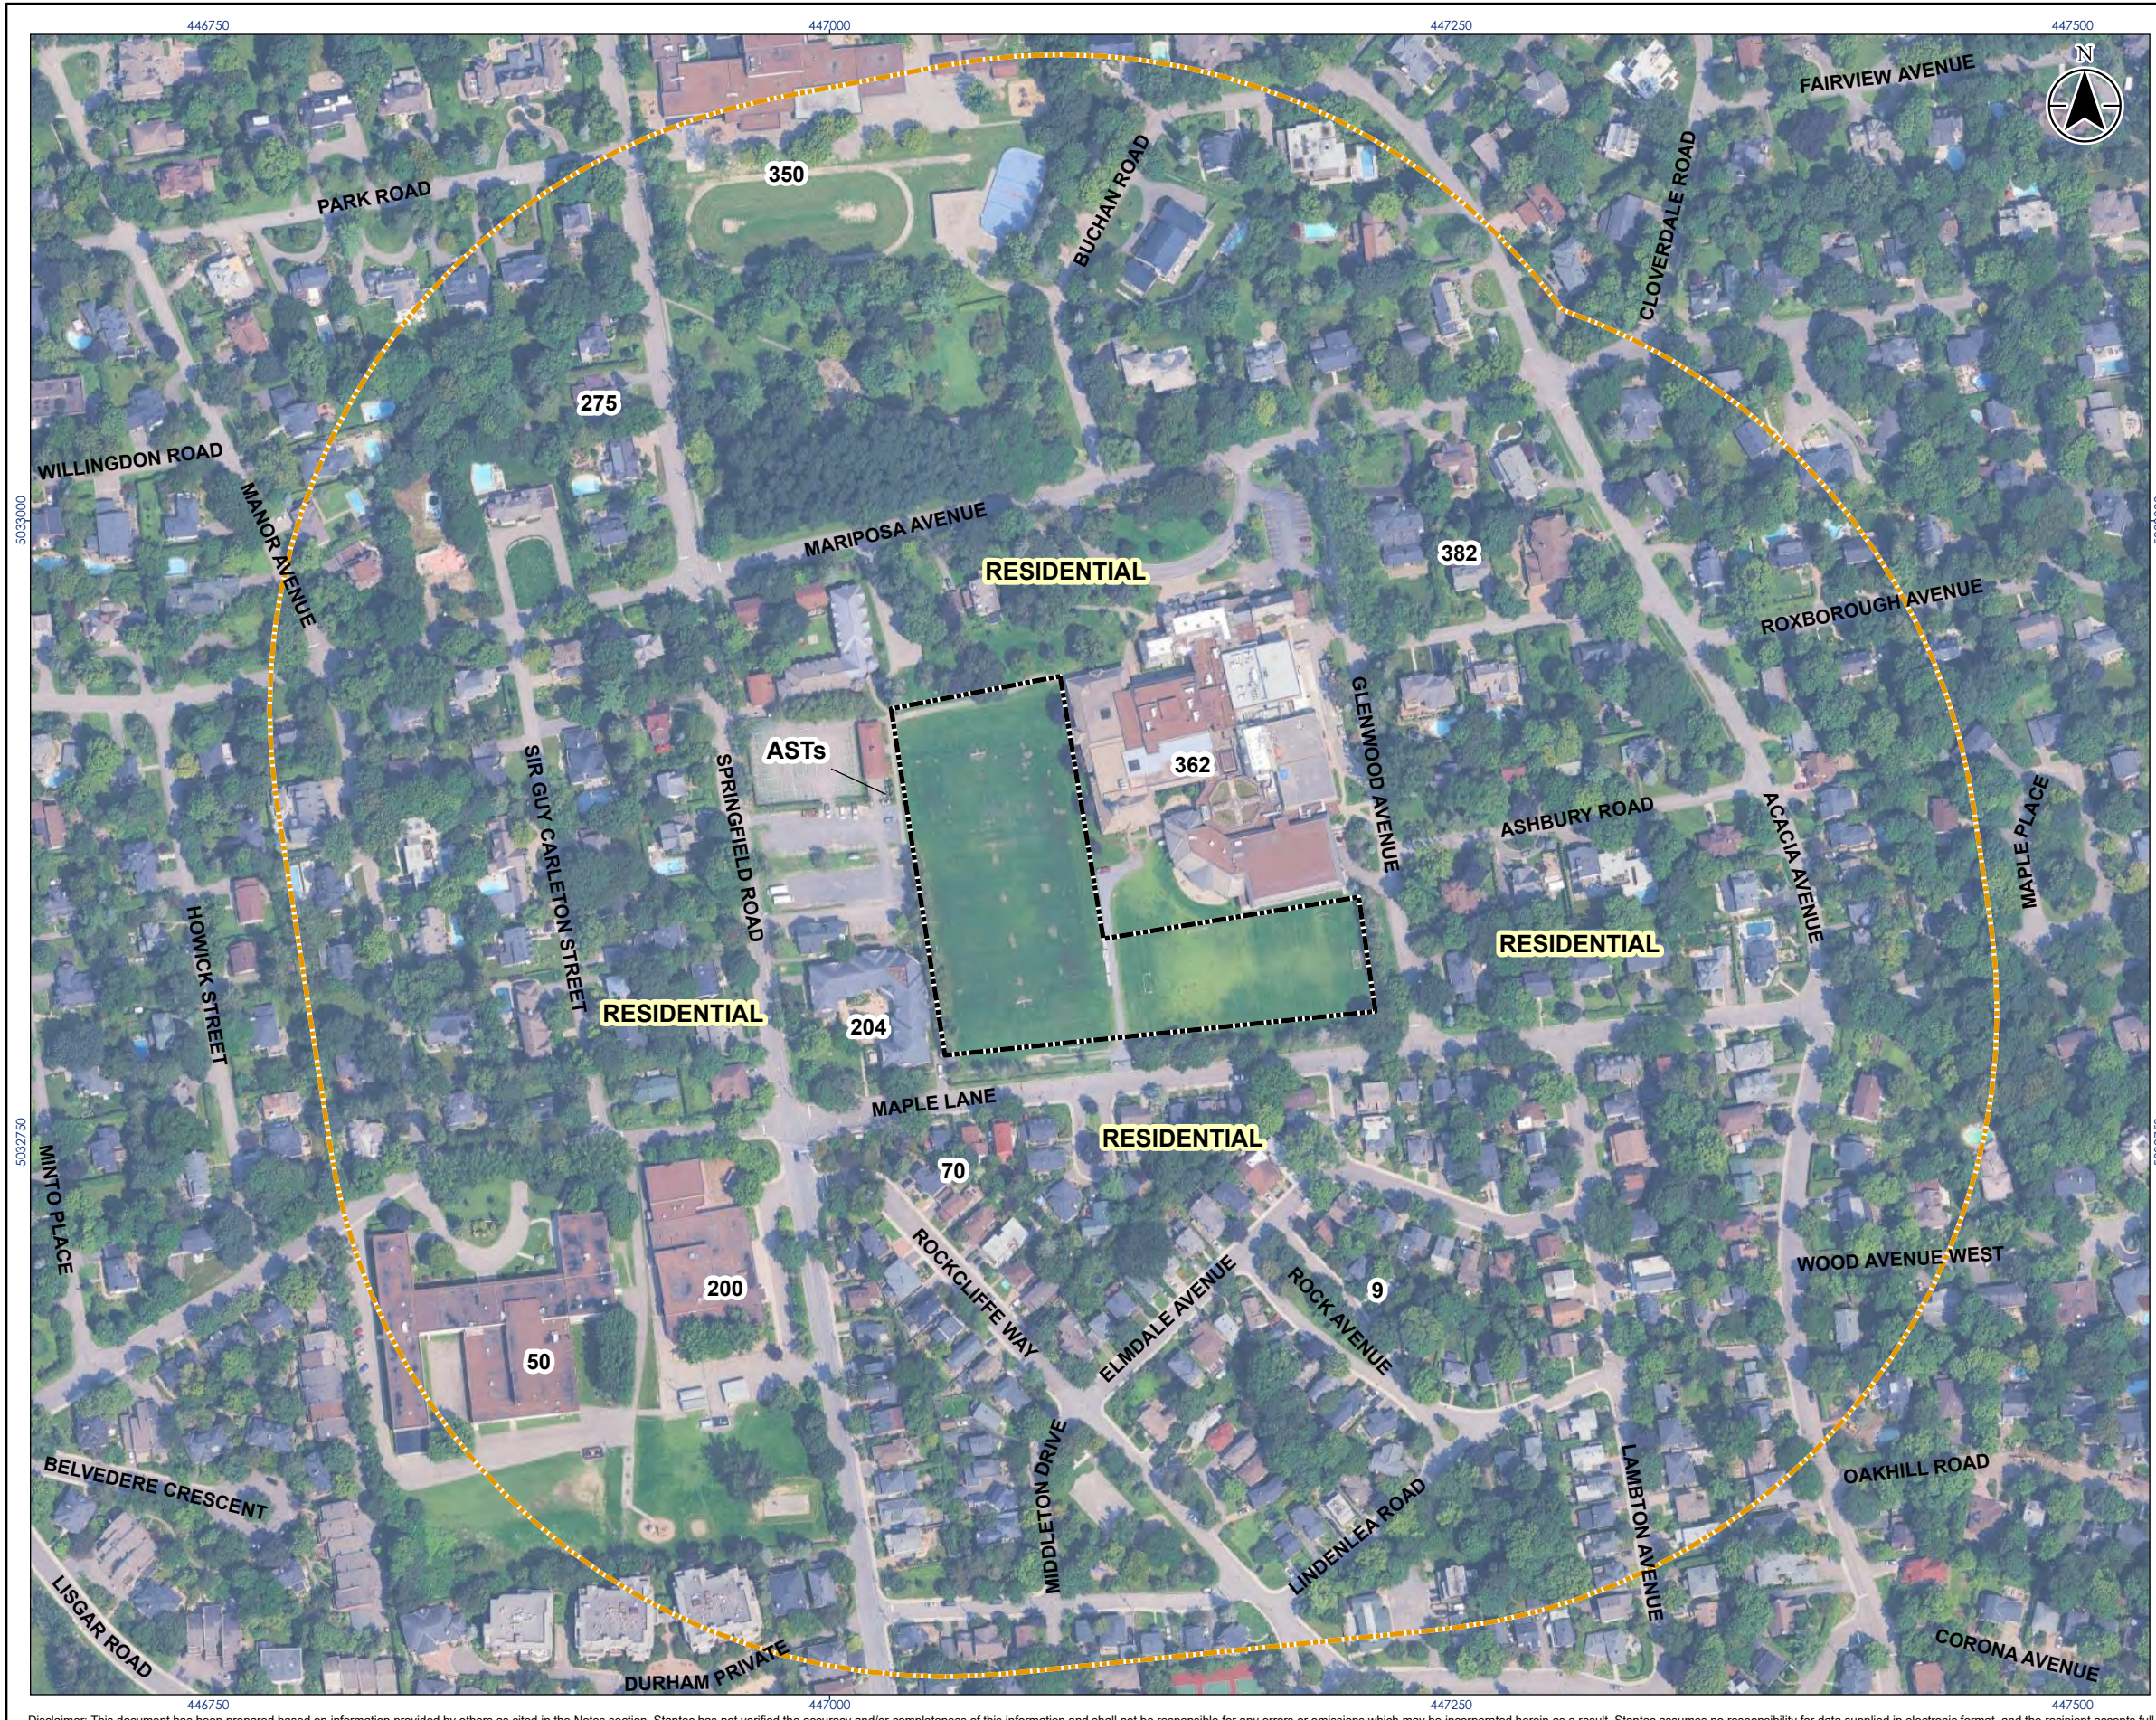
Figure No. **2**
 Title: **Phase One Study Area**

- Legend
- Approximate Phase One Property Boundary
 - Approximate Phase One Study Area - 250m

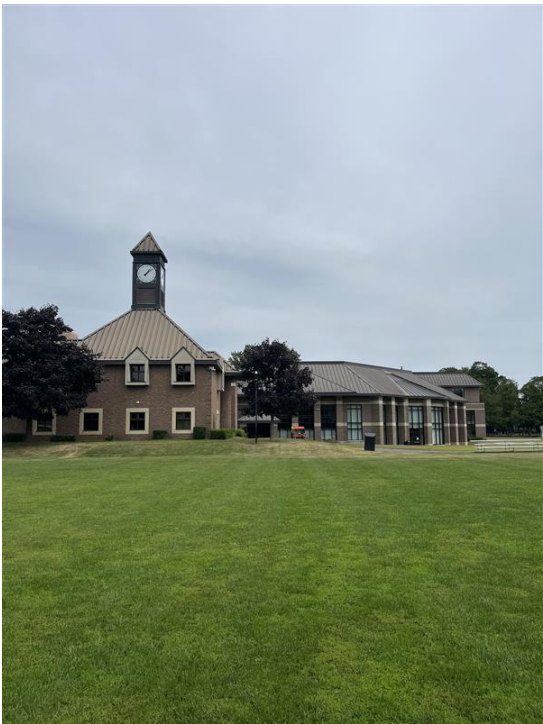
Photograph ID: 2

Photo Location: 362 Mariposa Avenue (On-Site)	
Direction: East	
Survey Date: 8/20/2025	
Comments: View of the western portion of the Site, facing east

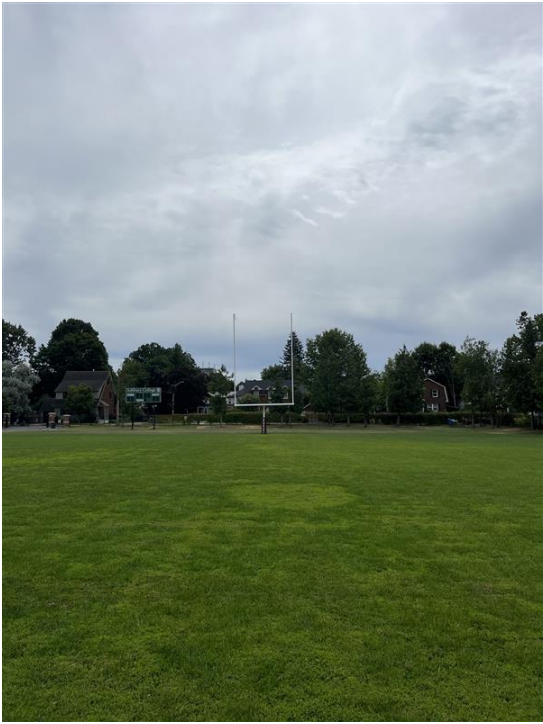
Photograph ID: 3

Photo Location: 362 Mariposa Avenue (On-Site)	
Direction: South	
Survey Date: 8/20/2025	
Comments: View of the western portion of the Site, facing south

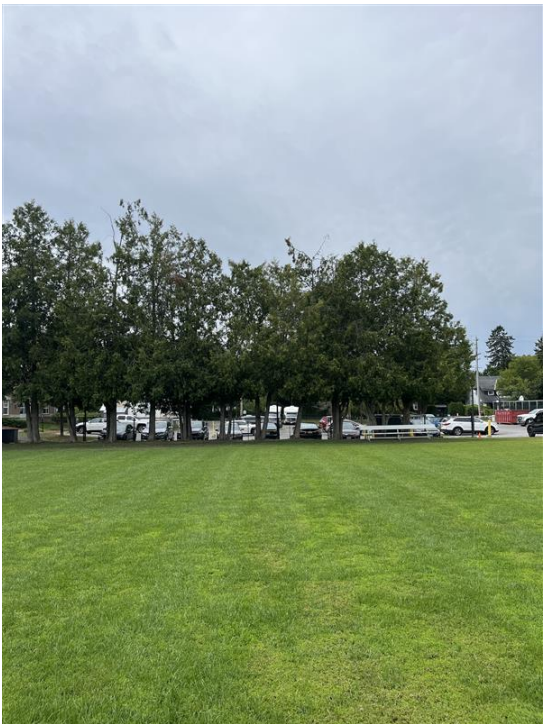
Photograph ID: 4

Photo Location: 362 Mariposa Avenue (On-Site)	
Direction: West	
Survey Date: 8/20/2025	
Comments: View of the western portion of the Site, facing west

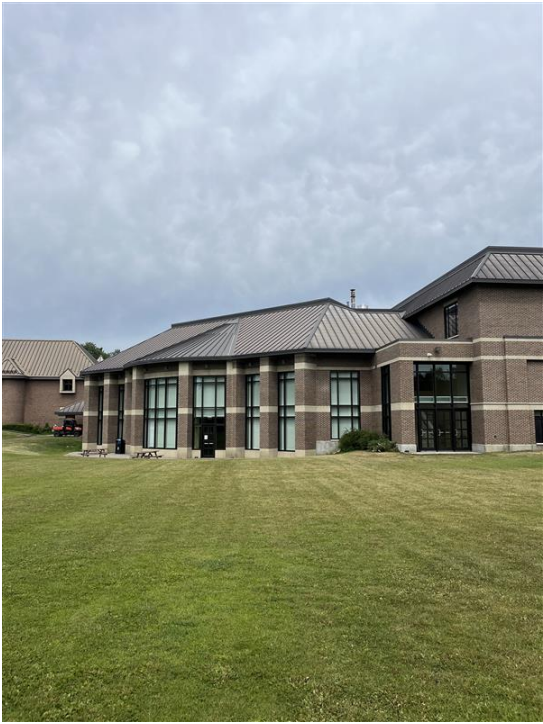
Photograph ID: 5

Photo Location: 362 Mariposa Avenue (On-Site)	
Direction: North	
Survey Date: 8/20/2025	
Comments: View of the eastern portion of Site, facing north

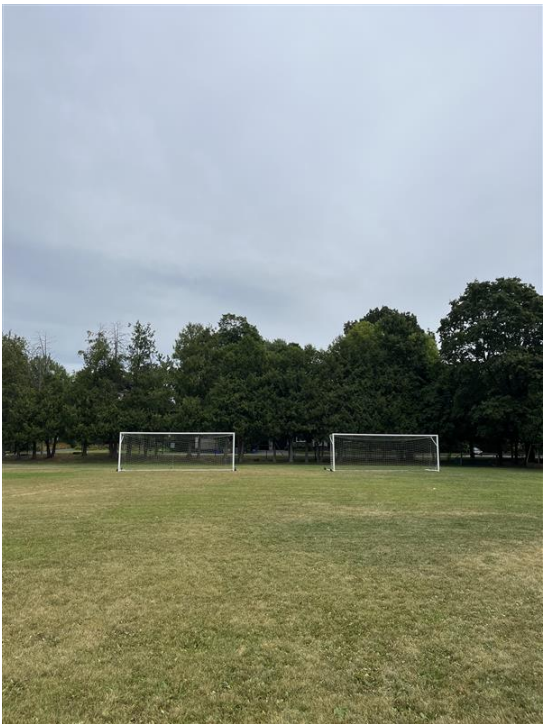
Photograph ID: 6

Photo Location: 362 Mariposa Avenue (On-Site)	
Direction: East	
Survey Date: 8/20/2025	
Comments: View of the eastern portion, facing east

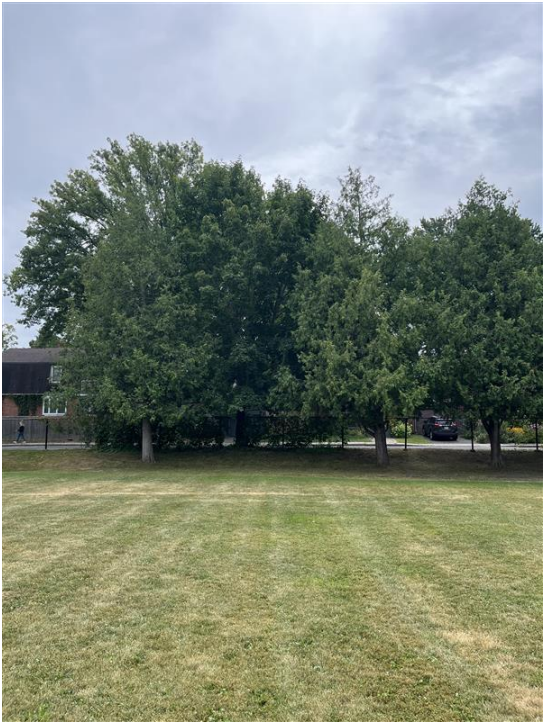
Photograph ID: 7

Photo Location: 362 Mariposa Avenue (On-Site)	
Direction: South	
Survey Date: 8/20/2025	
Comments: View of the eastern portion of the Site, facing south

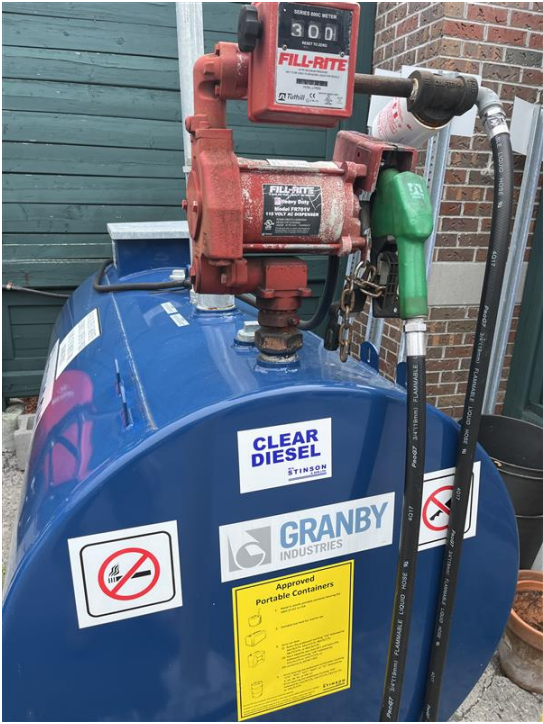
Photograph ID: 9

- Two double walled steel ASTs were observed. The volume of each of the ASTs was reportedly 3,785 litres (L) and the contents were gasoline and diesel. According to the site contact, the ASTs were used for fueling small vehicles at the school. The ASTs appeared to be relatively new and in good condition. Based on the interview completed during the site visit, the ASTs were installed prior to 2020. The site contact was not aware of the exact installation date and was not able to comment about the presence of previous ASTs at Ashbury College. The ground surface surrounding the ASTs was observed to be in good condition with no evidence of leaks or staining. Based on the proximity to the Phase One Property, the ASTs represent a PCA (**PCA 28 – Gasoline and Associated Products Storage in Fixed Tanks**) that contribute to an APEC (**APEC 2**) on the Phase One Property.

Photo Location: 362 Mariposa Avenue (Off-Site)	
Direction: East	
Survey Date: 8/20/2025	
Comments: View of one of the off-Site ASTs, present adjacent west of the Site
