# Tree Conservation Report

**Carlingwood Shopping Centre Parking Renovation –  
2085 Carling Avenue**

May 6, 2026

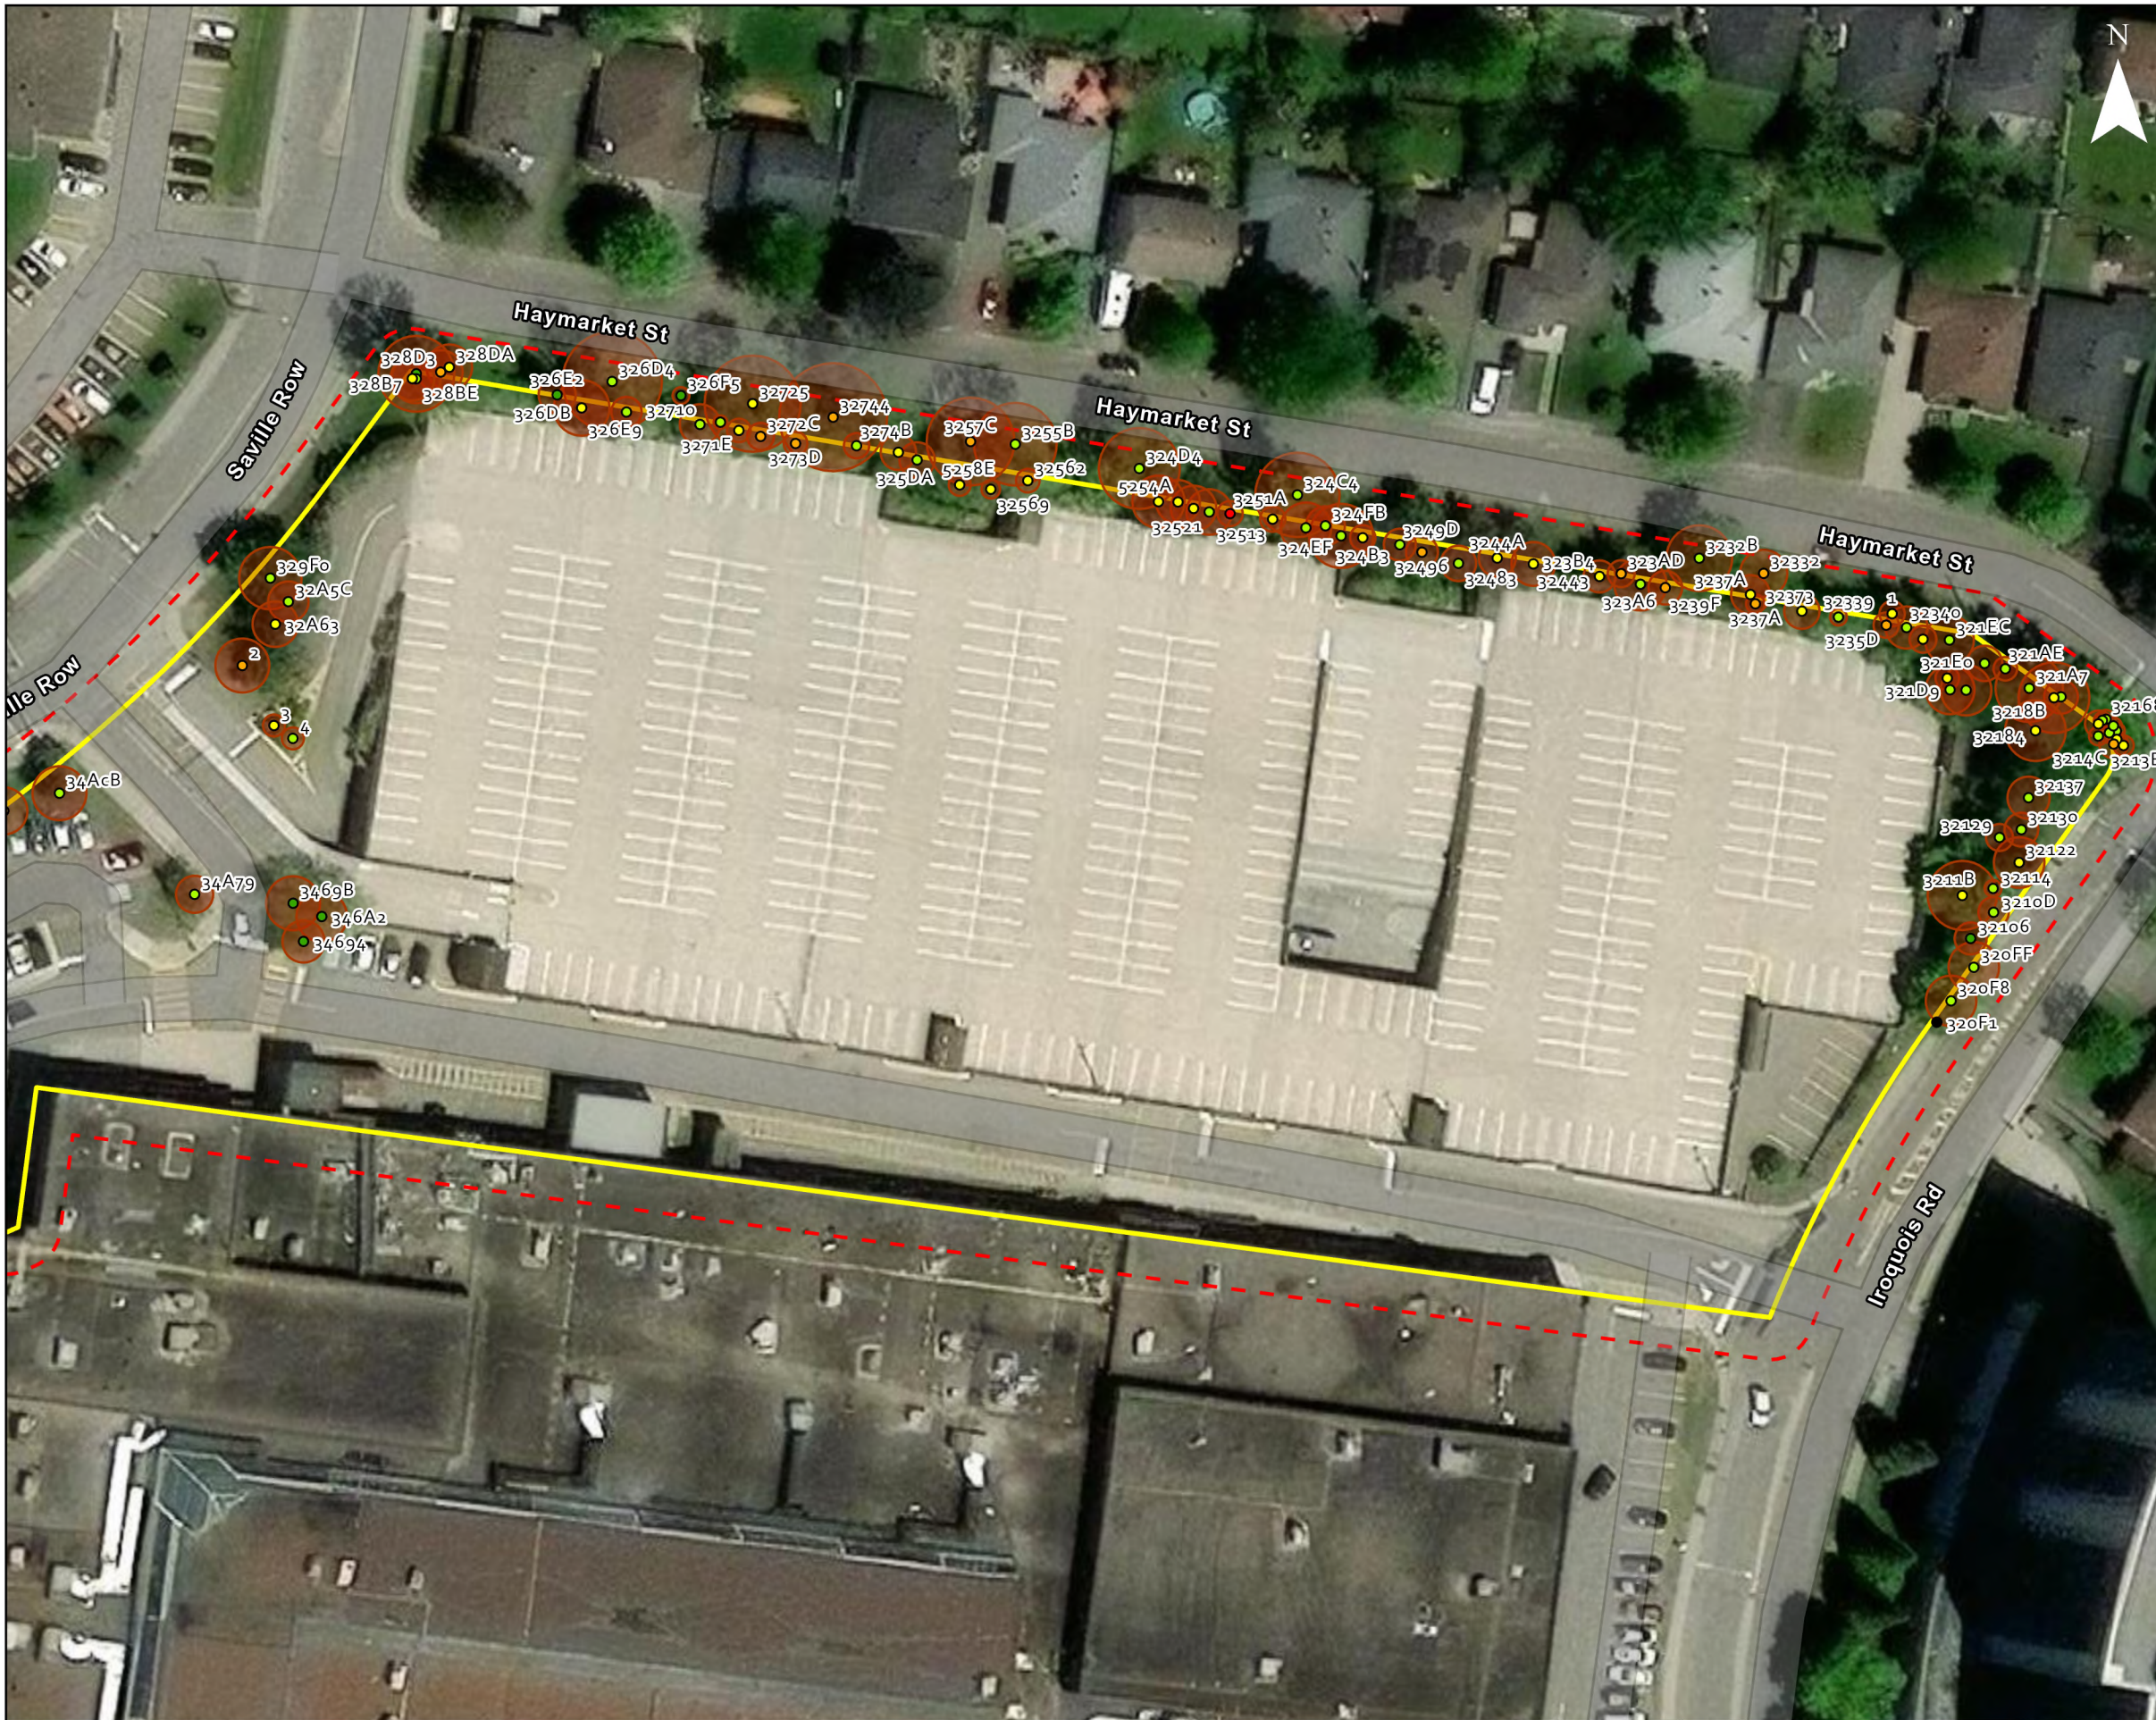
**Figure: 2a**

**Current Vegetation  
 (Map 1 As per City Guidelines)**

A total of 139 individual trees were assessed as part of this inventory and can be seen on Map 1 (**Figure 2**). The condition of the trees on Site ranged from Excellent to Dead, approximately 83% of which were in Excellent - Good condition. The most common species are Red Pine (19%), Norway Spruce (16%), Norway Maple (13%), and Apple species (13%).

There are 40 trees that meet the definition of a 'Distinctive Tree' as per Tree Protection By-law No. 2020-340 (any tree located on private property with a DBH of 30 cm or greater, within the inner urban area). Trees 2, 321D2, 3469B, and 346A2 are Distinctive tree that require removal based on the current design plans.

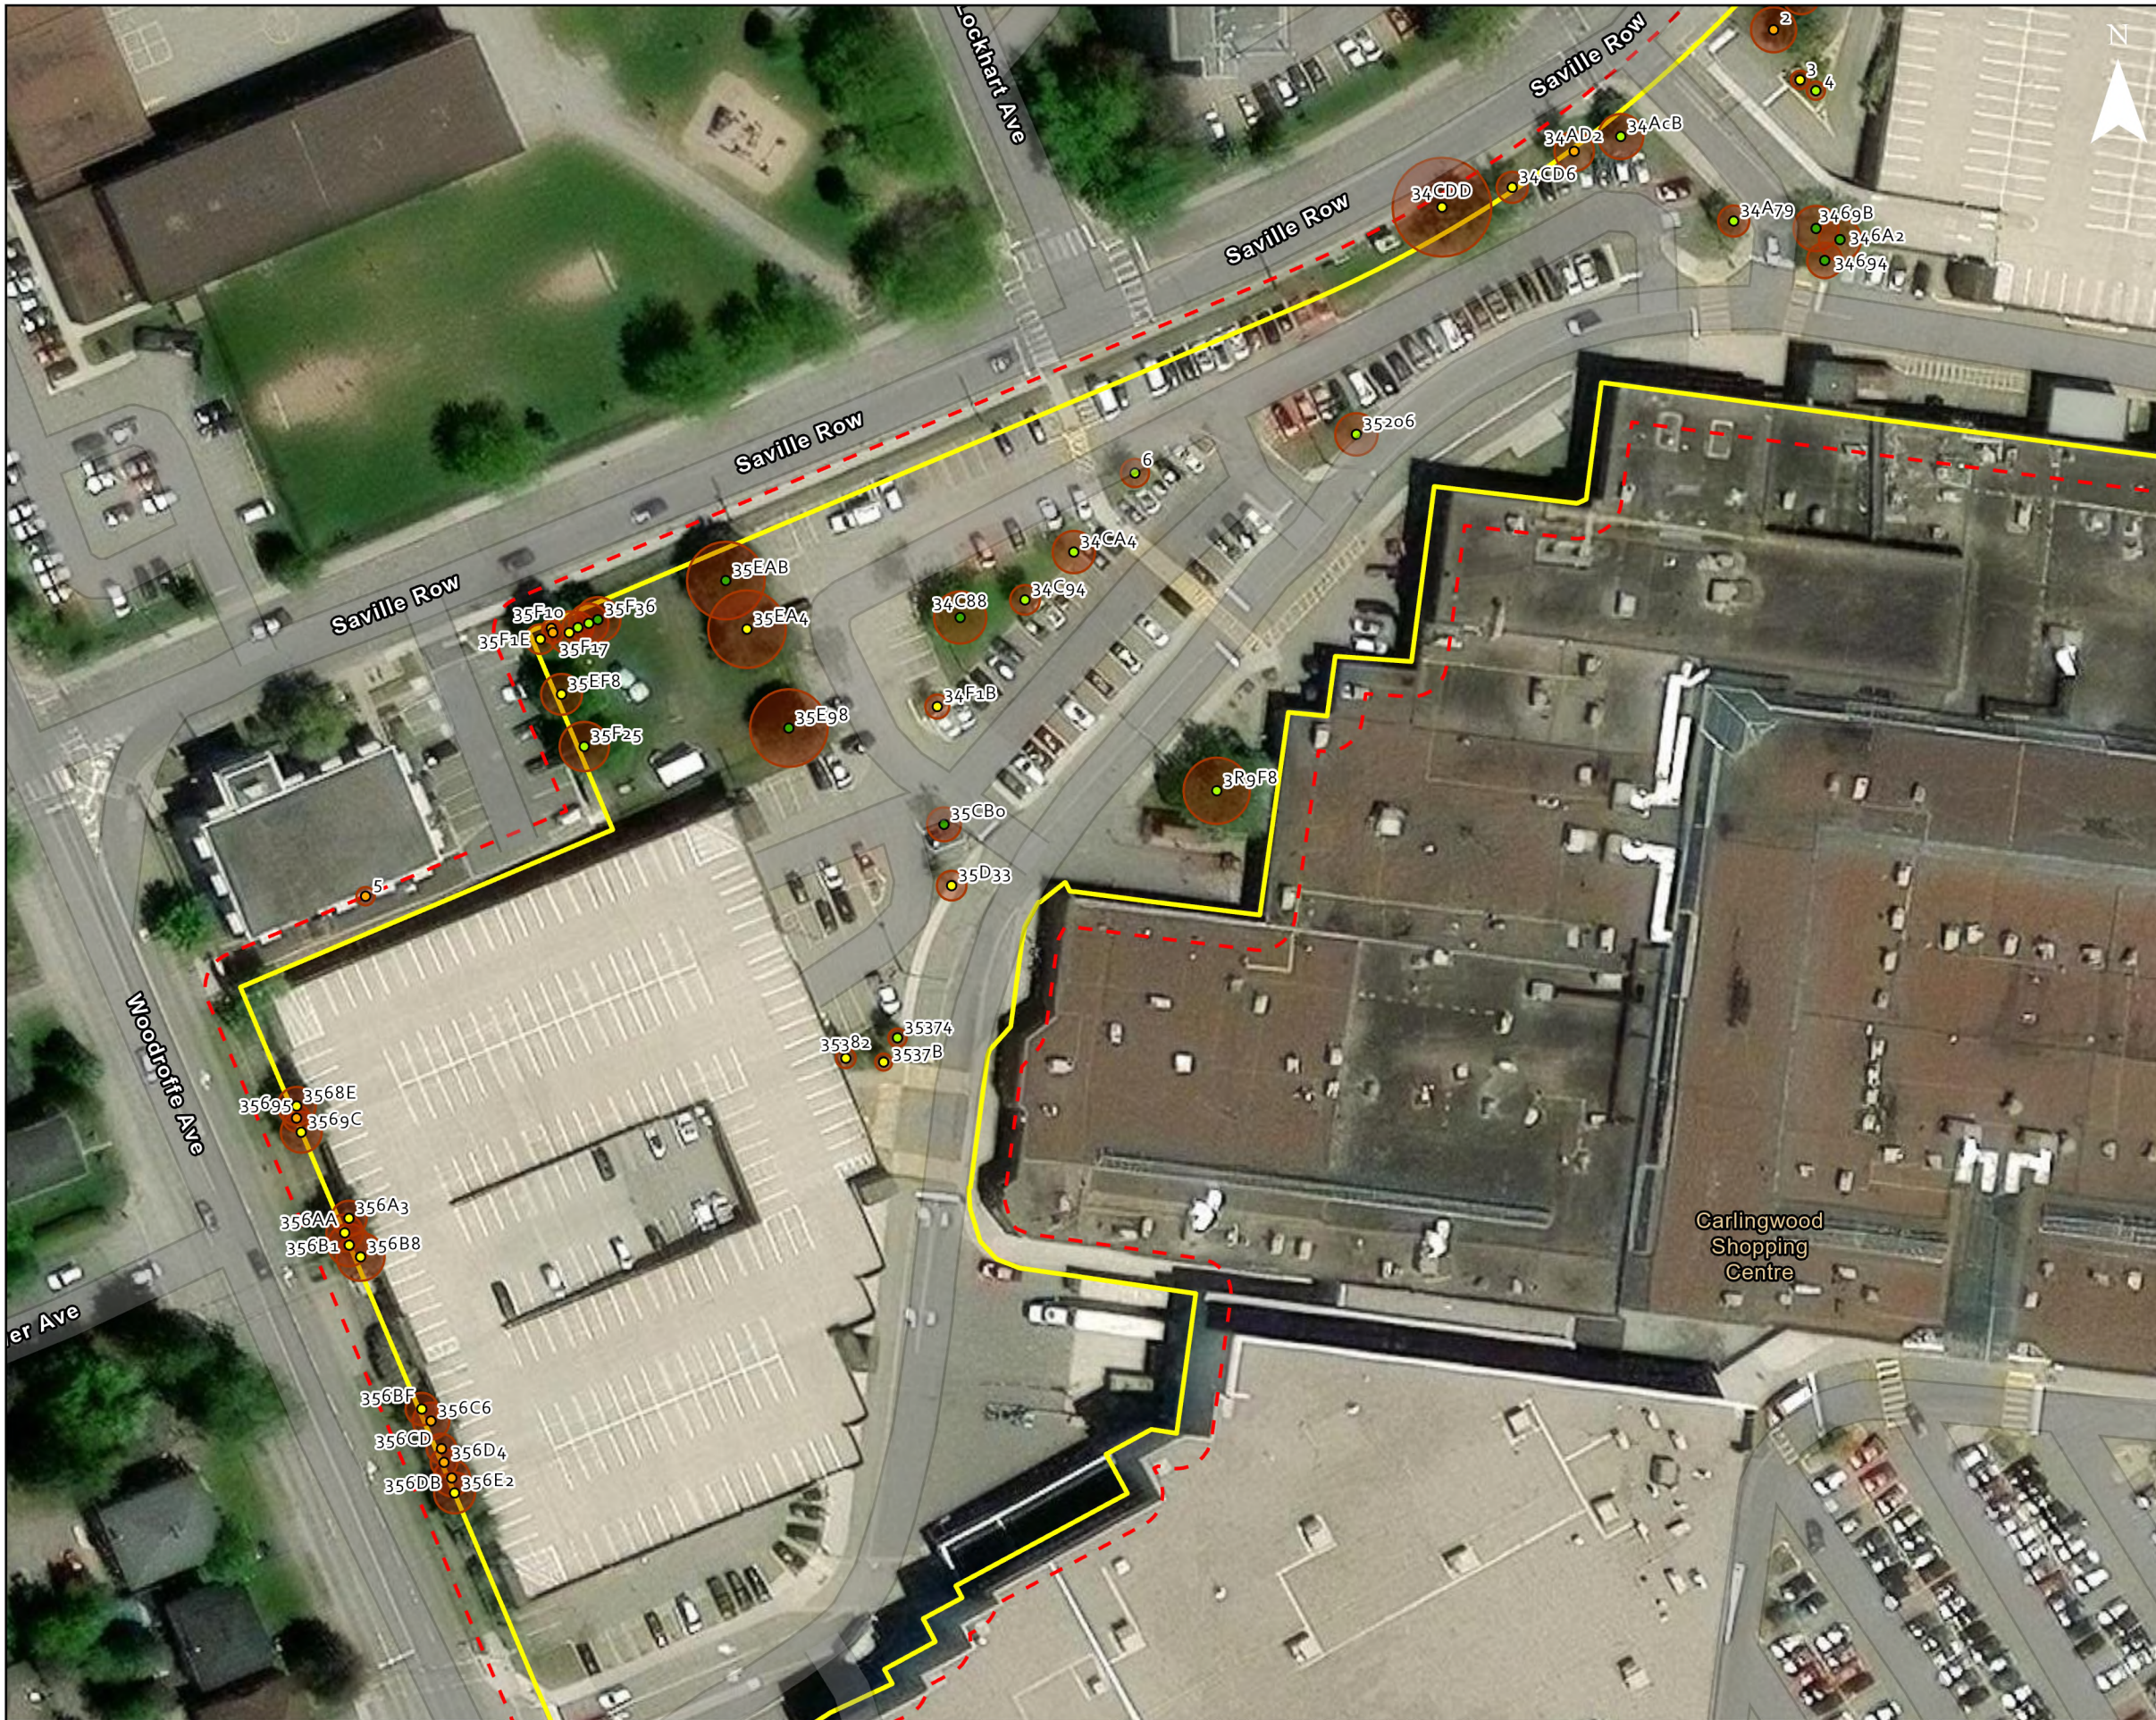
**Figure: 2b**

**Current Vegetation  
 (Map 1 As per City Guidelines)**

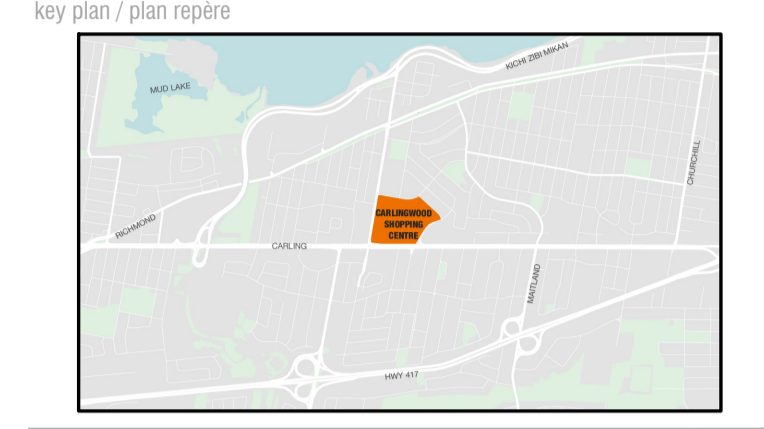
<b>Trees to be Removed</b>	<b>Trees to be Retained</b>
9 (client owned)	130 (97 client owned, 33 City owned)

Refer to **Section 8.2** below for information on measures recommended to protect all remaining trees within the Site prior to and during construction.

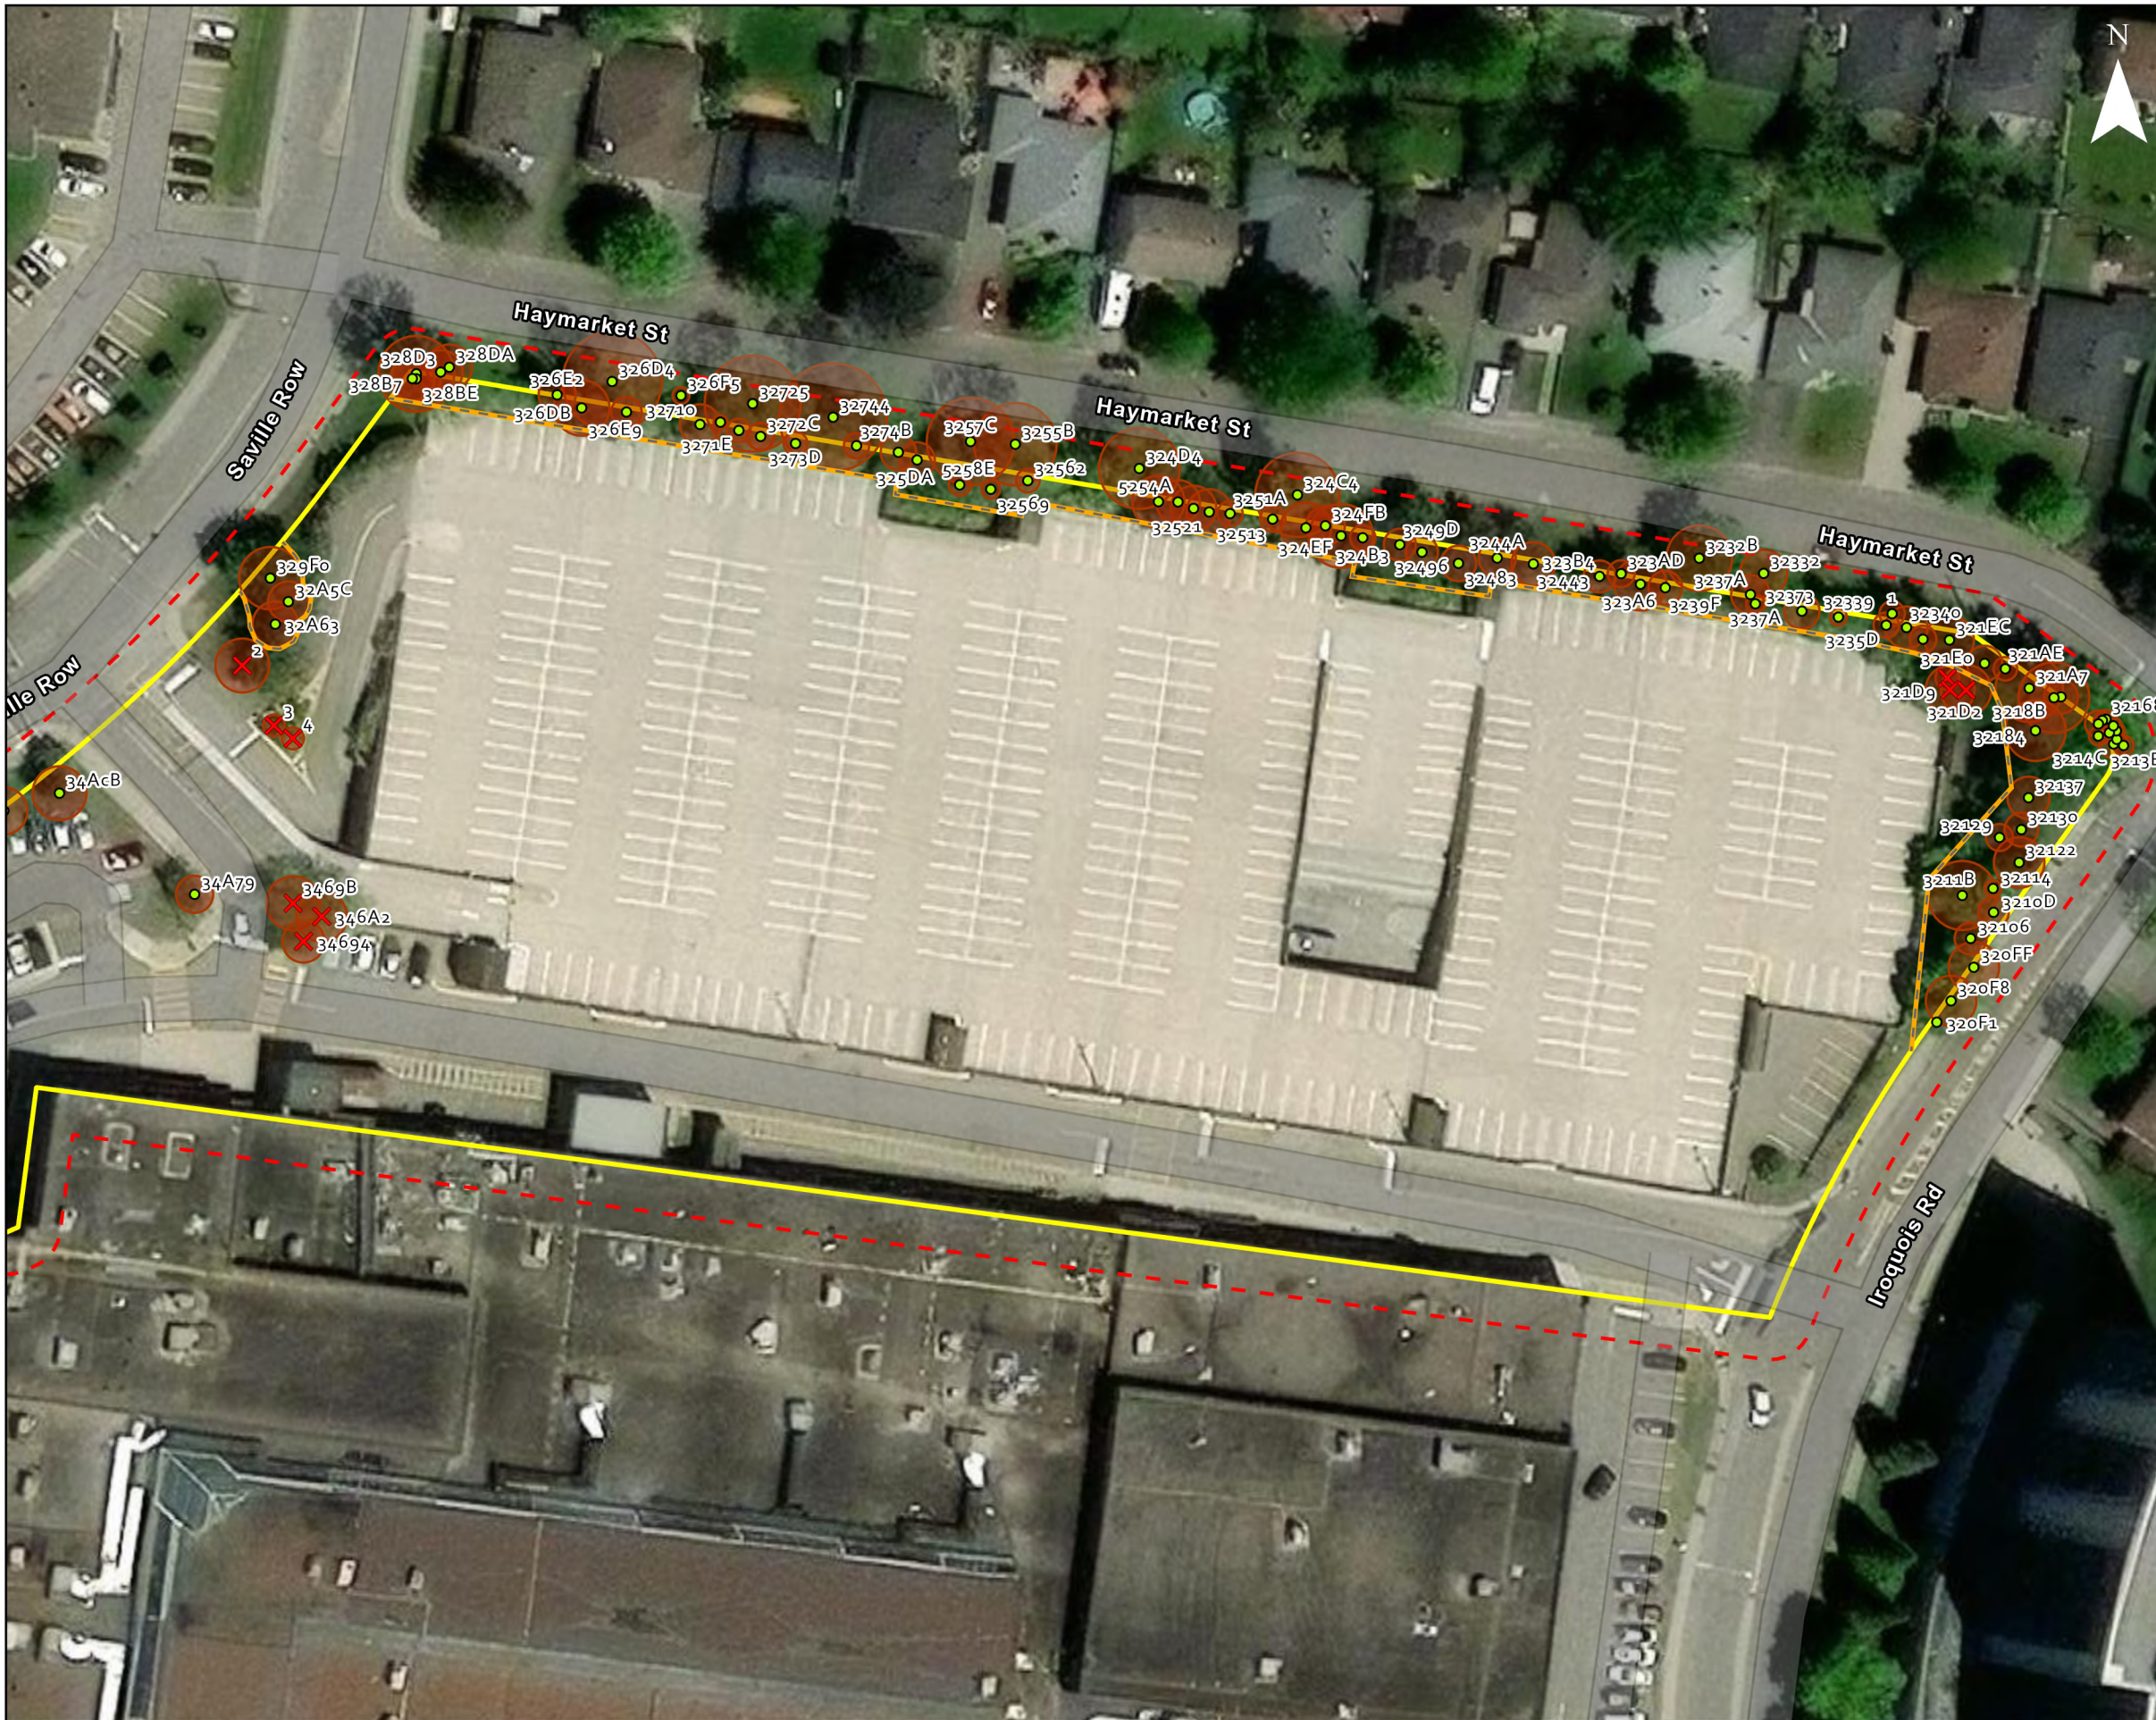
Figure: 3b

Tree Impact Assessment and  
 Recommendations  
 (Map 2 As per City Guidelines)

A review of the Site conditions indicates that most existing trees can be retained, except where the existing ramp will be demolished and drive lanes adjusted (**Figure 3**) and the far northeast corner of the garage structure. All trees within and slightly beyond the footprint of the existing structure have been surveyed, as additional inventory information may help inform future development options. Based on the conditions of the trees and extent of the proposed construction limits, **Table 2** summarizes the impact and recommended actions of the 139 trees assessed within the Site.

Based on the proposed project design and existing conditions of the trees on site, 9 trees have been recommended for removal in order to accommodate the demolition of the existing structure, existing ramp and adjustment of the drive lanes at this location (**Figure 3**). The following recommendations are provided:

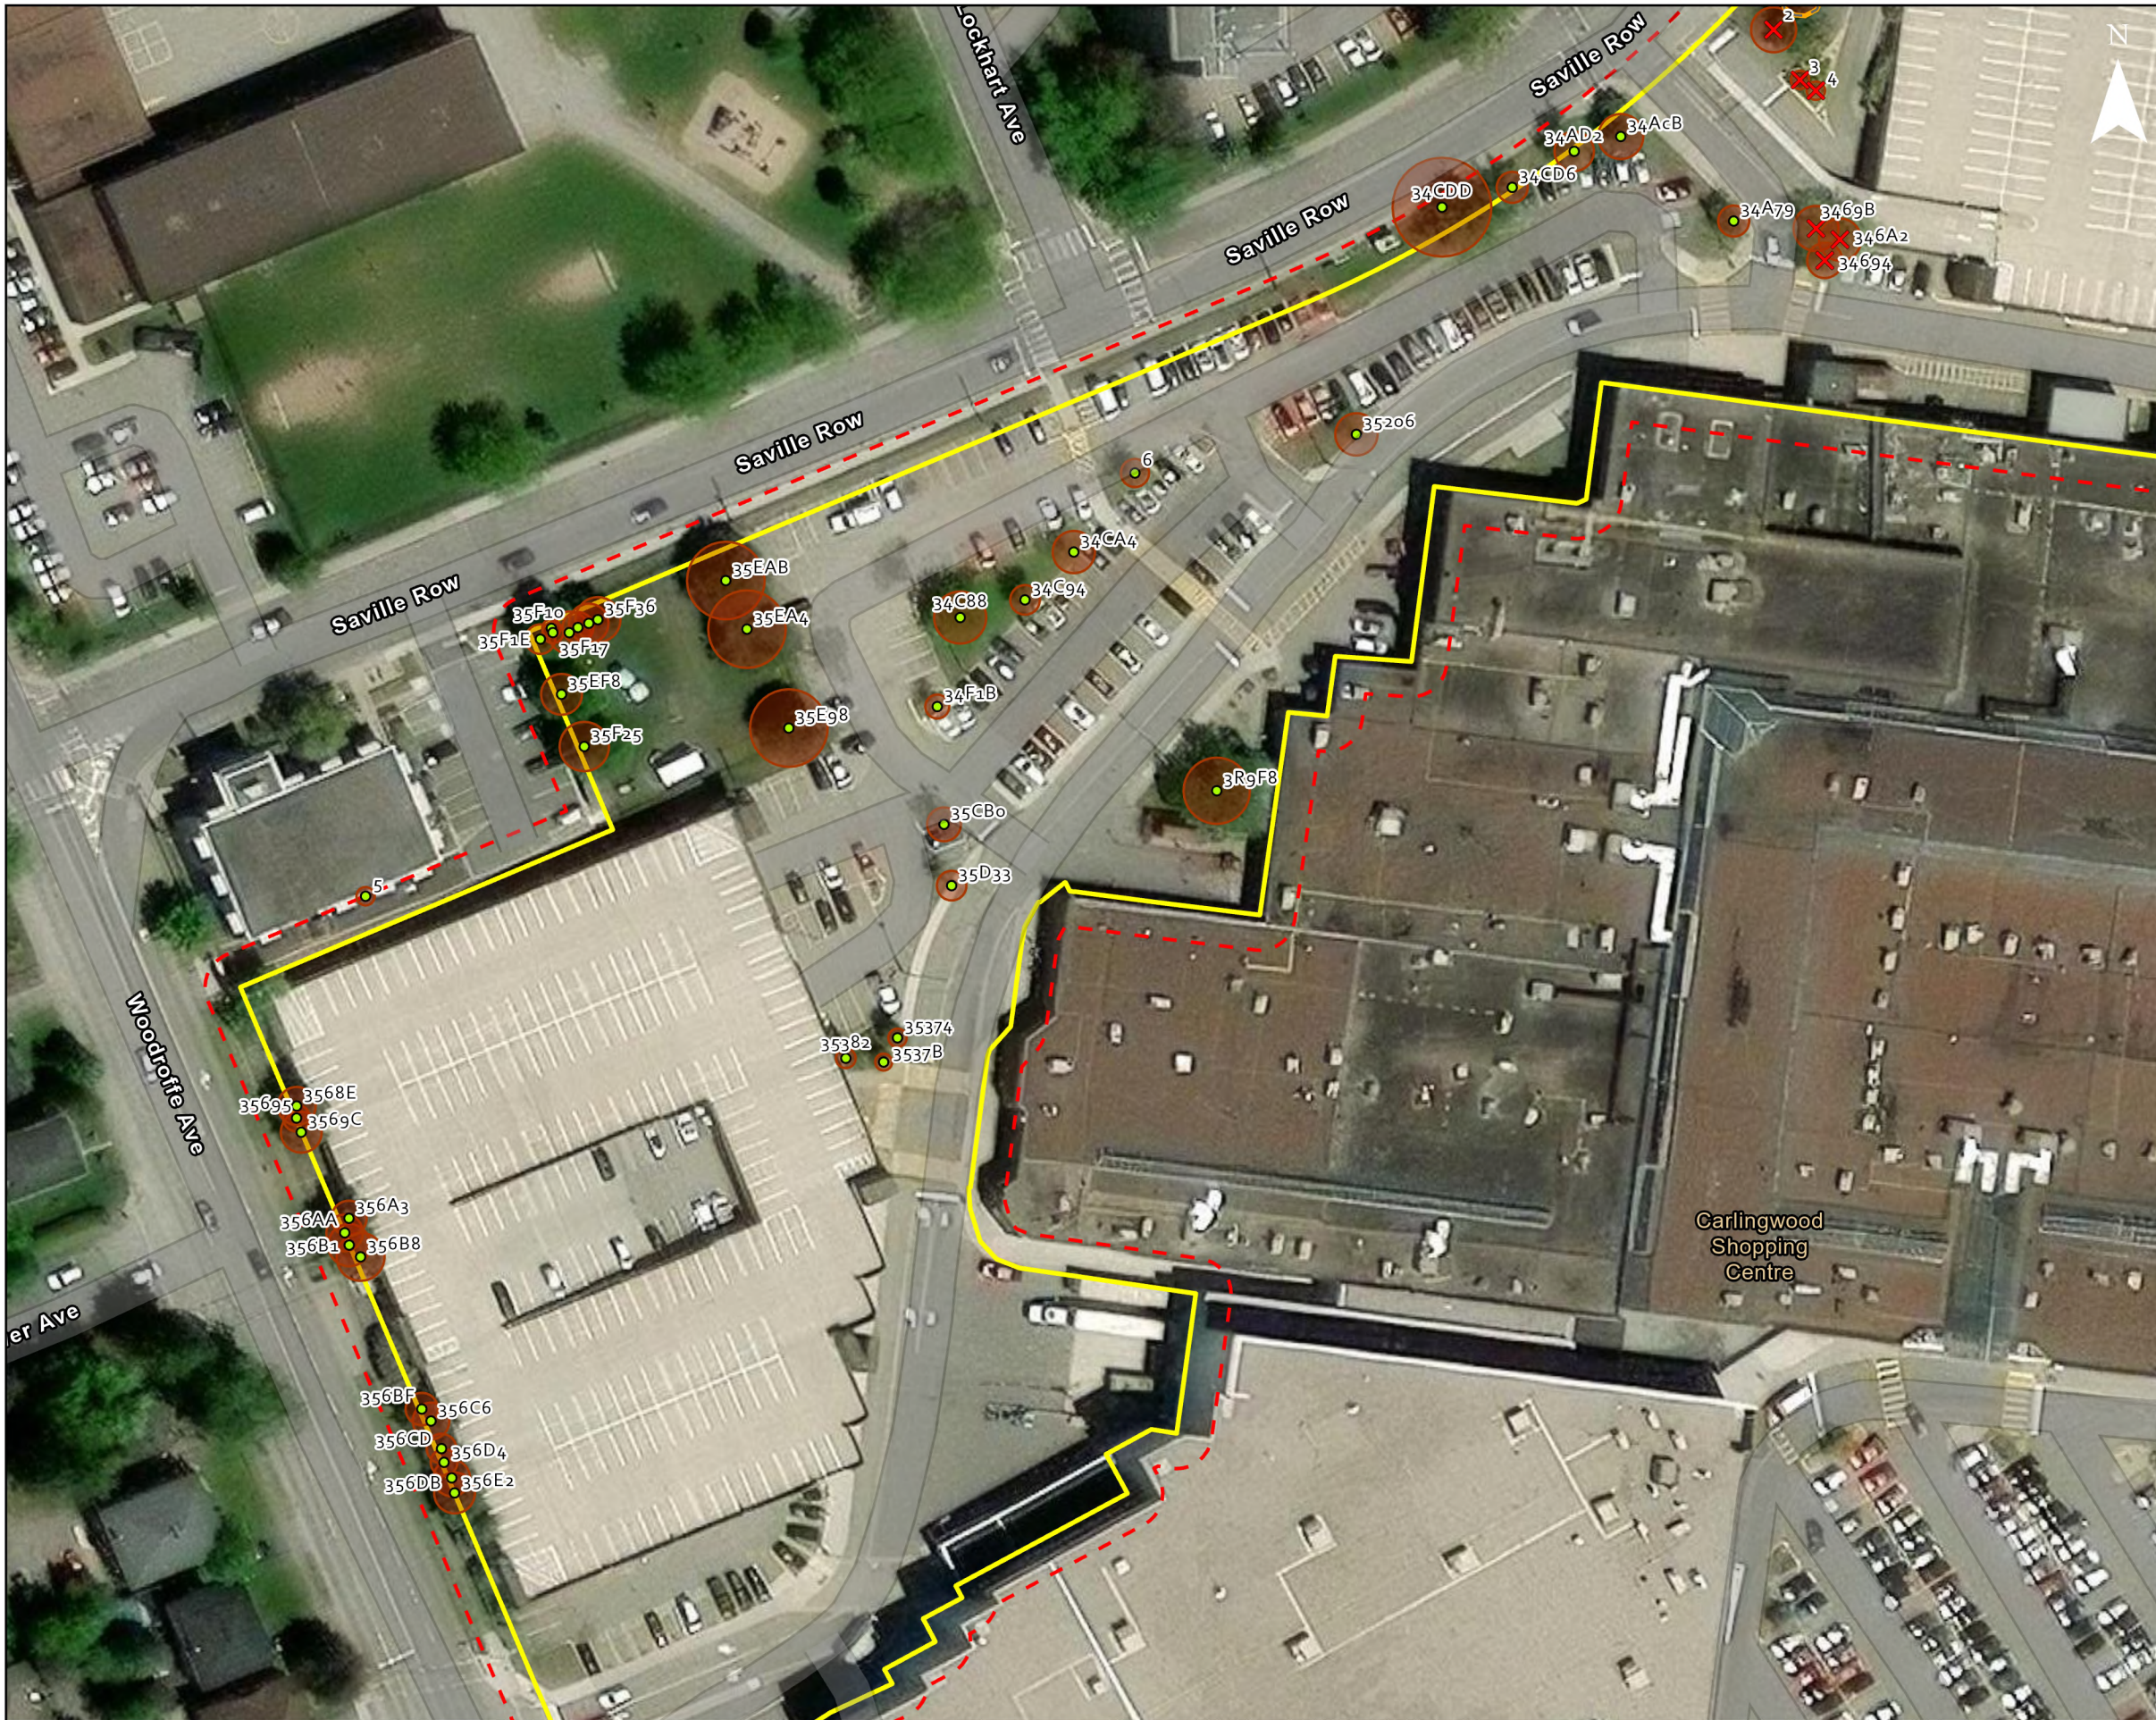
**Tree Impact Assessment and  
 Recommendations  
 (Map 2 As per City Guidelines)**
