Phase One Environmental Site Assessment Part of 1500 Saint Laurent Boulevard, Ottawa, Ontario

City of Ottawa

Phase One Environmental Site Assessment

OTT-22007382-A0

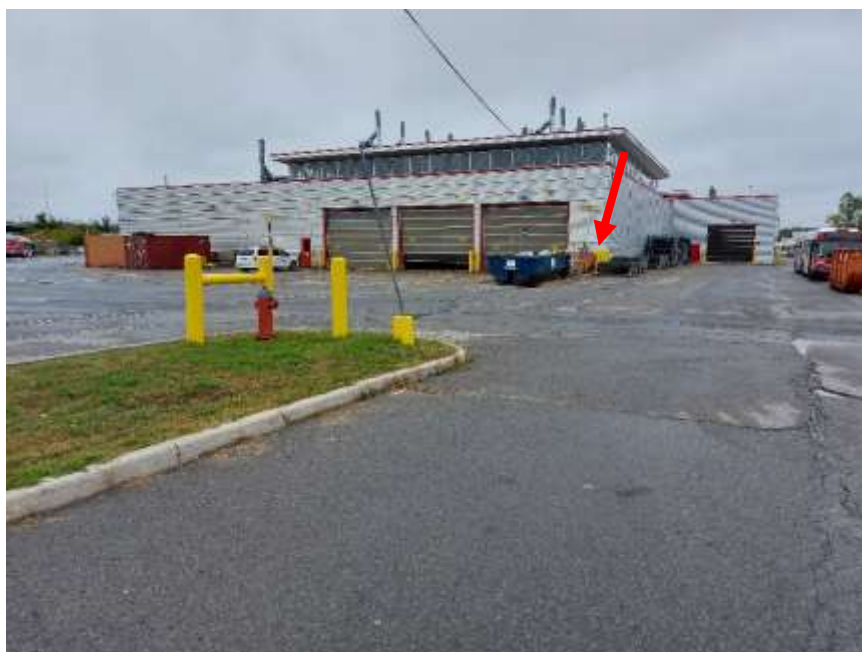
Photograph No. 4

A waste oil AST was observed on the north side of the north garage building at 1500 St. Laurent Boulevard.

View of the waste oil AST on the north side of the north garage.

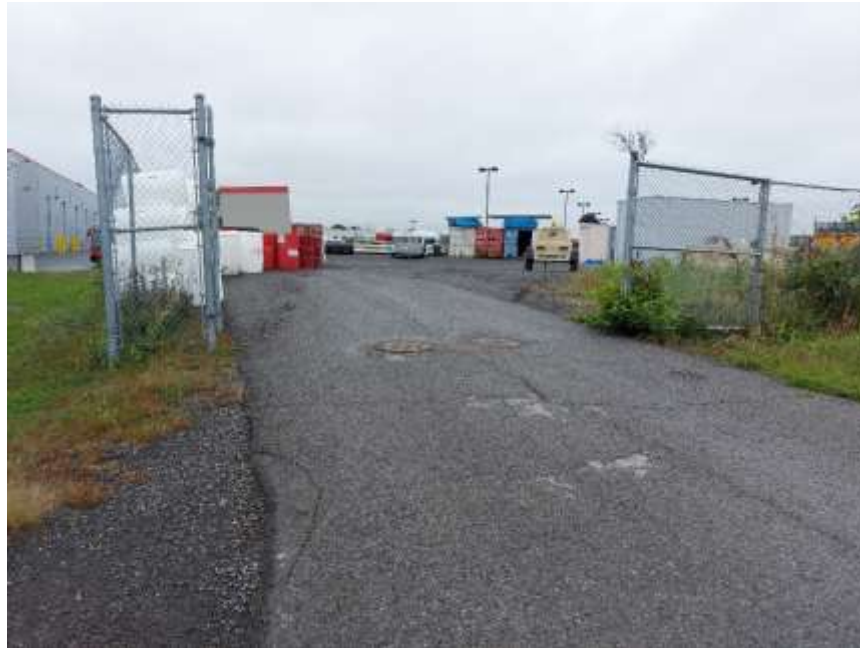
Photograph No. 5

View of the storage area at the centre of the Phase One property.
