Phase I Environmental Site Assessment

335 and 339 Roosevelt Avenue,
379 and 389 Wilmont Avenue, and
344 Winston Avenue
Ottawa, Ontario

Prepared for Uniform Developments

Report: PE2144-4
May 27, 2025

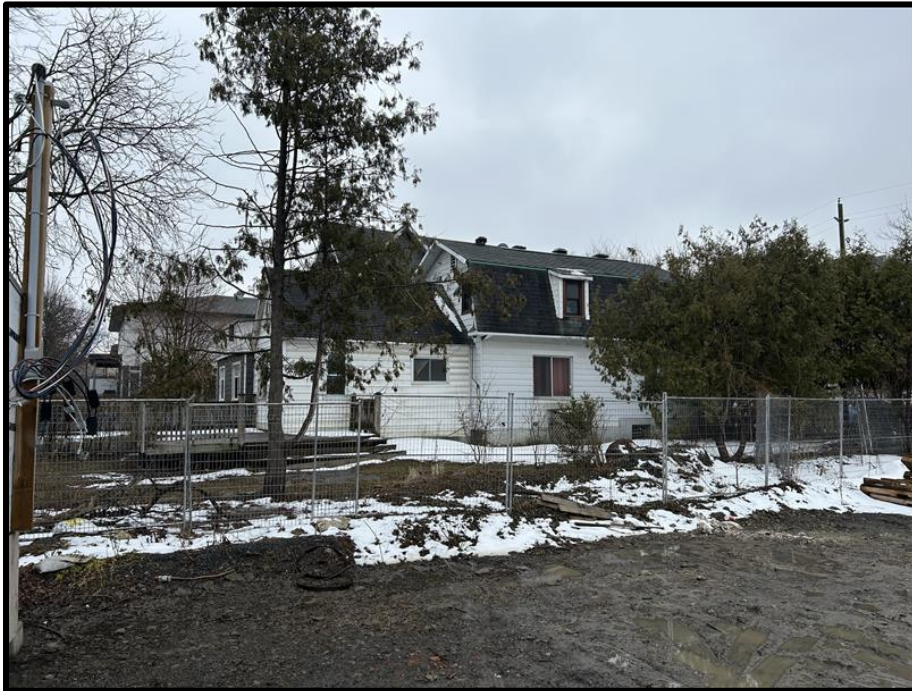
Photograph 5: View of the northern elevation of the 339 Roosevelt Avenue dwelling.

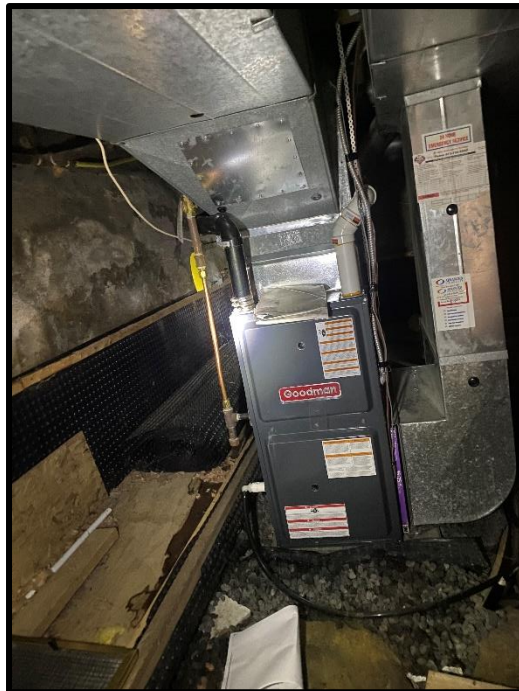
Photograph 8: View of the natural gas forced air furnace inside the 339 Roosevelt Avenue dwelling.

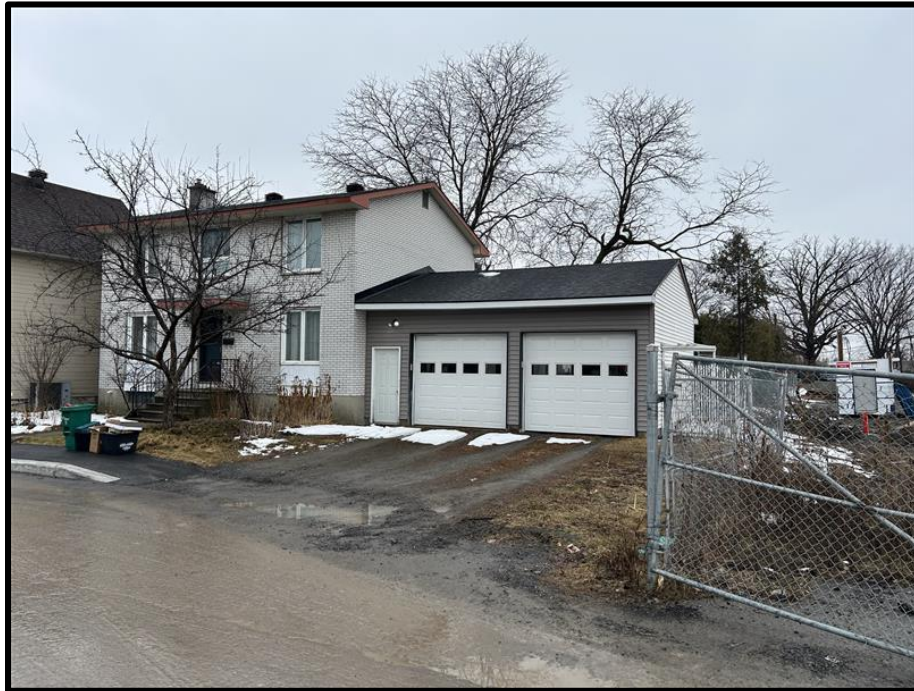
Photograph 9: View of the east elevation of the 344 Winston Avenue dwelling.

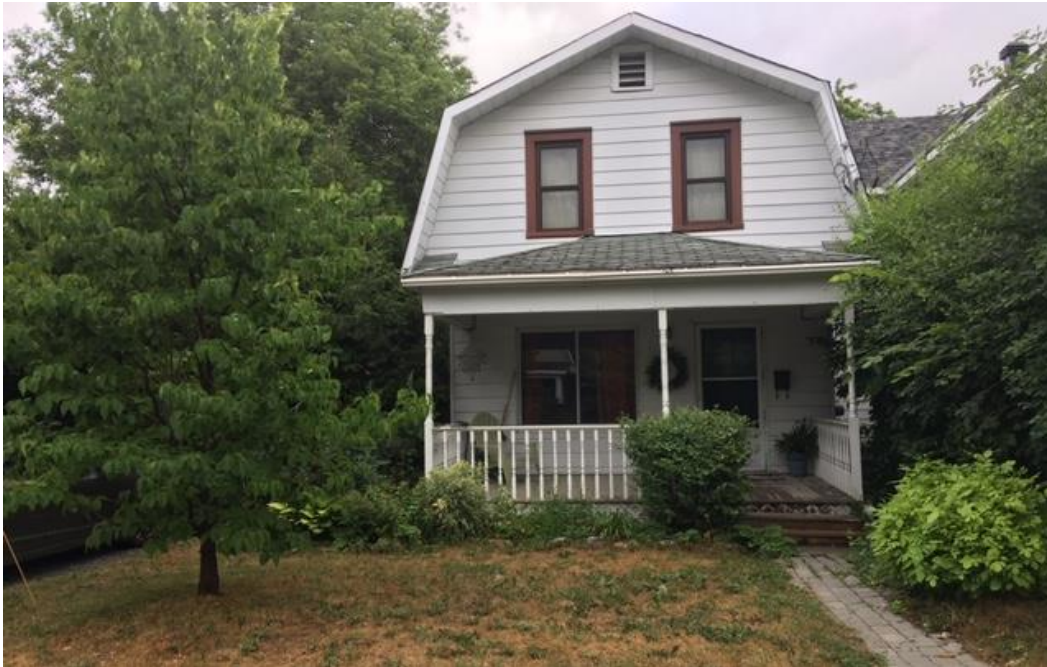
Photograph 13: Residential dwelling at 339 Roosevelt Avenue, situated on the southwest corner of the Phase I Property, looking east.

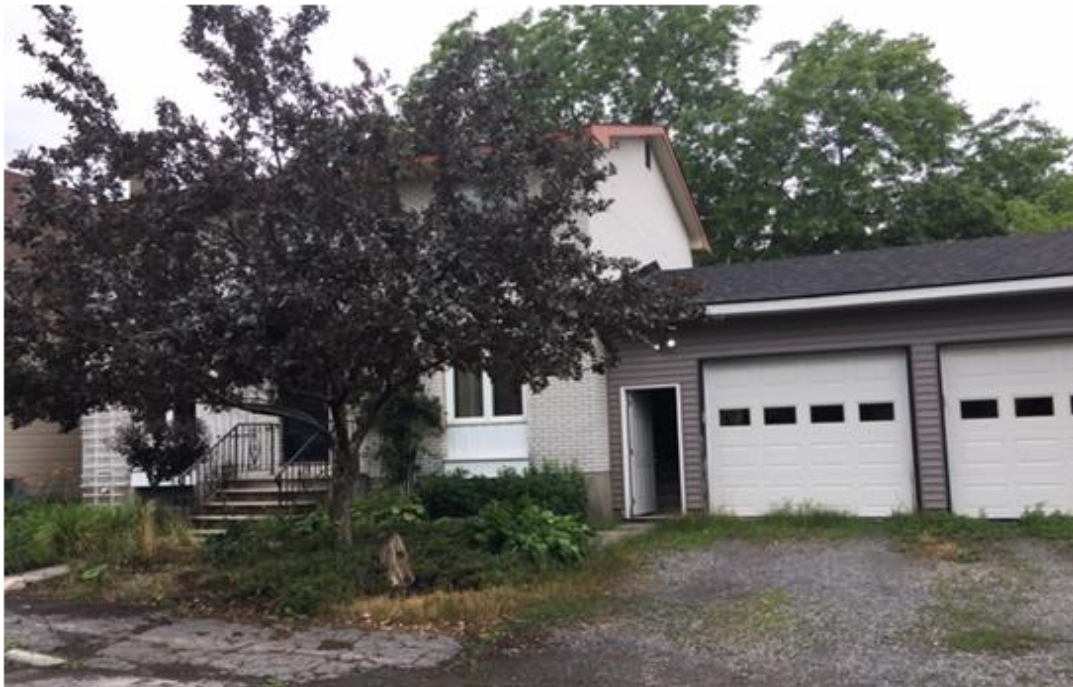
Photograph 14: Residential dwelling at 344 Winston Avenue, situated on the southwestern portion of the Phase I Property, west.

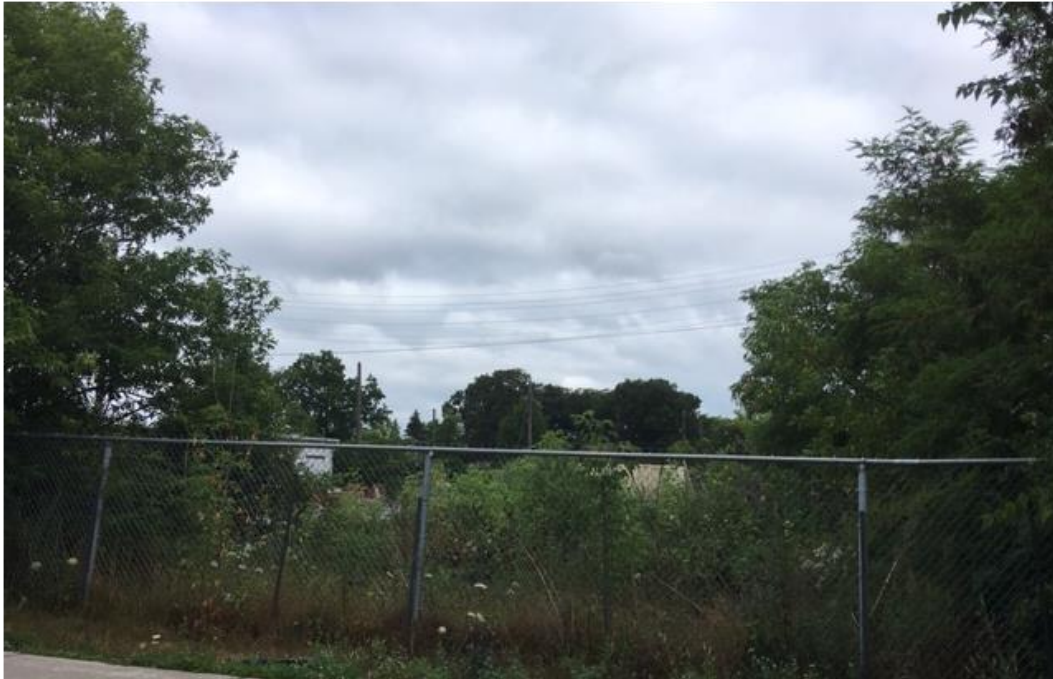
Photograph 15: Vacant lot at 389 Wilmont Avenue, situated on the southeast side of the Phase I Property, looking north.

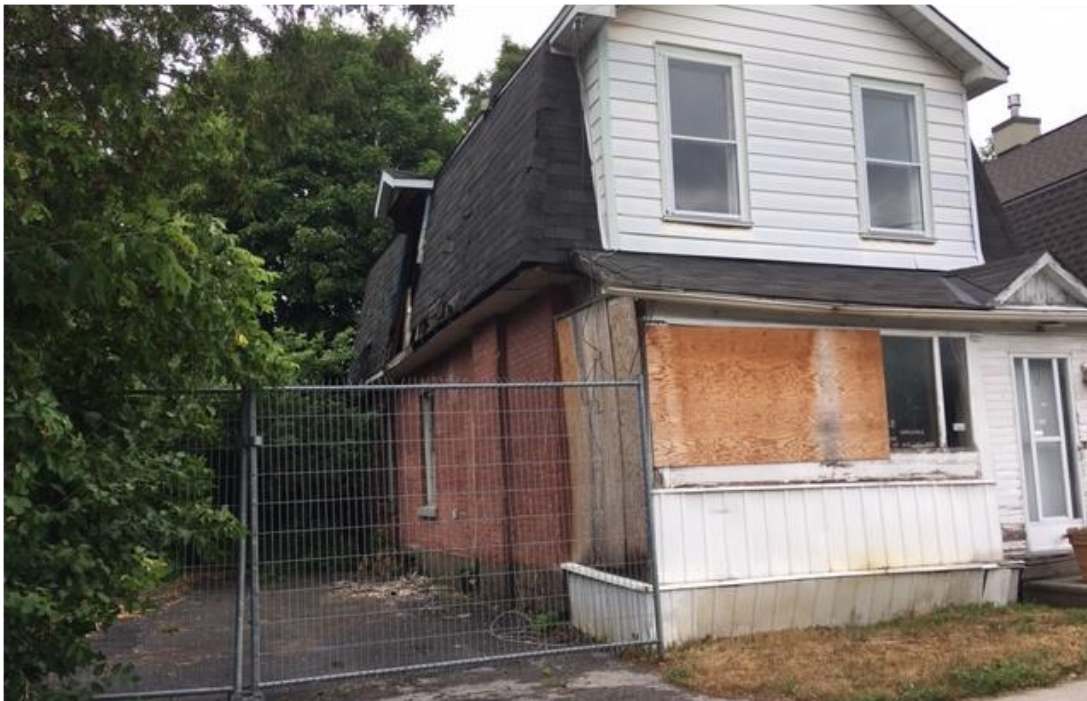
Photograph 16: Abandoned building at 379 Wilmont Avenue, situated on the southeast corner of the Phase I Property, looking north.
