Phase I Environmental Site Assessment

6408 Renaud Road
Ottawa, Ontario

Prepared for NCTL Homes Inc.

Report: PE6788-1

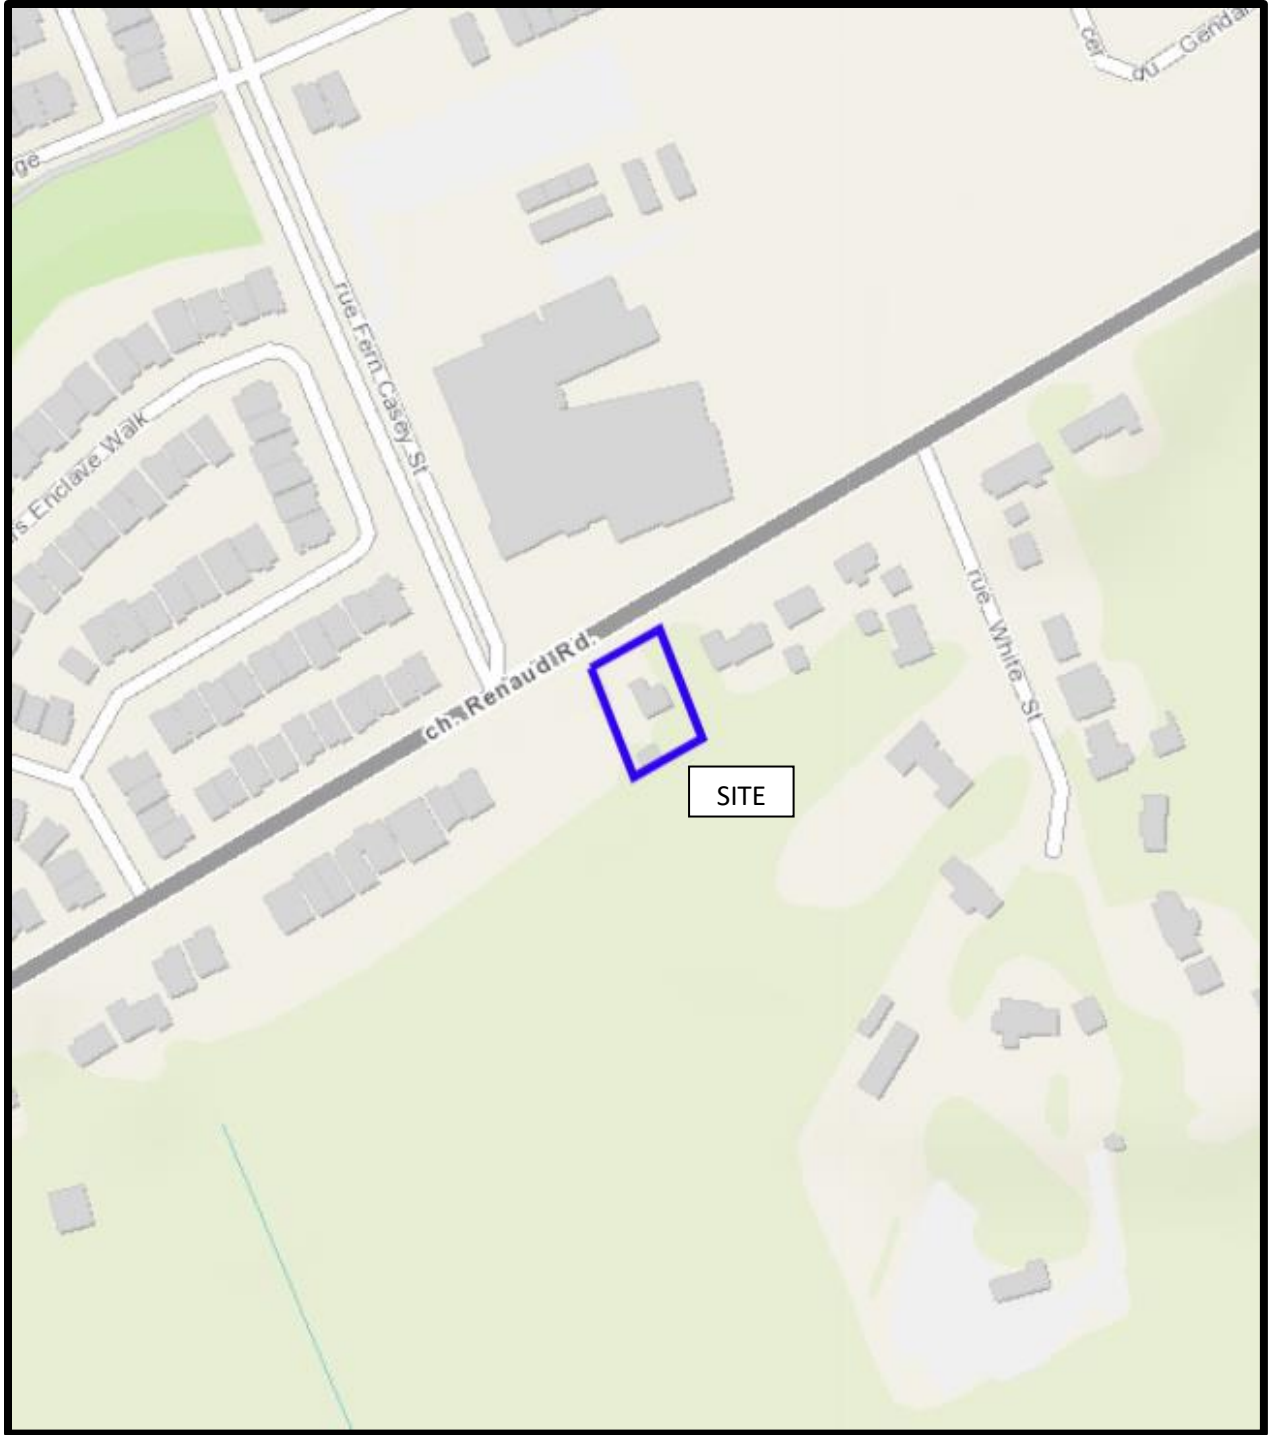
FIGURE 1
KEY PLAN

Address:	6408 Renaud Road, Ottawa, Ontario.
Legal Description:	Part of Lot 3, Concession 4 (Ottawa Front); City of Ottawa.
Property Identification Number (PIN):	04352-0273.
Location:	The Phase I Property is located on the south side of Renaud Road, approximately 35m east of the intersection of Fern Casey Street and Renaud Road, in the City of Ottawa, Ontario. For the purposes of this report, Renaud Road is considered to run east-west adjacent to the north of the subject site. Refer to Figure 1 - Key Plan in the Figures section following the text.
Latitude and Longitude:	45° 26' 4.9187" N, 75° 30' 16.421" W

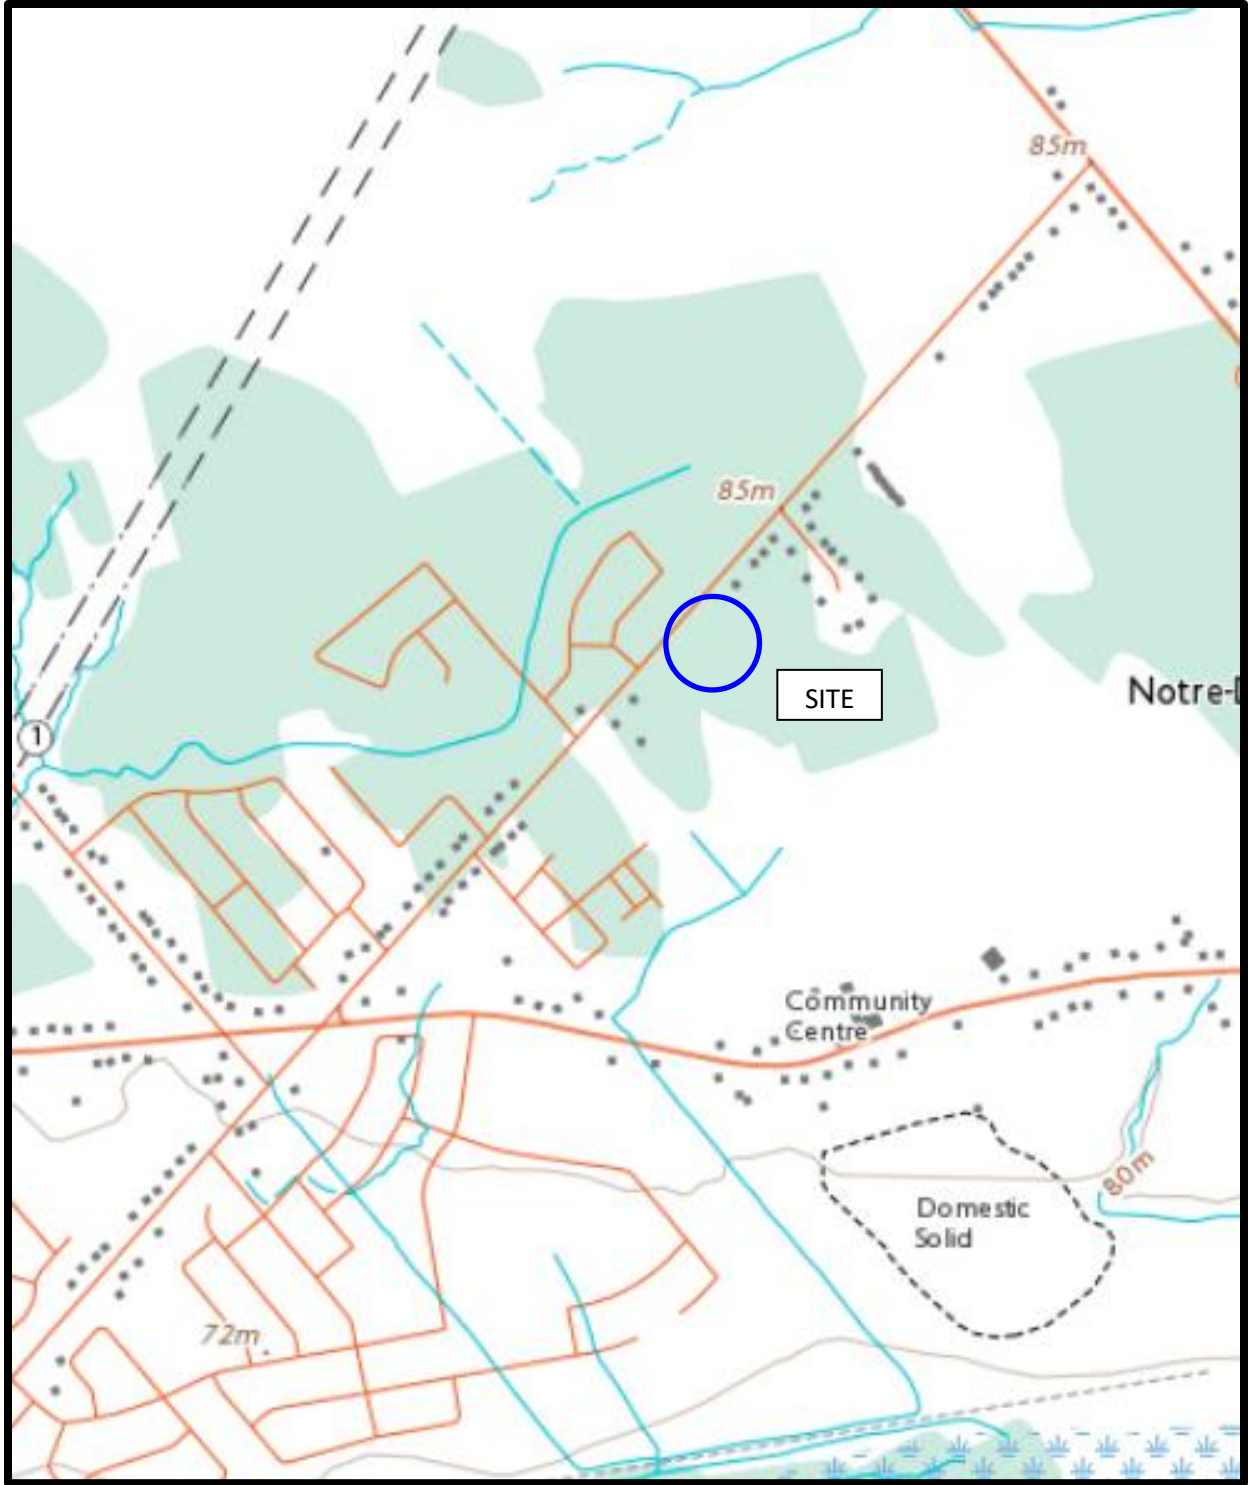
FIGURE 2
TOPOGRAPHIC MAP

Topographic maps were obtained from Natural Resources Canada – The Atlas of Canada website and from the City of Ottawa website. The topographic maps indicate that the elevation of the Phase I Property is approximately 85m above sea level. The regional topography in the general area of the Phase I Property slopes downward to the south. An illustration of the referenced topographic map is presented on Figure 2 – Topographic Map, appended to this report.

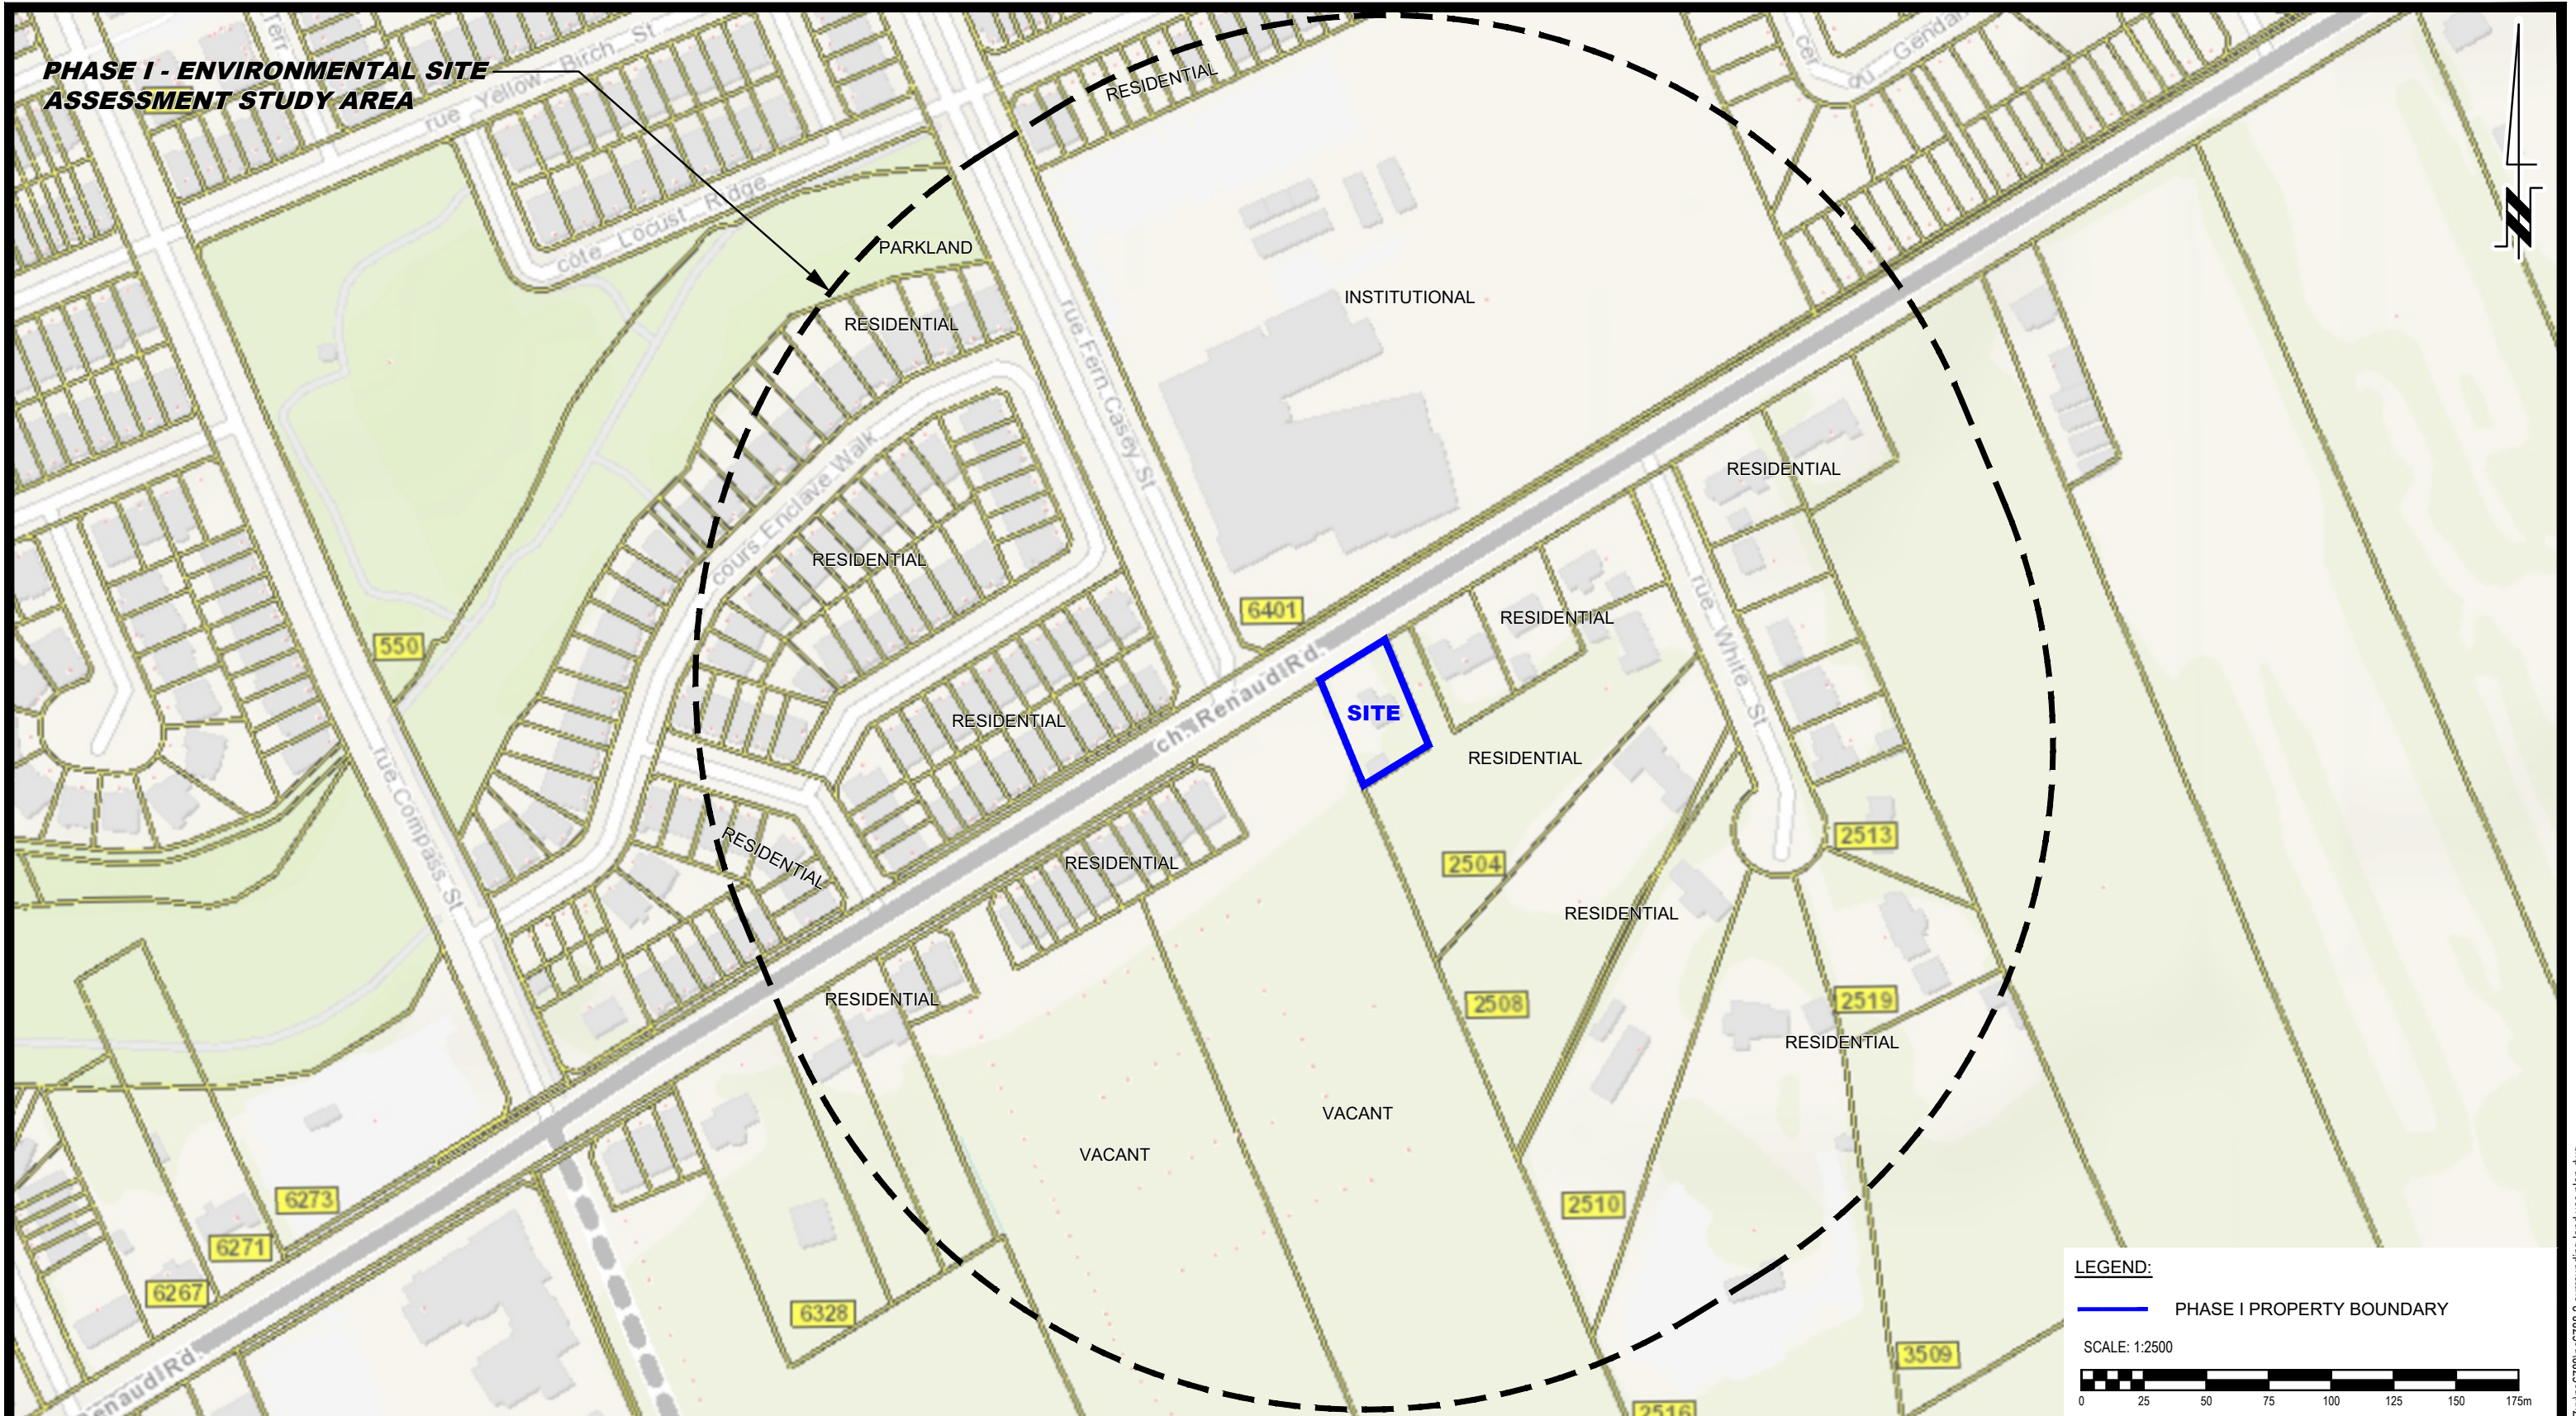
DRAWING PE6788-2 – SURROUNDING LAND USE PLAN

PHASE I - ENVIRONMENTAL SITE ASSESSMENT STUDY AREA

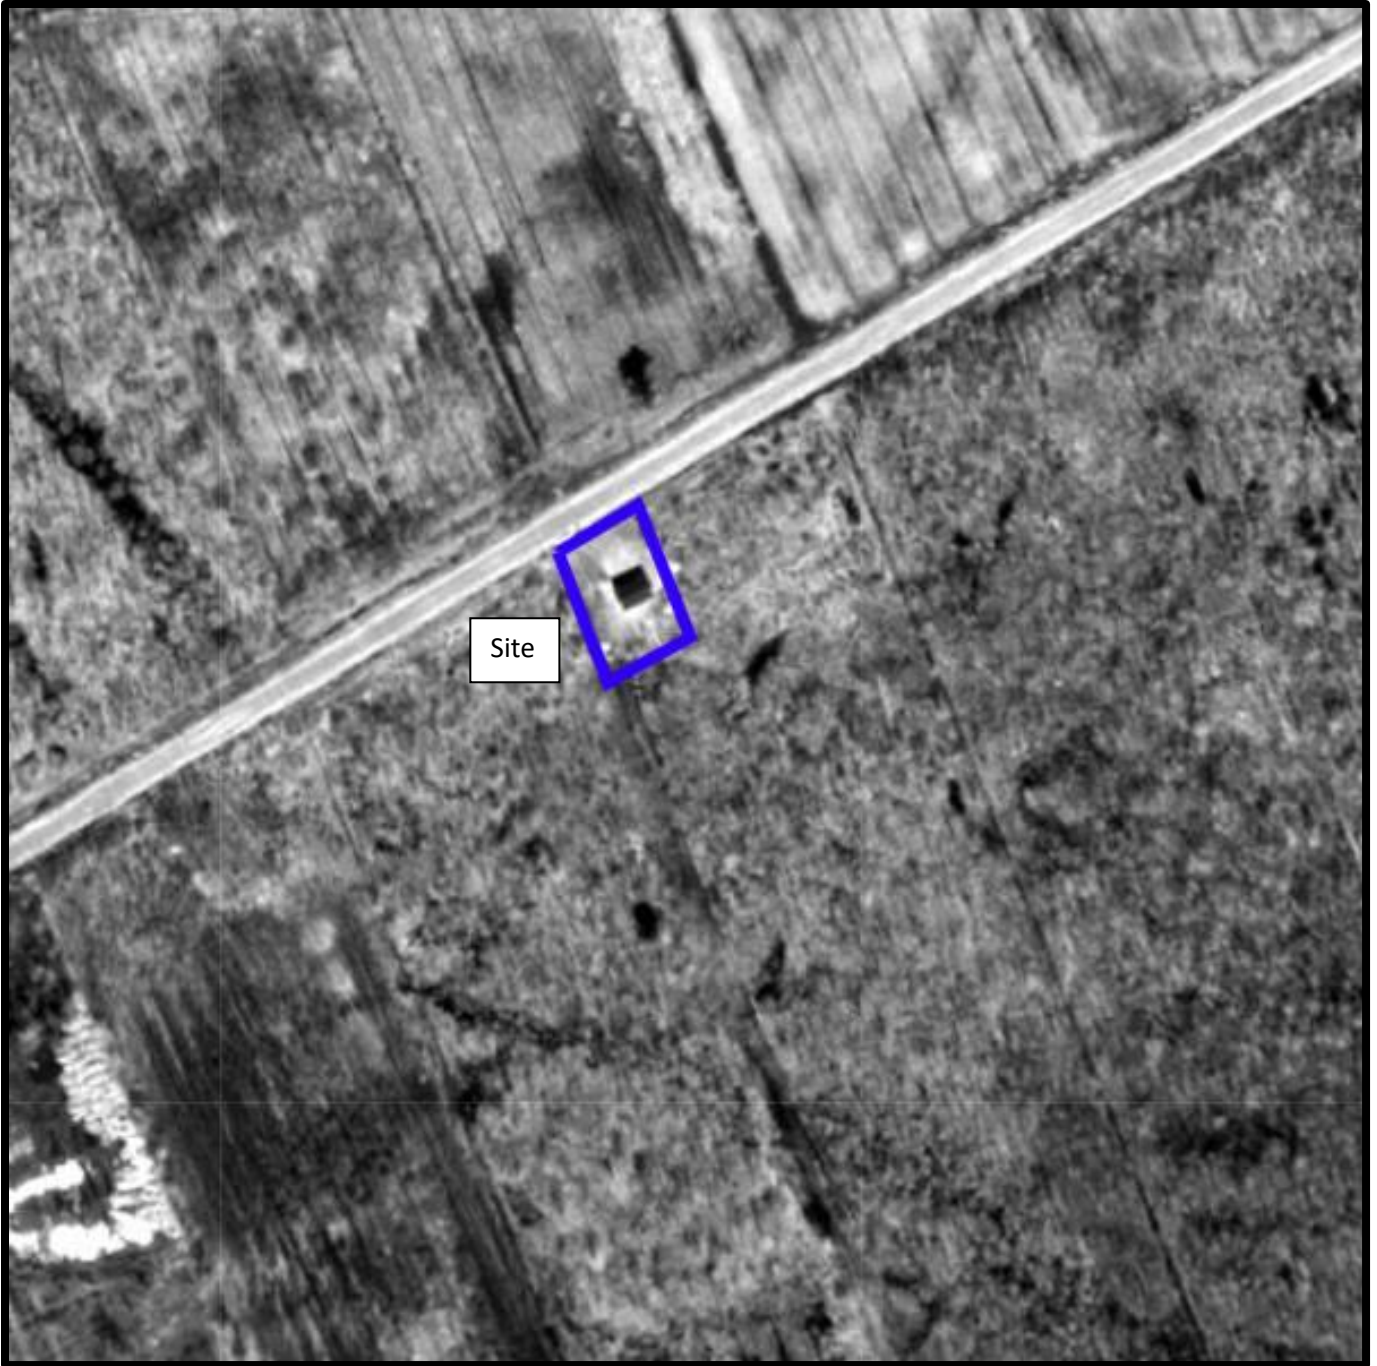
AERIAL PHOTOGRAPH
1965

| 1965 | The Phase I Property is occupied by a residential dwelling. Renaud Road is observed adjacent to north of the Phase I Property. The surrounding properties consist of vacant/agricultural lands. |

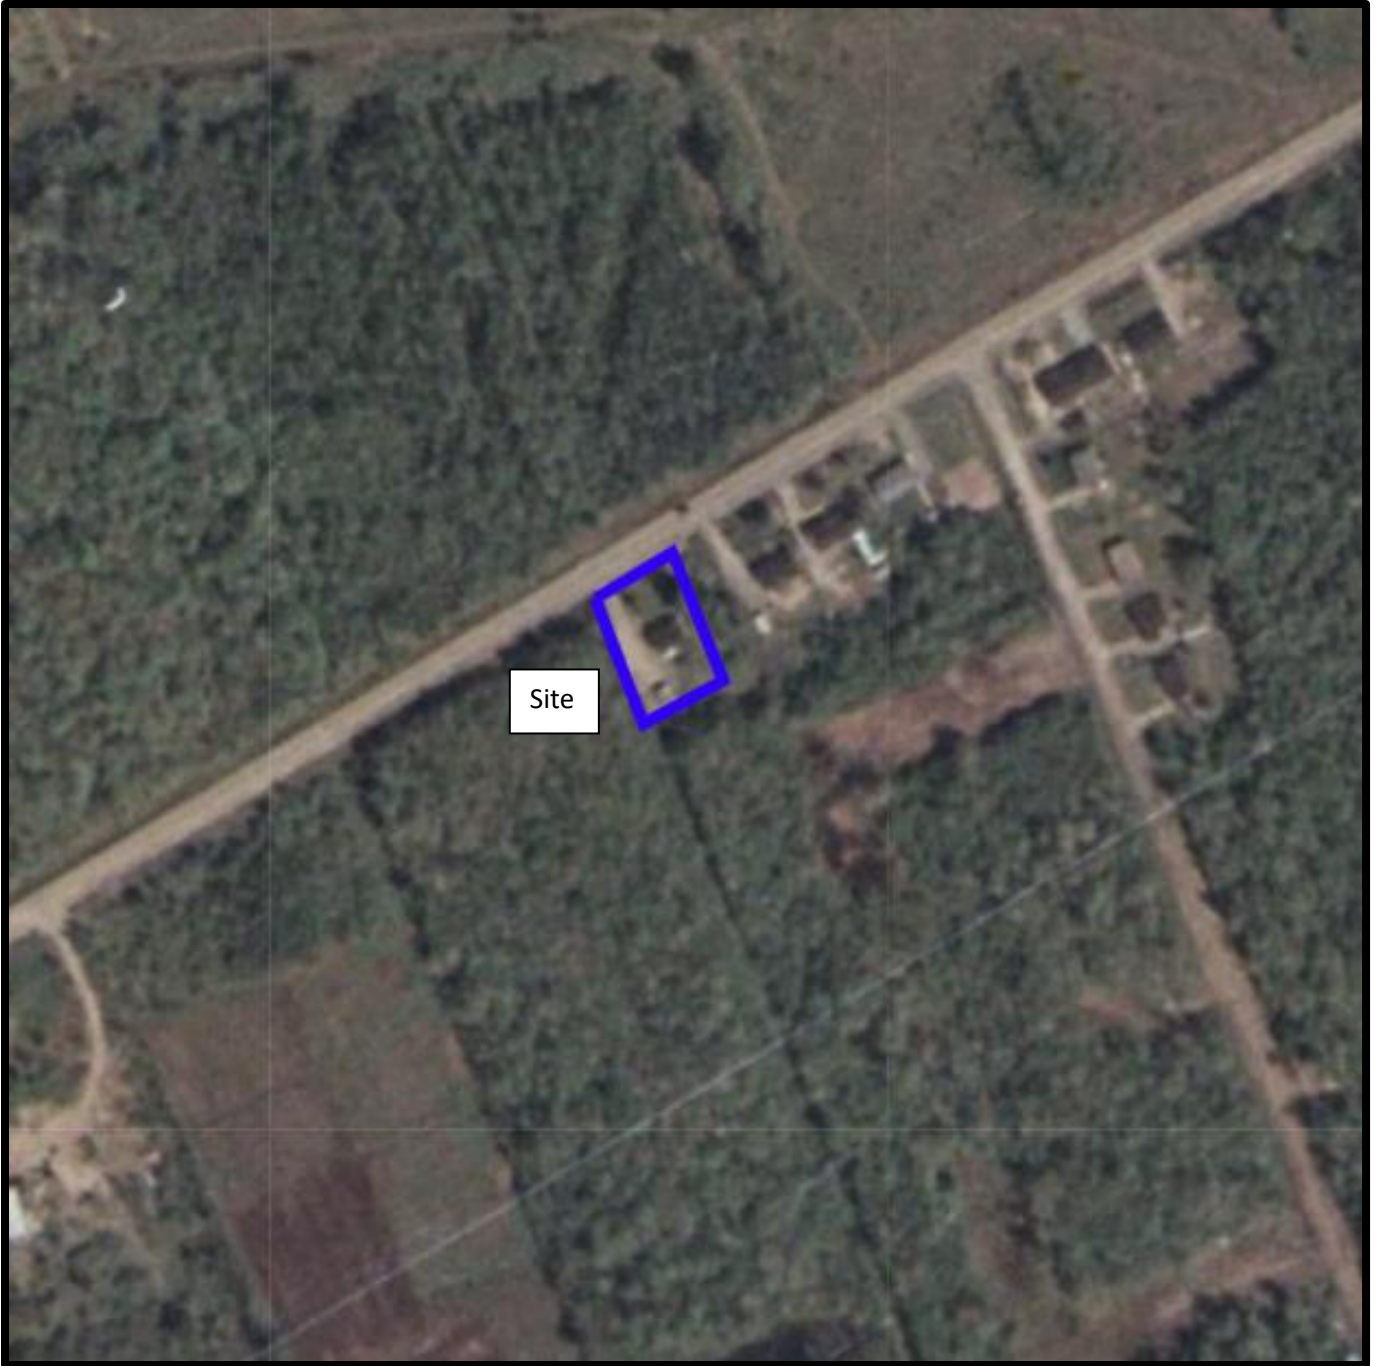
AERIAL PHOTOGRAPH
1976

| 1976 | A private car garage is constructed in the southwest portion of the Phase I Property. The properties to the east and southeast of the Phase I Property are developed with residential dwellings along White Street and Renaud Road. White Street is observed constructed to the east of the Phase I Property. |

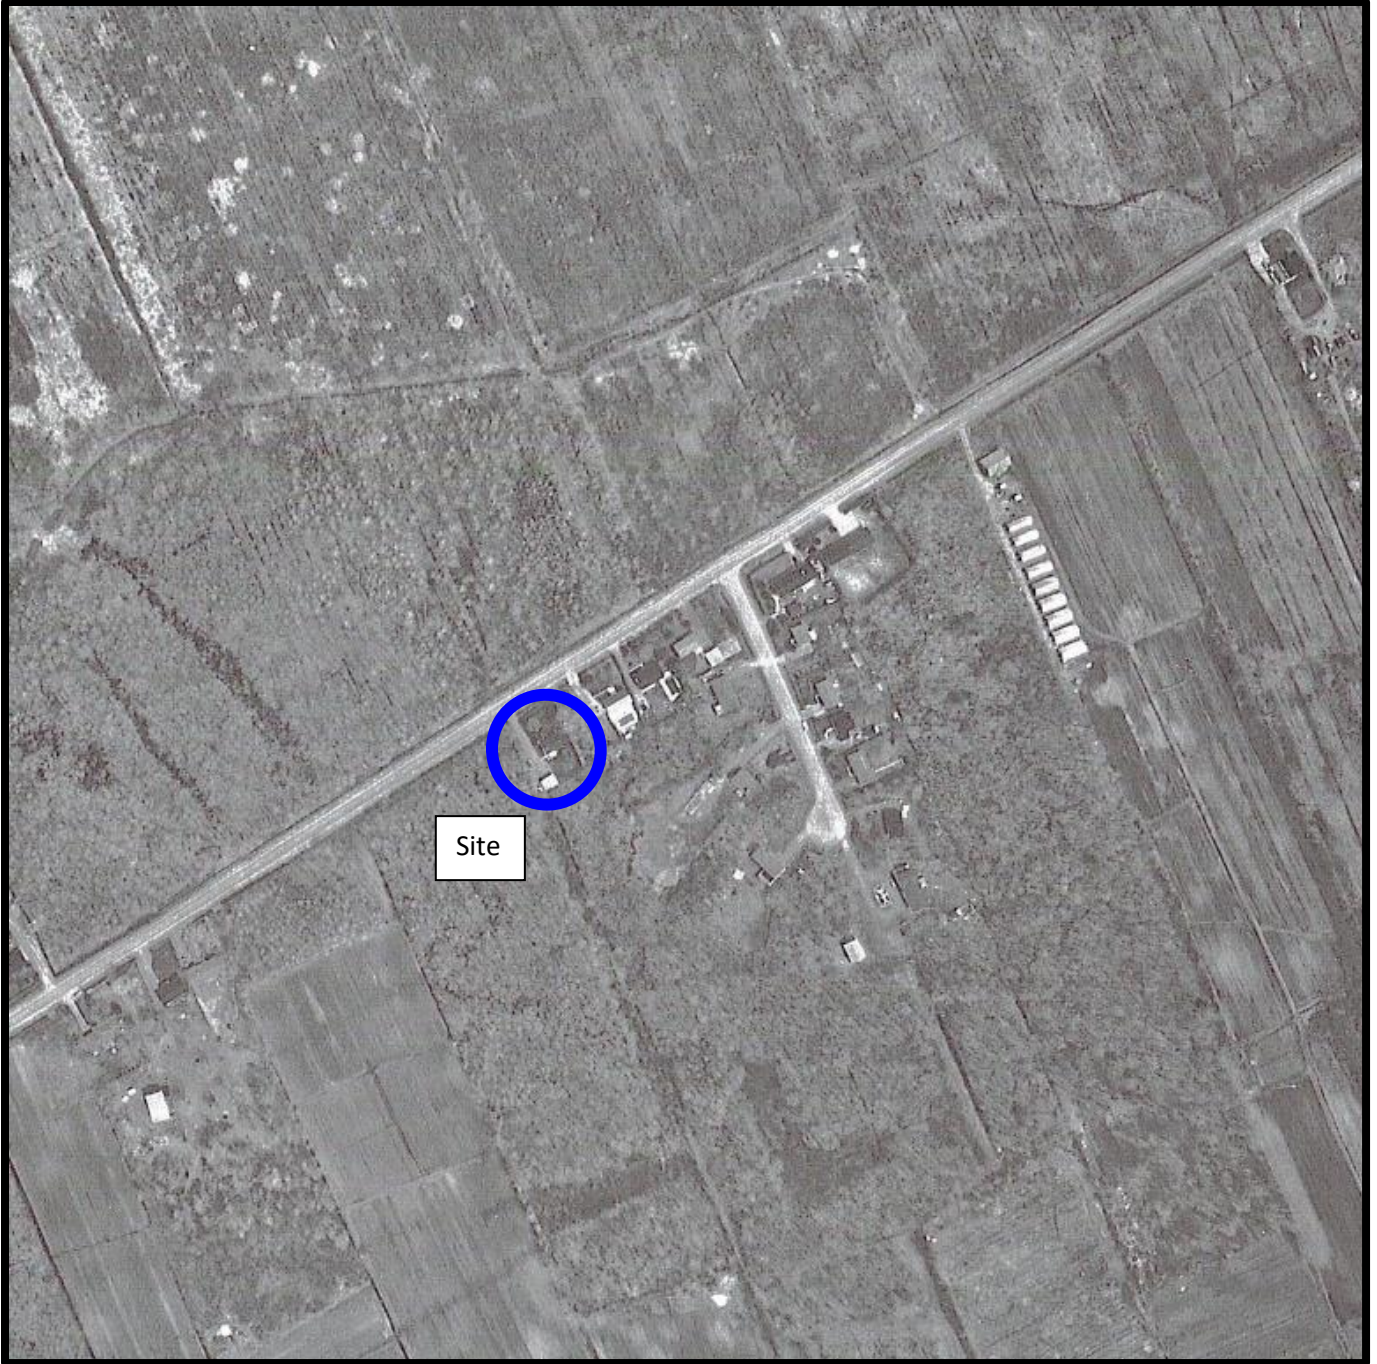
AERIAL PHOTOGRAPH
1988

| 1988 | (Poor Scale) No significant changes are apparent with regard to the Phase I Property. Further residential development is observed to the southeast of the Phase I Property, along White Street. |

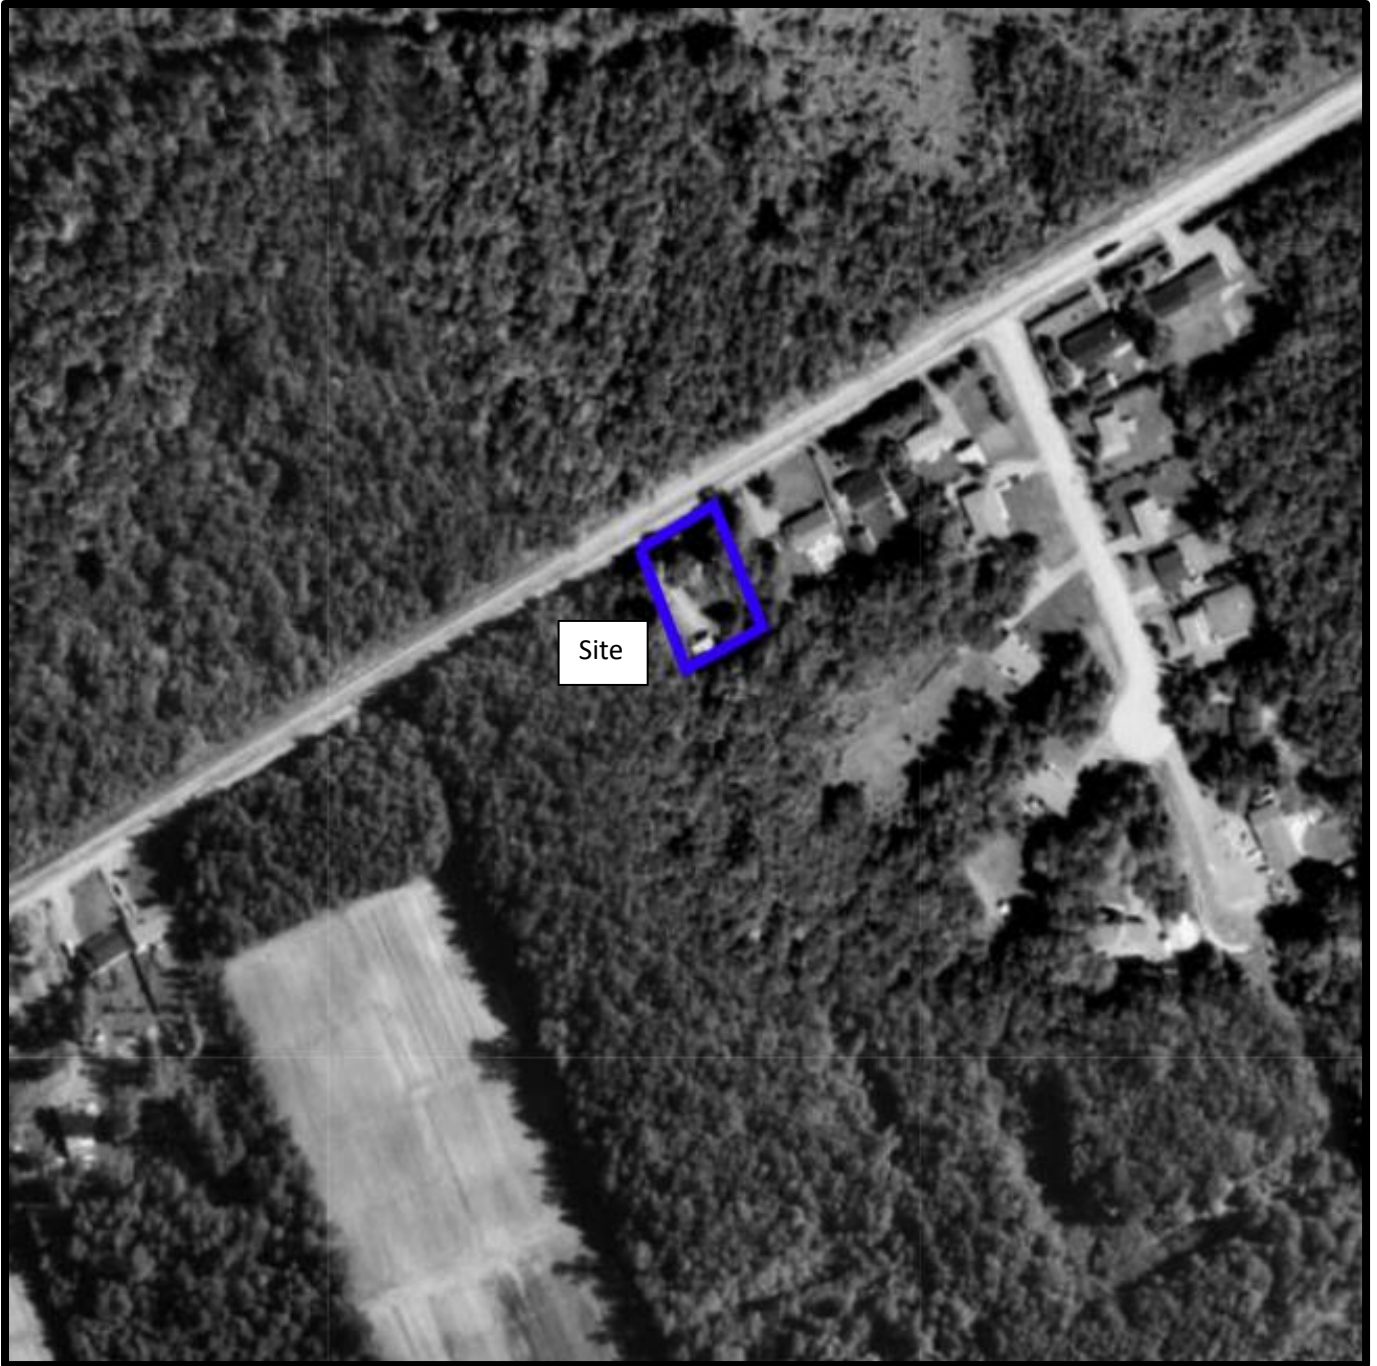
AERIAL PHOTOGRAPH
1991

- 1991 An addition to the former residential dwelling is observed on the Phase I Property. No significant changes are apparent with regard to the surrounding properties.
- 2002 No significant changes are apparent with regard to the Phase I Property. Further residential development is observed to the southeast of the Phase I Property, along White Street.
- 2011 No significant changes are apparent with regard to the Phase I Property. The vegetation has been cleared from the properties north of the Phase I Property.
- 2022 No significant changes are apparent with regard to the Phase I Property. The surrounding properties to the northwest and west of the Phase I Property are developed with residential buildings. Additionally, a school has been constructed to the north of the Phase I Property along Renaud Road.

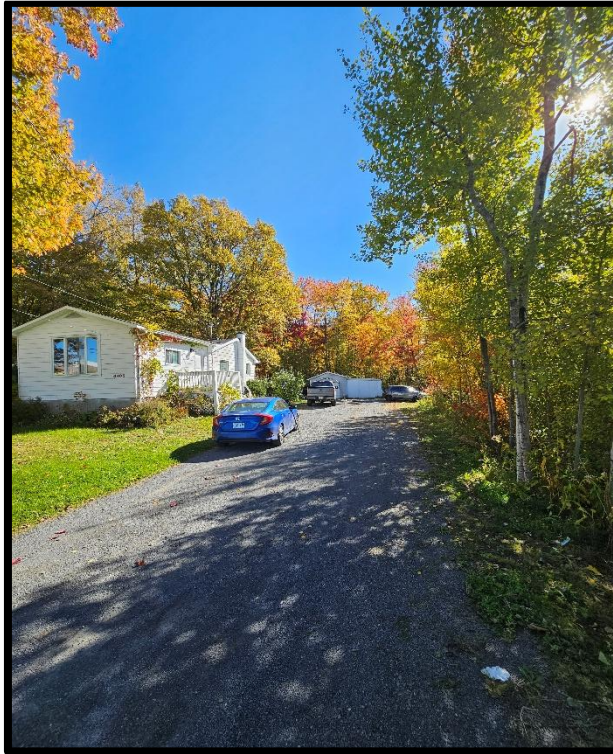
Photograph 1: View of the northwestern portion of the Phase I Property, facing south.

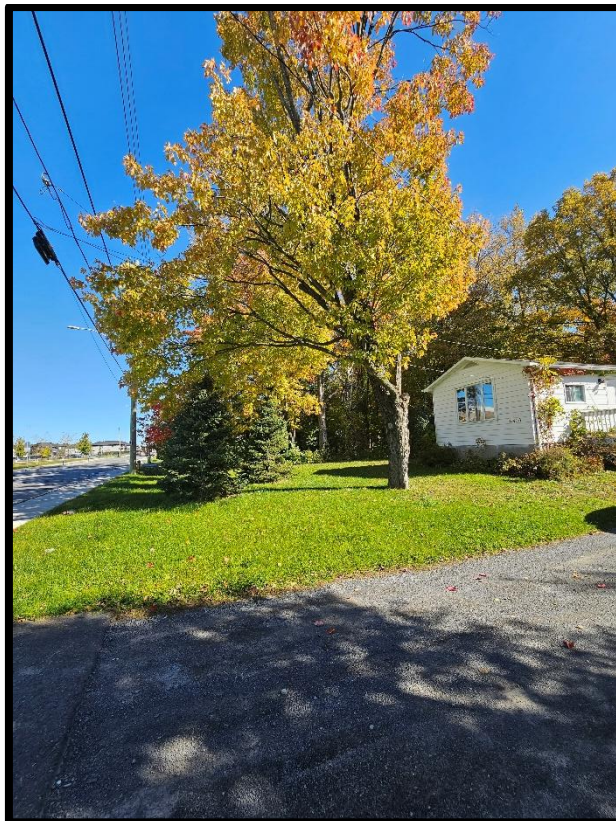
Photograph 2: View of the northern portion of the Phase I Property, facing east.

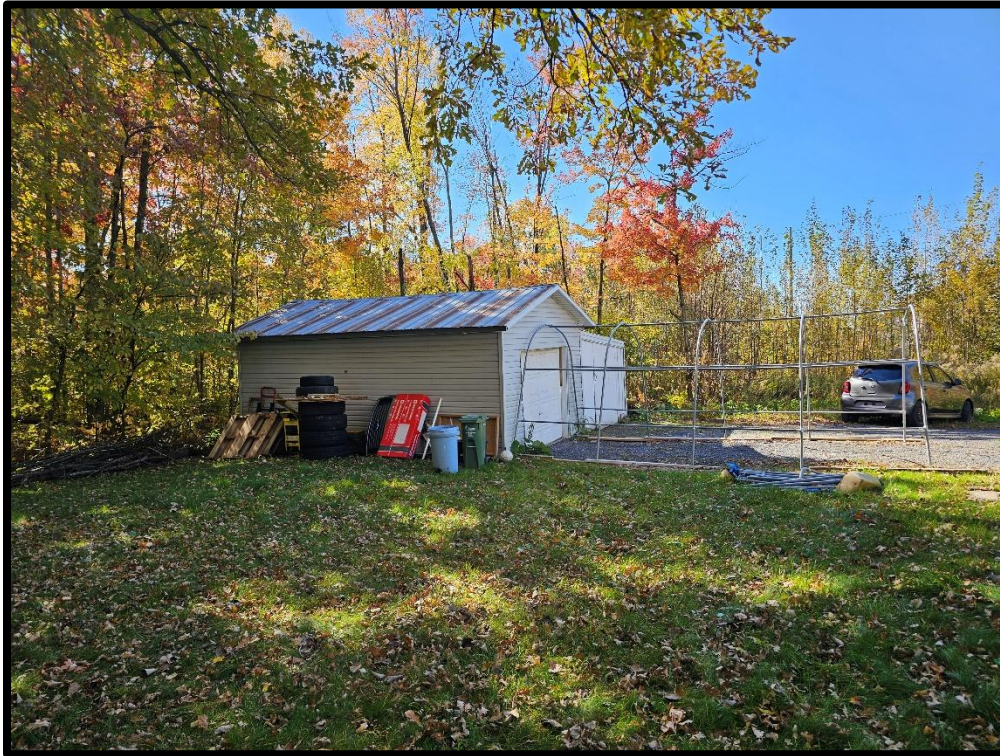
Photograph 3: View of the southwestern portion of the Phase I Property, facing west.
