March 9, 2026  
File: PE5280-LET.03

Subject: **Phase I-Environmental Site Assessment Update  
3750 North Bowesville Road  
Ottawa, Ontario**

Further to your request, Paterson Group (Paterson) conducted a Phase I - Environmental Site Assessment (ESA) Update for the aforementioned property. This report updates a Phase I ESA entitled "Phase I-ESA, 3750 North Bowesville Road, Ottawa, Ontario" prepared by Paterson, dated on August 28, 2022.

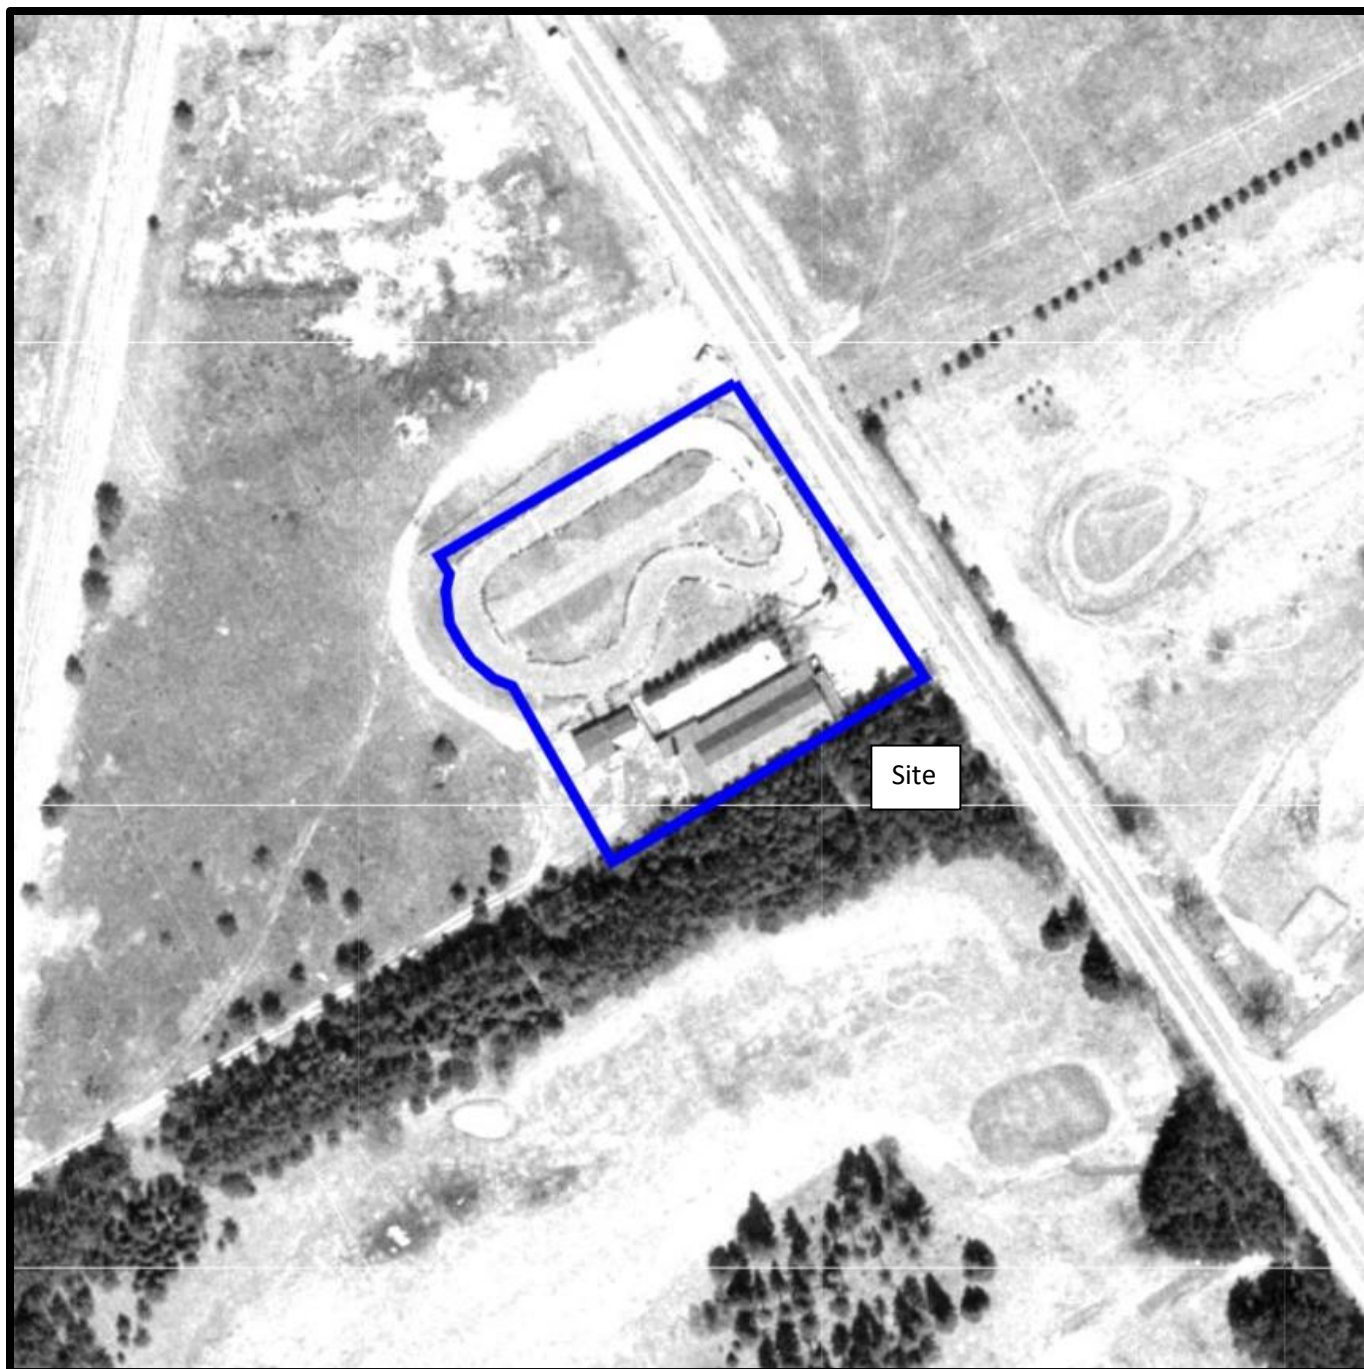
AERIAL PHOTOGRAPH  
1965

Historical aerial photographs indicate that prior to development of the current building in the 1980s, the Phase I Property was occupied by two buildings on the southern portion and a racetrack in the northern portion (visible in the 1965 aerial photograph).

The smaller of the two building was located in close proximity to the racetrack, with an asphalt apron connected to the track.
