**Ottawa-Carleton District School Board**

**Phase One Environmental Site Assessment  
3853 Cambrian Road,  
Ottawa, Ontario**

**ER1076**

**November 19, 2024**

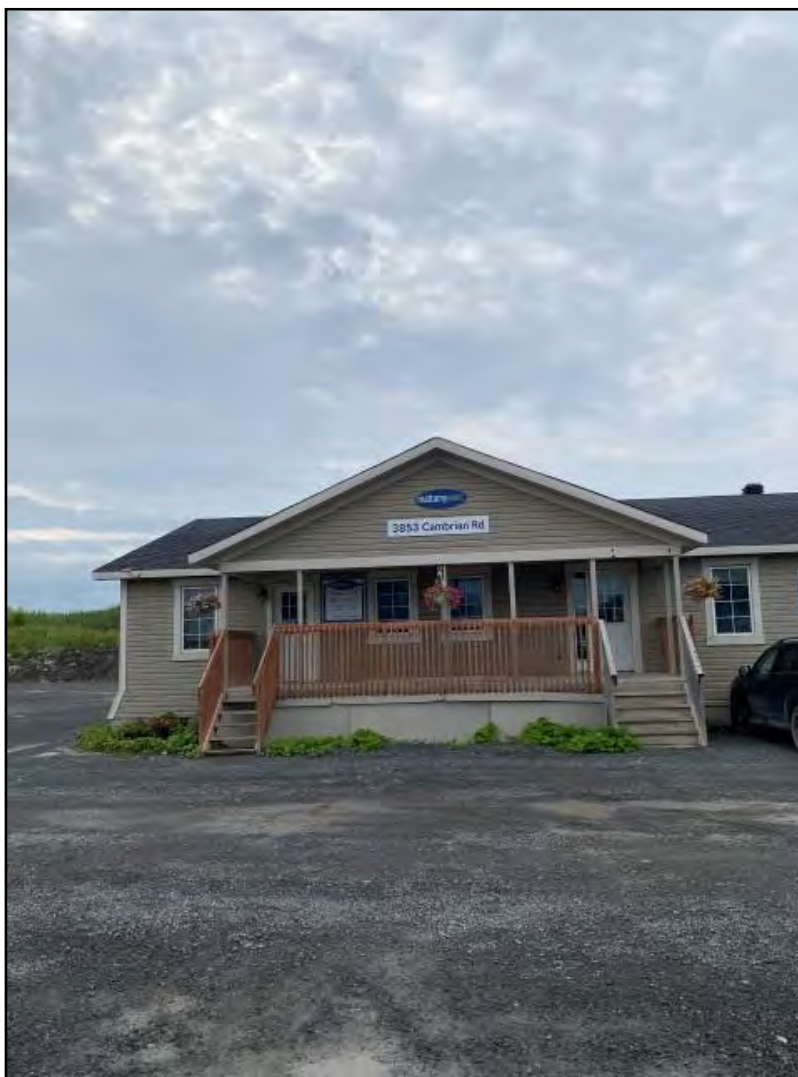
**Photograph 1:** Looking south-east at the temporary sales office for Mattamy from the gravel parking area on the north side of the site.

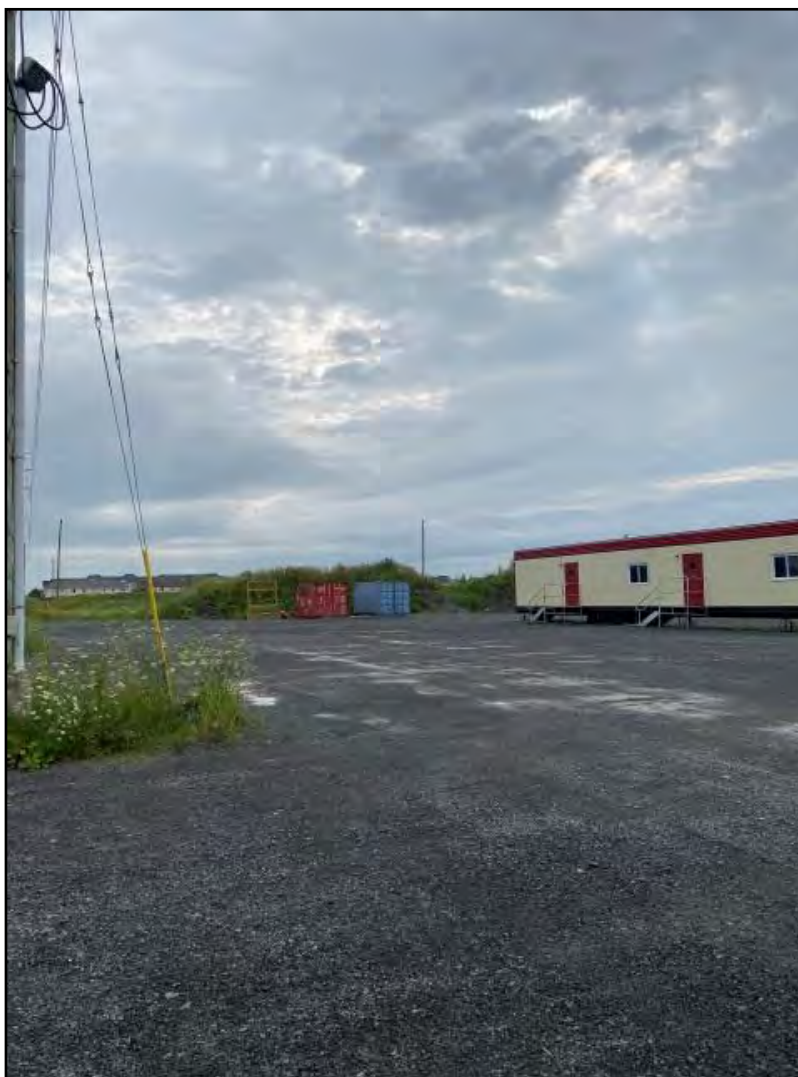
**Photograph 2:** Looking east at the mobile construction office and two storage containers. The sales office is out of frame on the right side of the photo.

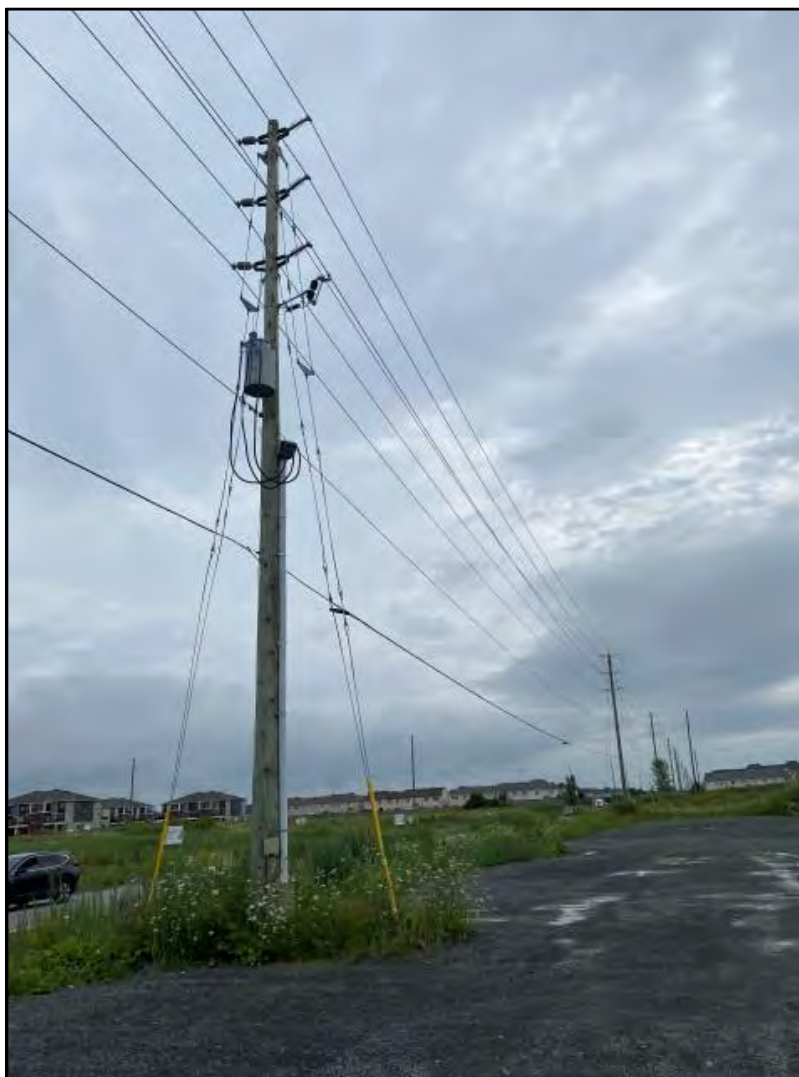
Polychlorinated Biphenyls (PCBs) may be present in transformers, capacitors, electromagnets, heat transfer units, and fluorescent lamp ballasts. One pole mounted transformer was present at the north property boundary. Due to the recent installation of the transformer (after 2011) it is not expected that the transformer oil contains PCBs. Additionally, no staining was observed that would indicate a leak.

**Photograph 3:** Looking north at the vehicle entrance to the site from Cambrian Road and a pole mounted transformer beyond the north property boundary.

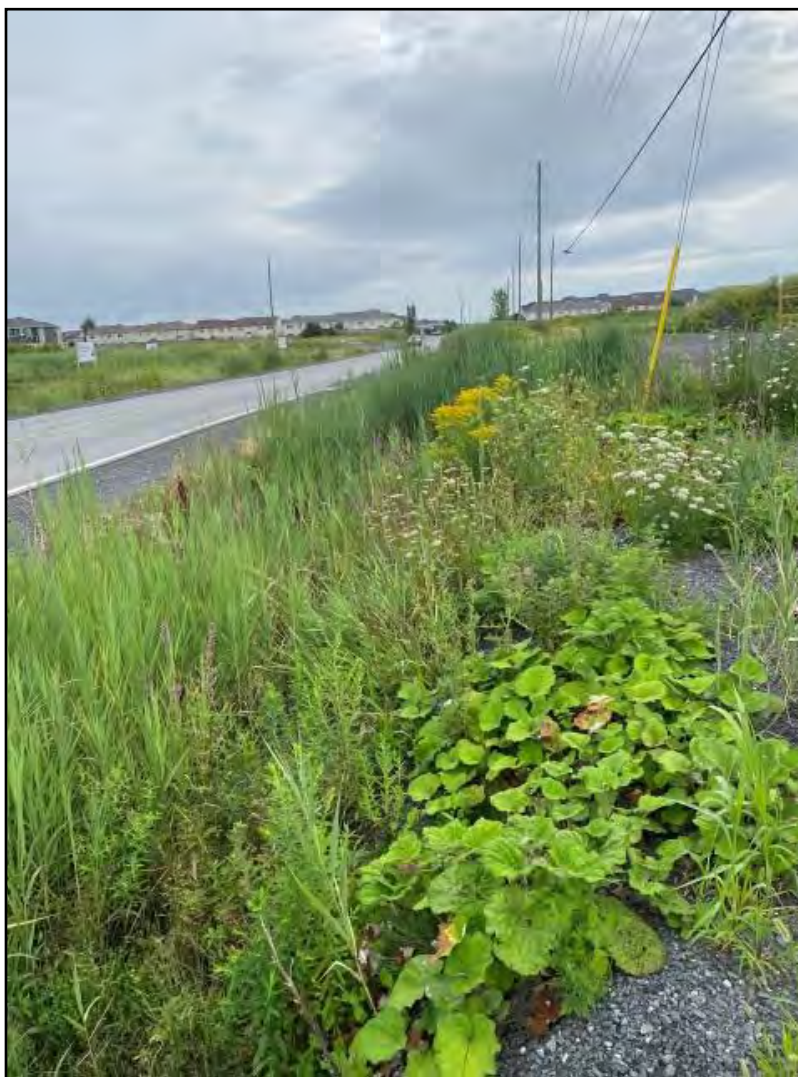
**Photograph 5:** View looking northeast down Cambrian Road. A drainage ditch flowing to the northeast is in view.

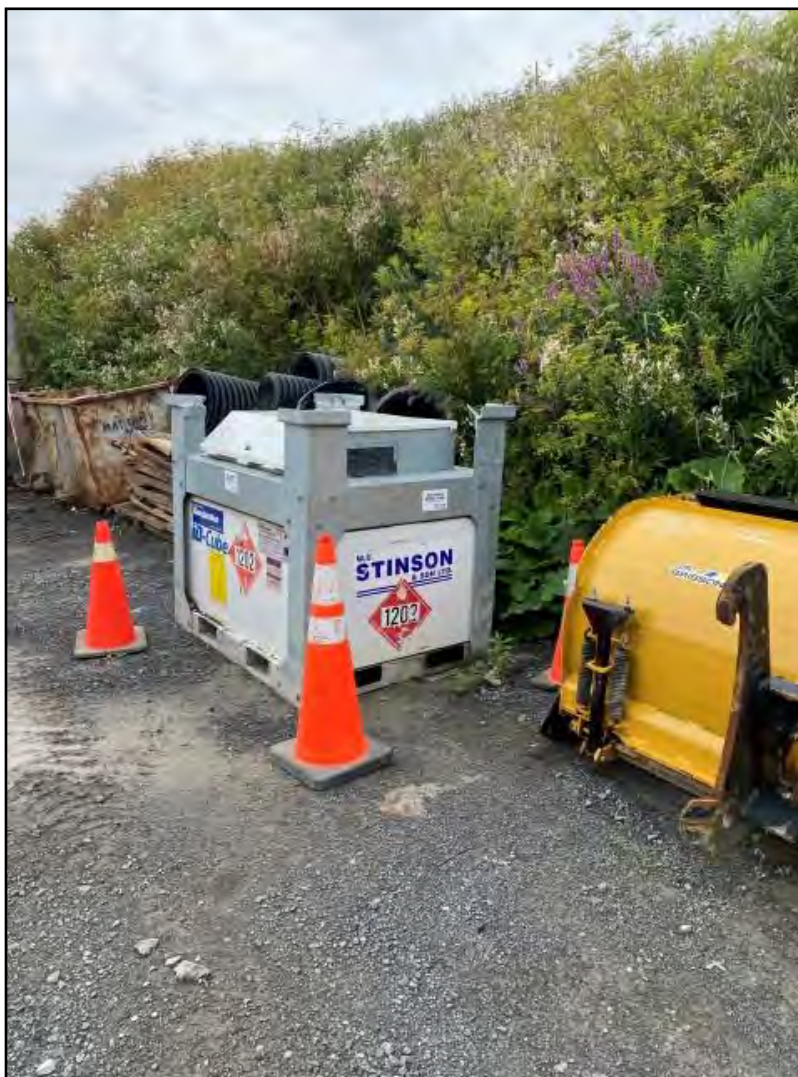
**Photograph 6:** View of a mobile diesel fuel tank on the west side of the temporary sales office.

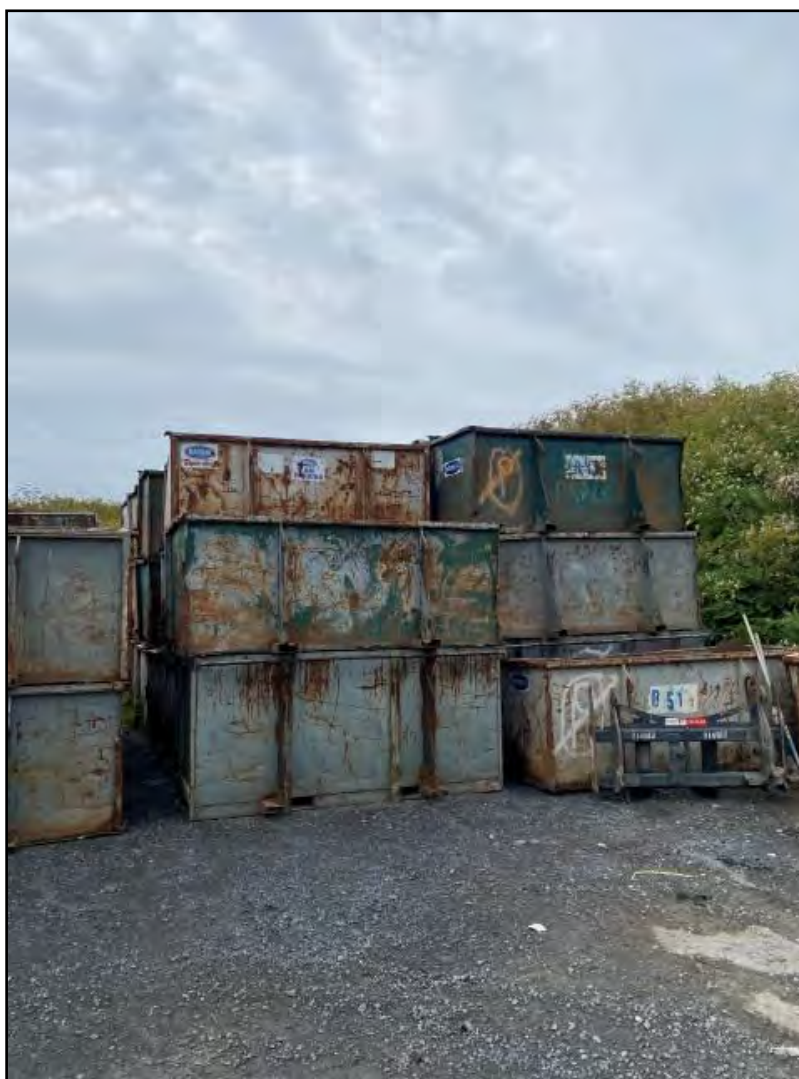
Waste bins were stacked at the south end of the office area. The interior of the bins observed had metal and wood scraps or building components (e.g. catch basin grates).

**Photograph 7:** View of metal storage bins on the south side of the temporary sales office.

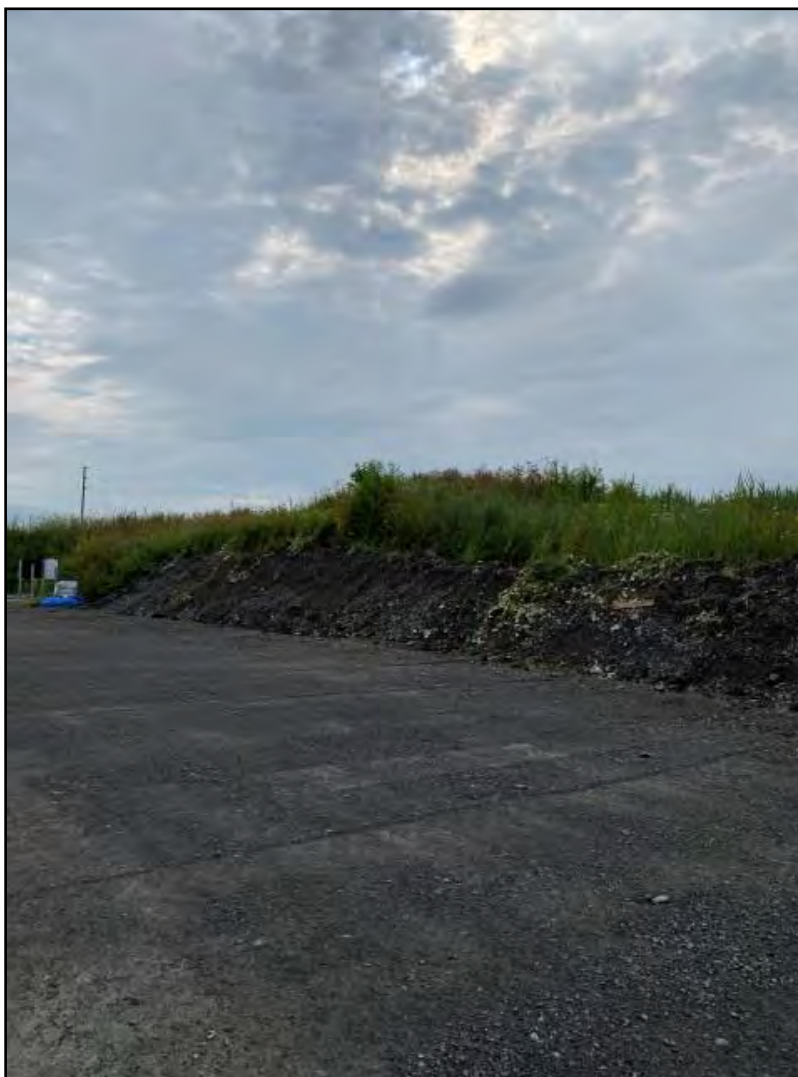
**Photograph 9:** Looking east at a view of the berm that surrounds the gravel covered office area at the north side of the site.

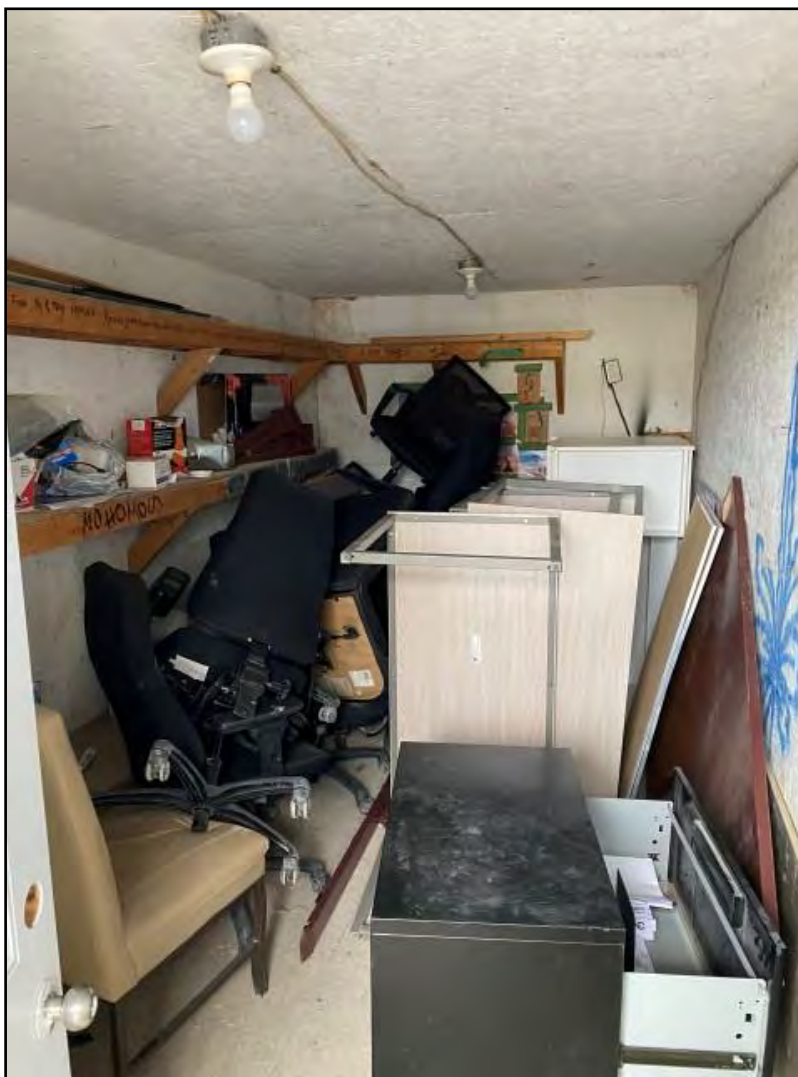
**Photograph 10:** Example of an interior view of a storage container.

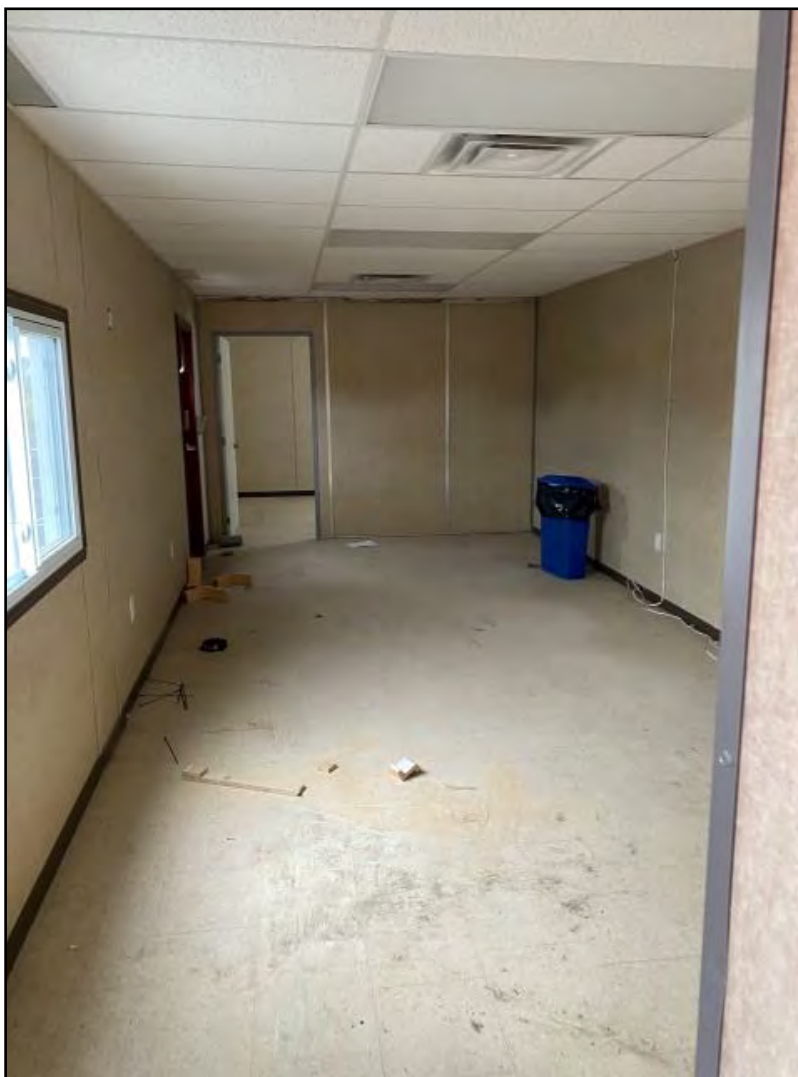
**Photograph 11:** Interior view of the mobile construction office.

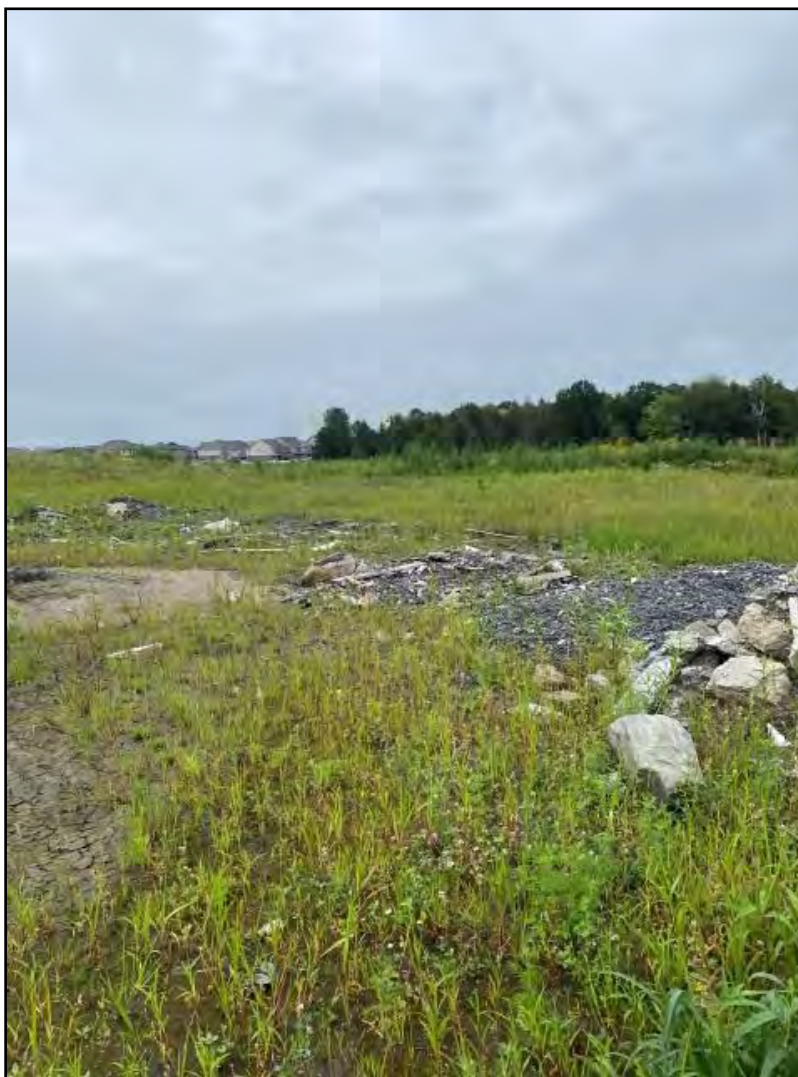
The historic records search and site inspection identified two on-site potentially contaminating activities (PCA) related to the potential importation of fill materials of unknown quality to the site and the former and current above ground fuel storage tanks (ASTs) on-site. Based on the evaluation of the PCAs, two areas of potential environmental concern (APEC) were identified at the subject property.

**Photograph 13:** Looking south at the subject property from the northwest section. Fill materials are in view.

A Phase Two ESA is required to characterize soils (and potentially groundwater) at the site. Contaminants of concern consisted of petroleum hydrocarbons in the F1-F4 fractions (PHCs), benzene, toluene, ethylbenzene, and xylenes (BTEX), polycyclic aromatic hydrocarbons (PAHs), and metals. CM3 added sodium adsorption ratio (SAR) and electrical conductivity (EC) to the analytical suite for future excess soil considerations.

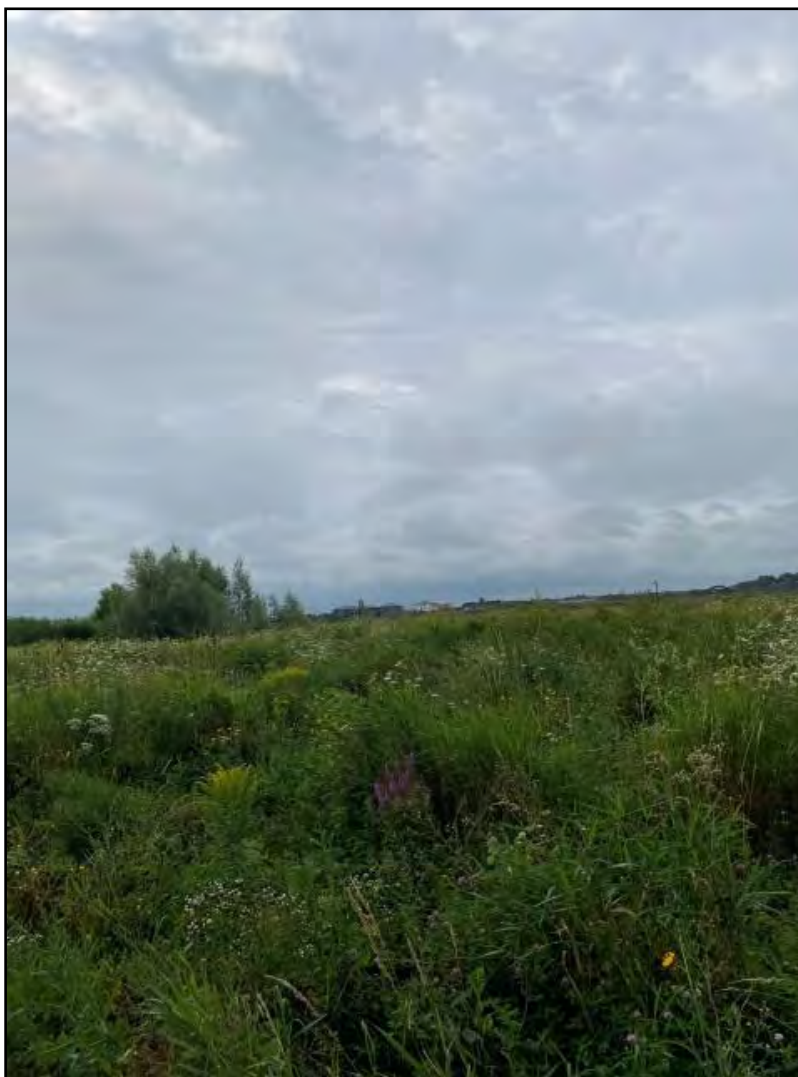
**Photograph 14:** Looking east at the subject property from the northwest section. Vegetation and built-up areas are in view.
