**Ottawa-Carleton District School Board**

**Phase Two Environmental Site Assessment  
3853 Cambrian Road  
Ottawa, Ontario**

**ER1076**

**November 19, 2024**

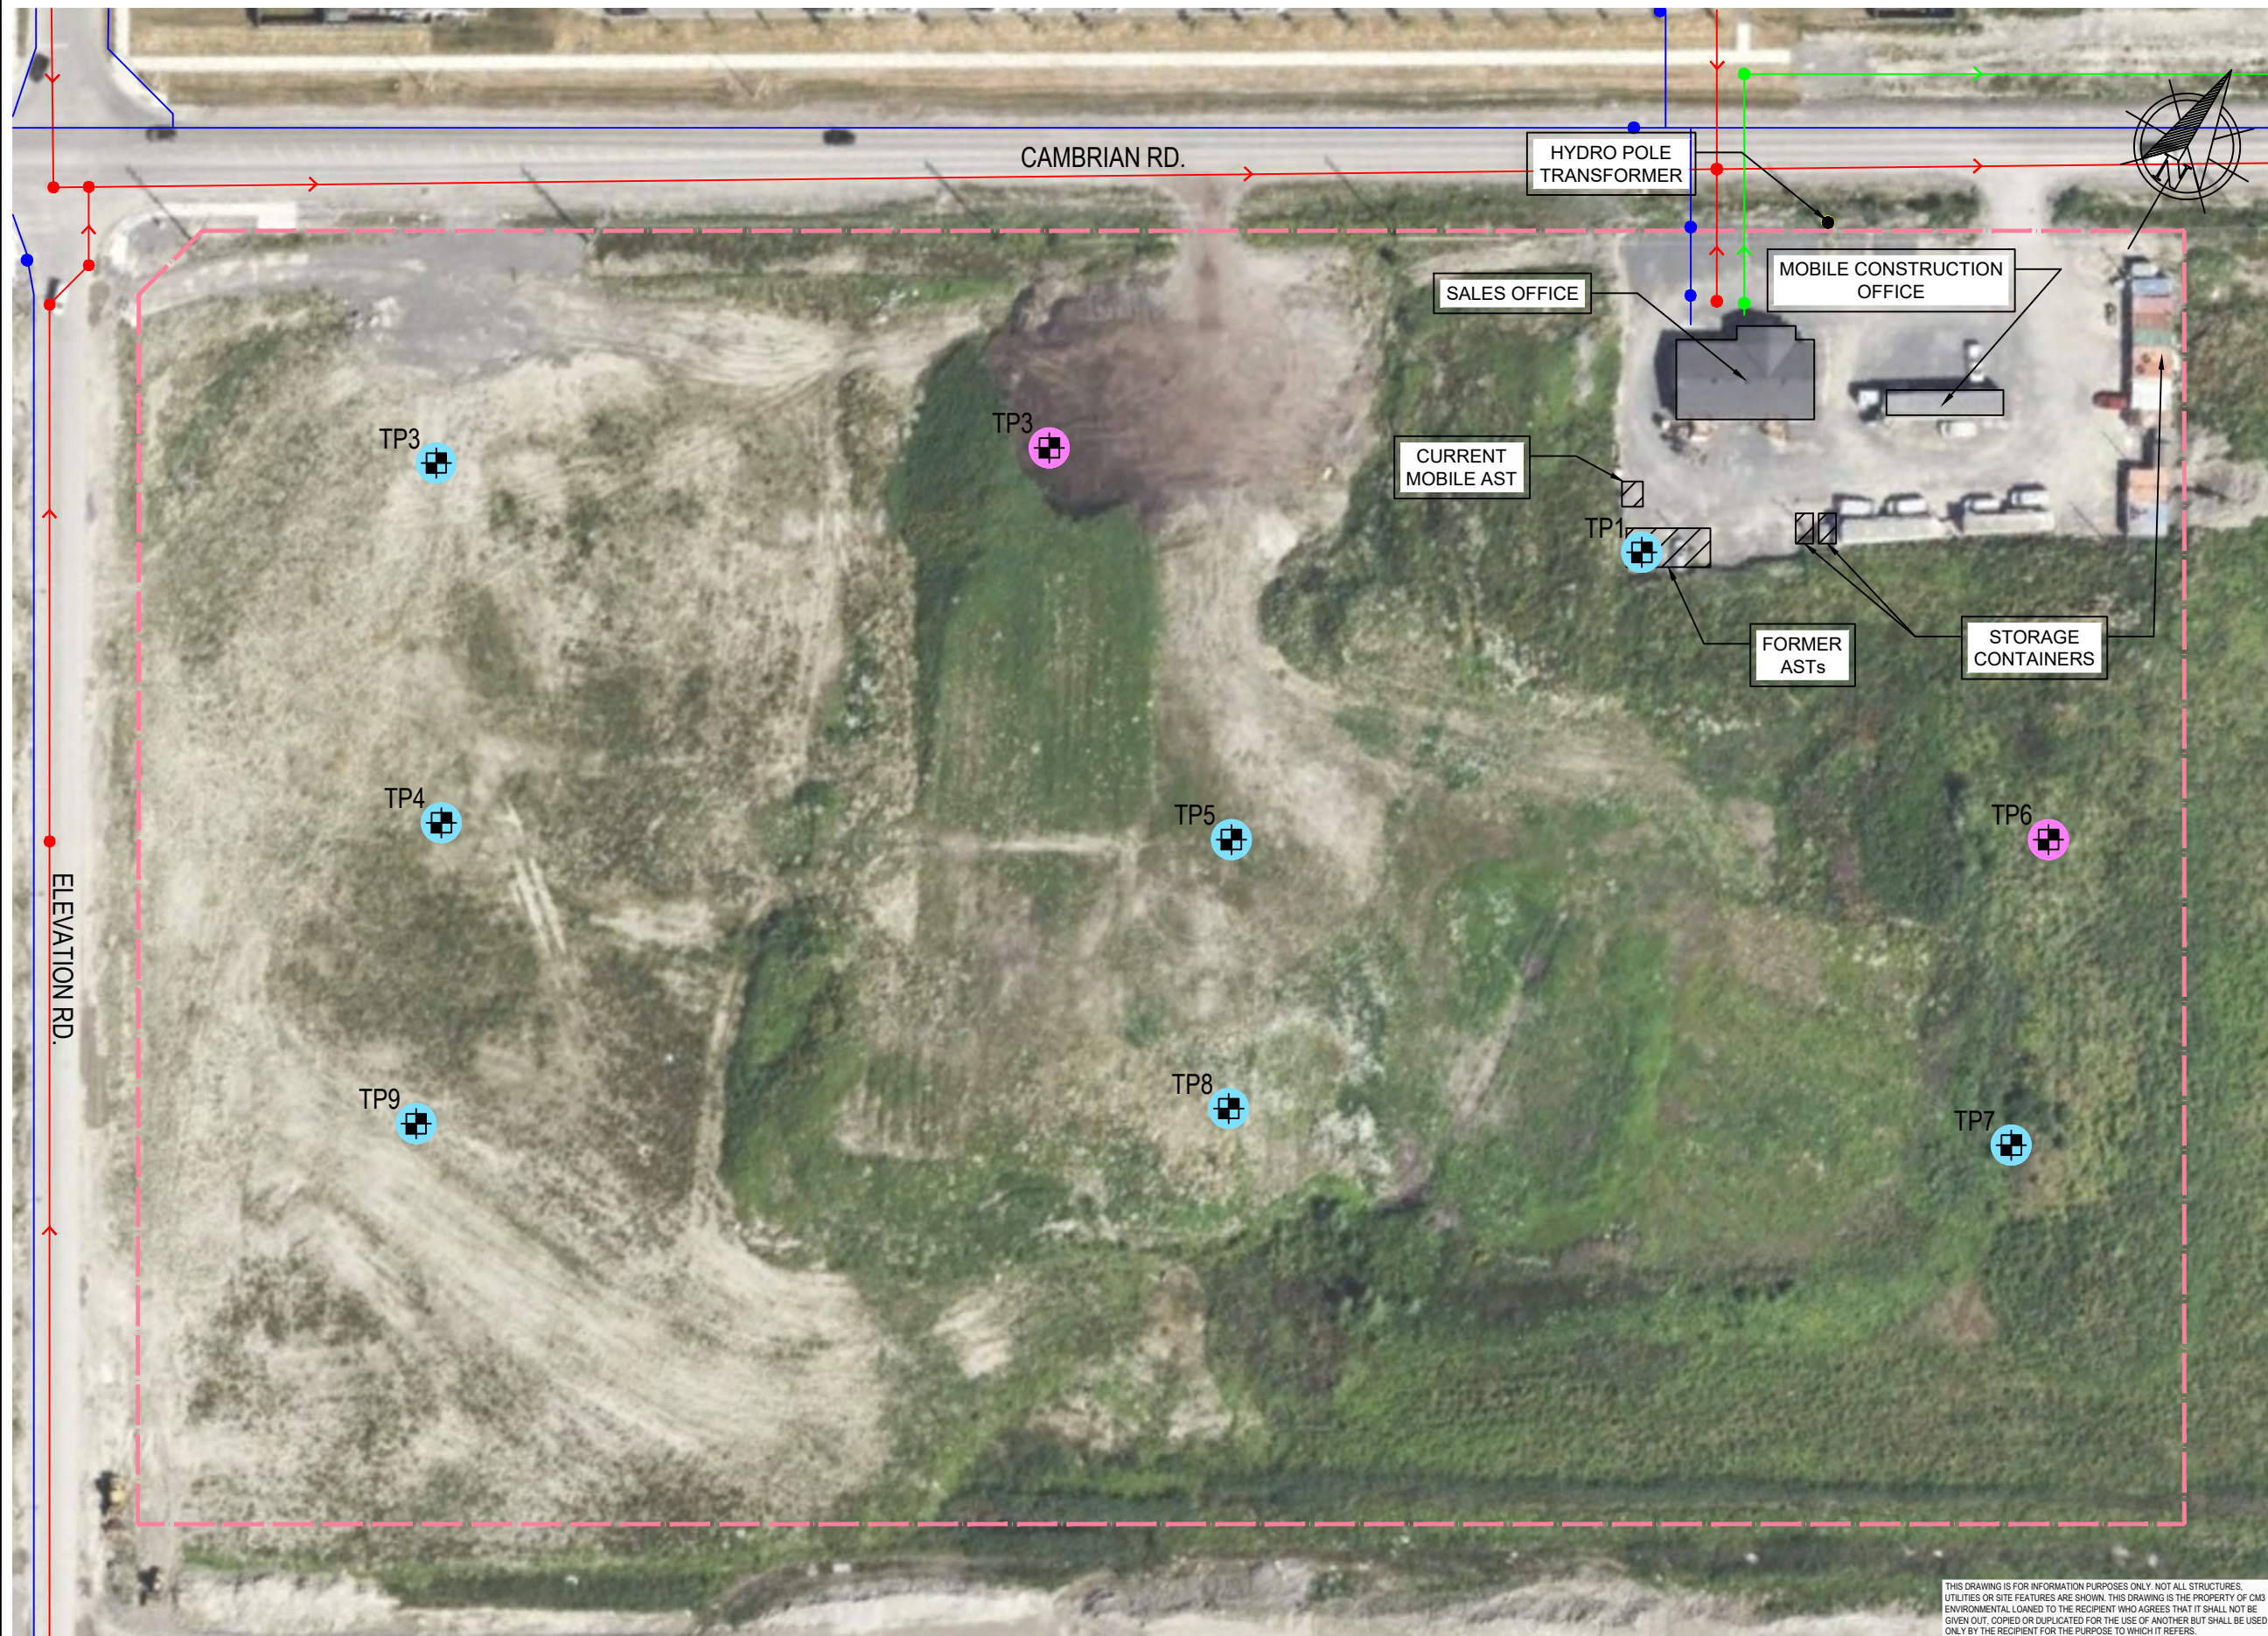
Groundwater was identified at a depth of 0.61 m bg in test pit 2. The test pit locations are provided on **Figure 3**.
