**PH5259-LET.01-Rev.01**

**Ottawa Home Select**

Subject: **Hydrogeological Assessment and Terrain Analysis**  
Site Plan Control Application  
Proposed Commercial Development  
**2966-2978 Carp Road**  
Ottawa (Carp), Ontario

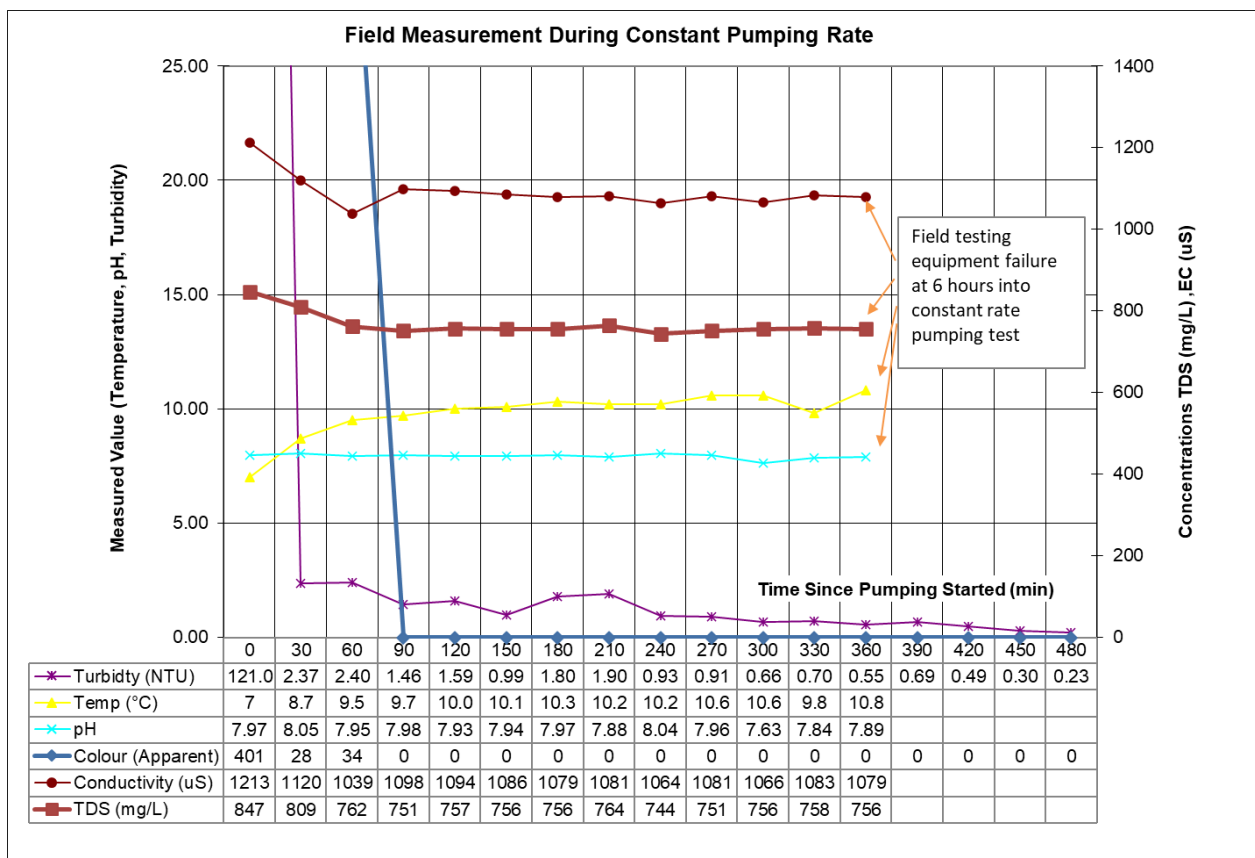
Turbidity, electrical conductivity, total dissolved solids (TDS), pH, true color and temperature were measured at the wellhead during the pumping test. The measurements and time intervals for each of these parameters are summarized on the graphical representation below. In addition, a HACH Pocket Colorimeter II chlorine reader was used to measure the free chlorine residual level. No chlorine residual was detected in the discharged water prior to the collection of the water samples. During the constant rate pumping test, the field-testing equipment which tests for pH, TDS, EC, and temperature malfunctioned at the 6-hour point. These parameters were noted to have stabilized prior to the malfunction of the equipment.

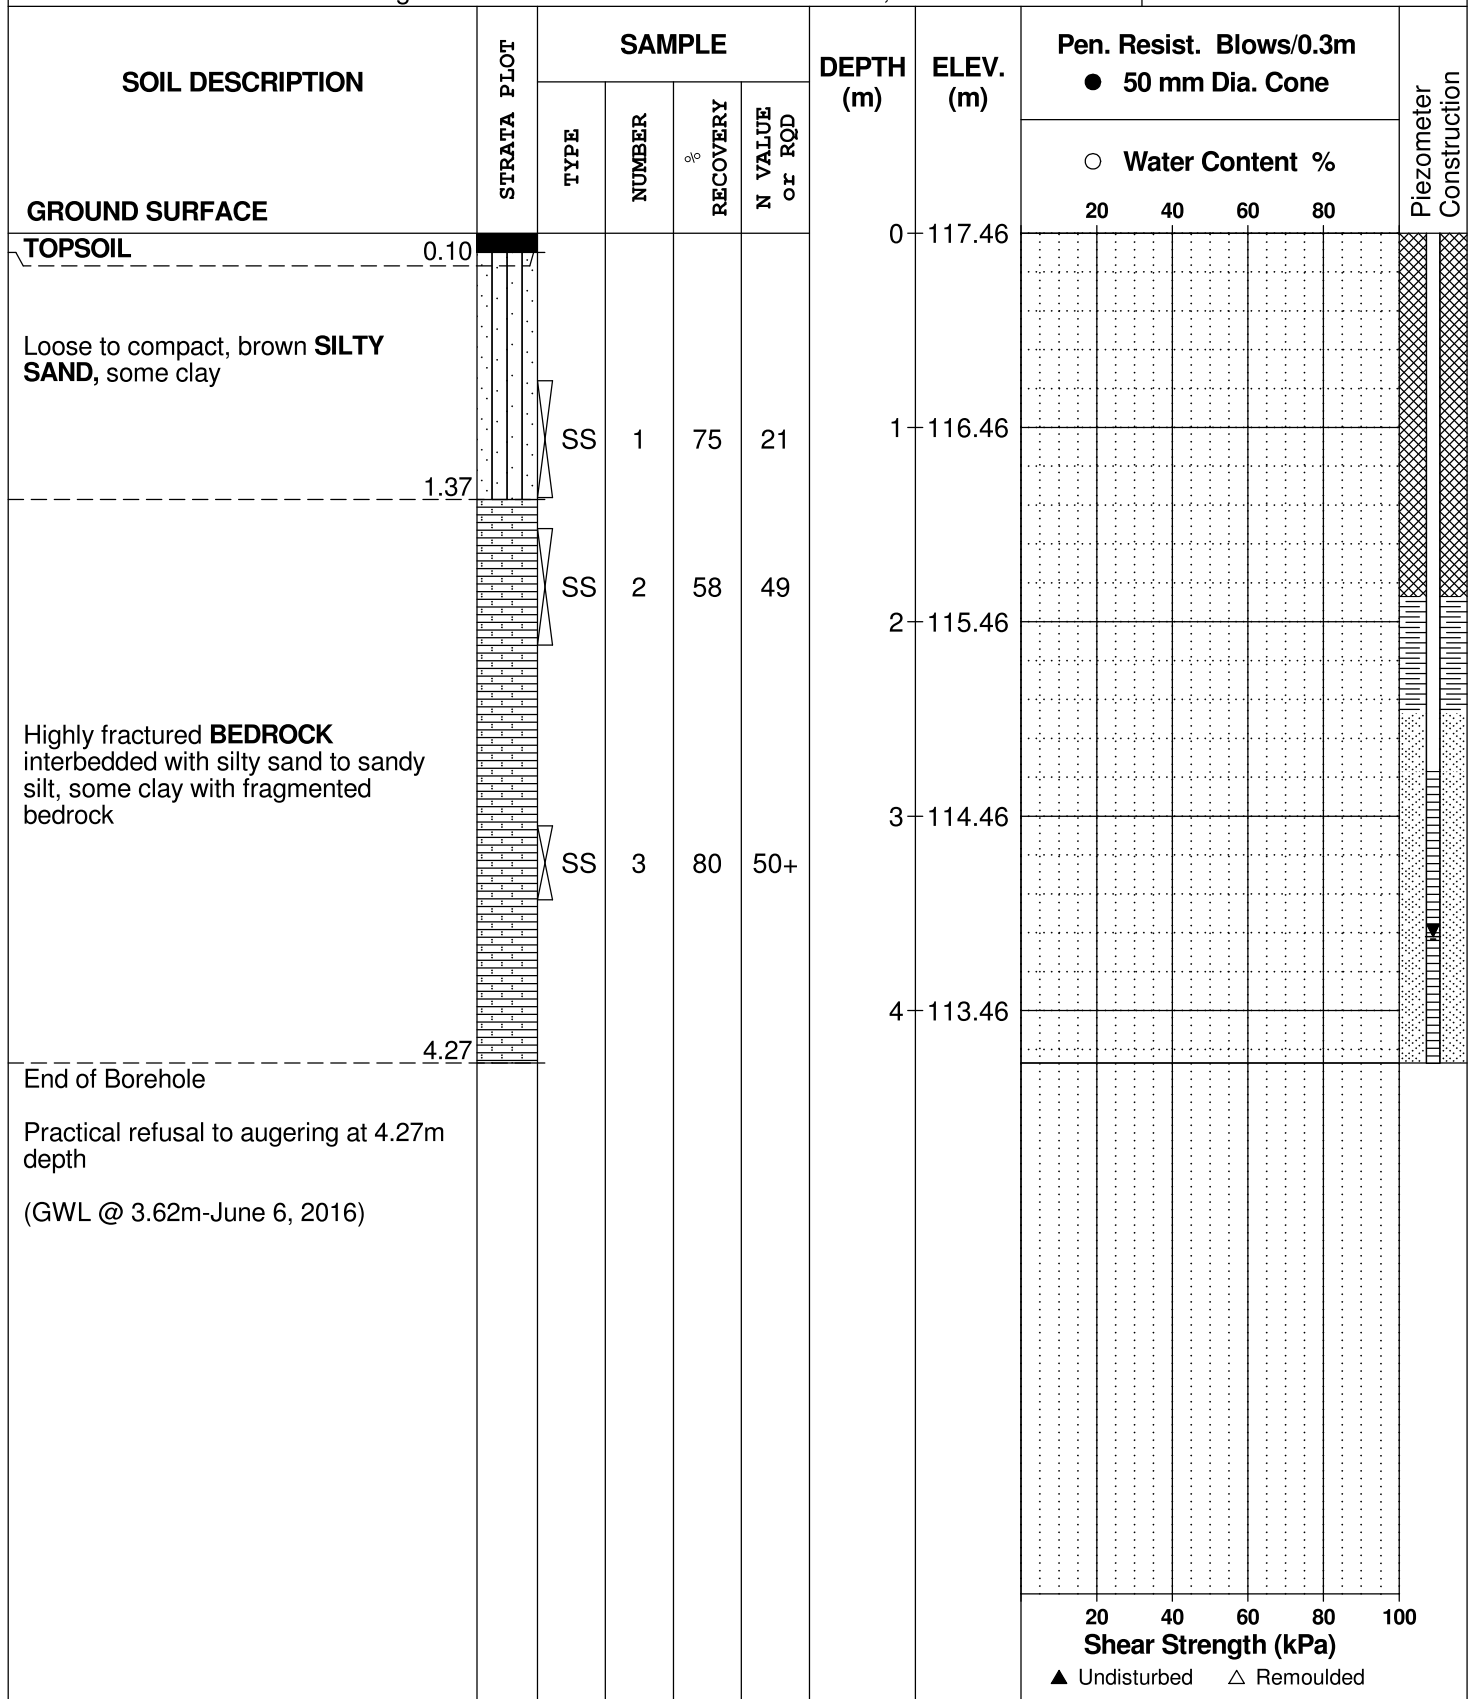
**HOLE NO.** BH10

**Geotechnical Investigation  
Proposed Storage Building - 2978 & 2966 Carp Road  
Ottawa, Ontario**

Reference should be made to the borehole logs appended to this report for the details of the soil profiles encountered at each test hole location. The client should be aware that any information pertaining to soils are furnished as a matter of general information only and borehole descriptions are not to be interpreted as descriptive of conditions at locations other than those described by the boreholes themselves.

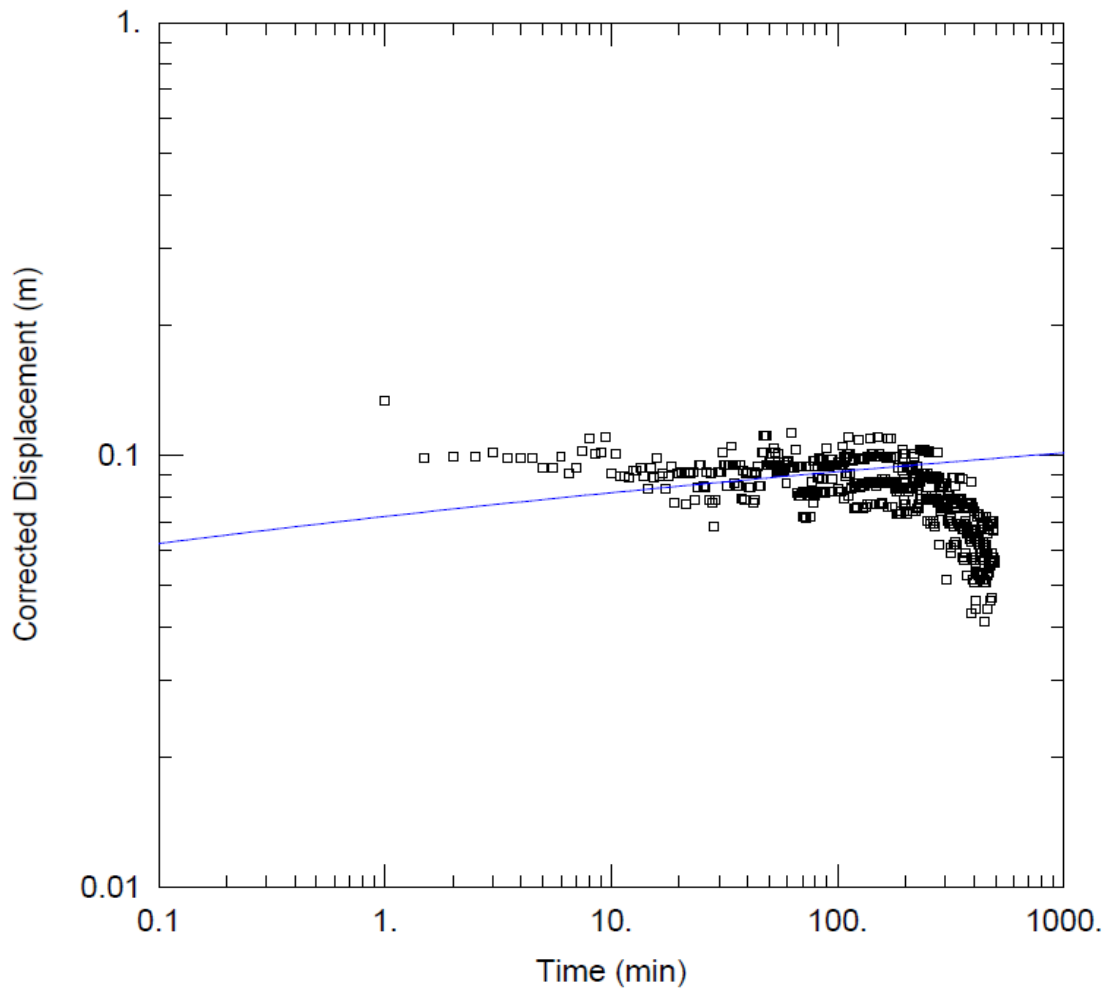
| File No. | PH4484 | Well ID: | TW1 |

| Site Address: | 2966 Carp Road, Ottawa | Discharge Rate (L/min) | 45 |

The pumping test results show that TW1 has a high yield to support the water demands that may be required. Overall maximum drawdown at a constant pumping rate for a period of 8 hours was approximately 0.14 m (0.3% of the available drawdown), but only 0.06 m at the end of the test period. 95% recovery was achieved approximately one minute after the end of pumping. It should be noted that the water level was measured to be increasing throughout the 8-hour constant rate pumping test.

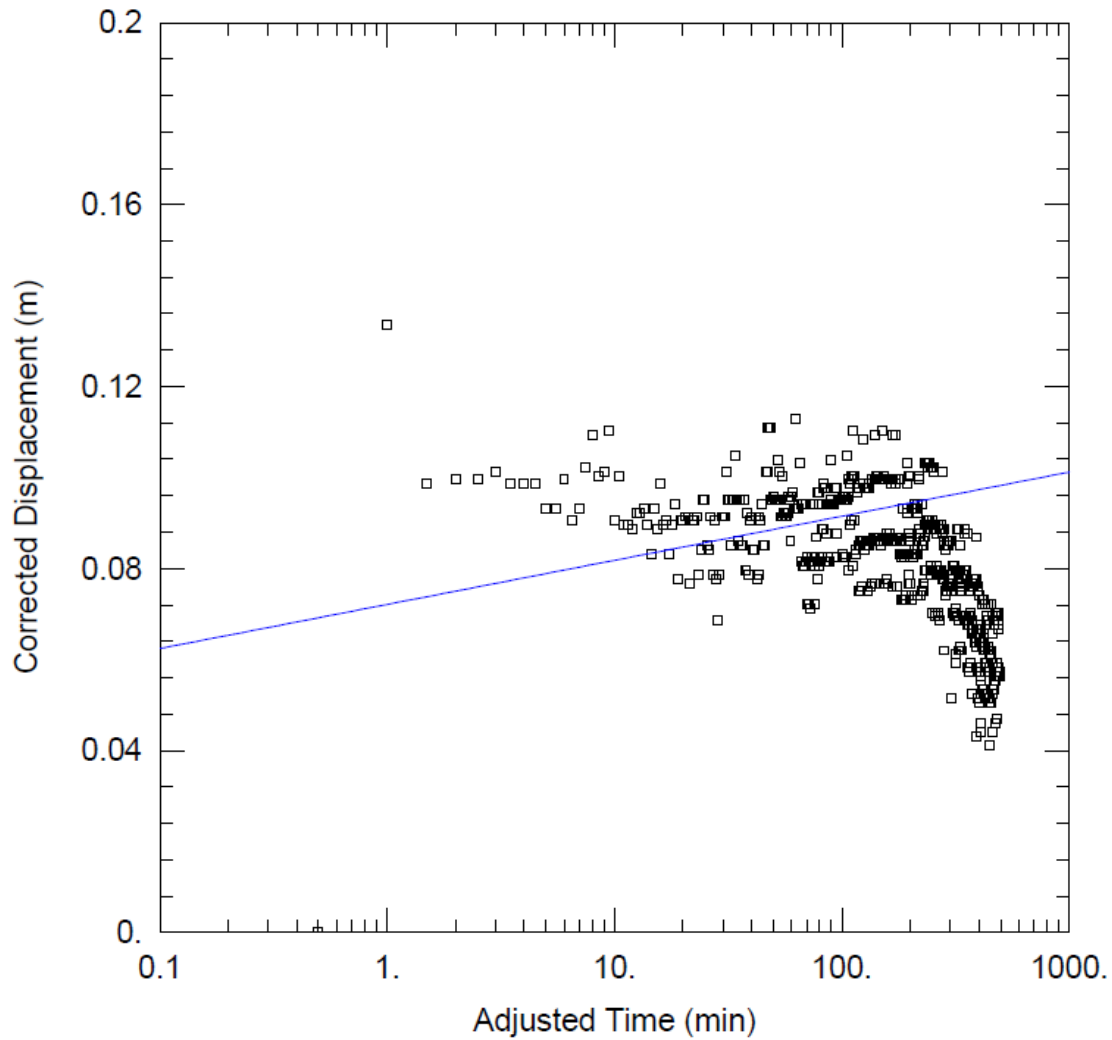
| File No. | PH4484 | Well ID: | TW1 |

| Site Address: | 2966 Carp Road, Ottawa | Discharge Rate (L/min) | 45 |

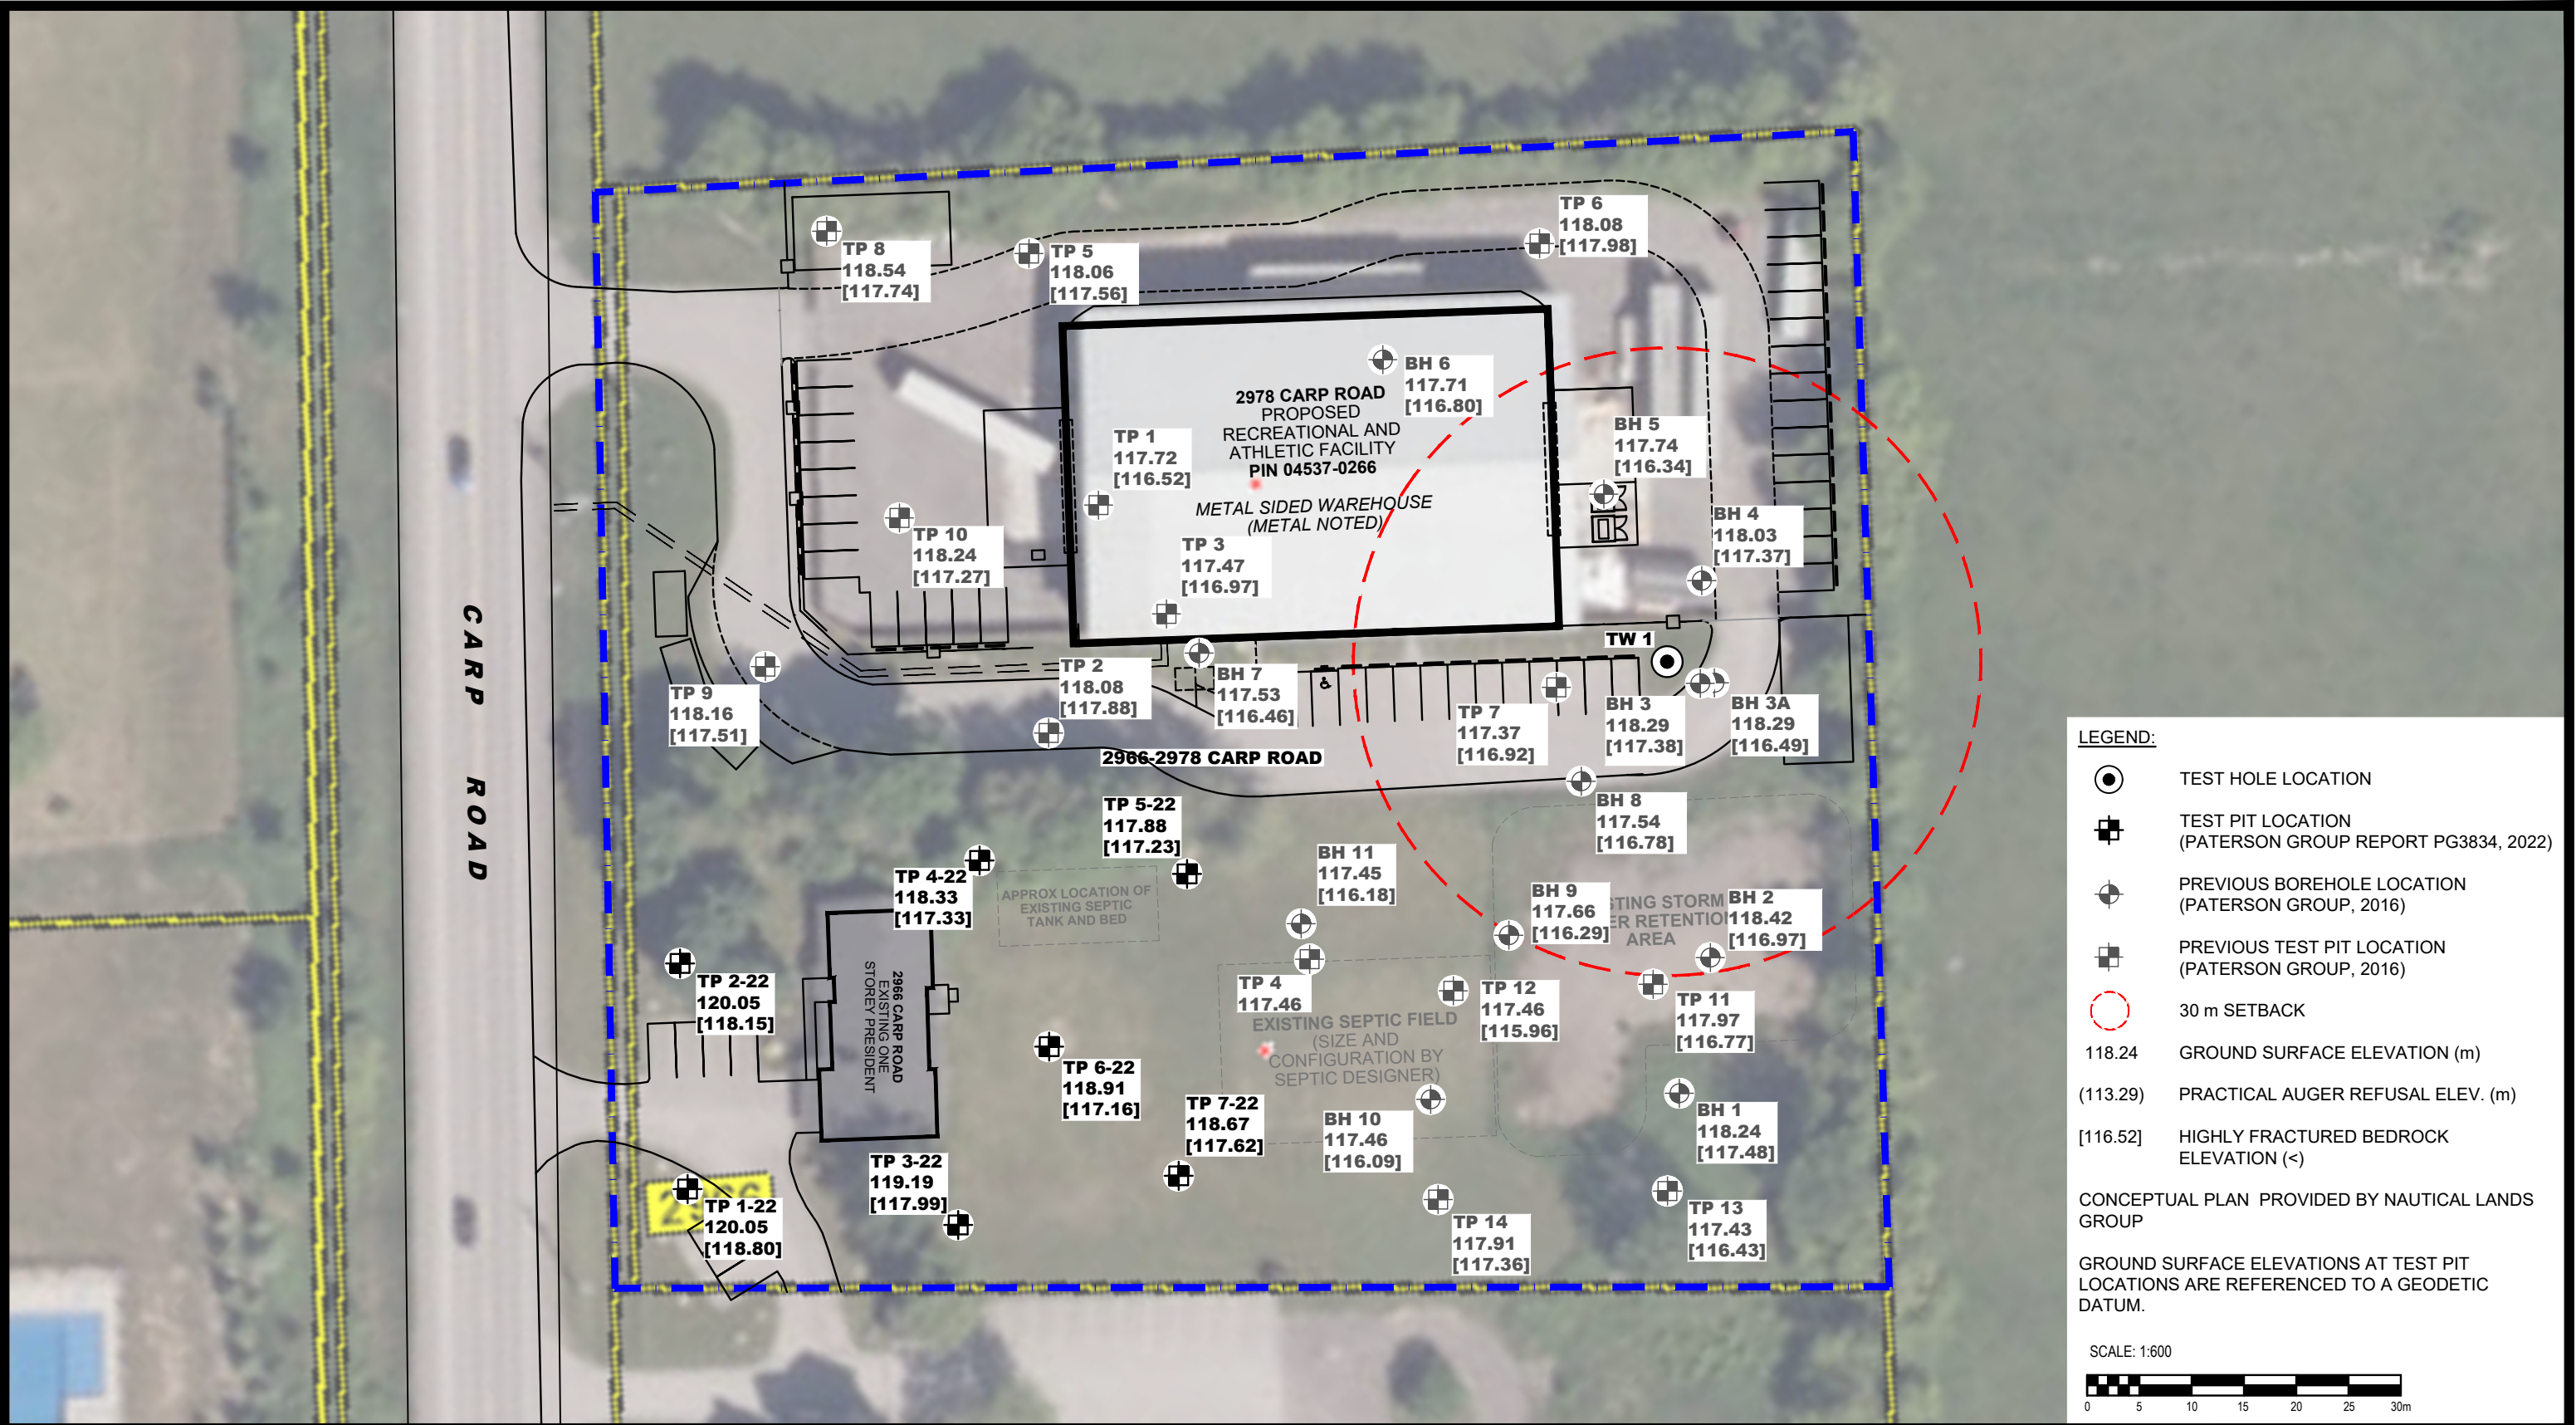
| Checked by: | AS | Dwg. No.: | <b>PH5259-4</b> |

- LEGEND:**
- TEST HOLE LOCATION
  - TEST PIT LOCATION (PATERSON GROUP REPORT PG3834, 2022)
  - PREVIOUS BOREHOLE LOCATION (PATERSON GROUP, 2016)
  - PREVIOUS TEST PIT LOCATION (PATERSON GROUP, 2016)
  - 30 m SETBACK
  - 118.24 GROUND SURFACE ELEVATION (m)
  - (113.29) PRACTICAL AUGER REFUSAL ELEV. (m)
  - [116.52] HIGHLY FRACTURED BEDROCK ELEVATION (<)
  - CONCEPTUAL PLAN PROVIDED BY NAUTICAL LANDS GROUP
  - GROUND SURFACE ELEVATIONS AT TEST PIT LOCATIONS ARE REFERENCED TO A GEODETIC DATUM.

A series of test pits were excavated on the subject parcel to delineate the subsurface soil conditions as part of a Geotechnical Field Investigation. On February 8, 2022, seven (7) test pits were completed on the property. A previous investigation (PG3834-1R, dated January 5, 2017) was completed at the subject site in June and November 2016, during which fourteen (14) test pits were excavated and eleven (11) boreholes were completed onsite. The location of the test pits are delineated on the drawing PH5103-1-Test Hole Location Plan, attached.
