# **Phase I – Environmental Site Assessment**

Orleans Kia – 2045 Mer Bleue Road  
Ottawa, Ontario

Prepared for Ride Automotive Group

**Report: PE7458-1**  
**April 8, 2026**

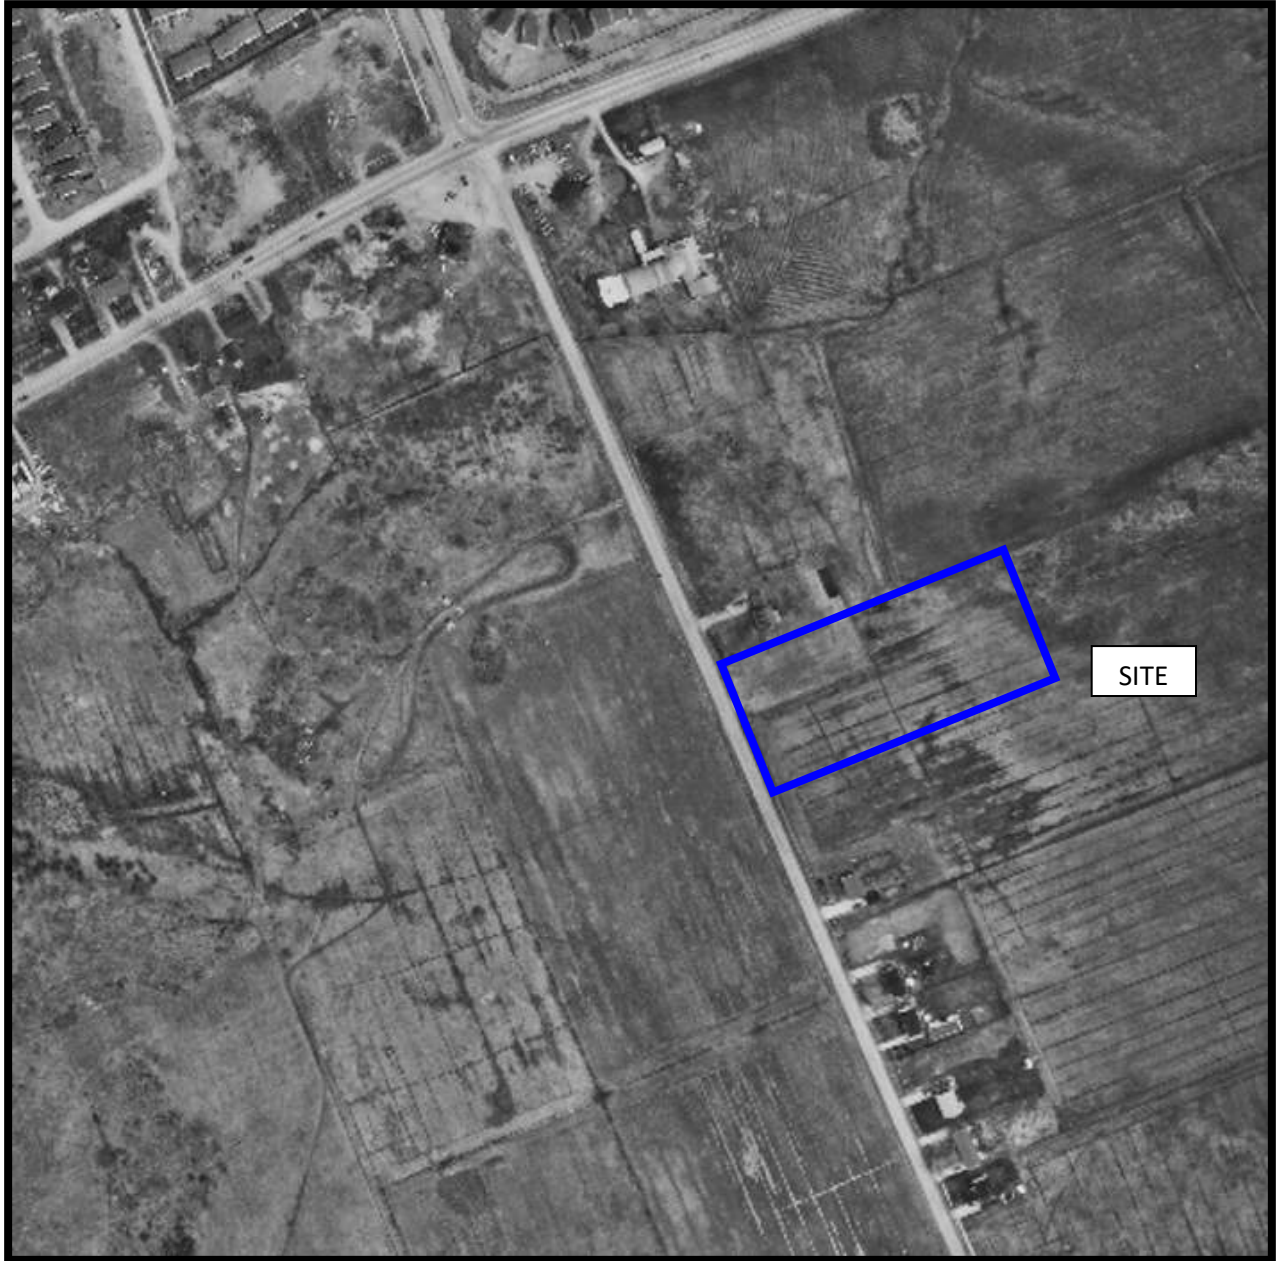
AERIAL PHOTOGRAPH  
1988

| 1988 | No significant changes are apparent with respect to the Phase I Property. A residential dwelling was constructed on the adjacent property to the north. The property at the intersection of Innes Road and Mer-Bleue Road has been developed with an automotive service garage. No other apparent changes can be observed with regards to the surrounding lands since the previous aerial photograph. |

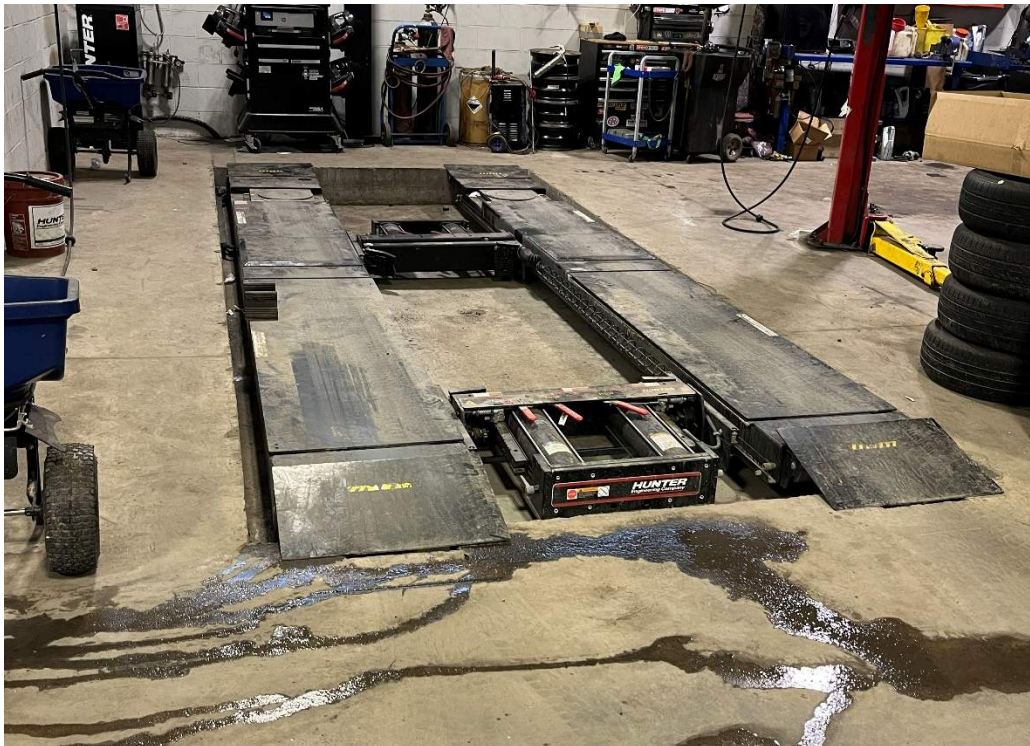
contains a flush wheel alignment rack. At the time of the site inspection, these maintenance bays were observed to be used for basic automotive repair operations, as detailed above. The concrete floor was generally observed to be in good condition with no evidence of significant product spillage observed.

Photograph 2: Service bay with a vehicle alignment rack.

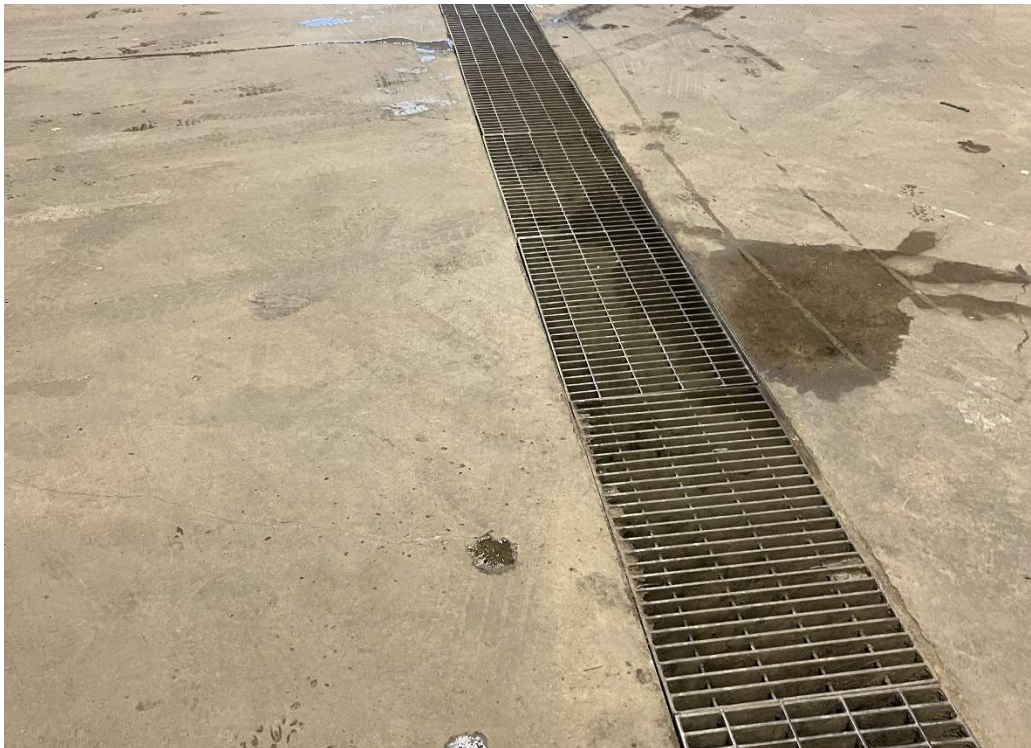
A trench drain was observed within the service garage portion of the dealership building, which drains towards an oil/water separator situated on the eastern side of the maintenance area, before draining into the City of Ottawa sanitary sewer system. The water present within the trench drain and oil/water separator showed no evidence of free product or significant contamination.

Photograph 4: Trench drain at the center of the service area.

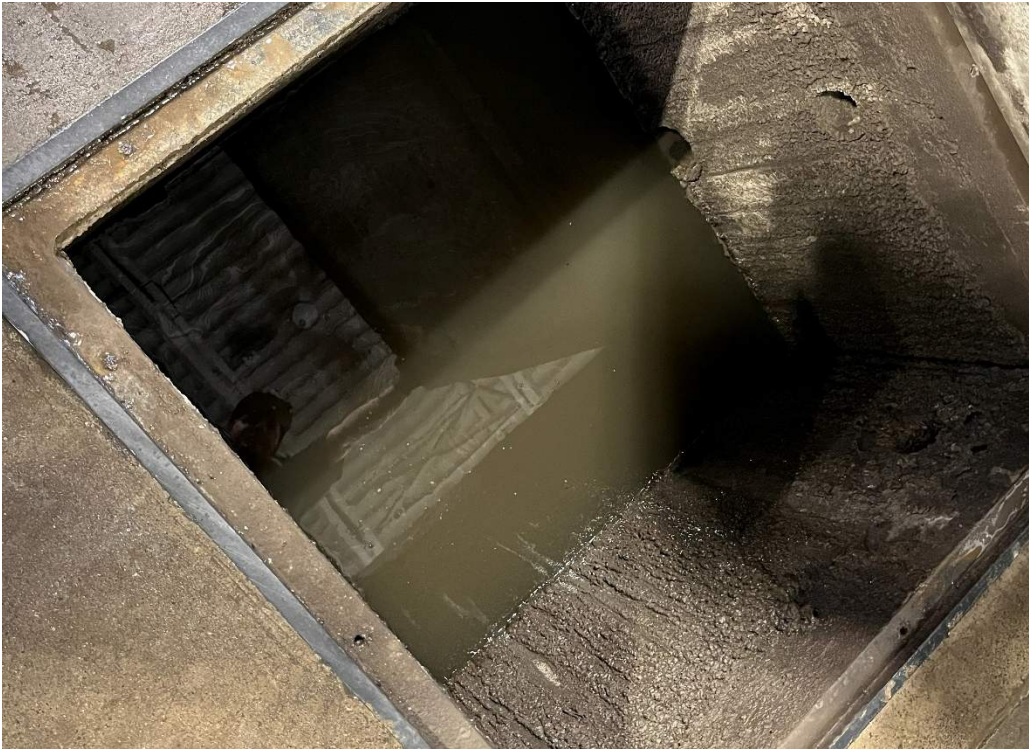
The central trench drain observed within the maintenance area drains into an oil/water separator located in the eastern portion of the building. According to staff members, Tomlinson Environmental performs bi-annual inspections and cleaning of the oil/water separator on a regular basis. The observed oil/water separator was noted to be in good condition and showed no evidence of significant corrosion at the time of the site inspection.

Photograph 5: Interior of the oil/water separator.

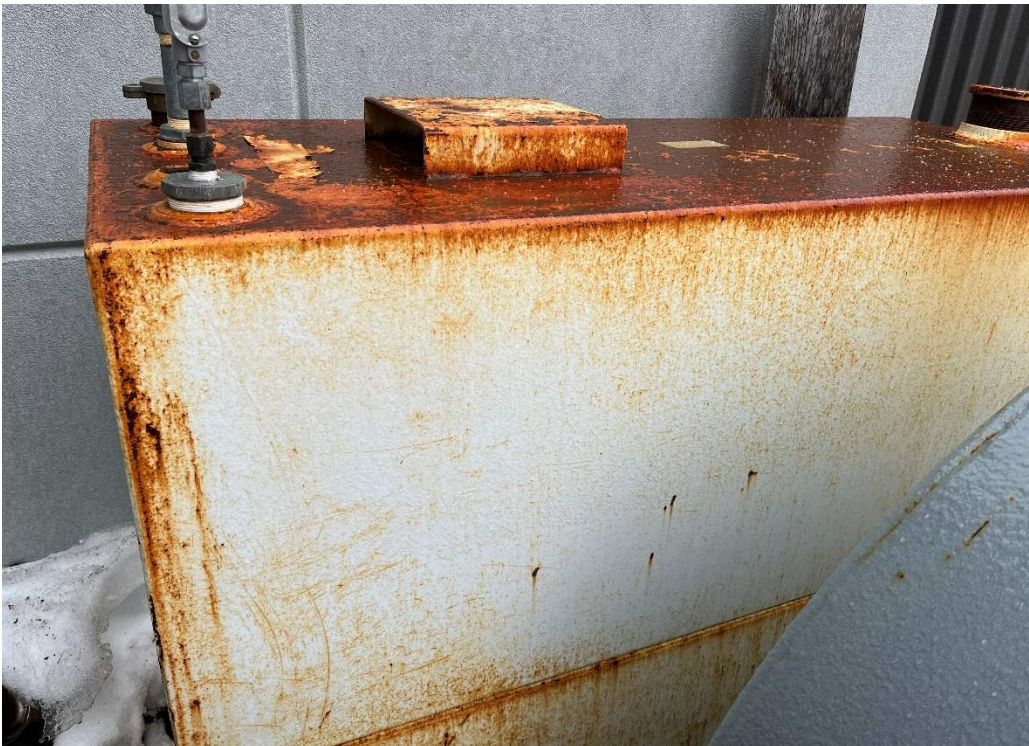
A second aboveground storage tank (AST) was also observed on the exterior of the building. This metal tank is used for storage of waste glycol and has an assumed capacity of up to 1,650 L. At the time of the site inspection, corrosion (rust) was observed on the top of the waste glycol tank, and no identification plaque was present. However, no signs of leaks or staining were noted on the exterior of the tank or on the underlying asphaltic pavement.

A second above ground storage tank was observed adjacent to the waste oil tank and is used for the storage of waste glycol. Some corrosion (rust) was observed on the top of the metal tank along the exterior shell; however, no signs of leaks or staining was observed on the exterior shell or the underlying ground surface.

Photograph 6: Waste glycol tank on the exterior of the subject building.

Noticeable corrosion (rust) was observed on the existing waste glycol tank. Consideration should be given to replacing this tank with another tank/container that is less susceptible to corrosion.

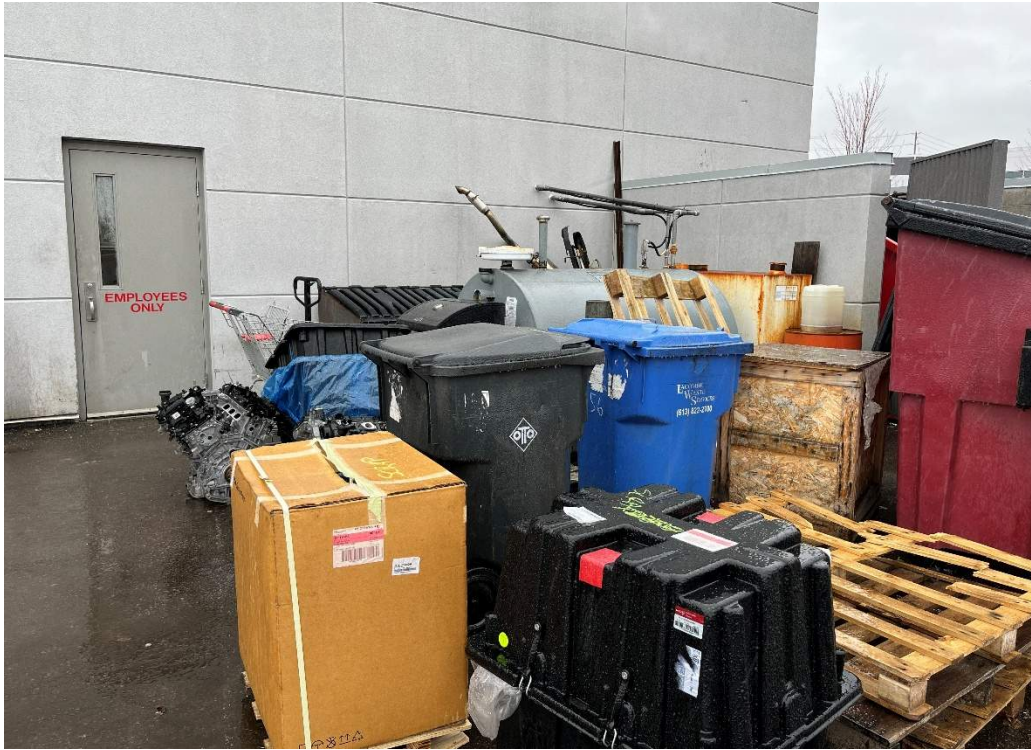
As previously stated, all waste oils generated via vehicle maintenance operations are stored in an exterior above ground storage tank situated on the east side of the building. According to the manufacturer's plaque on the exterior shell, the tank was manufactured in January 2015 and is vacuum sealed with 2.5mm thick double walls. A pressure gauge on the exterior of the tank displayed a negative pressure, indicating that the vacuum seal was intact and functioning as intended. The tank was observed to be in good condition at the time of the site inspection, with no signs of leaks, corrosion, or staining on the exterior shell or underlying ground surface.

Photograph 7: Waste oil tank and associated waste oil filter bins.
