# Phase Two Environmental Site Assessment

116 Albert Street  
Ottawa, Ontario

Prepared for:  
Metcalf Realty  
Company Limited

LOP26-044B

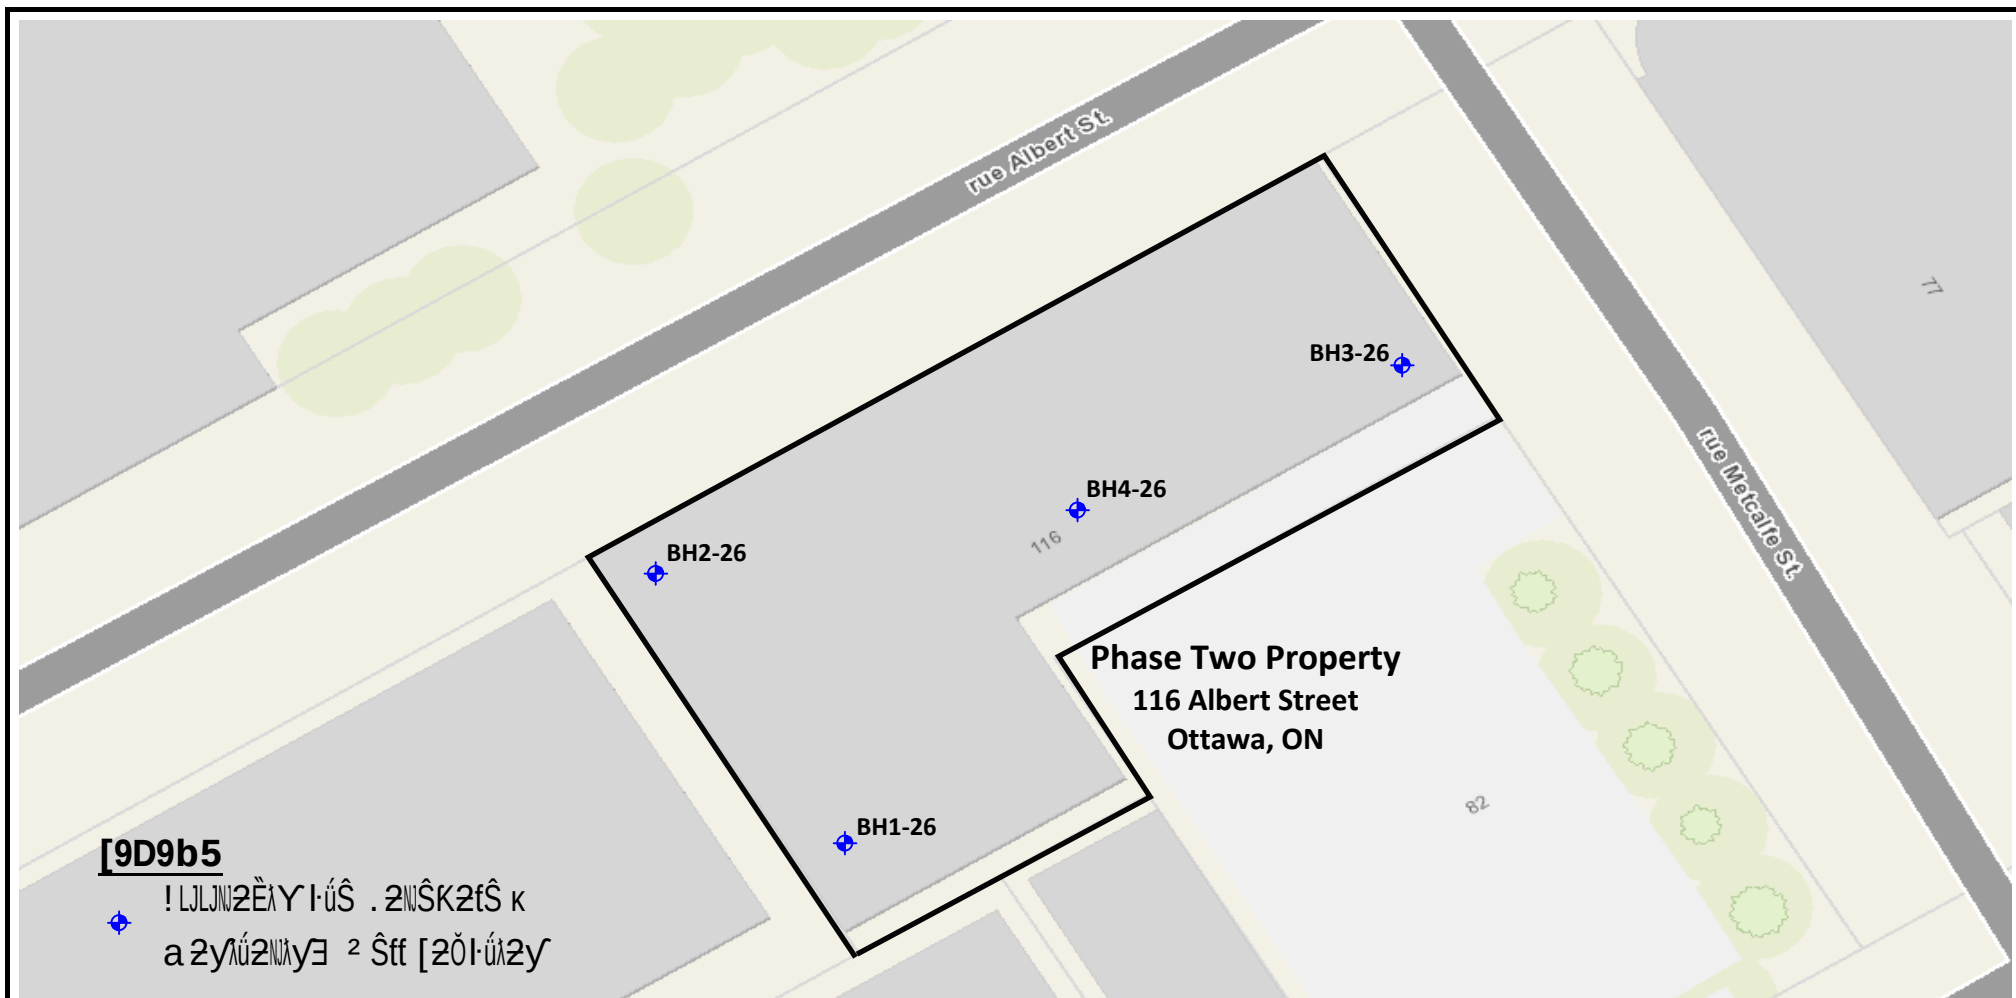
**Figure 2: Site Plan**

Four interior boreholes (BH1-26 through BH4-26) were drilled using a portable tripod drill on June 9 and June 10, 2026. The drilling equipment was operated by OGS Inc. Soil samples were collected using stainless steel split spoons. Soil samples recovered during the sampling program were screened in the field for volatile vapour concentrations, as well as visual and olfactory observations.

The Phase Two ESA drilling program was completed within an occupied building, and as such the boreholes were placed to avoid active services and/or foundations. The boreholes/monitoring wells were located in a manner suitable to adequately assess the PCAs and APECs identified at the Phase Two Property. It has been interpreted that the Phase Two ESA drilling locations provide an adequate assessment of the overall environmental soil and groundwater quality at the APECs and overall Phase Two Property.
