**re: Geotechnical Assessment of Existing Retaining Wall**  
**Proposed Commercial Development**  
**200 Maple Creek Court - Carp, ON**

**date:** April 24, 2020

**file:** PG5328-MEMO.01 Revision 1

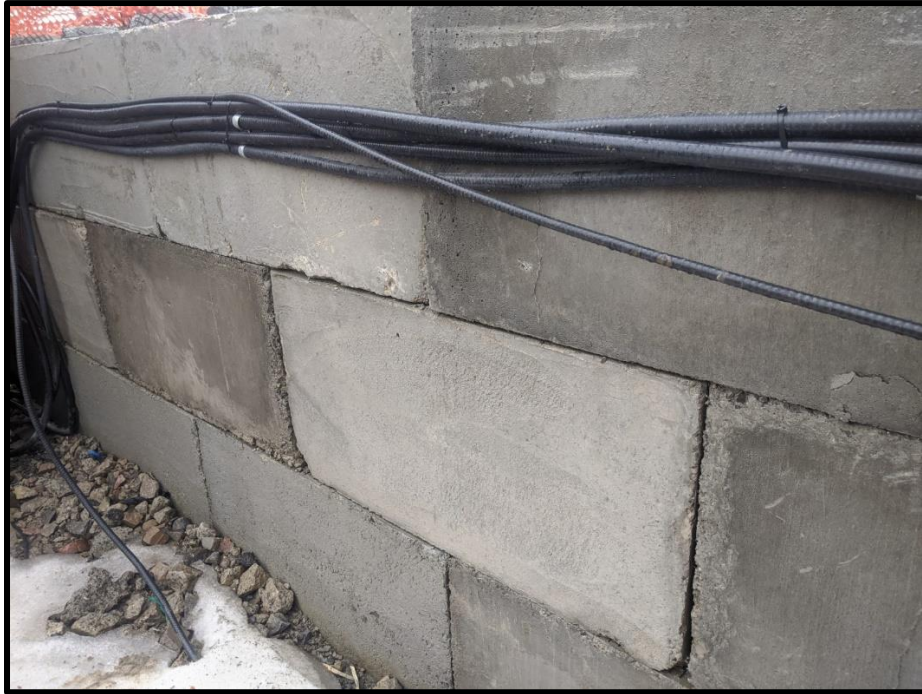
Photo 1: Photo of existing lower retaining wall with an approximate height of 1.8 m.

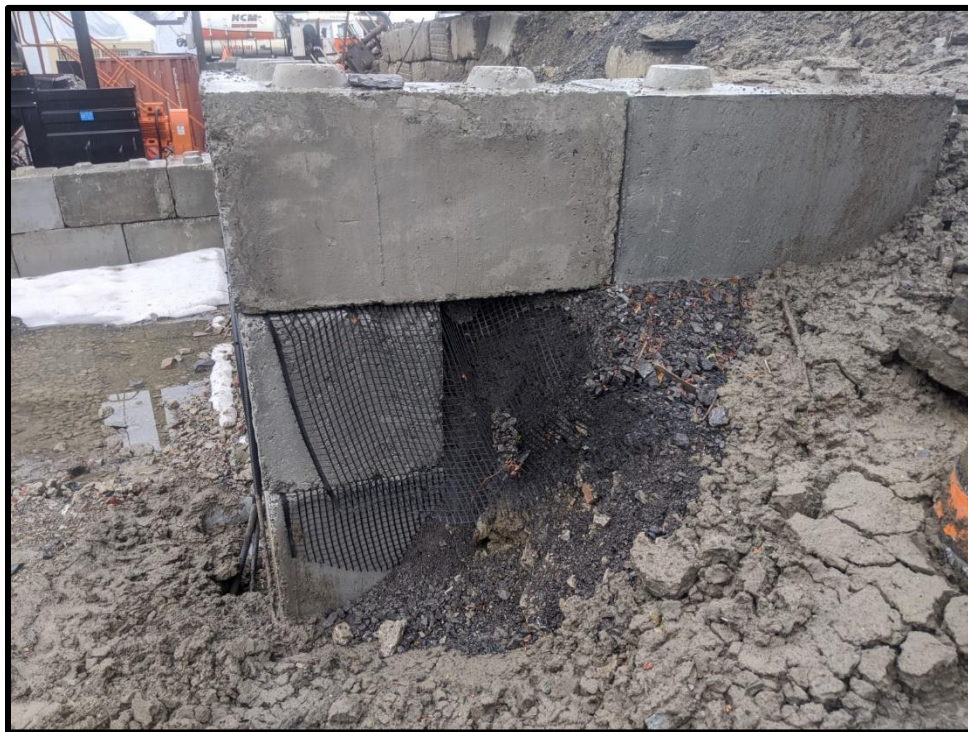
Photo 2: Photo of north face of lower retaining wall. Some soil noted sloughing onto the retained fill from the existing stockpile uphill from the retaining wall.

The area of retained soil behind the lower retaining wall should be clear of sloughing stockpile soil, construction debris and should not be used to store equipment and materials. Grades along the rear of the lower retaining wall should be sloped to promote positive drainage away from the wall and eliminate ponding of water. Furthermore, measures such as placement of a silt-fence barrier system along the length of the upper retaining wall and extending a minimum of 4 m away from the edge of the retaining wall should be considered. This measure would minimize the amount of soil sloughing from the stockpiles onto the retained backfill behind the lower wall.

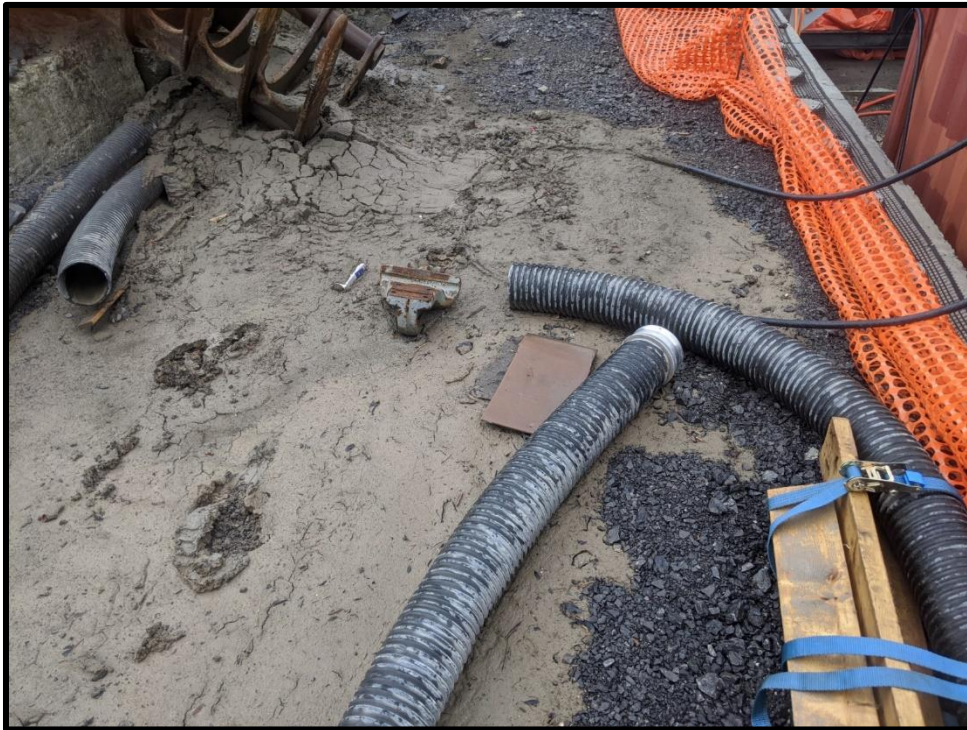
Photo 3: Photo of construction debris and excess stockpile soil along the top of the retaining wall.

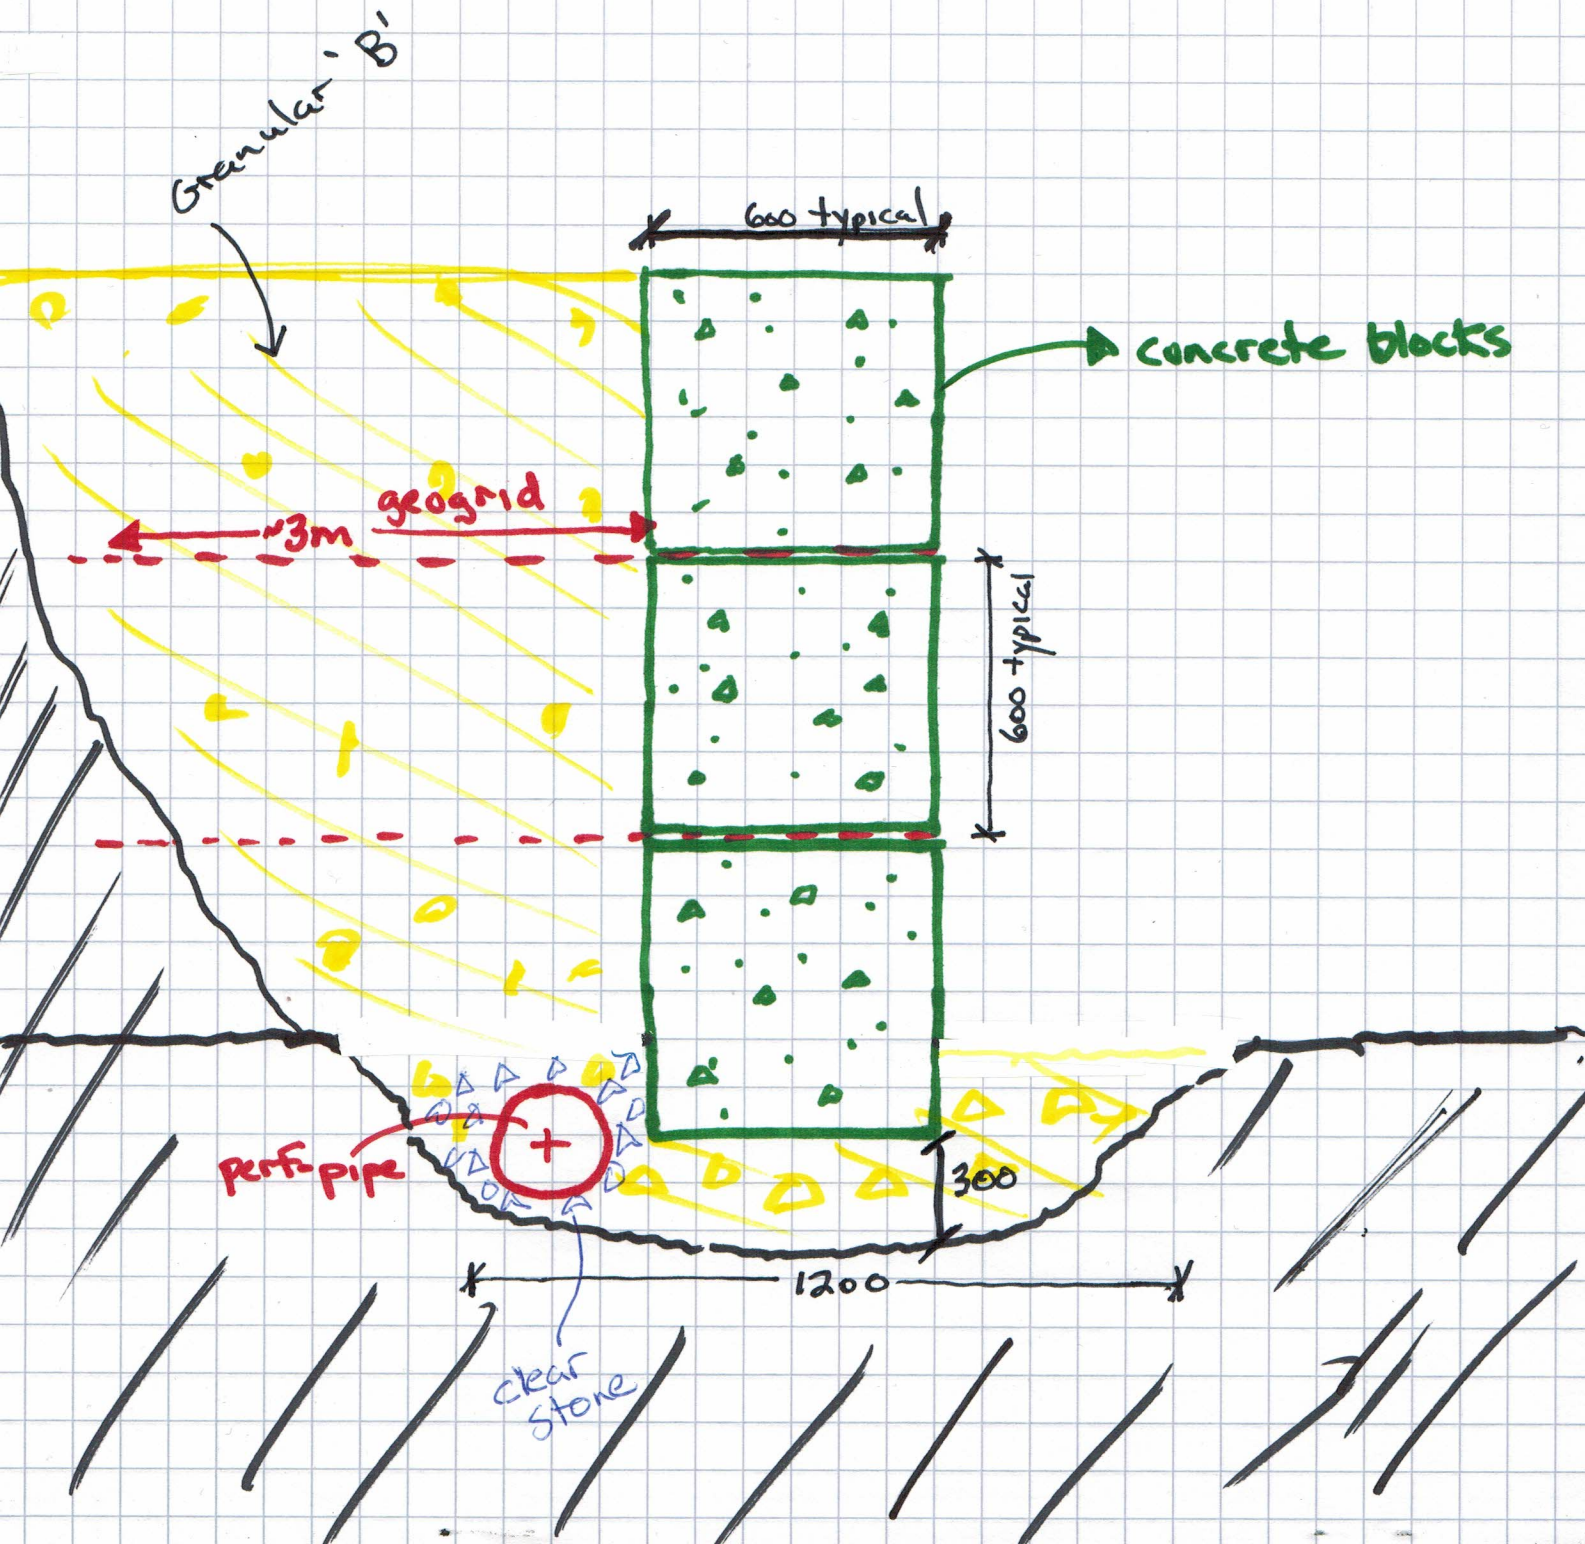
## Retaining Wall Schematic

- ☐ The observed top of wall height and wall span are not subject to further additions and/or modifications.
- ☐ The bottom block had been founded upon a minimum 300 mm thick and 1.2 m wide granular base, which had been further founded upon a competent, native glacial till bearing medium.
- ☐ The observed retained fill consisted of well-graded, free draining crushed granular fill material which likely consisted of OPSS Granular B Type II.
- ☐ The owner has advised that the bottom of the wall had been provided a 150 mm diameter perforated pipe surrounded by 19 mm clear stone, and had been provided a gravity drain towards a catch basin located to the front of the property.
- ☐ Each layer of geogrid extends approximately 3 m away from the retaining wall.

Figure 1 attached to the present memorandum depicts a typical cross-section of the above-noted retaining wall construction as based on the information provided by the owner.
