HYDROGEOLOGICAL STUDY

495 JINKINSON ROAD

Project No.: CP-17-0613

R1 - January 2019

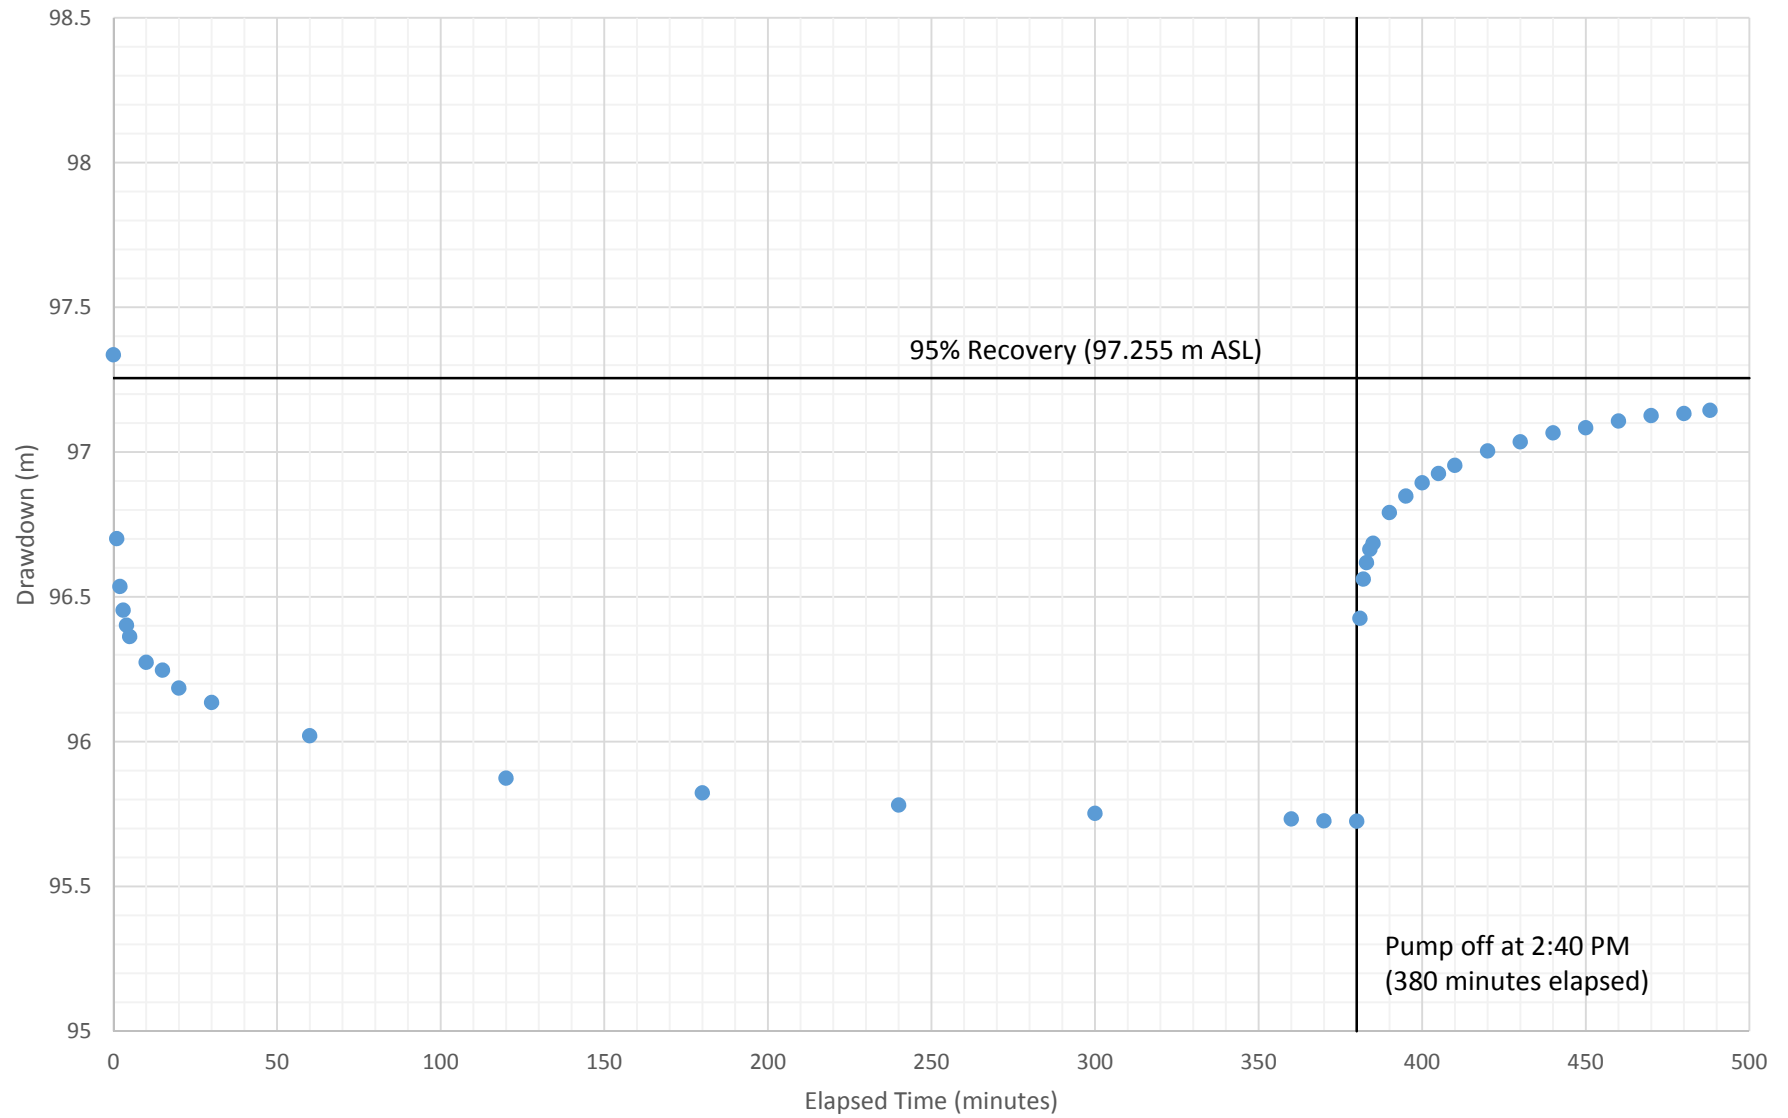
Drawdown vs Time
TW1 Pumping Test (Drawdown), June 15, 2018
J.R. Brisson, 495 Jinkinson Road, Ottawa, ON

The water level ranged between 95.725 m to 97.336 m asl (2.664 to 4.275 m btoc), with a maximum drawdown of 1.611 m observed. Due to the relatively low drawdown observed throughout the test, only 88% recovery in water level was achieved within 1 hr 48 min of terminating the test.

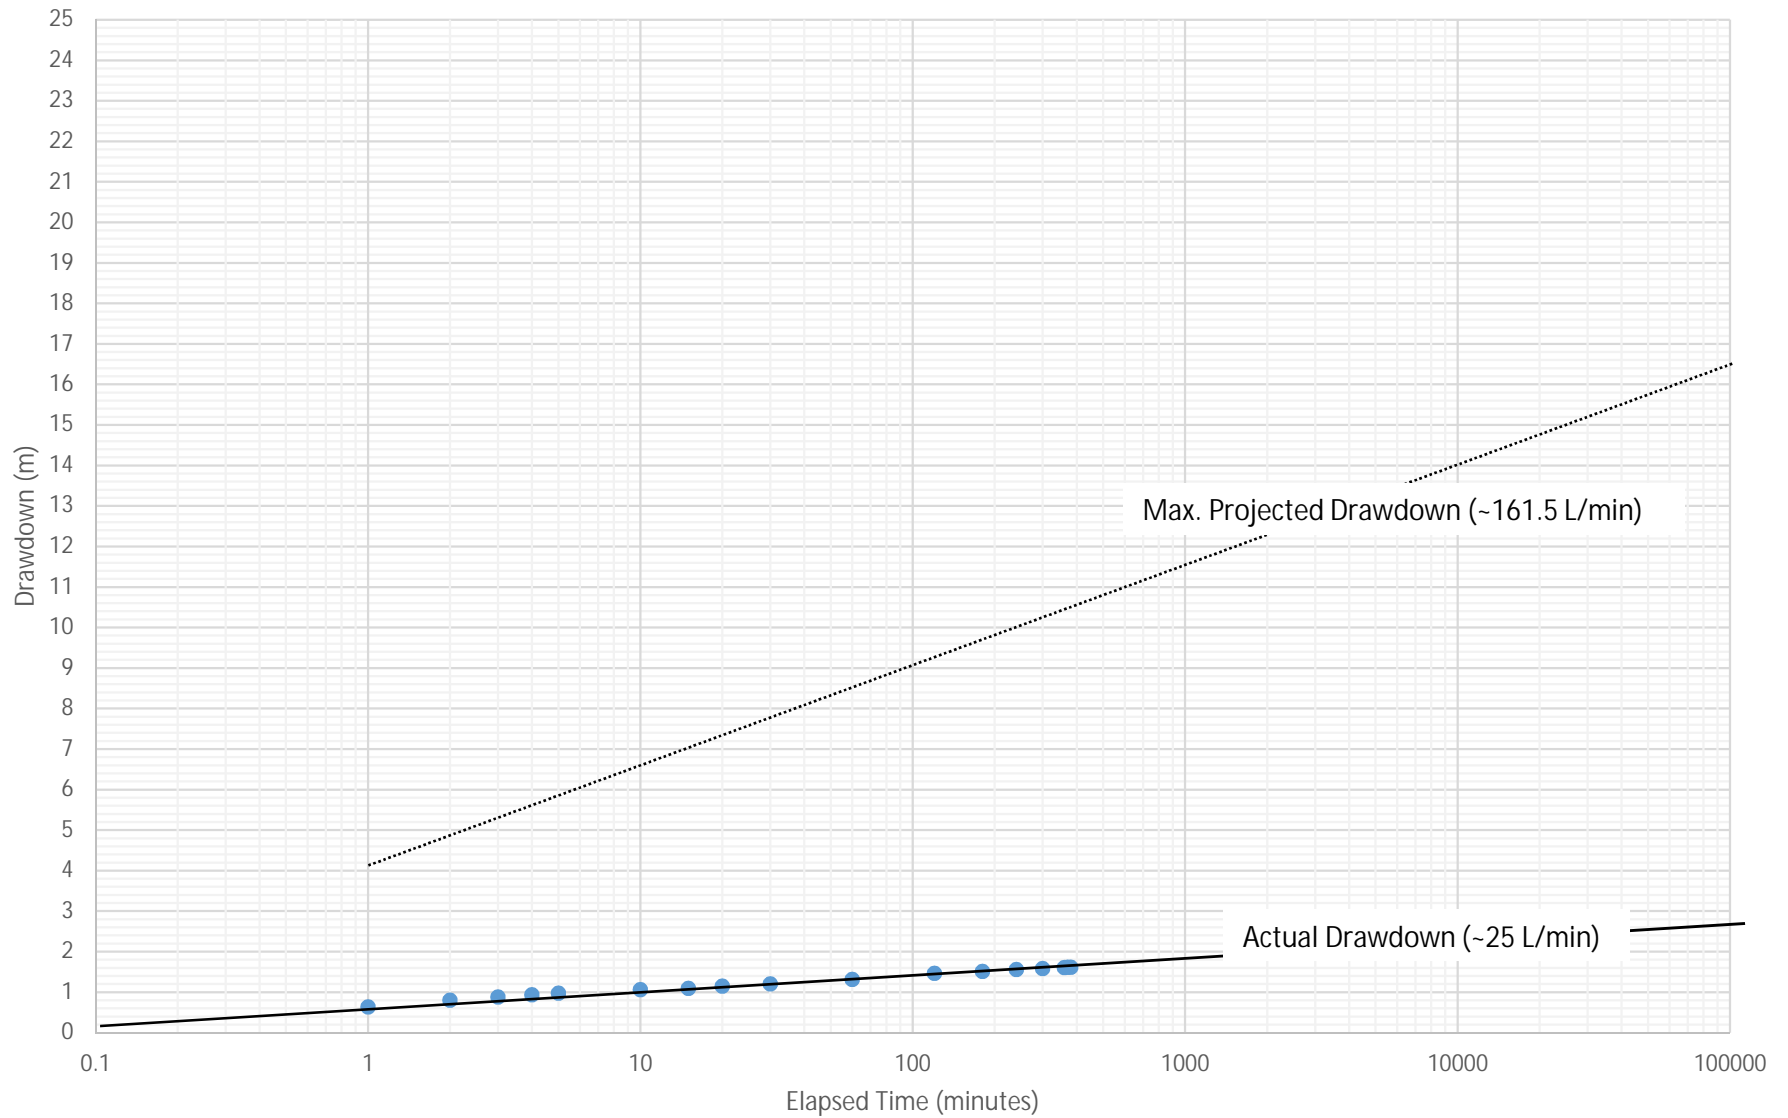
Drawdown vs Log Time
TW1 Pumping Test (Drawdown), June 15, 2018
J.R. Brisson, 495 Jinkinson Road, Ottawa, ON

Drawdown and recovery data from the pumping test were plotted and analyzed using the Cooper-Jacob and Theis Recovery methods, respectively. The hydraulic conductivity (K, m/s) and transmissivity (T, m²/d) of the

By extrapolating the drawdown data on a semi-logarithmic scale, it is estimated that a conservatively maximum pumping rate of 161.5 L/min could be sustained for over 100,000 minutes (69 days) of continuous pumping with a maximum drawdown of only 16.5 m (see Appendix D). It is noted that this situation is inherently conservative, as the pump will cycle on and off on a much shorter time scale, allowing the well to recharge.

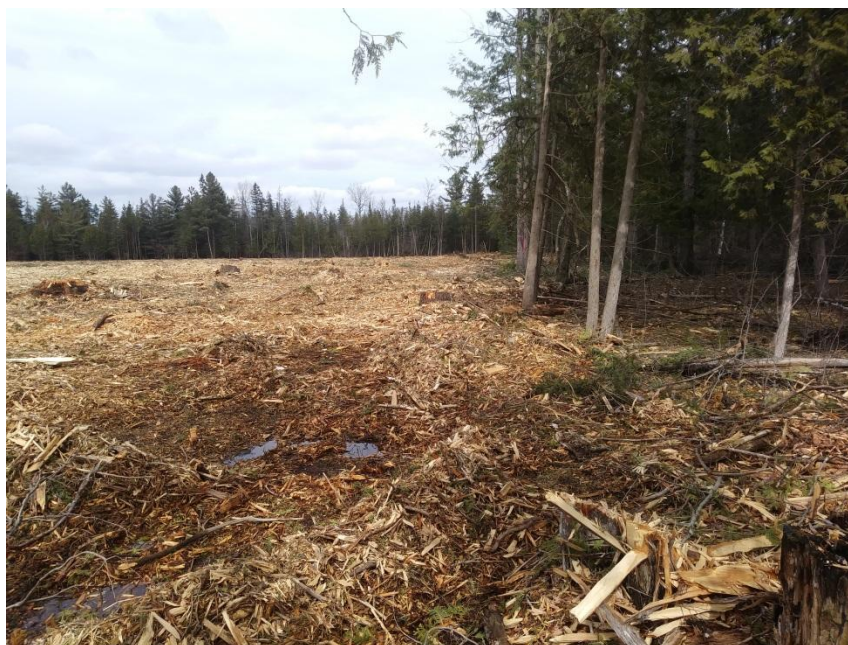
Photo 2: Cleared land along edge of forest – development area

At the present time, the proposed development consists solely of cleared (previously forested) land, and is situated approximately 120 m from an on-site PSW, at its closest point. It is noted that the proposed building footprint is located significantly further from the PSW. The retained (non-developed) portion of the Site consists of forested areas (dry-fresh White Pine/Maple/Oak mixed forest), cultural meadows (buried service easement), and Provincially Significant Wetland (predominantly cattails). Based on a review of aerial photographs available on GeoOttawa, no signs of previous Site development can be seen (earliest photo is 1976). Based on Site conditions observed during fieldwork, it is further unlikely that the Site has seen any contemporary use, other than forest clearing for the gas easement.

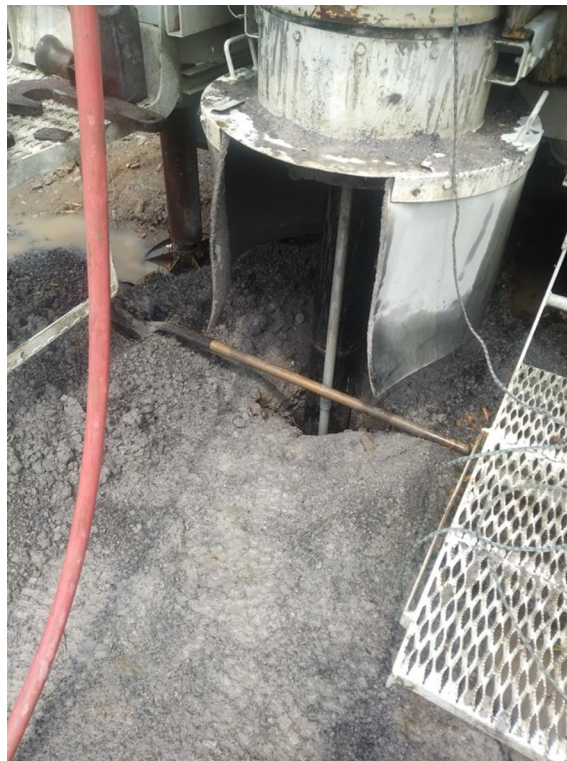
Photo 3: Drilling of TW1

McIntosh Perry tested a newly drilled, on-site water supply well (Test Well 1, TW1), which is believed to be representative of the hydrogeological conditions across the proposed development area. According to the MOECC well record, the well extends approximately 42.7 m bgs, with a 0.159 m (6 ¼ inch) diameter casing extending approximately 12.8 m bgs. The MOECC Well Record for TW1 is included in Appendix G.

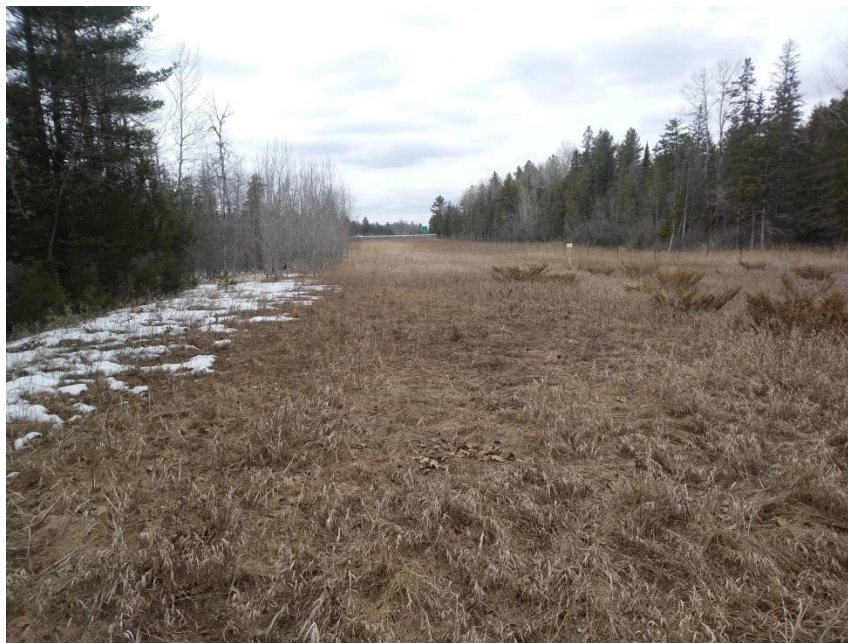
Photo 4: Buried service (gas) easement along northeast side of Site
