# TREE CONSERVATION REPORT

**87 Mann Avenue  
Ottawa, ON K1N 6Y8**

**REVISED: December 5, 2014**

## 87 Mann Avenue Ottawa, ON

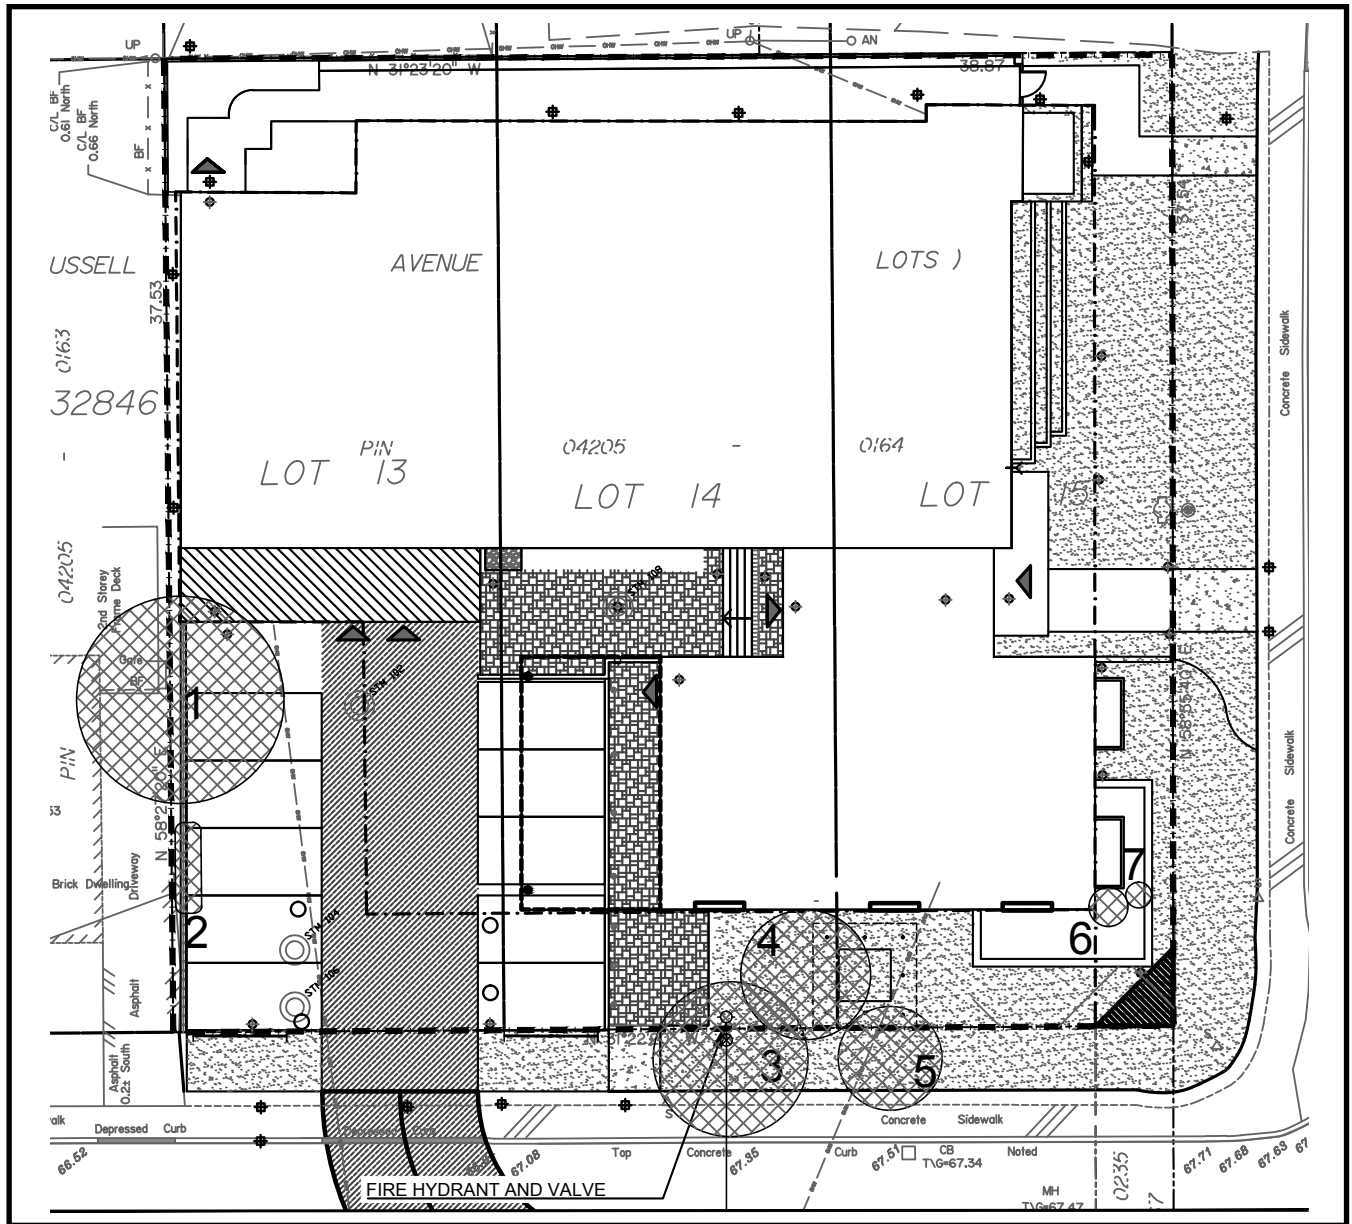
Figure 3: 87 Mann Avenue Tree Conservation Plan

Trees were found to be in good, fair and poor condition based on the health of the tree, overall branching structure, trunk condition and presence of disease or other ailment. The impact of the proposed building expansion on the existing trees was analyzed, and the results are shown in Figure 3 and Table 1 below:

- None of the trees are species that are threatened, or endangered
- Trees No. 1, No. 2, No. 3, No. 4, No. 5, No. 6, and No. 7 will be negatively impacted by the proposed construction and are recommended for removal, as well as all shrubs on site.
- Tree No. 3, Malus sp. (Crabapple) will be heavily impacted by the fire hydrant installation, requiring the tree to be removed.
- Tree No. 5, Malus sp. (Crabapple) is located adjacent to/on the property line of the Russell Avenue road right-of-way. This tree will be impacted by the installation of the external utility box shown in the plan. It should be removed and replaced with Street Tree planting in the appropriate alignment within the road right-of-way, resulting in a proposed line of trees that will be located further from the proposed building and will have more room to branch out to their full potential.
