PHASE TWO ENVIRONMENTAL SITE ASSESSMENT

316 SOMERSET STREET EAST, OTTAWA, ON

Project No.: CP-17-0637

April 25, 2018

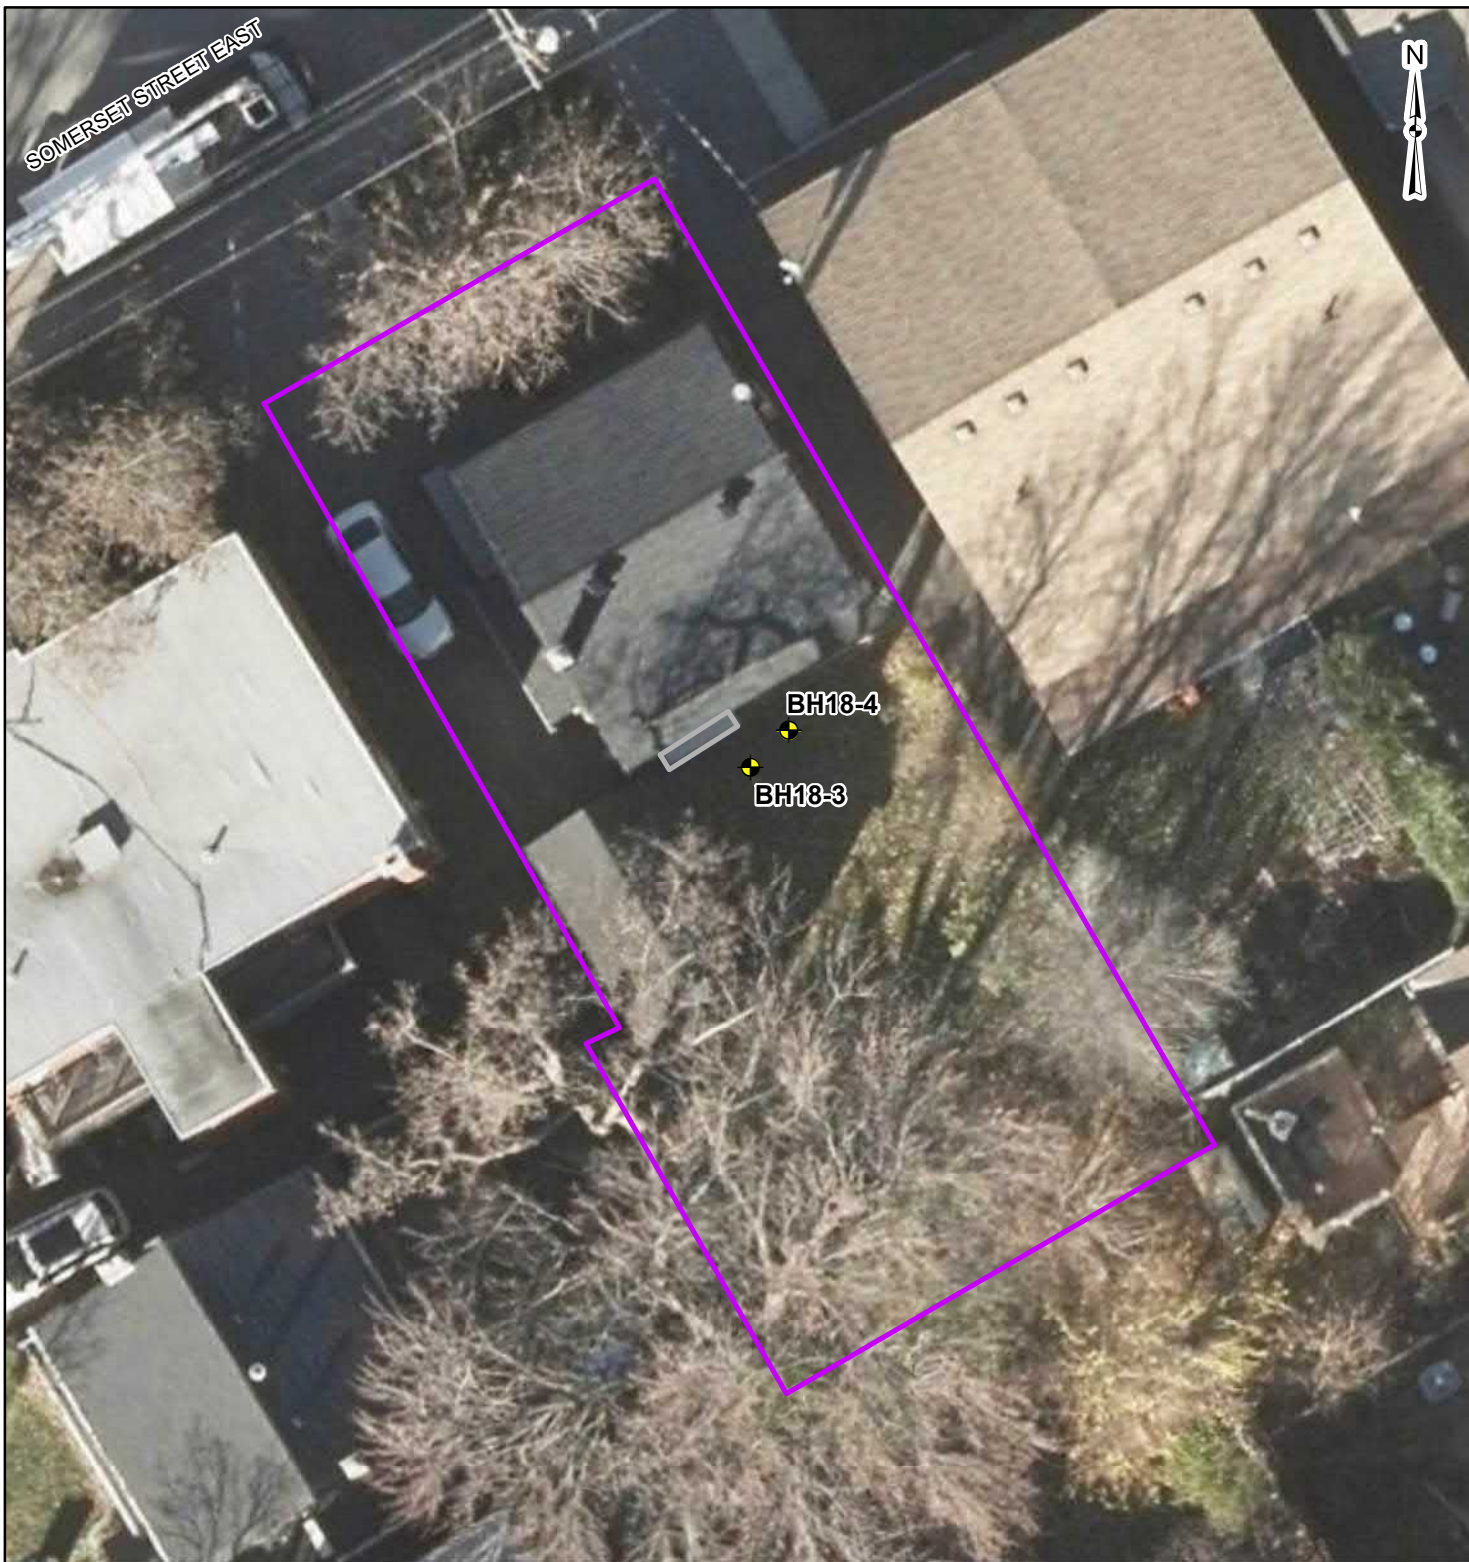
Phil Hulan (C.E.T.) of McIntosh Perry supervised a drilling and sampling program at the Site on February 16, 2018. McIntosh Perry's field program consisted of advancing two boreholes (BH18-3 and BH18-4) in the overburden, in the area of the AST, as presented on Figure 2. It is noted that a previous geotechnical investigation was completed by McIntosh Perry, with the field investigation portion of the geotechnical investigation completed in January 2018; two boreholes were completed at this time (BH18-1 and BH18-2); these boreholes were not considered to be located in the APEC on the Site.

- Approximate Site Boundary
- Above-Ground Storage Tank
- Borehole Location

Based on the limited nature of this investigation and the discrete spatial location of boreholes, there is always the possibility that higher concentrations of PHCs (F1 – F4) may be present in the non-investigated shallow soils in the area of the AST. Previously, McIntosh Perry recommended that if soils in the area of the AST are to be disturbed or removed from site during demolition of the residence, and that visual or olfactory evidence of contamination is encountered, further soil testing should be completed at this time (i.e. from beneath the area of the tank and to the west of the tank), to confirm applicable SCS compliance for the soils in these areas.
