# Phase One Environmental Site Assessment

*Part of 1910 St Laurent Boulevard, Ottawa, ON*

**Golder Associates Ltd.**

November 2018

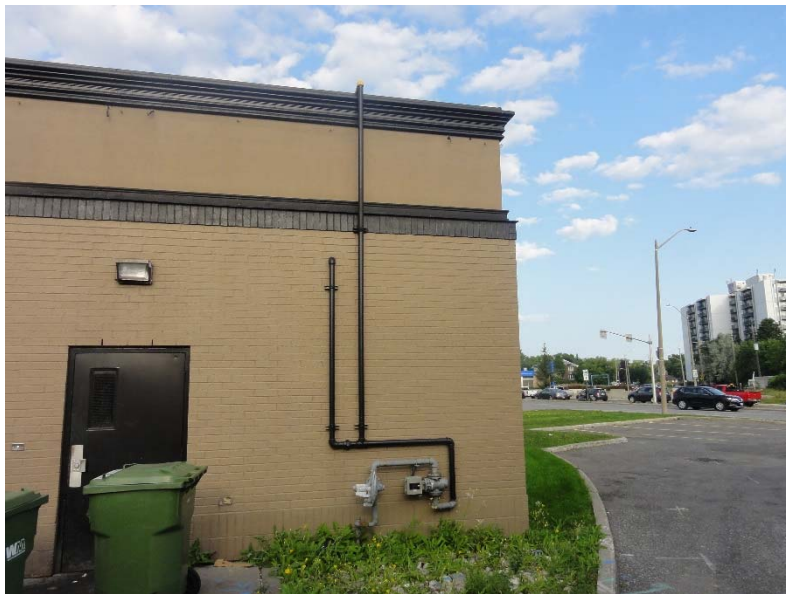
Photo 8 – View of natural gas line for the Site Building, indicating heating and cooling systems are fired by natural gas.

<b>Existing and Former Heating System(s) (include fuel type / source)</b>	There were three natural gas fired roof top heating, ventilation and air conditioning (HVAC) units associated with heating and cooling of the Site Building.	Site observations
<b>Existing and Former Cooling System(s) (include fuel type / source)</b>	Three natural gas fired rooftop units (as mentioned above).	Site observations

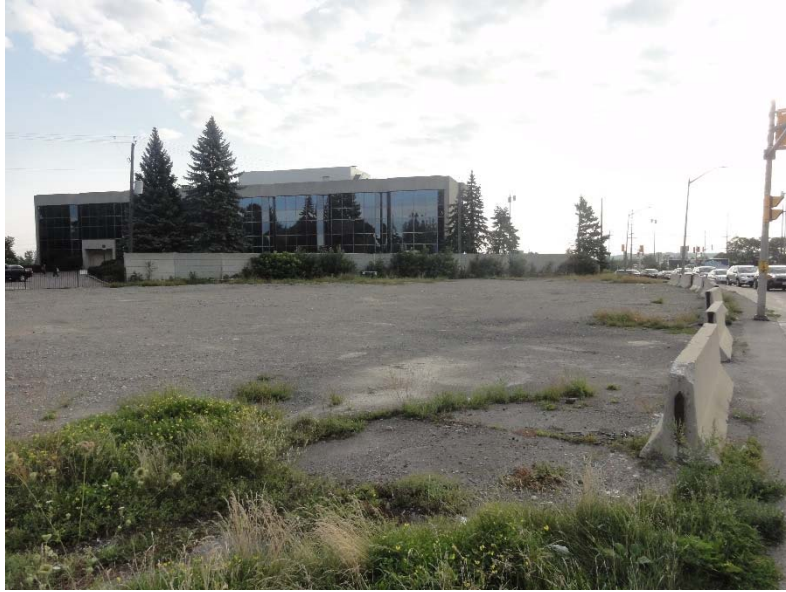
Photo 11 – View of the vacant land at 969 Smyth Road, former location of the gasoline service station (located north of the Site across Smyth Road).

During the Site visit, a vacant land was noted to the north of the Site (across Smyth Road) with four monitoring wells. It is likely the former location of the gasoline service station with associated USTs (addressed 969 Smyth Road, approximately 30 m north of the Site, with former USTs 50 metres north of the Site) and hence is considered an off-Site PCA for the Site. In addition, Smyth Medical Centre was located at 1929 Russell Road; however, that property was historically occupied by auto service garage (formerly addressed 1850 St. Laurent Boulevard, approximately 110 m north of the Site) and gasoline and fuel storage facility for Imperial Oil Products

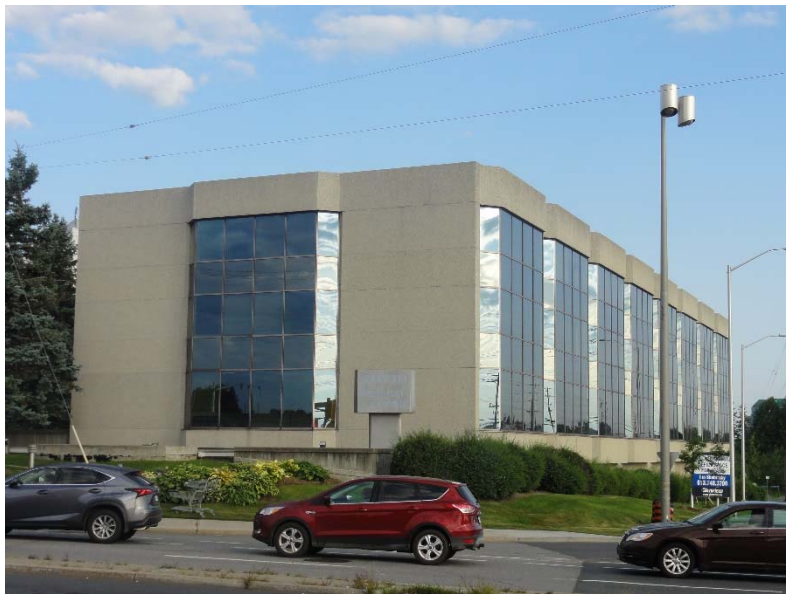
Photo 12 – View of a commercial property at 1929 Russell Road (located north of the Site across Smyth Road), former land use includes auto service garage and gasoline storage tanks.

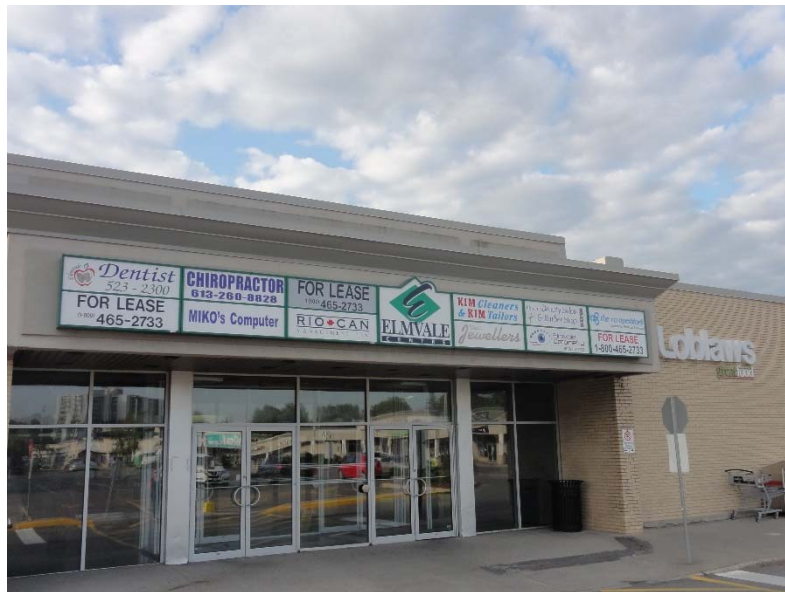
Photo 16 – View of typical commercial tenants at Elmvale Acres Shopping Centre building including a dry cleaning facility (reportedly a drop-off depot only).

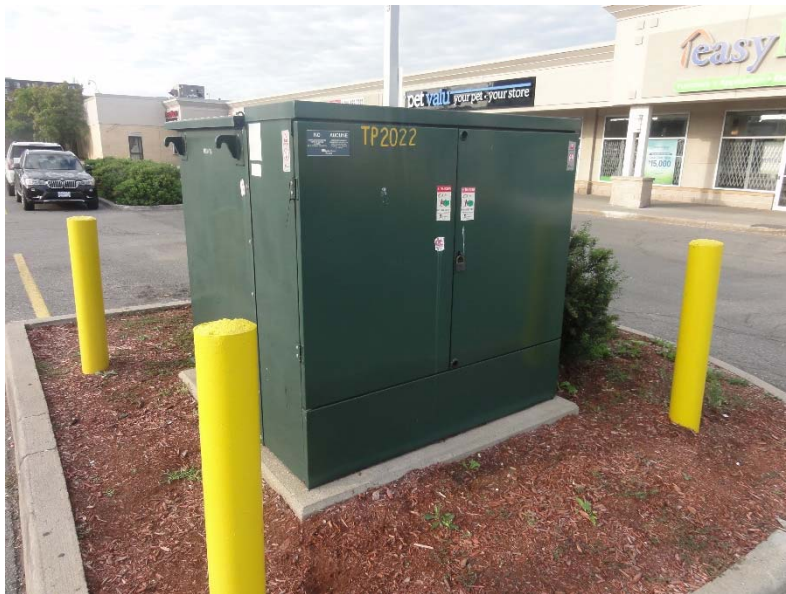
Photo 18 – View of concrete pad mounted transformer on the Subject Property, located southwest of the Site.

<p><b>#55 Transformer Manufacturing Processing and Use –</b> Four concrete pad mounted transformers located off-Site (shown as H1 to H4 on Figure 9).</p>	<p>Aerial photographs, Site observations</p>	<p>Based on the visual observations, no evidence of any stains or spills in the vicinity of the pad mounted transformers, and location of these transformers at least 40 m away from the RSC Property, it is not considered that this PCA will represent an APEC to the Site.</p>
<p><b>Phase One Study Area (excluding the Subject Property)</b></p>	<p><b>#28. Gasoline and Associated Products in Fixed Tanks -</b> North of the Site there was a gas station at the intersection of St. Laurent Boulevard and Smyth Road. The gasoline station was located at 969 Smyth Road (approximately 30 m north of the Site) and has been decommissioned. The land is now vacant (shown as I on Figure 9)</p>	<p>Ecolog ERIS Report, City Directories</p>	<p>Based on a review of the air photos the USTs at this location were 50 metres from the Site and is separated from the Site by Smyth road and its associated service trenches. This combined with investigation work for the Subject Property which included investigation opposite this PCA, did not identify any evidence of impacts. Thus this PCA is not considered to represent an APEC to the Site.</p>

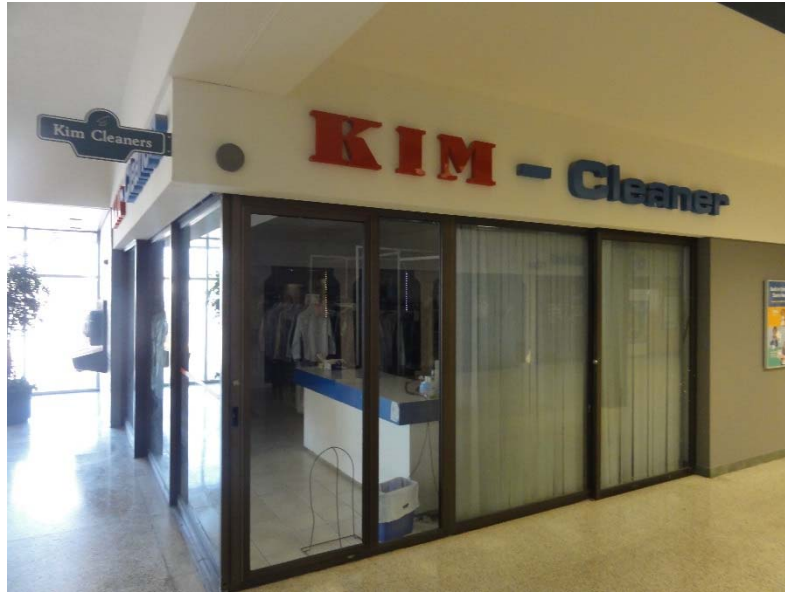
Photo 19 – View of a dry cleaning facility (reportedly drop-off depot only) approximately 100 m south of the Site. No visual evidence of dry cleaning solvents use during the Site visit.

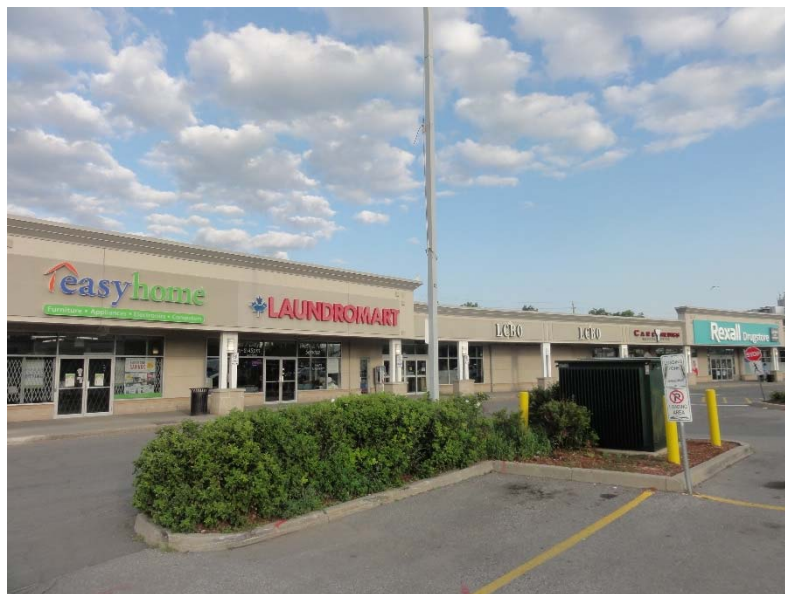
Photo 20 – View of the laundromat on Subject Property, located southwest of the Site; however, no dry cleaning operations or solvents appear to be used at this facility.
