Project: **ELMVALE ACRES REDEVELOPMENT - PH I**

Drawing: **TREE CONSERVATION PROPOSED DEVELOPMENT**

Scale: 1:200	Date: SEPT 2018
Design By: SE	Drawn By: SE
Project Number: 1907-02	Sheet Number: TCR 1.1

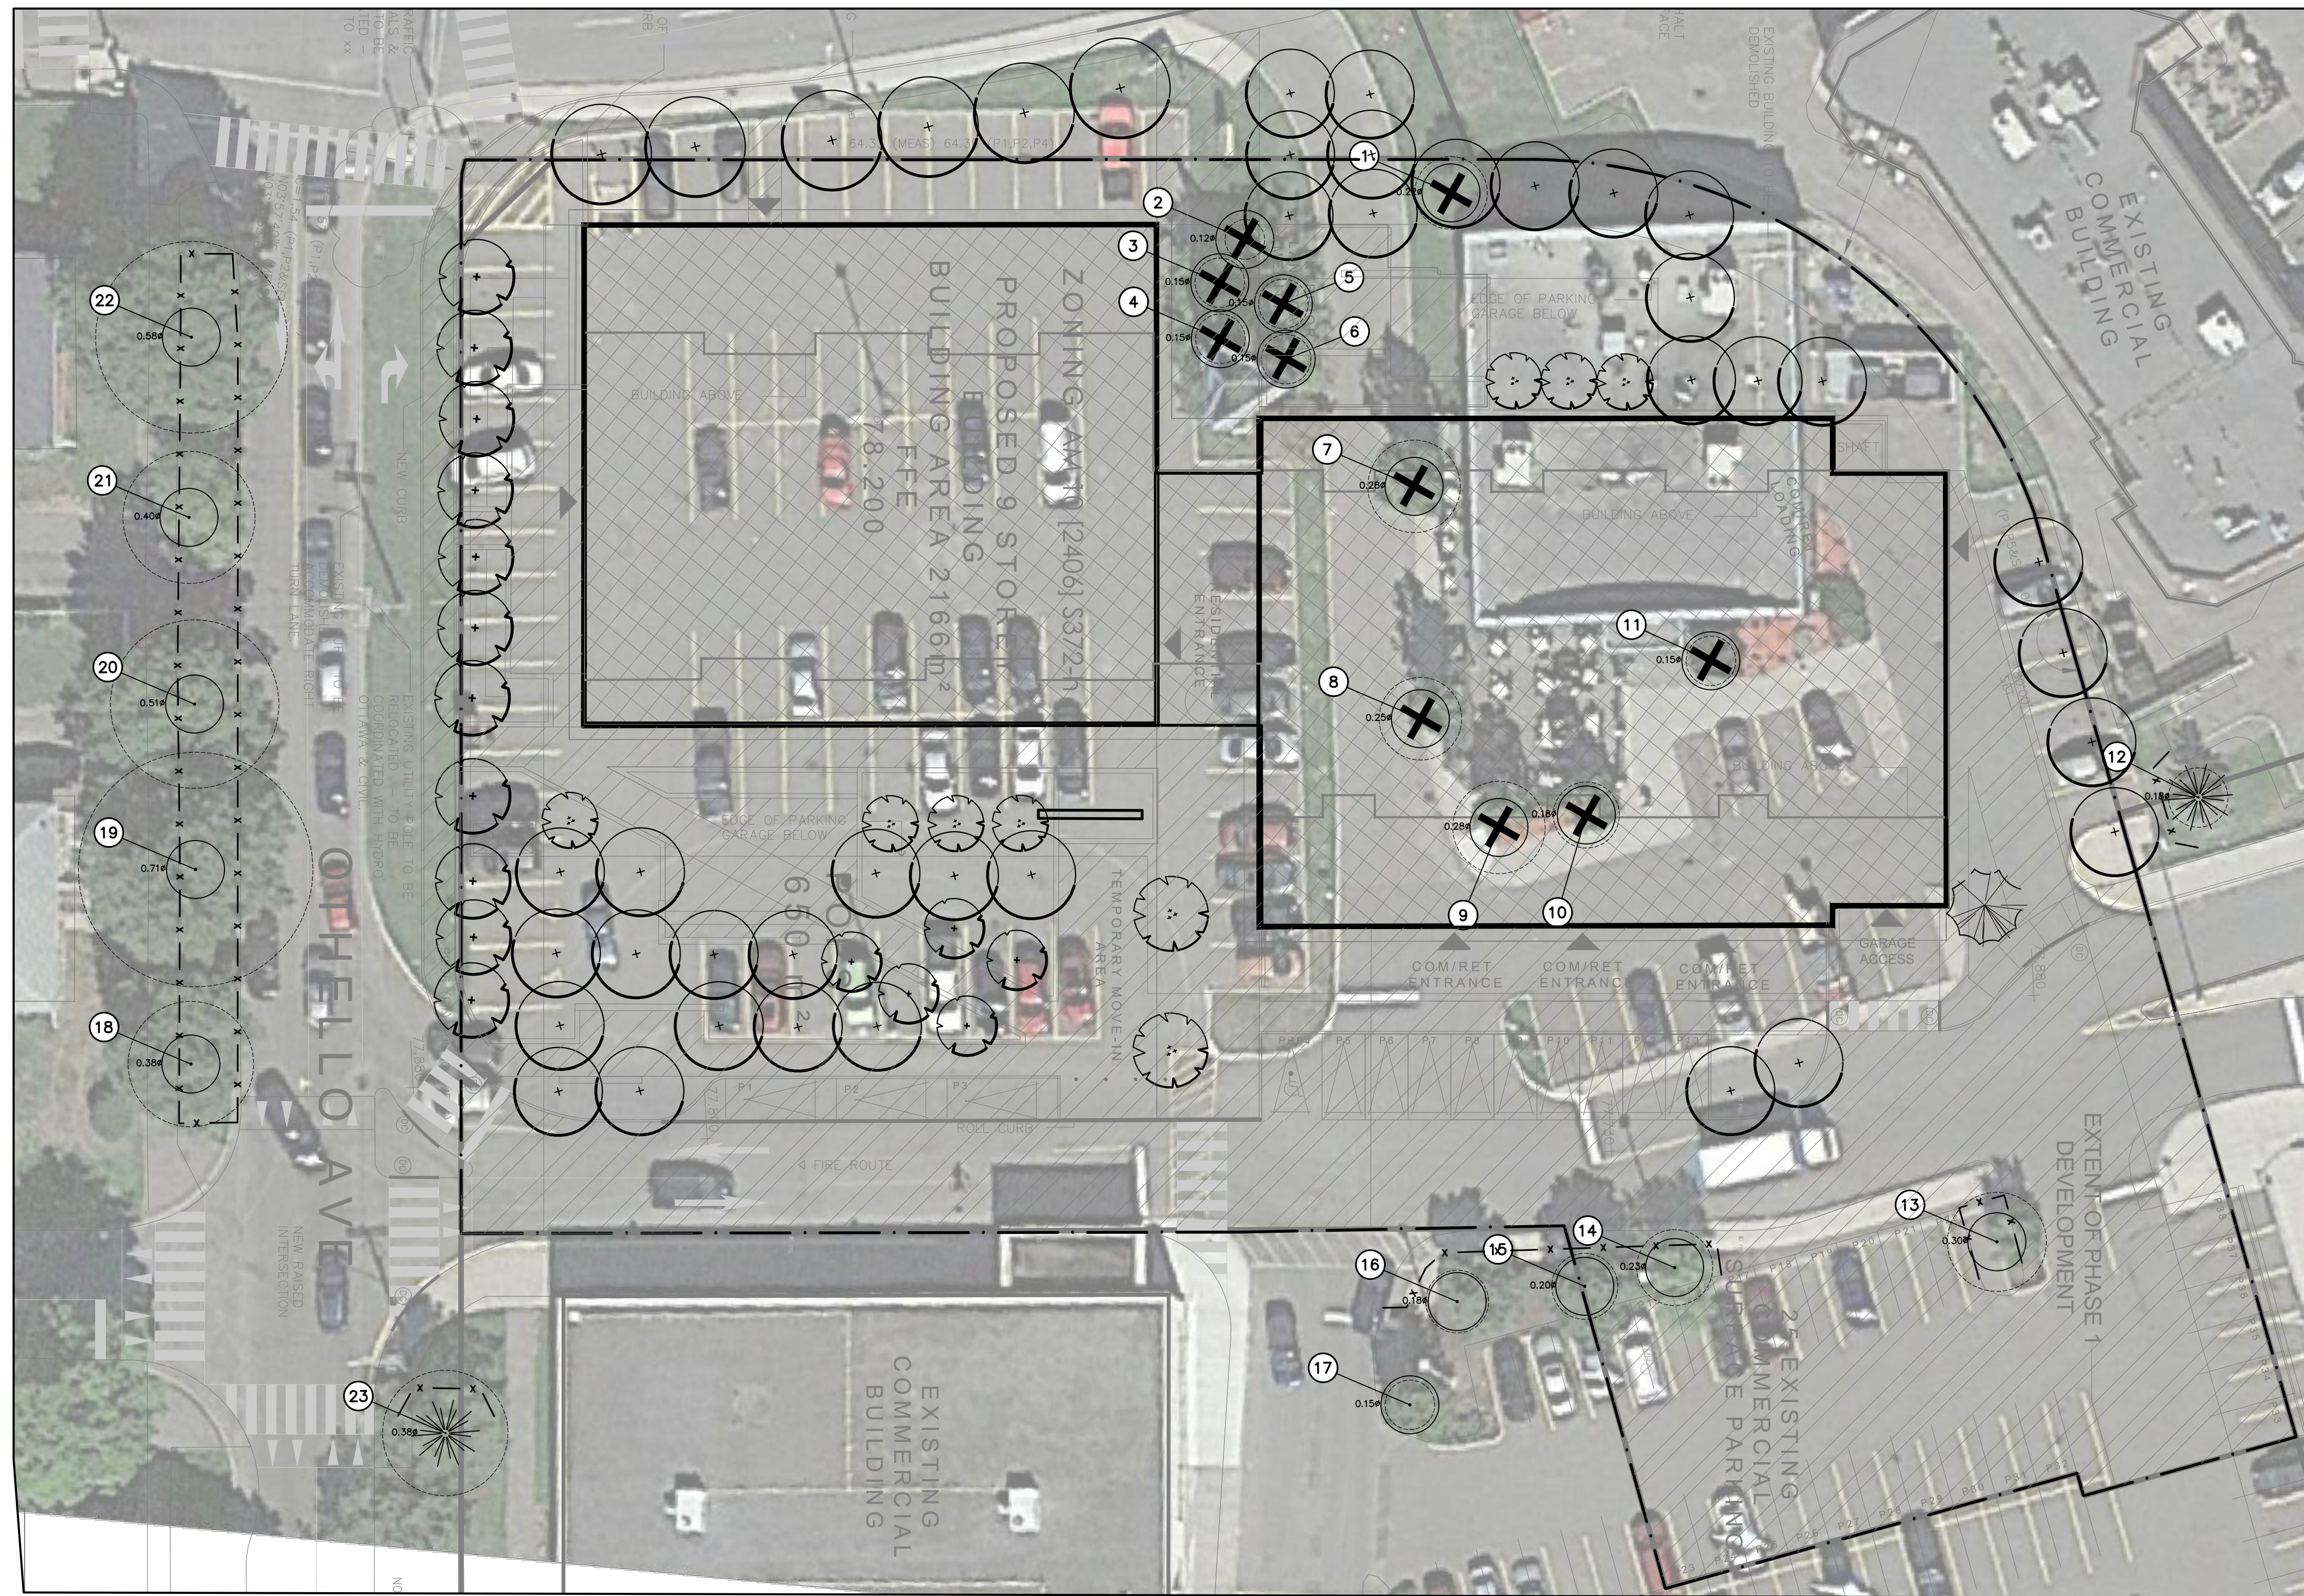
SITE DESCRIPTION:
 THE SITE INCLUDES AN EXISTING SINGLE STORY COMMERCIAL BUILDING WITH ASPHALT ACCESS DRIVE AND PARKING AREAS AND CONCRETE PATHWAYS. EXISTING TREES APPEAR TO HAVE BEEN PLANTED AS PART OF THE ORIGINAL COMMERCIAL DEVELOPMENT AND ARE LOCATED IN EXISTING TRAFFIC ISLANDS AND GRASS VERGES. ADJACENT TO THE SITE ON THE WEST SIDE OF OTHELLO IS AN AVENUE OF MATURE LITTLE LEAF LINDEN TREES.

THE PROPOSED DEVELOPMENT REQUIRES THE REMOVAL OF 11 TREES. THE LOCATION FOR NEW TREE PLANTING HAS BEEN DETERMINED TO ALLOW FOR MAXIMUM SOIL VOLUMES AND MINIMAL CONFLICTS WITH UNDERGROUND STRUCTURES TO ALLOW FOR THE ESTABLISHMENT OF LARGE MATURE TREES IN THE 'POPS' SPACE AND AVENUE TREE PLANTING ALONG THE NORTH AND WEST BOUNDARIES OF THE SITE. REFER TO THE LANDSCAPE PLAN FOR PROPOSED TREE SPECIES.
