REPORT ON

PHASE I ENVIRONMENTAL SITE ASSESSMENT 5574 ROCKDALE ROAD CITY OF OTTAWA, ONTARIO

(REPORT REVISED AS PER CITY OF OTTAWA MARCH 14, 2014)

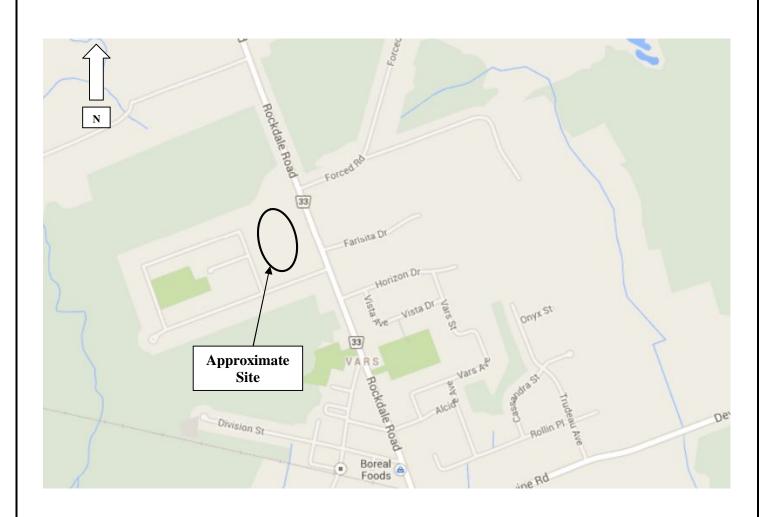
KEY PLAN FIGURE 1

The subject site for this assessment consists of a property located at 5574 Rockdale Road, in the City of Ottawa, Ontario (see Key Plan, Figure 1. A Site Plan is provided (see Figure 2) showing a 250 metre distance out beyond the site.

The attached Key Plan, Figure 1 and air photographs show the relative location of the subject site with respect to the surrounding land and the existing roadway network. Adjacent land uses consist of woodland and single family dwelling development.

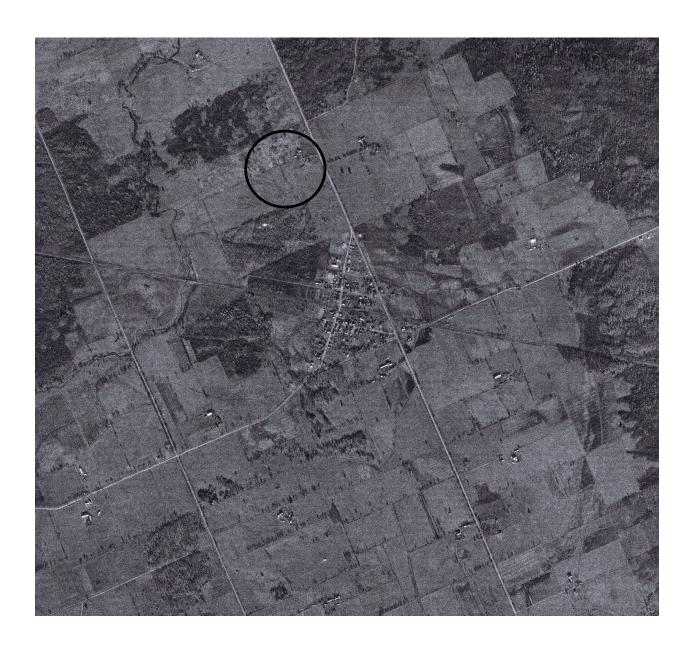
1960

A review of air photographs of the site for the years 1960, 1971, 1979 and 2002 was carried out as part of this Phase I ESA (see Attachment B). The 1960, 1971 and 1979 air photographs indicate the site is farmland with possibly one or two buildings at the site. The 2002 air photograph indicates the site as vacant with residential development at the west south and northeast sides.
