**ENVIRONMENTAL IMPACT STATEMENT  
and  
TREE CONSERVATION REPORT**

**PROPOSED MIXED USE DEVELOPMENT**

**PALLADIUM DRIVE  
KANATA WEST  
CITY of OTTAWA**

**Revised January, 2013**

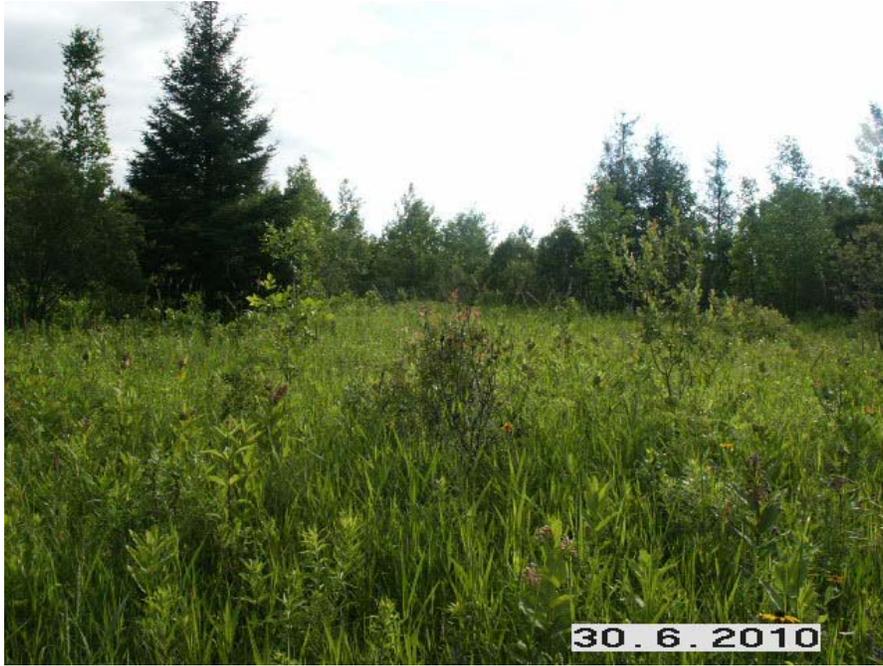
*Photo 1 –Cultural meadow habitat in the central-west portion of the site*

The majority of the site outside of the Feedmill Creek corridor was cultivated in corn in 2009, 2010 and 2011. Cultural meadow vegetation adjacent to the cultivated fields includes reed canary grass, common dandelion, St. John's wort, Canada goldenrod, tall goldenrod, late goldenrod, common milkweed, narrow-leaved meadowsweet, wild parsnip, ox-eye daisy, June meadow grass and common buckthorn, slender willow and red-osier dogwood shrubs.

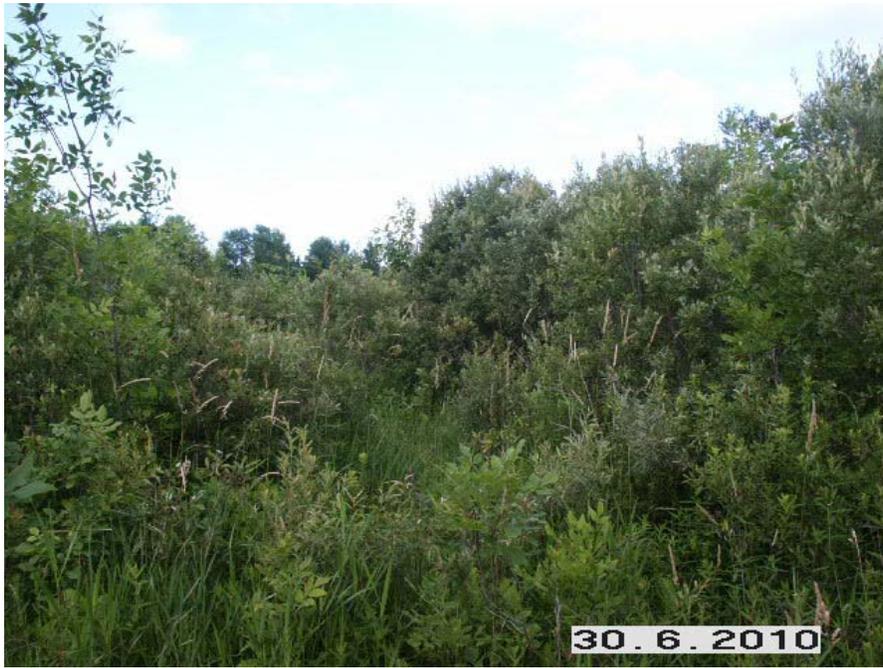
*Photo 2 – Cultural thicket habitat in the southwest portion of the site*

Cultural thickets in the far west portion of the site are dominated by common buckthorn, glossy buckthorn, red-osier dogwood, Bebb’s willow, slender willow, pussy willow and red raspberry. Glossy buckthorn is dominant in the central part of the thicket habitat. Scattered regenerating stems of balsam poplar, trembling aspen, red ash, white elm, white cedar and tamarack are up to 20cm dbh. Canada and tall goldenrod are abundant ground cover in the cultural thicket, along with common dandelion, wormseed mustard, tufted vetch, brown-eyed susan, timothy, Philadelphia fleabane, daisy fleabane, bird’s-foot trefoil, red clover, tall buttercup, ox-eye daisy, common yarrow, white-sweet clover, joe-pye-weed, blue vervain, yellow avens, purple loosestrife, orchard grass, awnless brome grass, wild grape, helleborine, Virginia creeper, common milkweed, blue violet and wild madder.

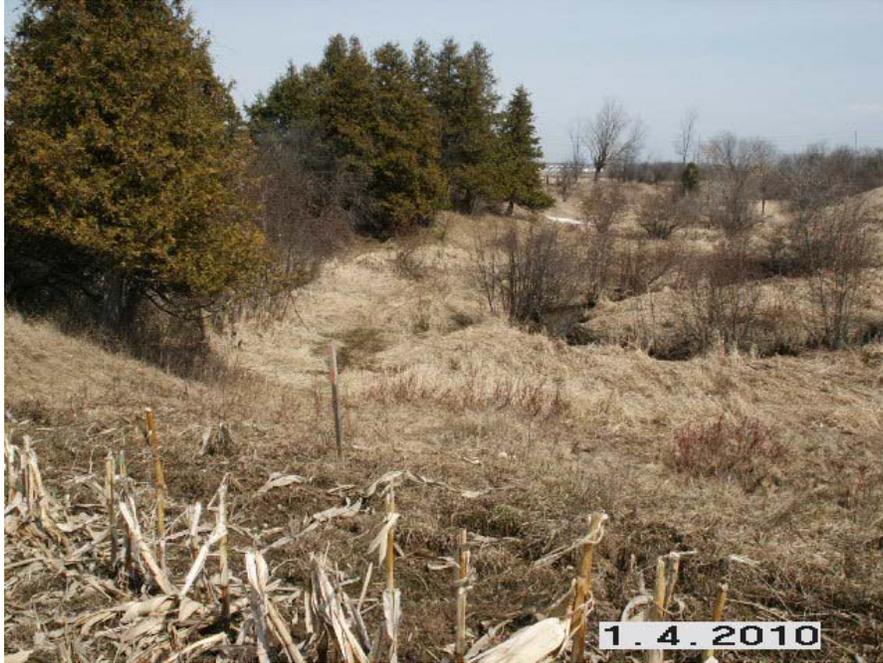
*Photo 3 – Feedmill Creek corridor in the east portion of the site. Note corn to edge of valley top-of-slope as indicated by stake. View looking east*

Another cultural woodland representation is along Feedmill Creek in the east portion of the site. Mature white cedar and white pine up to 55cm dbh are present, along with many intermediate-aged white cedars (Photo 3). Manitoba maple, red ash and white elm are common, as is common buckthorn in the understorey. Red raspberry, speckled alder and red-osier dogwood are also present. Ground flora included reed canary grass, orchard grass, Canada anemone, common milkweed, bluegrass, tall meadow-rue, soapwort and common burdock. Plantings of white ash and red ash along Feedmill Creek are up to 18cm dbh and appear to be in good condition.

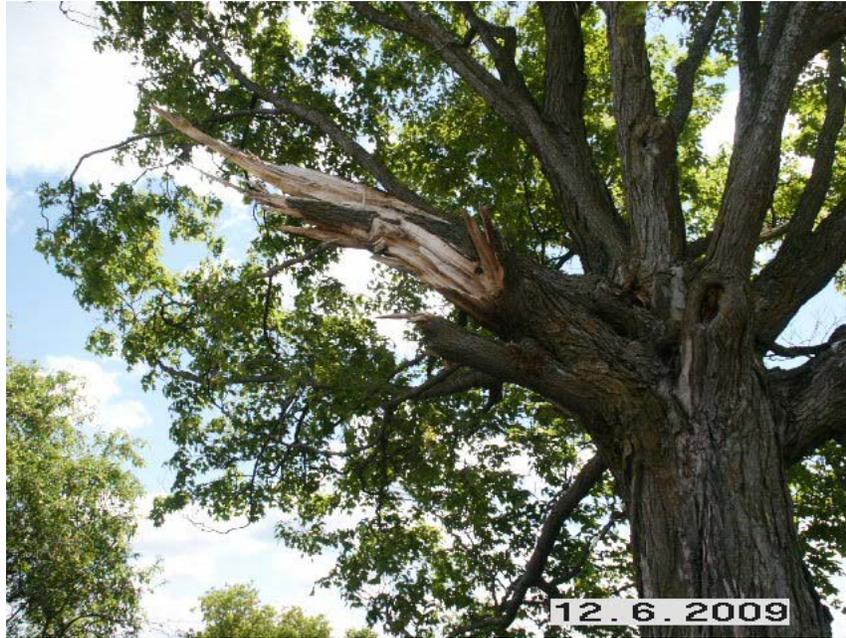
*Photo 4 – Mature sugar maple at end of hedgerow in southeast portion of site.*

Two short north-south deciduous hedgerows south of Feedmill Creek in the southeast portion of the site are dominated by mature Manitoba maples up to 60cm dbh. Smaller bur oak and trembling aspens and staghorn sumac shrubs are adjacent to the Manitoba maples and old foundations, along with a very large, 115cm dbh, sugar maple at the south end of the west north-south hedgerow. The maple appeared to be in senescence with reduced leaf-out and broken limbs (Photo 4).

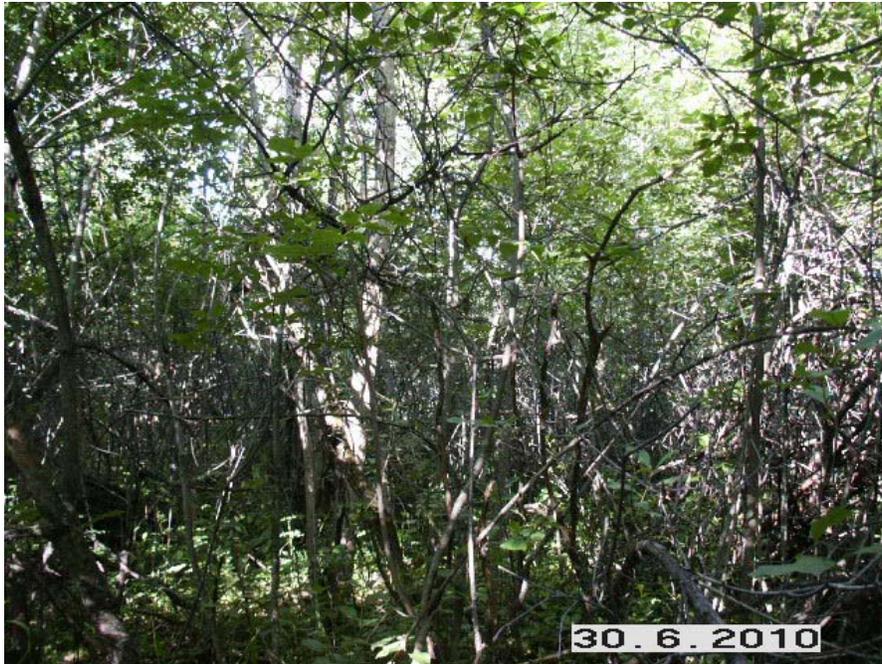
*Photo 5 – Young poplar deciduous forest with thick buckthorn in understorey*

This community, in the central-west portion of the site, occurs where the poplar coverage is greater than 60 percent adjacent to the cultural thickets dominated by buckthorn to the east and north and willow thickets to the south (Photo 5, vegetation community 5 on Map 1). Glossy buckthorn continues to be dominant in the understorey, with regenerating red ash stems in many areas. Balsam poplar, trembling aspen and white birch are the common tree species, with pockets of dense white cedar up to 22cm dbh. Most deciduous trees are less than 20cm dbh, with a few poplars up to 32cm dbh. Many of the young tree trunks and limbs are broken in this scrub-like vegetation unit, with wind throw and ice storm damage appearing extensive. Wild

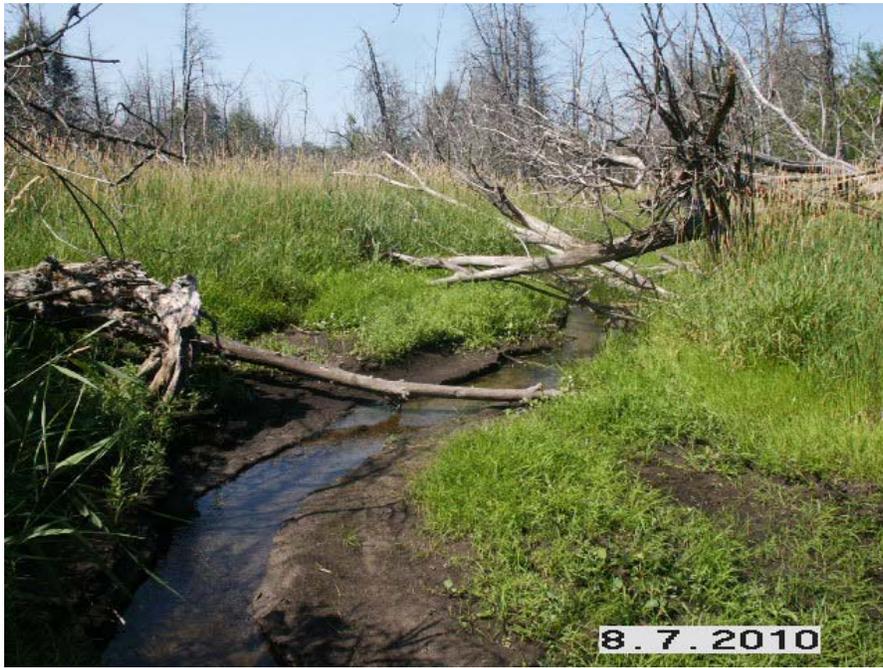
*Photo 6 – Feedmill Creek through the meadow marsh in the southwest portion of the site.  
View looking west*

Reed canary grass is dominant in the marsh habitat along the north side of Feedmill Creek in the southwest portion of the site (Photos 6 and 7). Canada bluejoint, purple loosestrife, soft-stem bulrush, boneset, blue vervain, joe-pye-weed and spotted jewelweed are also present.

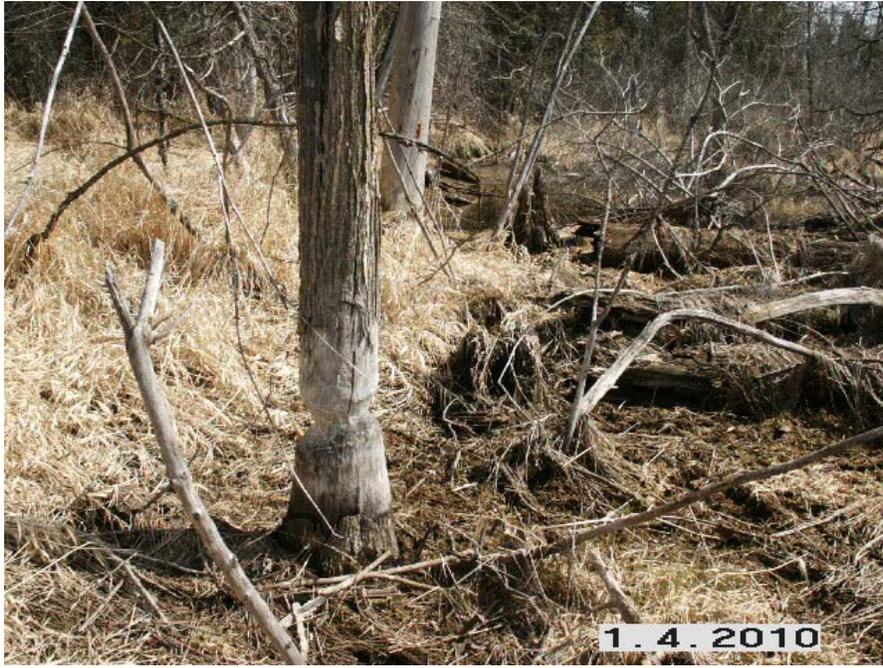
*Photo 7 – Former beaver activity in meadow marsh at Feedmill Creek in the west part of the site.*

The owner reports removal of beavers in the area of the meadow marsh and a breached beaver dam through Feedmill Creek itself is present in the southeast corner of the meadow marsh. Dead white cedar stems up to 30cm dbh are scattered in the marsh habitat, which has a maximum width of about 50 metres in the vicinity of the former dam. It is likely that the expanse of the meadow marsh has been strongly influenced by the beaver dam and associated holding back of water. It is anticipated that the extent of meadow marsh would be reduced if the beaver dam was not re-established.

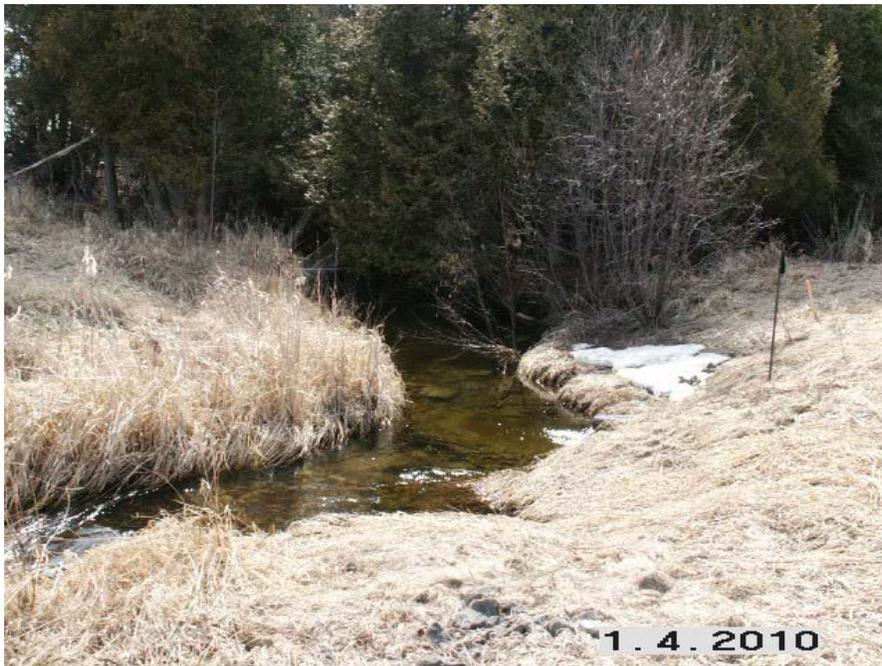
*Photo 8 – Feedmill Creek emerging from the mixed forest just west of Palladium Drive. View looking southwest*

In the southwest portion of the site Feedmill Creek meanders along the periphery of and through a mixed forest (Photo 8). A breached beaver dam was through the creek in the south-central portion of the west part of the site. This likely accounted for standing water observed to the north of Feedmill Creek in this area on 2005 and 2008 aerial photography. The lack of a dam should assist in maintaining a cool water thermal regime for Feedmill Creek. In addition to stream shading, the good canopy cover in most this reach will provide a source of woody debris, bank erosion protection, surface water filtering and a cool microclimate (Robinson, 2004).

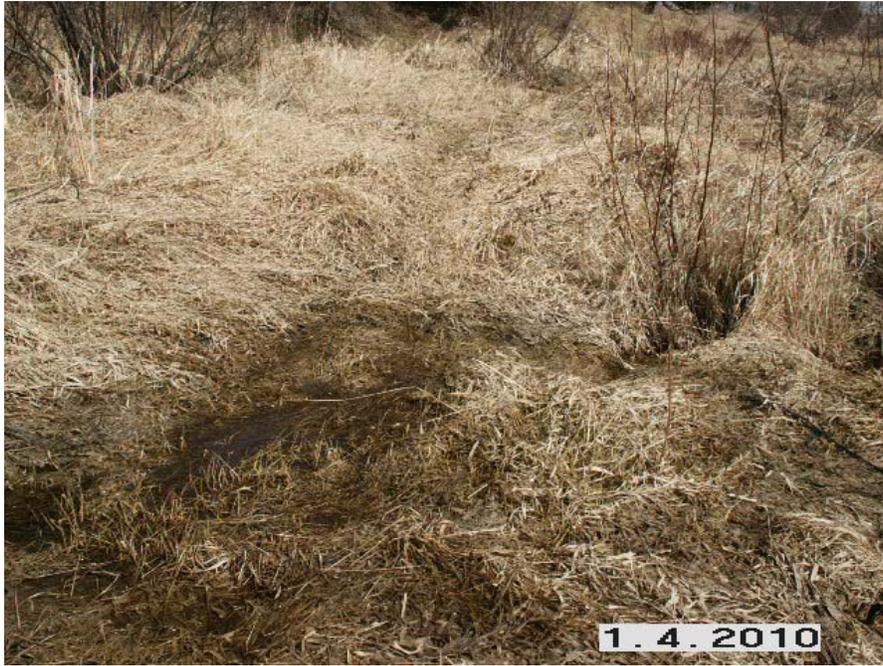
*Photo 11 – No definition of tributary to Feedmill Creek in east portion of the site, east of westbound off-ramp from Highway 417. View looking east*

A swale entering Feedmill Creek east of the westbound off-ramp from Highway 417 was examined on April 1<sup>st</sup>, 2010. No defined channel was observed more than two metres northeast, upstream, of the creek channel and the slope further upstream would prohibit any fish utilization, even during elevated flows (Photos 11 and 12).

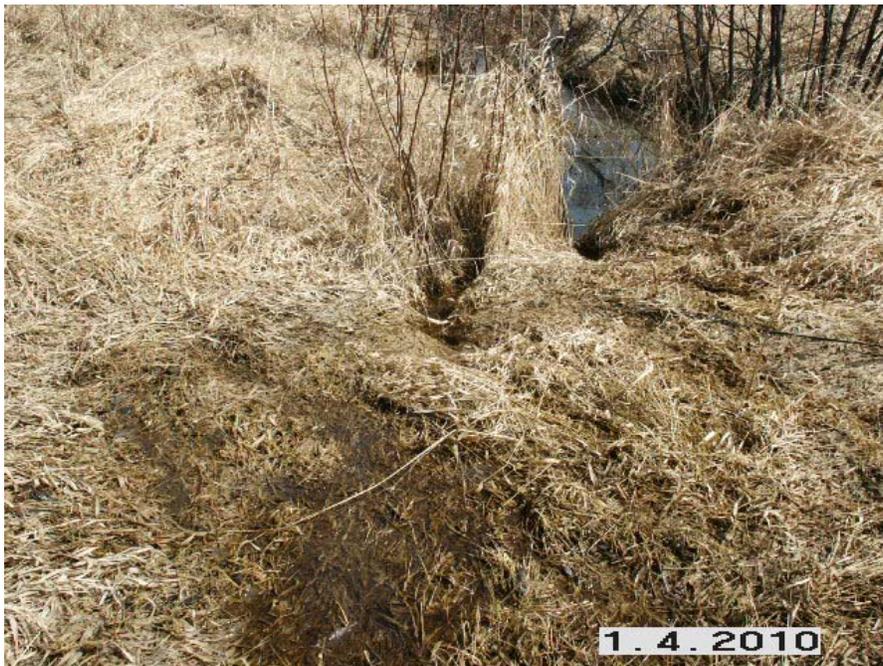
*Photo 12 – Tributary to Feedmill Creek in east portion of the site, east of westbound off-ramp from Highway 417, with Feedmill Creek in the background. View looking southeast*

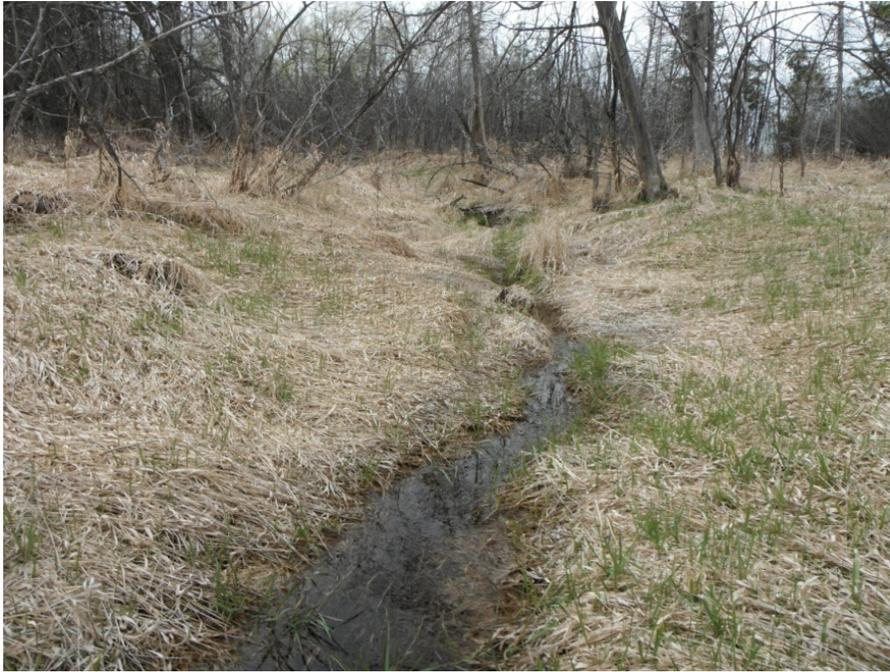
*Photo 13 - Station E3 and D1 looking upstream from downstream (April 30<sup>th</sup>, 2012)*

Three stations were sampled along the tributary with an electrofisher and dip nets. Electroshocking was completed for a station length of 35 metres at 50-100 volts, and 1.5-1.7 amps. The water temperature was 11.8° C, with an air temperature of 16.0° C at 14:30. The conductivity was 875 µs, with a pH of 7.47 and total dissolved solids of 450 ppm. The downstream sampling station included a pool. The average wetted widths and depths were 1.8 metres and 13 cm, respectively (Photos 13 and 14). The area fished was 37 m<sup>2</sup> and the shock time was 27 seconds. No fish were captured or observed using either the electrofisher or a total of ninety- three dips at the three sampling stations.

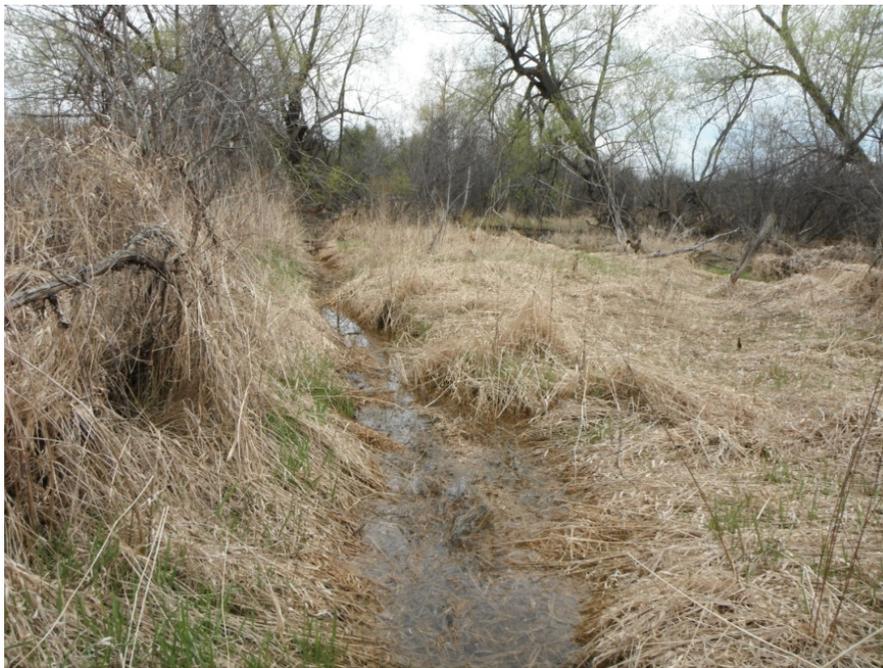
*Photo 14 - Station D3 (April 30<sup>th</sup>, 2012)*

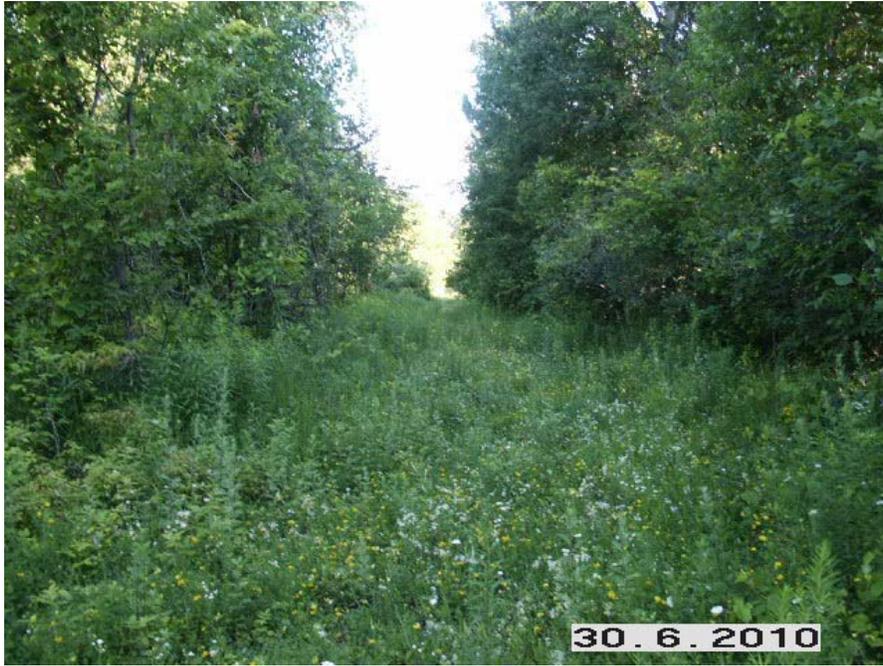
*Photo 15 – Old access lane along central and north portion of west edge of site.  
View looking north, with west edge of site on right*

The oldest of the on-site trees would be in the range of 60 – 70 years old, although the vast majority are much younger. Although the site is in the urban area, the adjacent lands to the west are in the rural area. Of the three criteria that must be met for identifying significant woodlands in the rural portion of the City of Ottawa, the east edge of the adjacent forest does not contain forest interior habitat or mature stands of trees 80 years of age or older. Lands further to the west that could not be observed from the west edge of the site were not surveyed due to access concerns and may meet the rural criteria for significant woodlands. However, as described below the adjacent woodlands will be protected and no impacts are anticipated on any significant woodlands that may be present off-site in the woodlands. An access trail is along the west edge of the site, providing a break in the young forest cover (Photo 15).

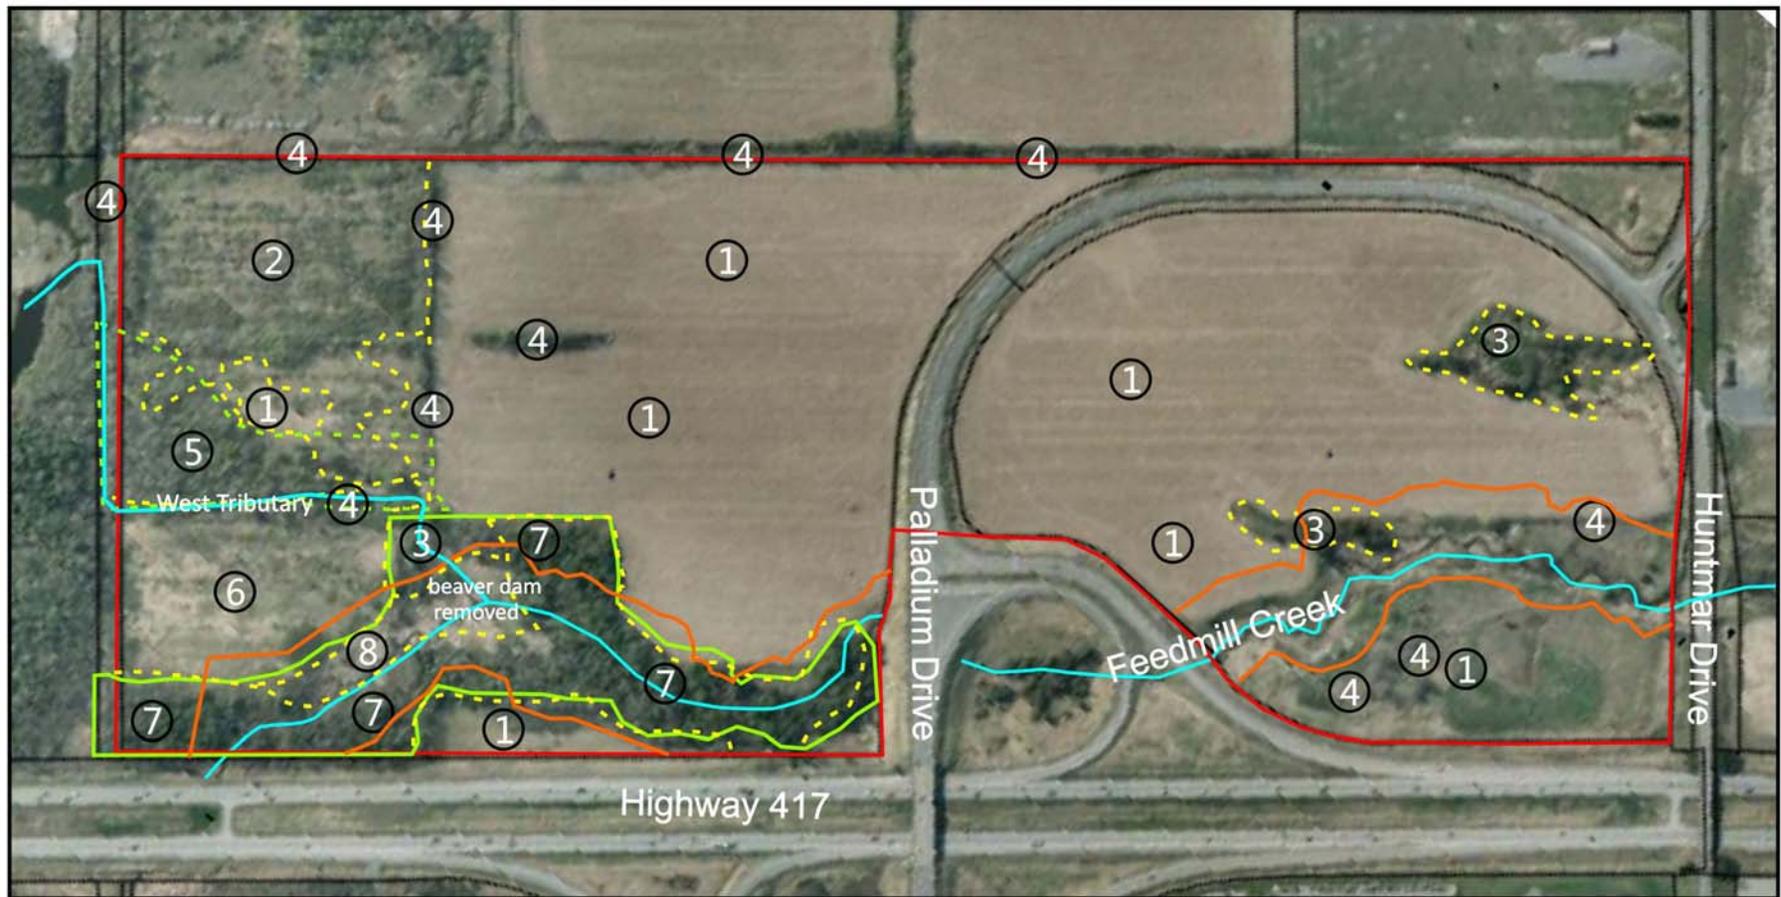
2011 airphoto base from City website

- ① Cultural meadow/agricultural field
- ② Cultural thicket
- ③ Cultural woodland
- ④ Deciduous hedgerow
- ⑤ Fresh-moist poplar deciduous forest
- ⑥ Willow thicket
- ⑦ Fresh-moist cedar coniferous forest
- ⑧ Meadow marsh

Map 1 identifies the recommended Urban Natural Area boundary. The original site Urban Natural Area boundary included more land to the northwest of the Feedmill Creek corridor (shown as a green-dashed line on Map 1). This original boundary was determined without the benefit of on-site examinations. The 2009 and 2010 fieldwork have identified in this area highly disturbed thickets dominated by buckthorn, young poplar forests with the understorey and ground flora dominated by disturbed species and deciduous hedgerows dominated by poplar. No significant features and functions were identified for this area that would add to the Urban Natural Area along the Feedmill Creek corridor. The Feedmill Creek corridor is separated by the original UNA lands to the northwest by thicket habitat.

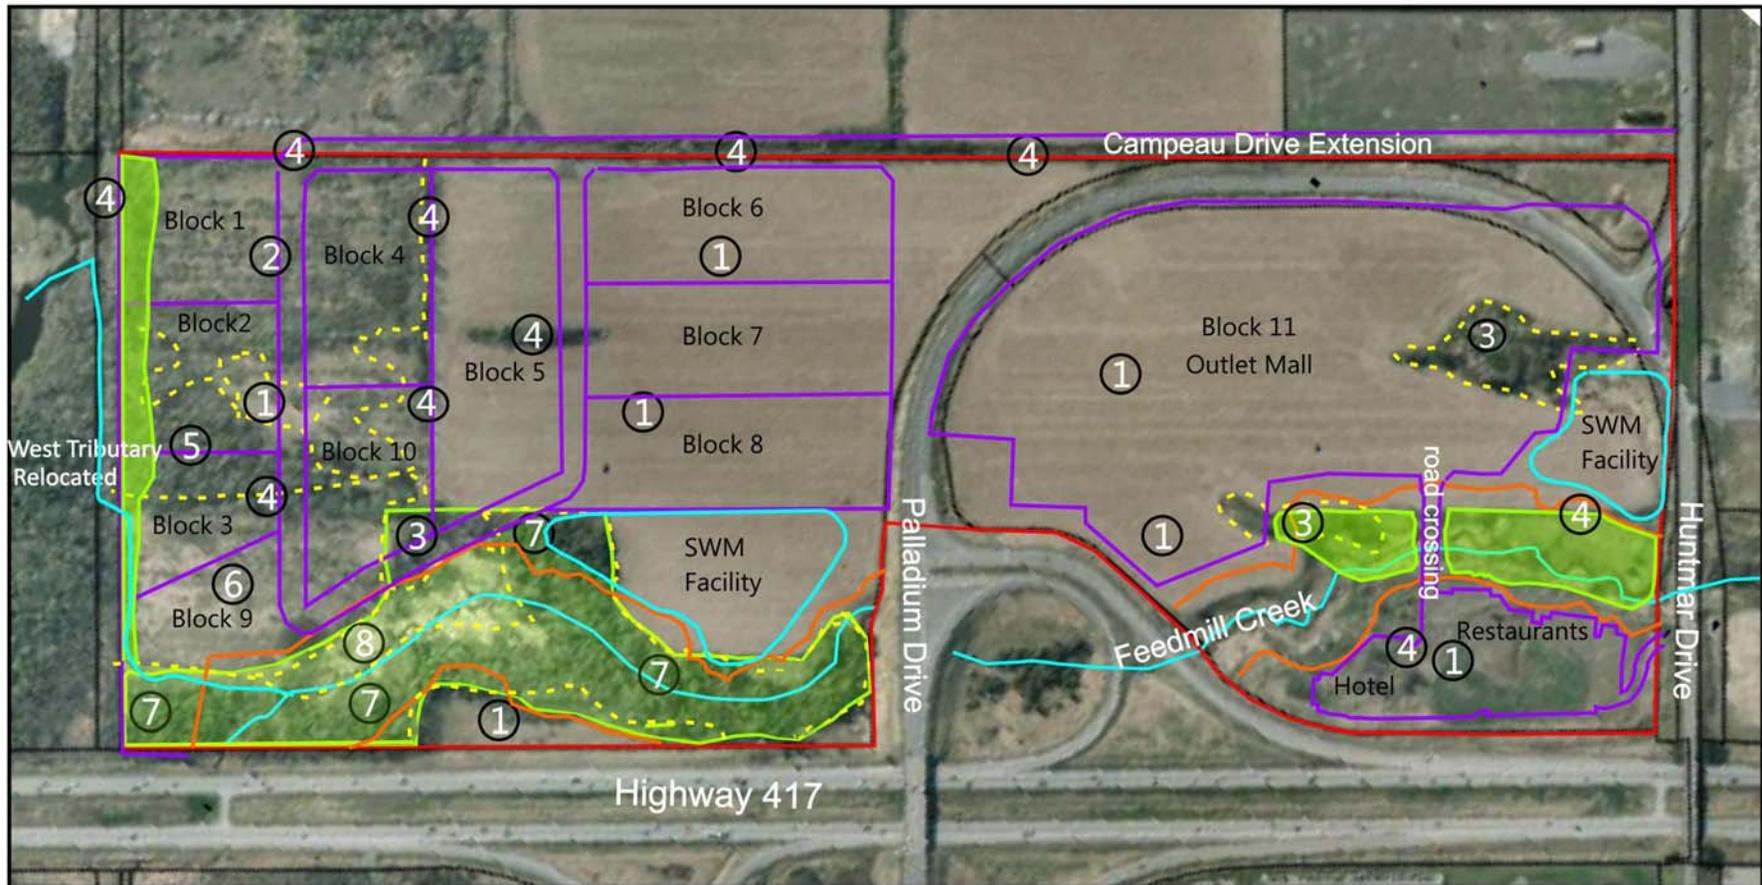
2011 airphoto base from City website

- Site
- Recommended Palladium Interchange UNA Boundary
- General areas of woody vegetation retention
- Feedmill Creek Corridor and Setback
- Vegetation communities

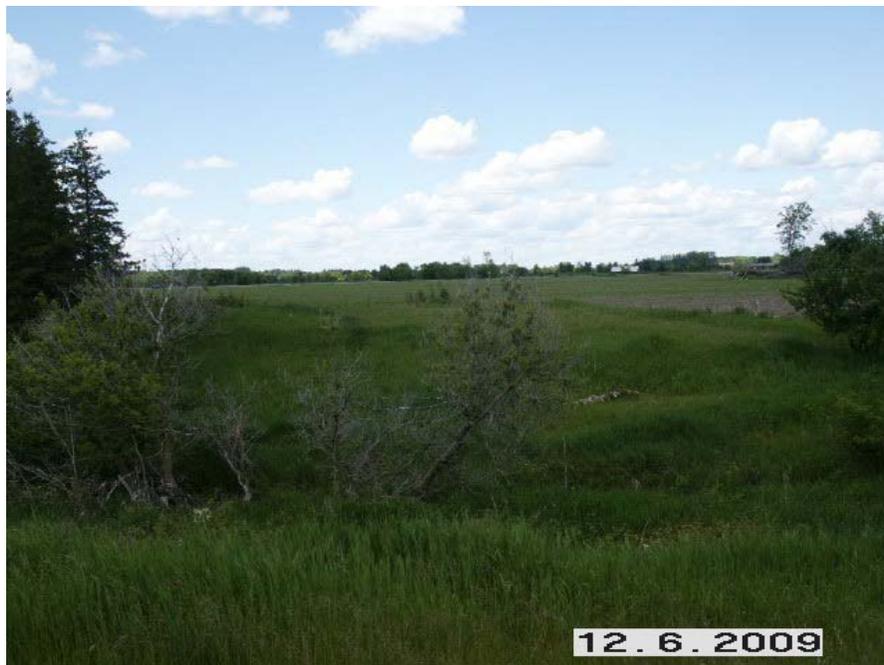
*Photo 14 – Approach for proposed road crossing of Feedmill Creek in east portion of site.*

*Crossing location selected to avoid trees to west and east.  
View looking north from south side of creek*

Approvals will be required from Mississippi Valley Conservation for the road crossing of Feedmill Creek in the southeast portion of the site. Photo 14 below shows a preferred crossing location that would minimize the removal of woody vegetation in the approaches to the crossing. The crossing would also need to avoid, relocate or replace the plantings and other stream enhancement measures completed along this reach of Feedmill Creek. The road and associated culvert should be as narrow as possible to minimize potential impacts on the creek habitats.
