**ENVIRONMENTAL IMPACT STATEMENT
and
TREE CONSERVATION REPORT**

PROPOSED MIXED USE DEVELOPMENT

**PALLADIUM DRIVE
KANATA WEST
CITY of OTTAWA**

Revised January, 2013

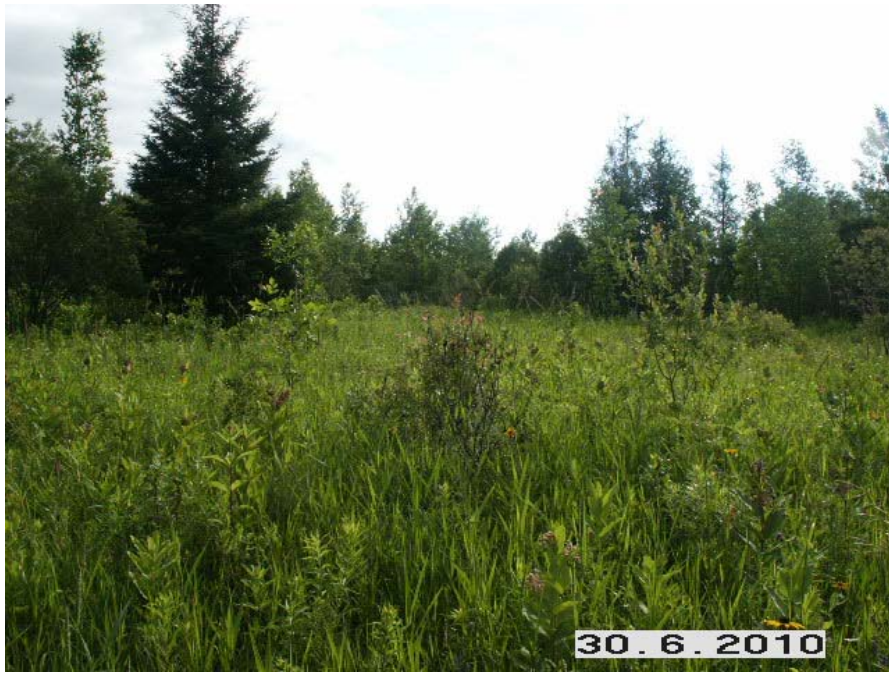
Photo 1 –Cultural meadow habitat in the central-west portion of the site

The majority of the site outside of the Feedmill Creek corridor was cultivated in corn in 2009, 2010 and 2011. Cultural meadow vegetation adjacent to the cultivated fields includes reed canary grass, common dandelion, St. John's wort, Canada goldenrod, tall goldenrod, late goldenrod, common milkweed, narrow-leaved meadowsweet, wild parsnip, ox-eye daisy, June meadow grass and common buckthorn, slender willow and red-osier dogwood shrubs.

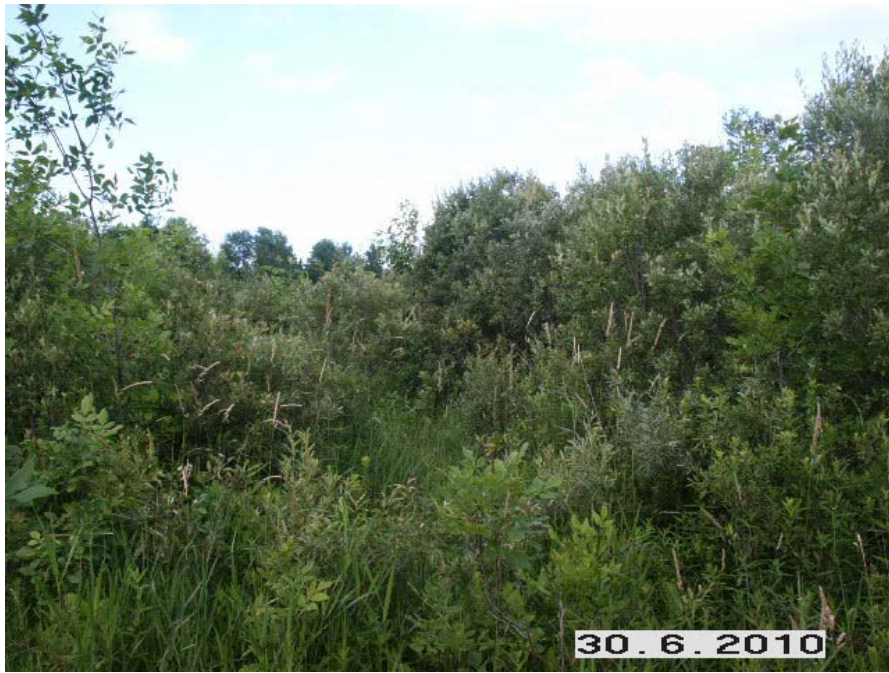
Photo 2 – Cultural thicket habitat in the southwest portion of the site

Cultural thickets in the far west portion of the site are dominated by common buckthorn, glossy buckthorn, red-osier dogwood, Bebb's willow, slender willow, pussy willow and red raspberry. Glossy buckthorn is dominant in the central part of the thicket habitat. Scattered regenerating stems of balsam poplar, trembling aspen, red ash, white elm, white cedar and tamarack are up to 20cm dbh. Canada and tall goldenrod are abundant ground cover in the cultural thicket, along with common dandelion, wormseed mustard, tufted vetch, brown-eyed susan, timothy, Philadelphia fleabane, daisy fleabane, bird's-foot trefoil, red clover, tall buttercup, ox-eye daisy, common yarrow, white-sweet clover, joe-pye-weed, blue vervain, yellow avens, purple loosestrife, orchard grass, awnless brome grass, wild grape, helleborine, Virginia creeper, common milkweed, blue violet and wild madder.

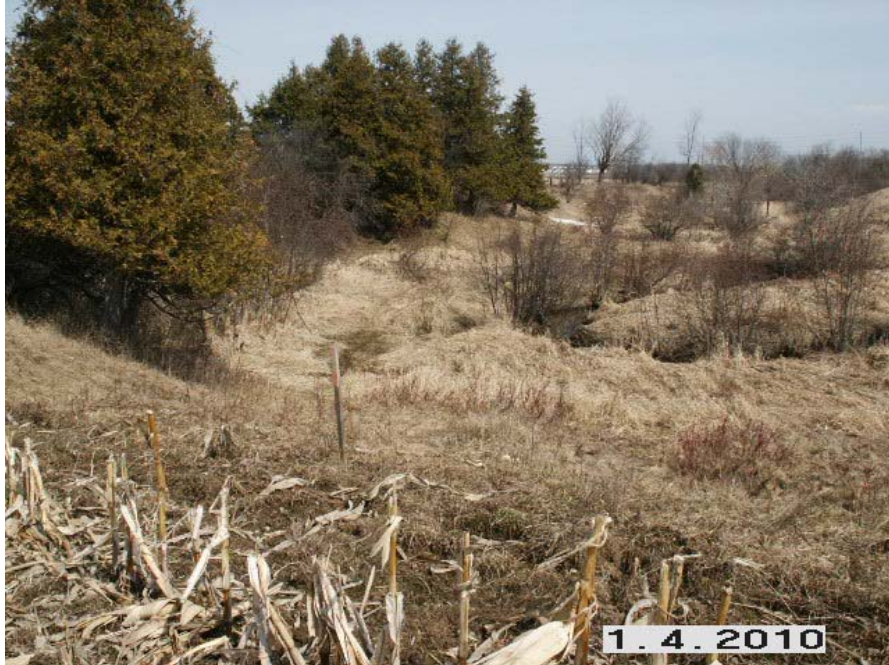
Photo 3 – Feedmill Creek corridor in the east portion of the site. Note corn to edge of valley top-of-slope as indicated by stake. View looking east

Canopy cover in the east portion of the site is minimal along Feedmill Creek itself, with only scattered Manitoba maple and white cedar trees (Photo 3). However some fallen trees provide some stream cover and inputs to the aquatic system. Portions of Feedmill Creek in the vicinity of the site were diverted to accommodate the Palladium Drive and Highway 417 interchange. Enhancement measures were completed in the mid-1990s to compensate for the disturbances to the creek, including the relocated channel. Deciduous tree and shrub plantings were completed in sections along the creek. The plantings are now in the range of 18cm dbh and appear to be in good condition. Deflectors were installed along both sides of the channel to assist in scouring (Photos 9 and 10). The deflectors reduced the wetted width to one metre and coarse material, providing important fish and insect habitat, was common in the areas of the deflectors during 2010 observations.

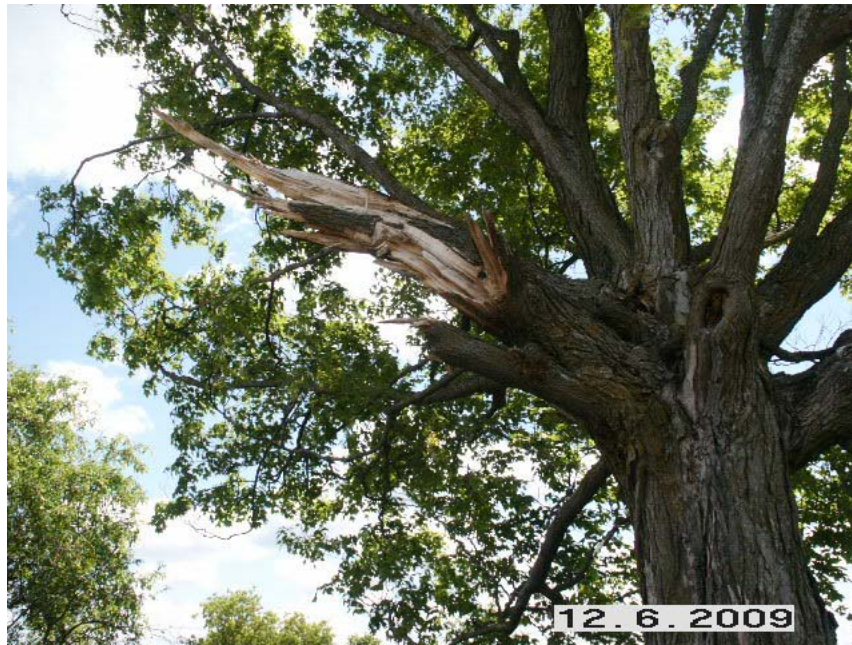
Photo 4 – Mature sugar maple at end of hedgerow in southeast portion of site.

Two short north-south deciduous hedgerows south of Feedmill Creek in the southeast portion of the site are dominated by mature Manitoba maples up to 60cm dbh. Smaller bur oak and trembling aspens and staghorn sumac shrubs are adjacent to the Manitoba maples and old foundations, along with a very large, 115cm dbh, sugar maple at the south end of the west north-south hedgerow. The maple appeared to be in senescence with reduced leaf-out and broken limbs (Photo 4).

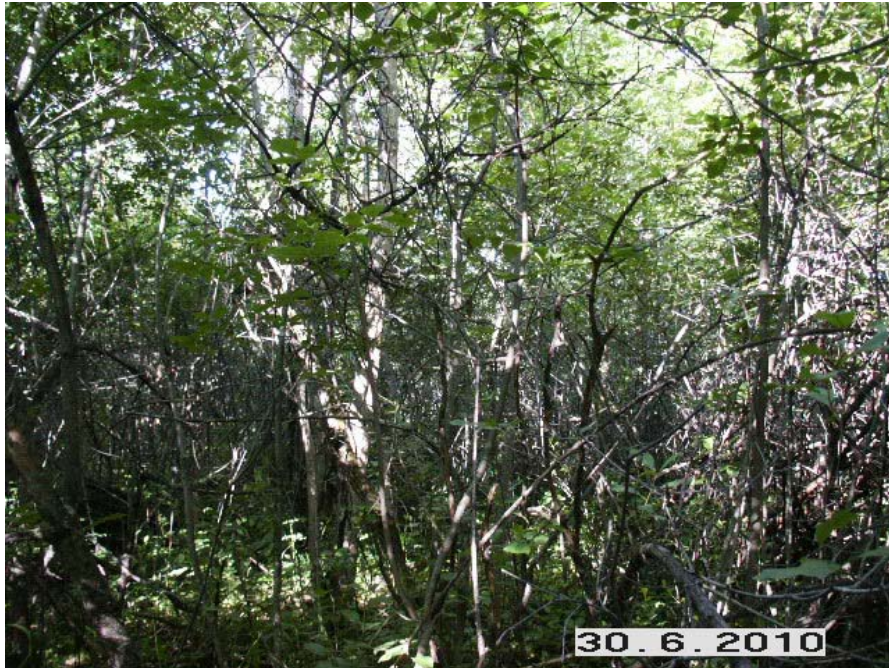
Photo 5 – Young poplar deciduous forest with thick buckthorn in understory

This community, in the central-west portion of the site, occurs where the poplar coverage is greater than 60 percent adjacent to the cultural thickets dominated by buckthorn to the east and north and willow thickets to the south (Photo 5, vegetation community 5 on Map 1). Glossy buckthorn continues to be dominant in the understorey, with regenerating red ash stems in many areas. Balsam poplar, trembling aspen and white birch are the common tree species, with pockets of dense white cedar up to 22cm dbh. Most deciduous trees are less than 20cm dbh, with a few poplars up to 32cm dbh. Many of the young tree trunks and limbs are broken in this scrub-like vegetation unit, with wind throw and ice storm damage appearing extensive. Wild

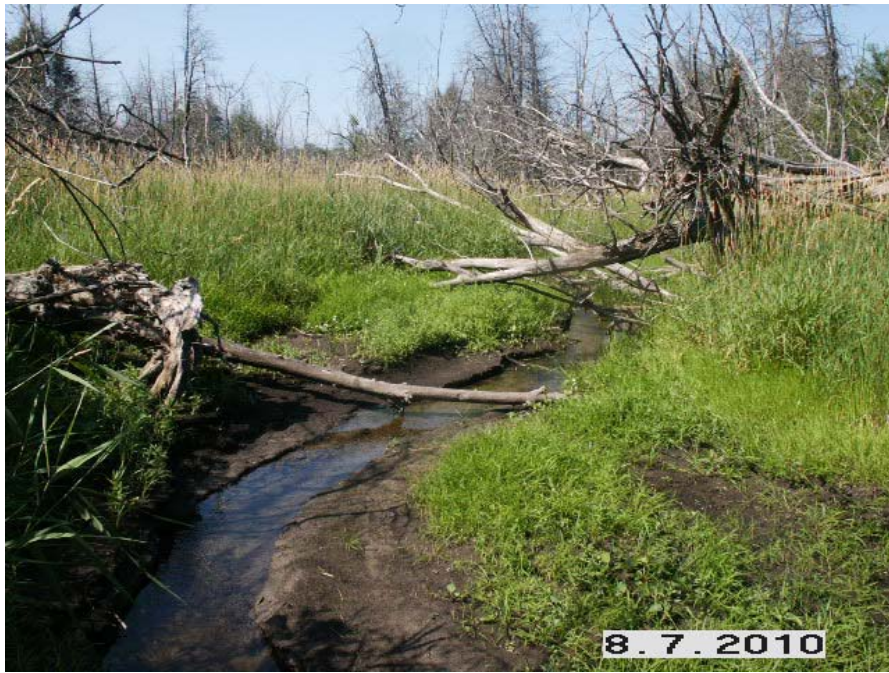
*Photo 6 – Feedmill Creek through the meadow marsh in the southwest portion of the site.
View looking west*

Reed canary grass is dominant in the marsh habitat along the north side of Feedmill Creek in the southwest portion of the site (Photos 6 and 7). Canada bluejoint, purple loosestrife, soft-stem bulrush, boneset, blue vervain, joe-pye-weed and spotted jewelweed are also present.

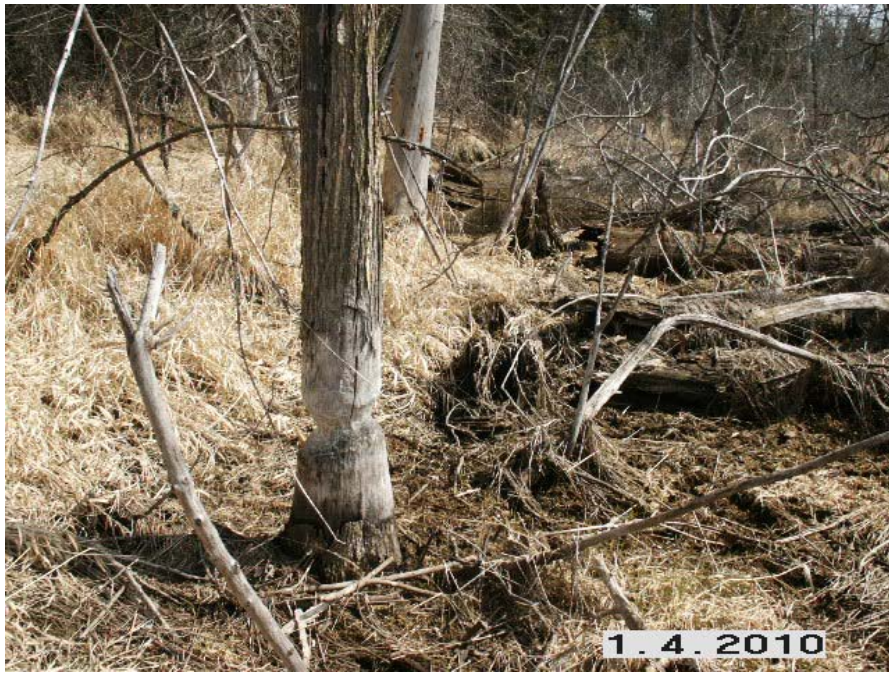
Photo 7 – Former beaver activity in meadow marsh at Feedmill Creek in the west part of the site.

The owner reports removal of beavers in the area of the meadow marsh and a breeched beaver dam through Feedmill Creek itself is present in the southeast corner of the meadow marsh. Dead white cedar stems up to 30cm dbh are scattered in the marsh habitat, which has a maximum width of about 50 metres in the vicinity of the former dam. It is likely that the expanse of the meadow marsh has been strongly influenced by the beaver dam and associated holding back of water. It is anticipated that the extent of meadow marsh would be reduced if the beaver dam was not re-established.

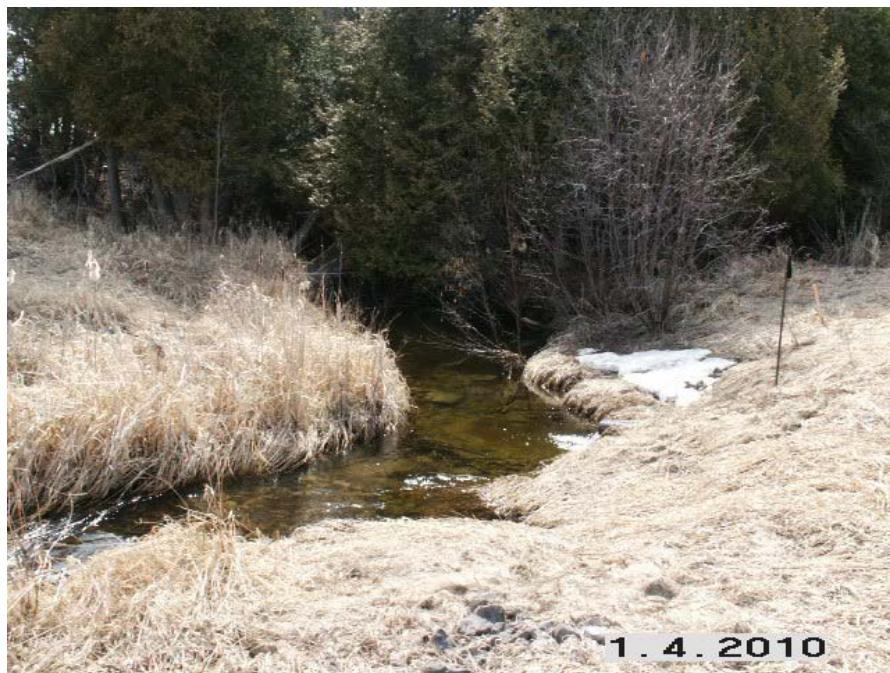
Photo 8 – Feedmill Creek emerging from the mixed forest just west of Palladium Drive. View looking southwest

In the southwest portion of the site Feedmill Creek meanders along the periphery of and through a mixed forest (Photo 8). A breeched beaver dam was through the creek in the south-central portion of the west part of the site. This likely accounted for standing water observed to the north of Feedmill Creek in this area on 2005 and 2008 aerial photography. The lack of a dam should assist in maintaining a cool water thermal regime for Feedmill Creek. In addition to stream shading, the good canopy cover in most this reach will provide a source of woody debris, bank erosion protection, surface water filtering and a cool microclimate (Robinson, 2004).

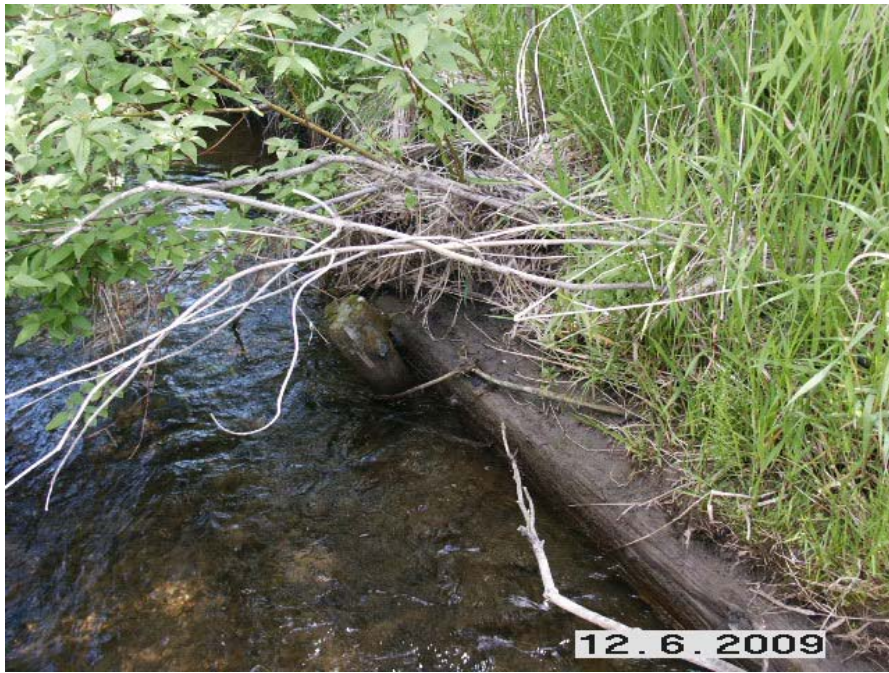
Photo 9 – Deflectors installed and shrub plantings along Feedmill Creek in east portion of site as part of 1990s compensation work. Note coarse exposed substrate

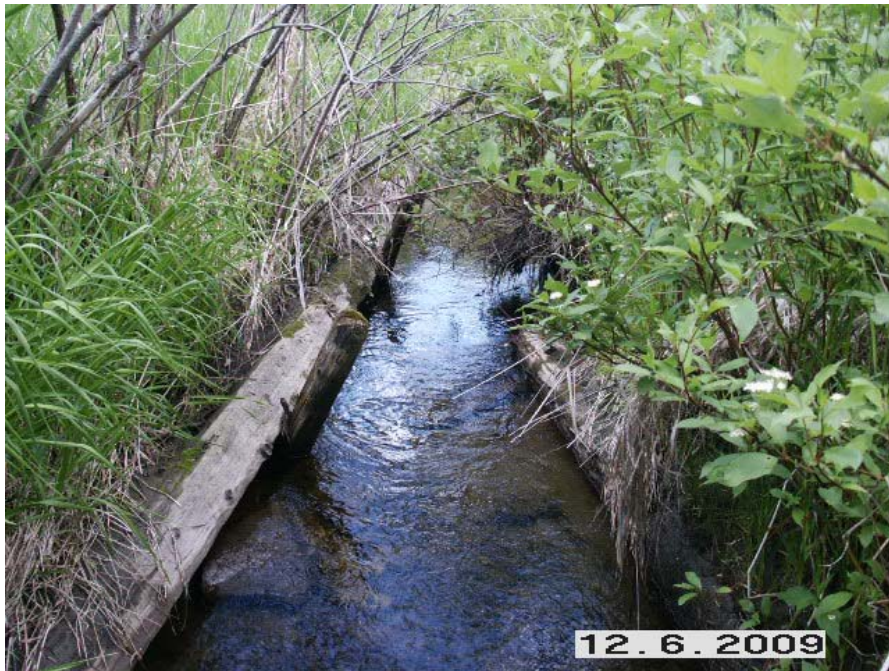
Photo 10 – Deflectors installed and shrub plantings along Feedmill Creek in east portion of site as part of 1990s compensation work. Note boulders, coarse substrate and good shrub growth

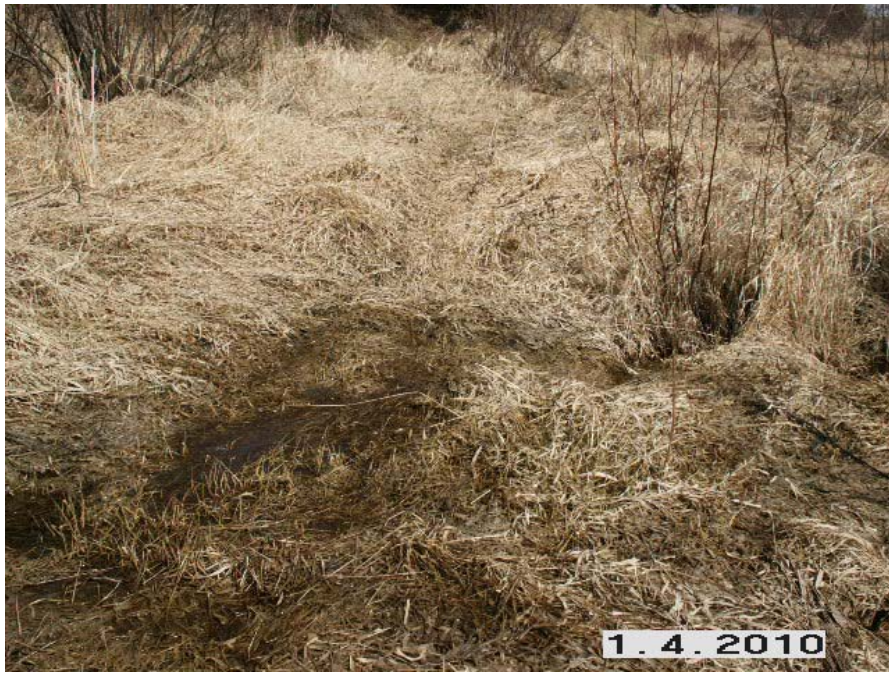
Photo 11 – No definition of tributary to Feedmill Creek in east portion of the site, east of westbound off-ramp from Highway 417. View looking east

A swale entering Feedmill Creek east of the westbound off-ramp from Highway 417 was examined on April 1st, 2010. No defined channel was observed more than two metres northeast, upstream, of the creek channel and the slope further upstream would prohibit any fish utilization, even during elevated flows (Photos 11 and 12).

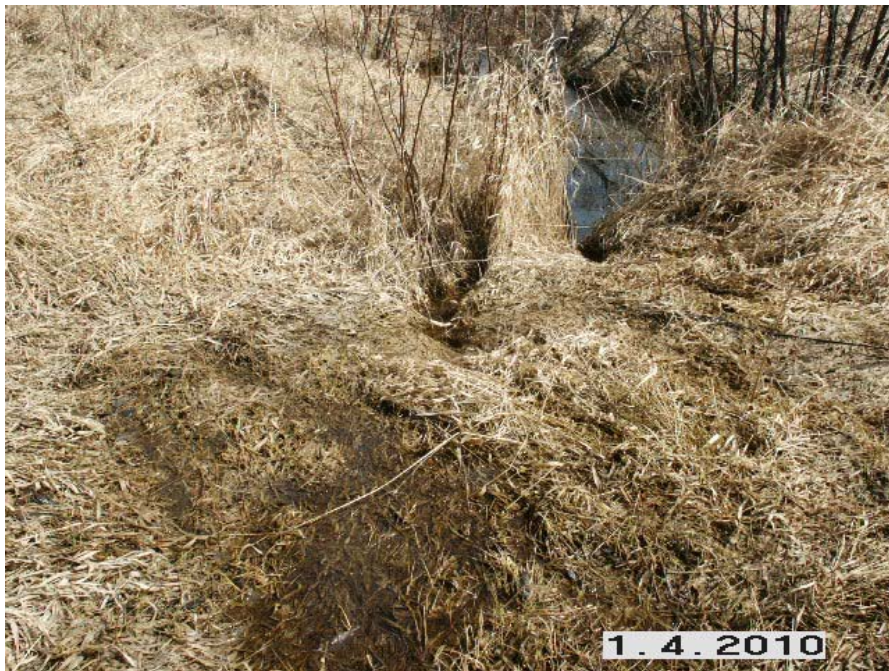
Photo 12 – Tributary to Feedmill Creek in east portion of the site, east of westbound off-ramp from Highway 417, with Feedmill Creek in the background. View looking southeast

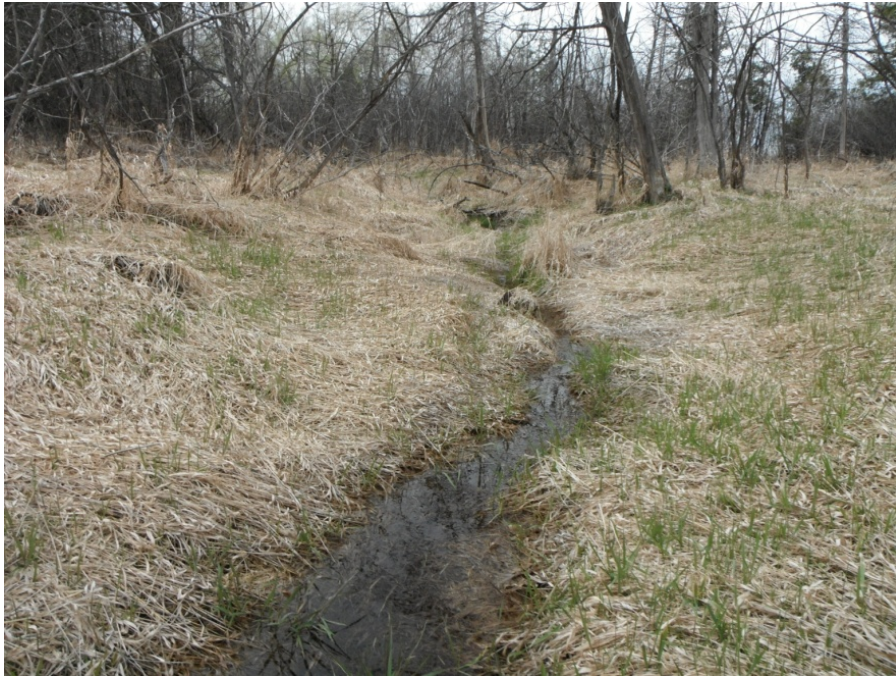
Photo 13 - Station E3 and D1 looking upstream from downstream (April 30th, 2012)

Three stations were sampled along the tributary with an electrofisher and dip nets. Electroshocking was completed for a station length of 35 metres at 50-100 volts, and 1.5-1.7 amps. The water temperature was 11.8° C, with an air temperature of 16.0° C at 14:30. The conductivity was 875 μ s, with a pH of 7.47 and total dissolved solids of 450 ppm. The downstream sampling station included a pool. The average wetted widths and depths were 1.8 metres and 13 cm, respectively (Photos 13 and 14). The area fished was 37 m² and the shock time was 27 seconds. No fish were captured or observed using either the electrofisher or a total of ninety- three dips at the three sampling stations.

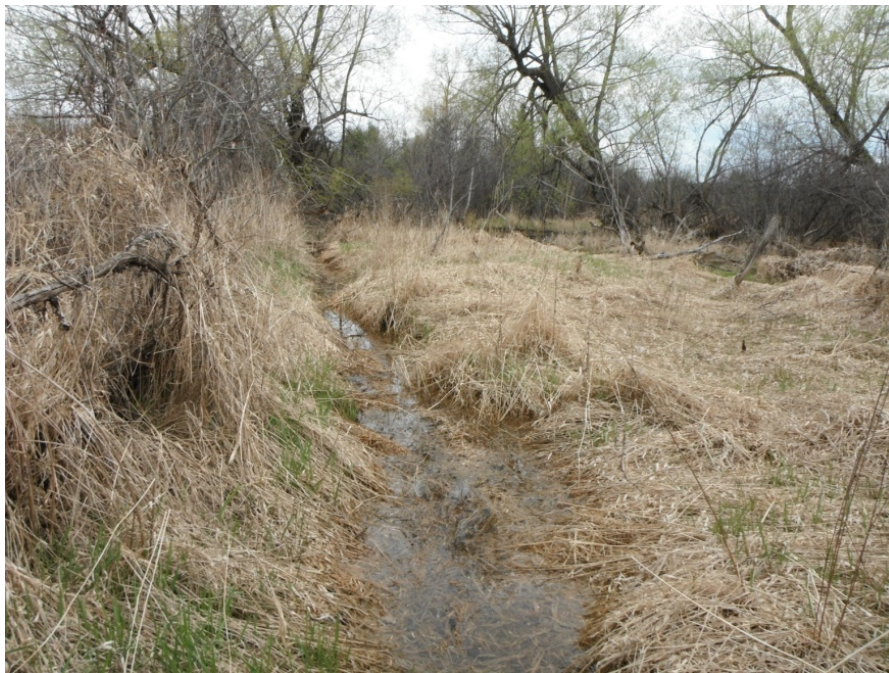
Photo 14 - Station D3 (April 30th, 2012)

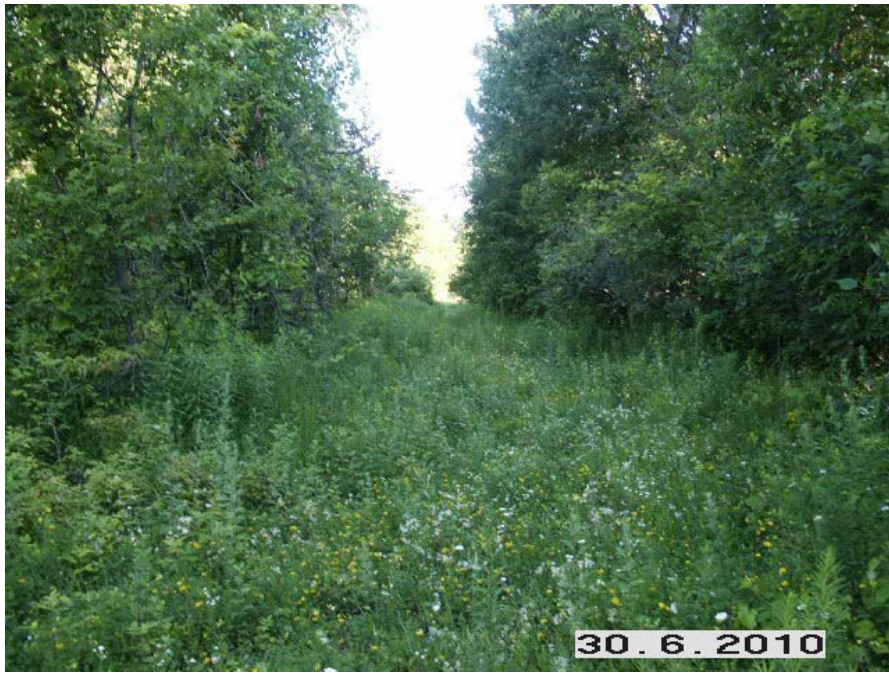
*Photo 15 – Old access lane along central and north portion of west edge of site.
View looking north, with west edge of site on right*

The oldest of the on-site trees would be in the range of 60 – 70 years old, although the vast majority are much younger. Although the site is in the urban area, the adjacent lands to the west are in the rural area. Of the three criteria that must be met for identifying significant woodlands in the rural portion of the City of Ottawa, the east edge of the adjacent forest does not contain forest interior habitat or mature stands of trees 80 years of age or older. Lands further to the west that could not be observed from the west edge of the site were not surveyed due to access concerns and may meet the rural criteria for significant woodlands. However, as described below the adjacent woodlands will be protected and no impacts are anticipated on any significant woodlands that may be present off-site in the woodlands. An access trail is along the west edge of the site, providing a break in the young forest cover (Photo 15).

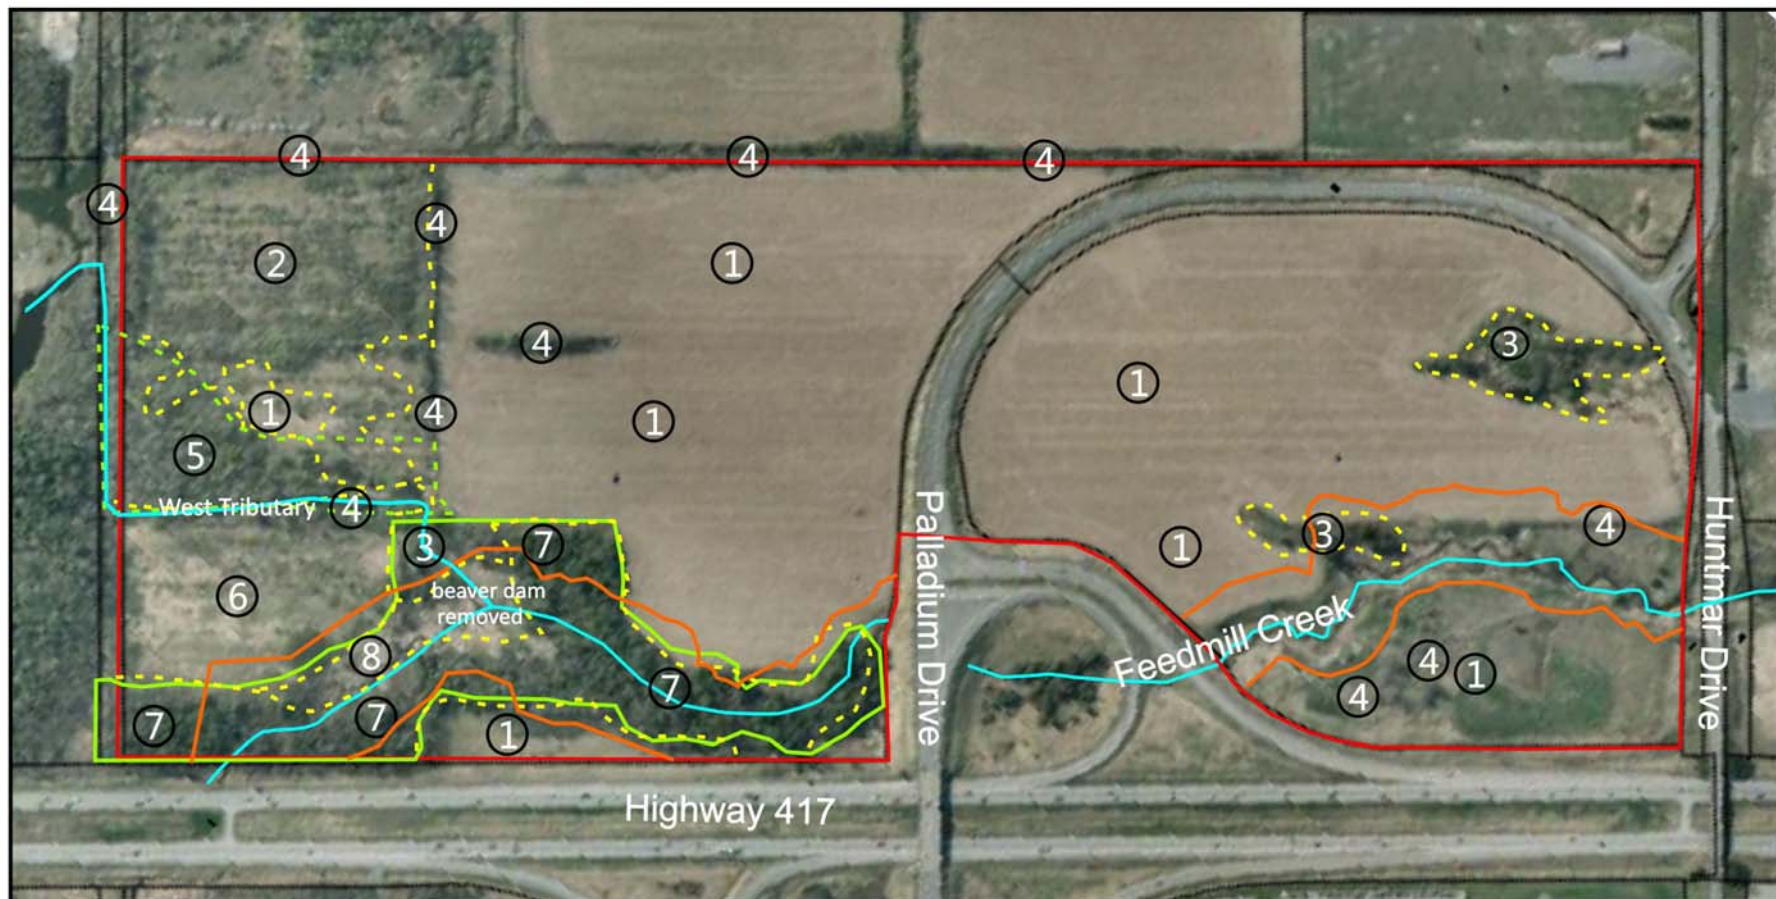
2011 airphoto base from City website

Map 1 identifies the recommended Urban Natural Area boundary. The original site Urban Natural Area boundary included more land to the northwest of the Feedmill Creek corridor (shown as a green-dashed line on Map 1). This original boundary was determined without the benefit of on-site examinations. The 2009 and 2010 fieldwork have identified in this area highly disturbed thickets dominated by buckthorn, young poplar forests with the understorey and ground flora dominated by disturbed species and deciduous hedgerows dominated by poplar. No significant features and functions were identified for this area that would add to the Urban Natural Area along the Feedmill Creek corridor. The Feedmill Creek corridor is separated by the original UNA lands to the northwest by thicket habitat.

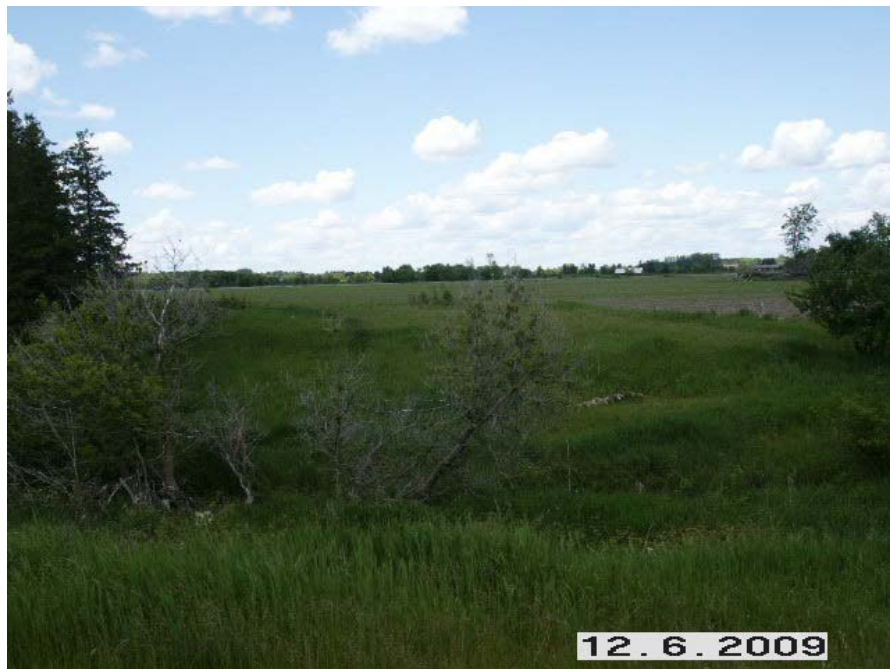
Photo 14 – Approach for proposed road crossing of Feedmill Creek in east portion of site.

*Crossing location selected to avoid trees to west and east.
View looking north from south side of creek*

Approvals will be required from Mississippi Valley Conservation for the road crossing of Feedmill Creek in the southeast portion of the site. Photo 14 below shows a preferred crossing location that would minimize the removal of woody vegetation in the approaches to the crossing. The crossing would also need to avoid, relocate or replace the plantings and other stream enhancement measures completed along this reach of Feedmill Creek. The road and associated culvert should be as narrow as possible to minimize potential impacts on the creek habitats.
