Phase One Environmental Site Assessment

3025 Albion Road North, Ottawa, ON

OTT-00246047-B0

EXP Services Inc.
100-2650 Queensview Drive
Ottawa, ON K2B 8H6
Canada

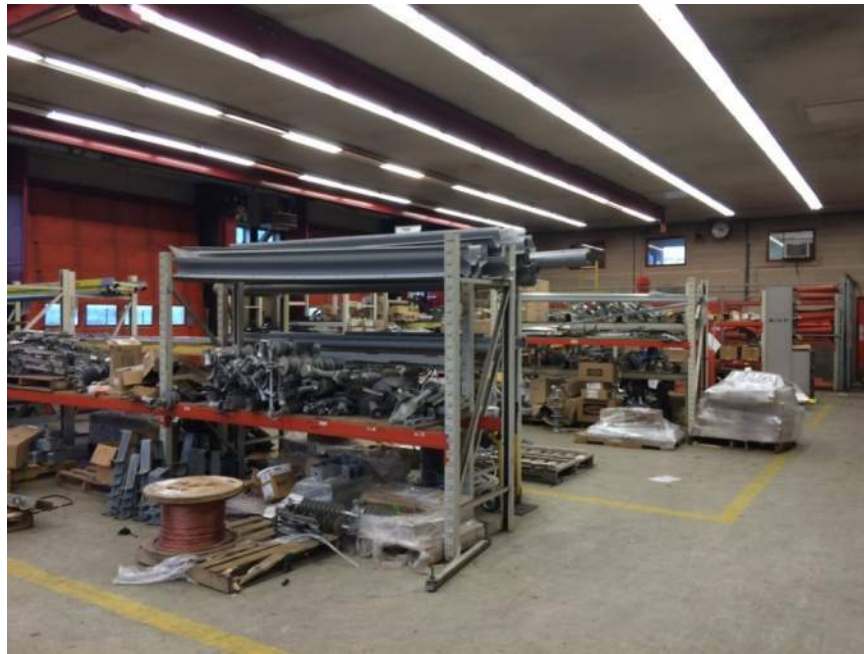
Photograph 1

There were no pits or lagoons observed on the site at the time of the site visit. In 2005, a contractor oversaw the removal of two in-ground hydraulic hoists and their associated piston pits within the old garage bay in the western section of what is now the vehicle storage area. These former pits were reportedly remediated to meet environmental guidelines, though no supporting documentation was made available. Monitoring wells (MW307 and MW308) were installed at these locations in 2015 to assess the soil and groundwater conditions.

The former service garage area (now storage)

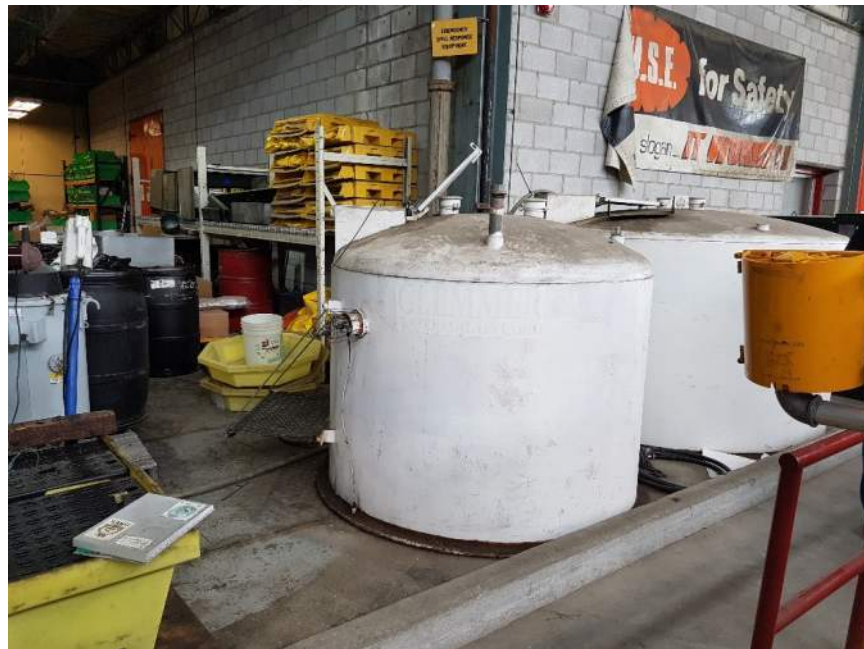
Photograph 2

Two (2) large plastic holding tanks were observed in the transformer workshop area, north of the loading dock. These are within the workshops spill retaining wall and are used for the collection of waste transformer oil. The oil is tested and if it contains PCBs, then it is transferred to the PCB storage area located approximately 20 m east of the Phase One Property. If the oil is not PCB containing, the waste transformer oil is collected by a contractor on a regular basis. This aspect is associated with PCA#28-Gasoline and Associated Products Storage in Fixed Tanks.

Waste oil ASTs in the containment area beside the loading dock

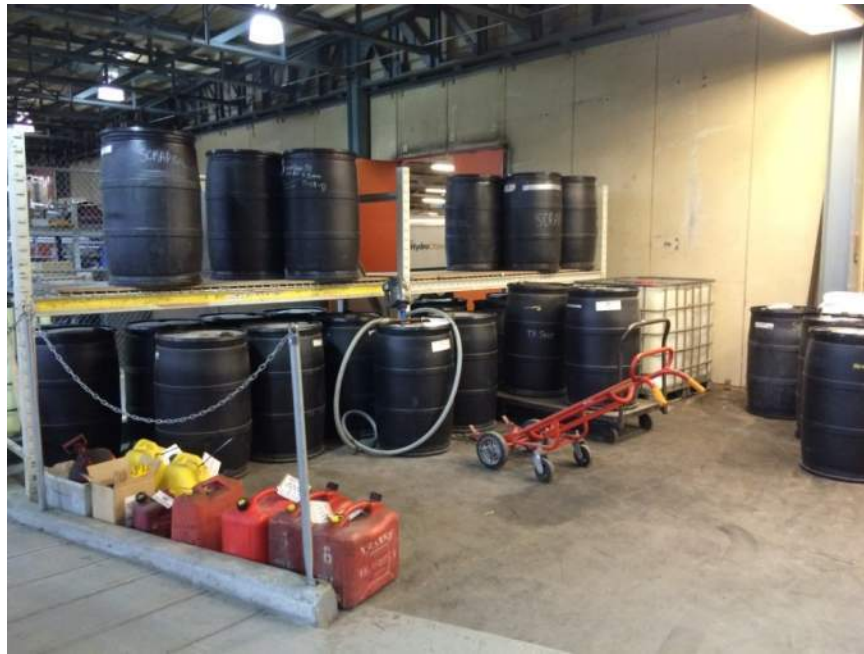
Photograph 3

New oil storage in the containment area near the loading dock

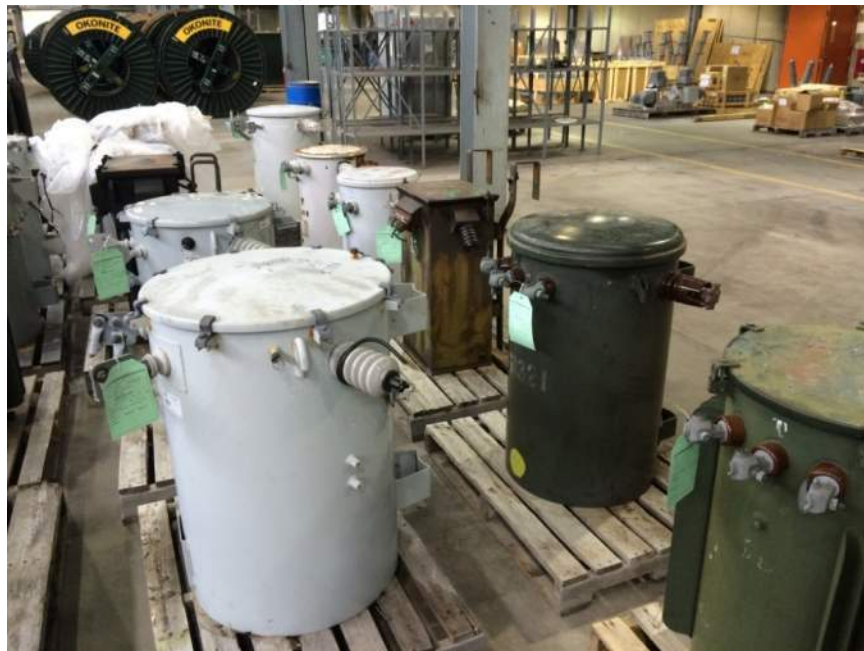
Photograph 4

Transformer storage in the central workshop area

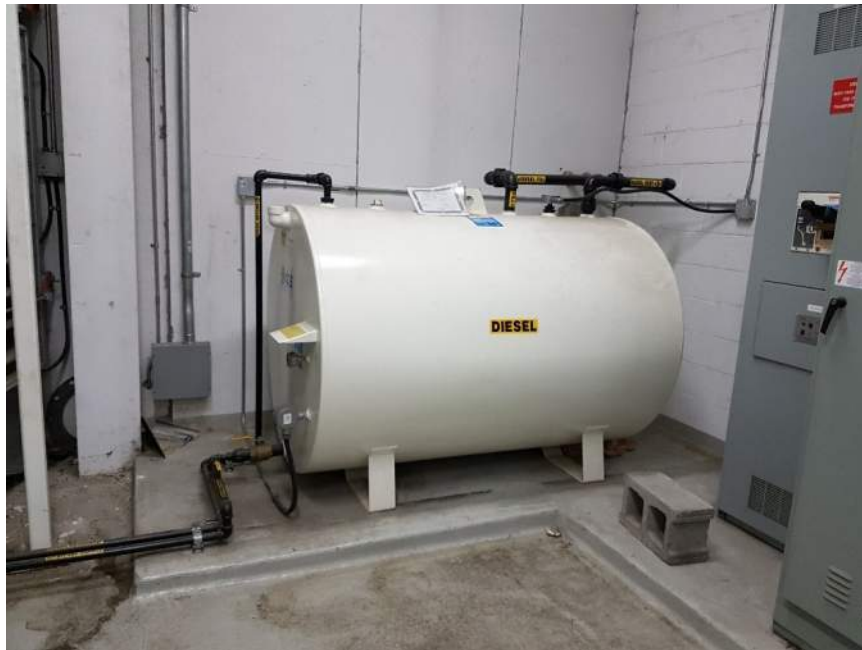
Photograph 5

Within the building, the back-up generator has an associated 2,460 L double-walled diesel AST which was installed in 2010. No staining was observed in its vicinity and it was in good condition. This aspect is associated with PCA#28-Gasoline and Associated Products Storage in Fixed Tanks.

AST associated with the emergency generator

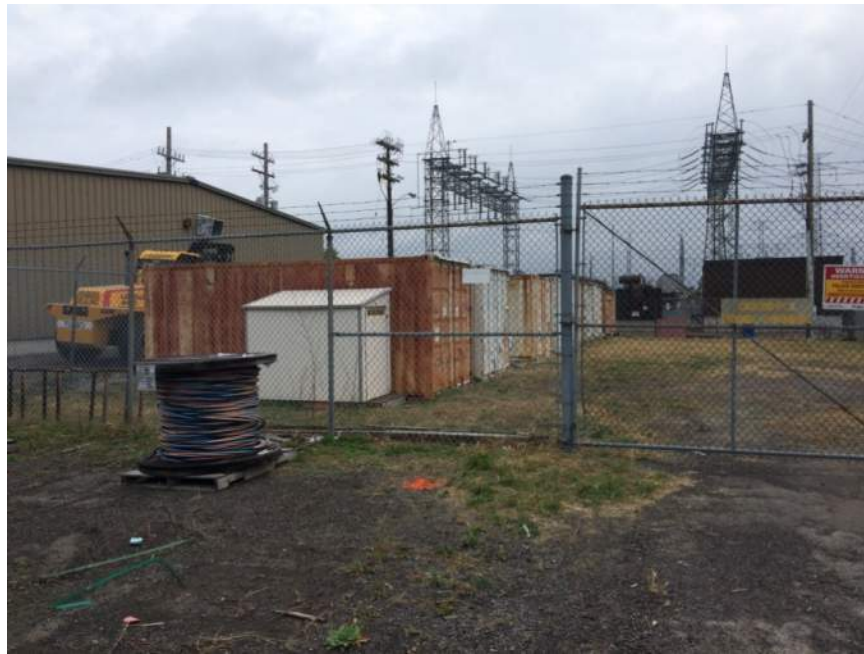
Photograph 7

Current PCB storage sheds, east of the Site

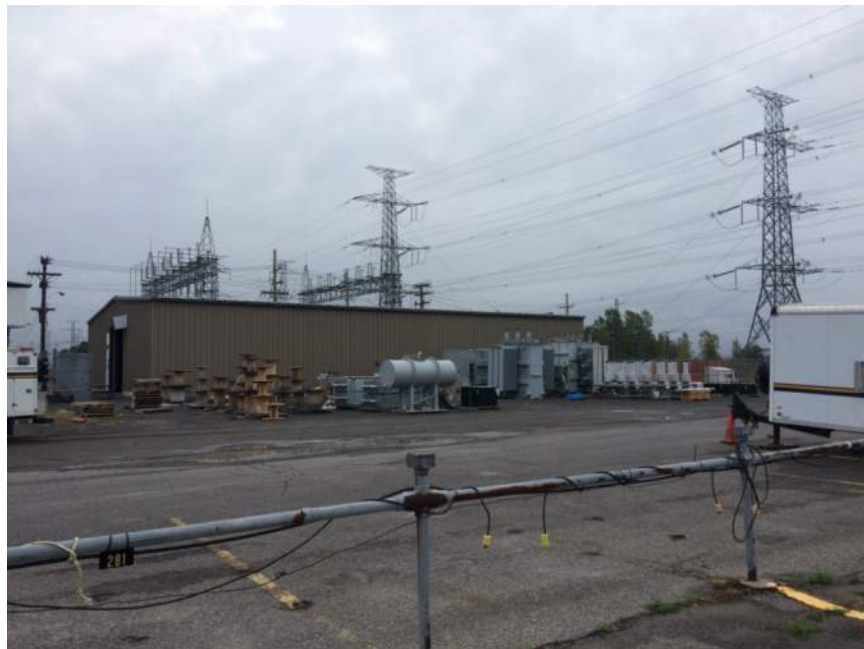
Photograph 8

Former PCB storage in the brown building, east of Site

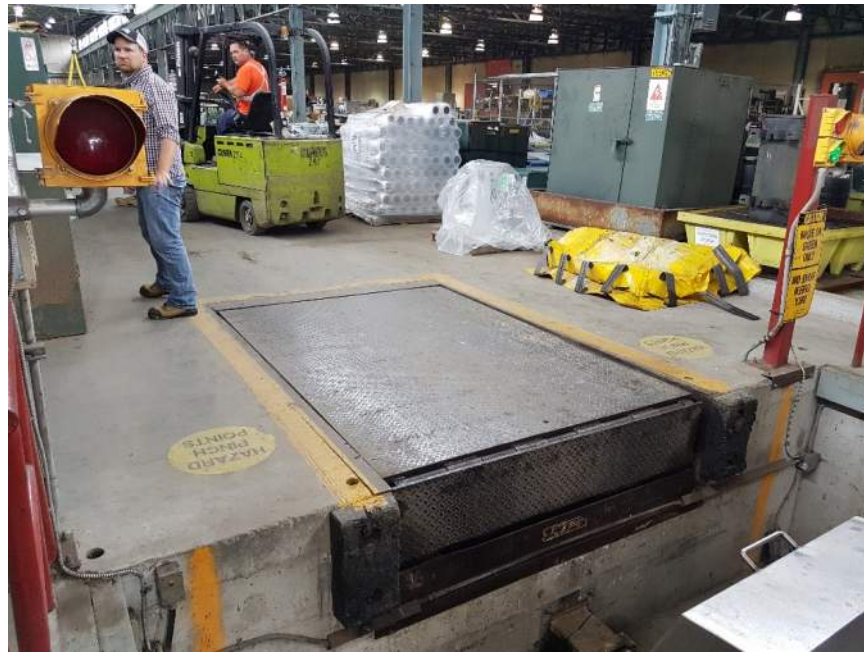
Photograph 9

A hydraulic lift was observed in the loading dock in the south part of the building. It was in good condition with no evidence of leakage.

Hydraulic lift in loading dock

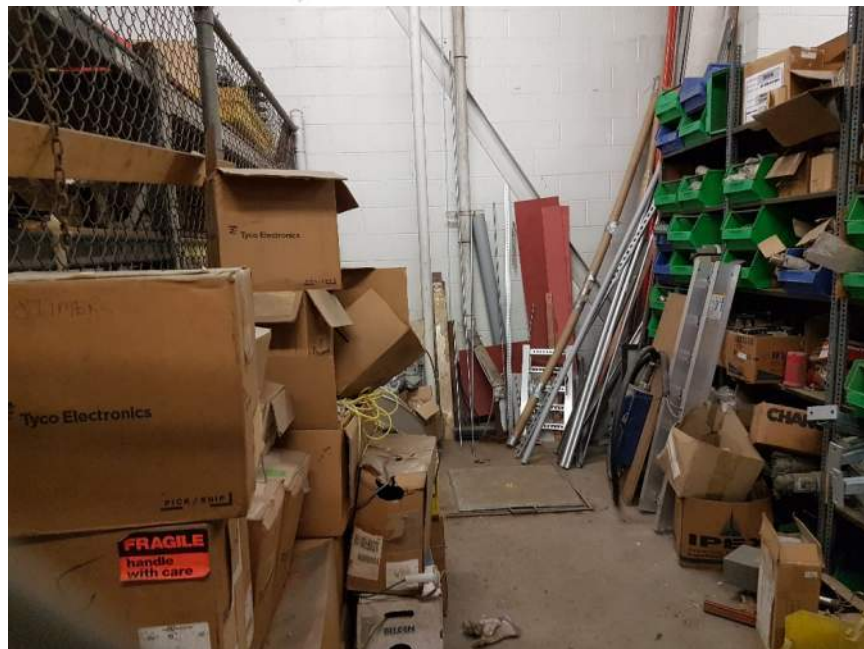
Photograph 10

Grit sump in southeast part of building

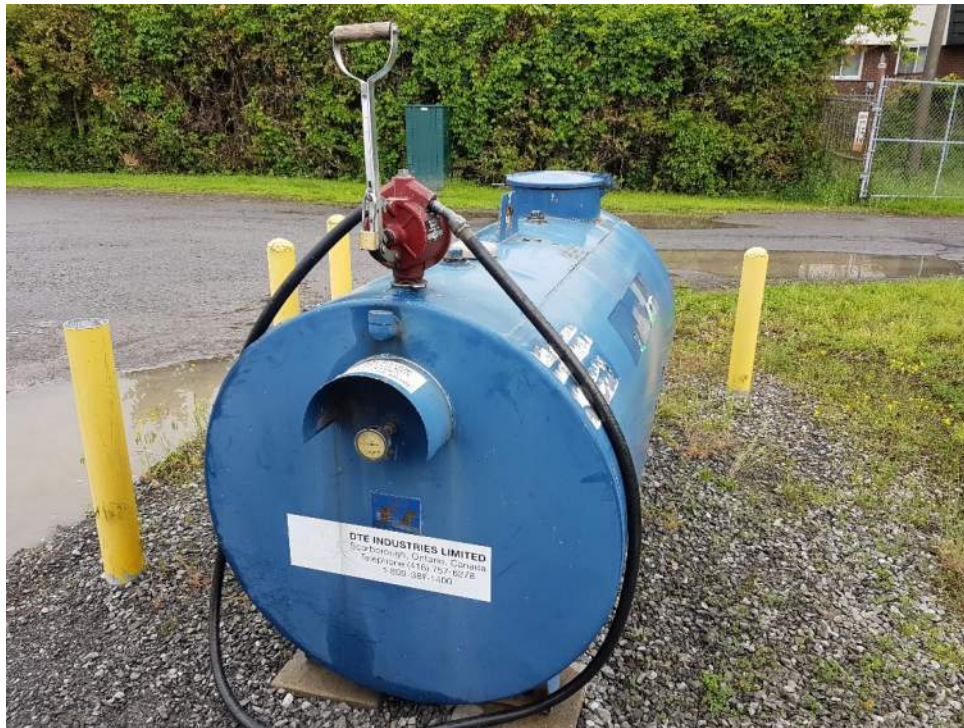
Photograph 11

A double-walled diesel aboveground storage tank was observed at the neighbouring site to the east, approximately 60 m east of the property line. This is a leased 1,345 L tank equipped with a hand pump which contains coloured diesel used for refueling equipment. This aspect is associated with PCA#28-Gasoline and Associated Products Storage in Fixed Tanks.

Diesel AST located 50 m east of Site

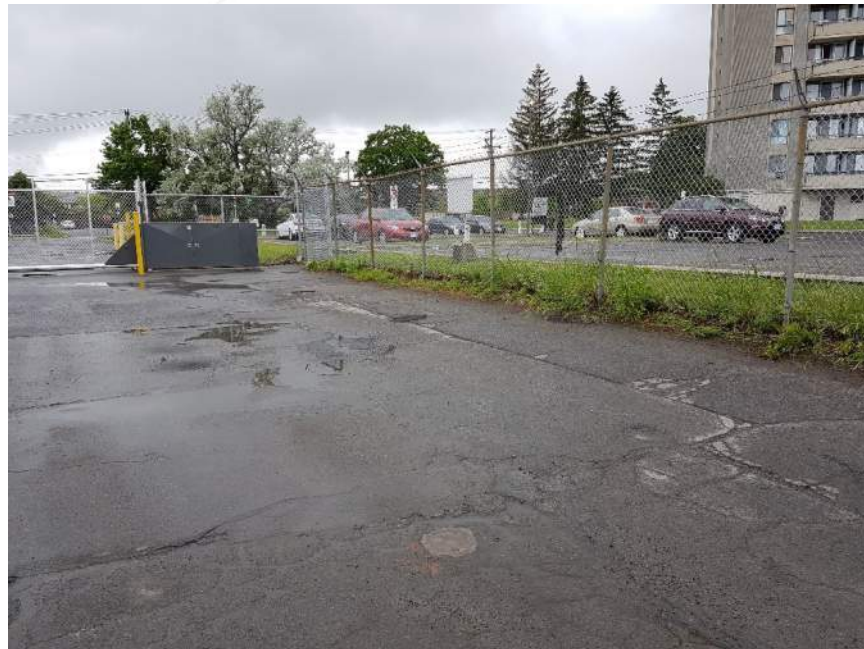
Photograph 12

Area of former gasoline AST in northwest part of Site
