Phase Two Environmental Site Assessment

3025 Albion Road North, Ottawa, ON

OTT-00246047-B0

December 21, 2018

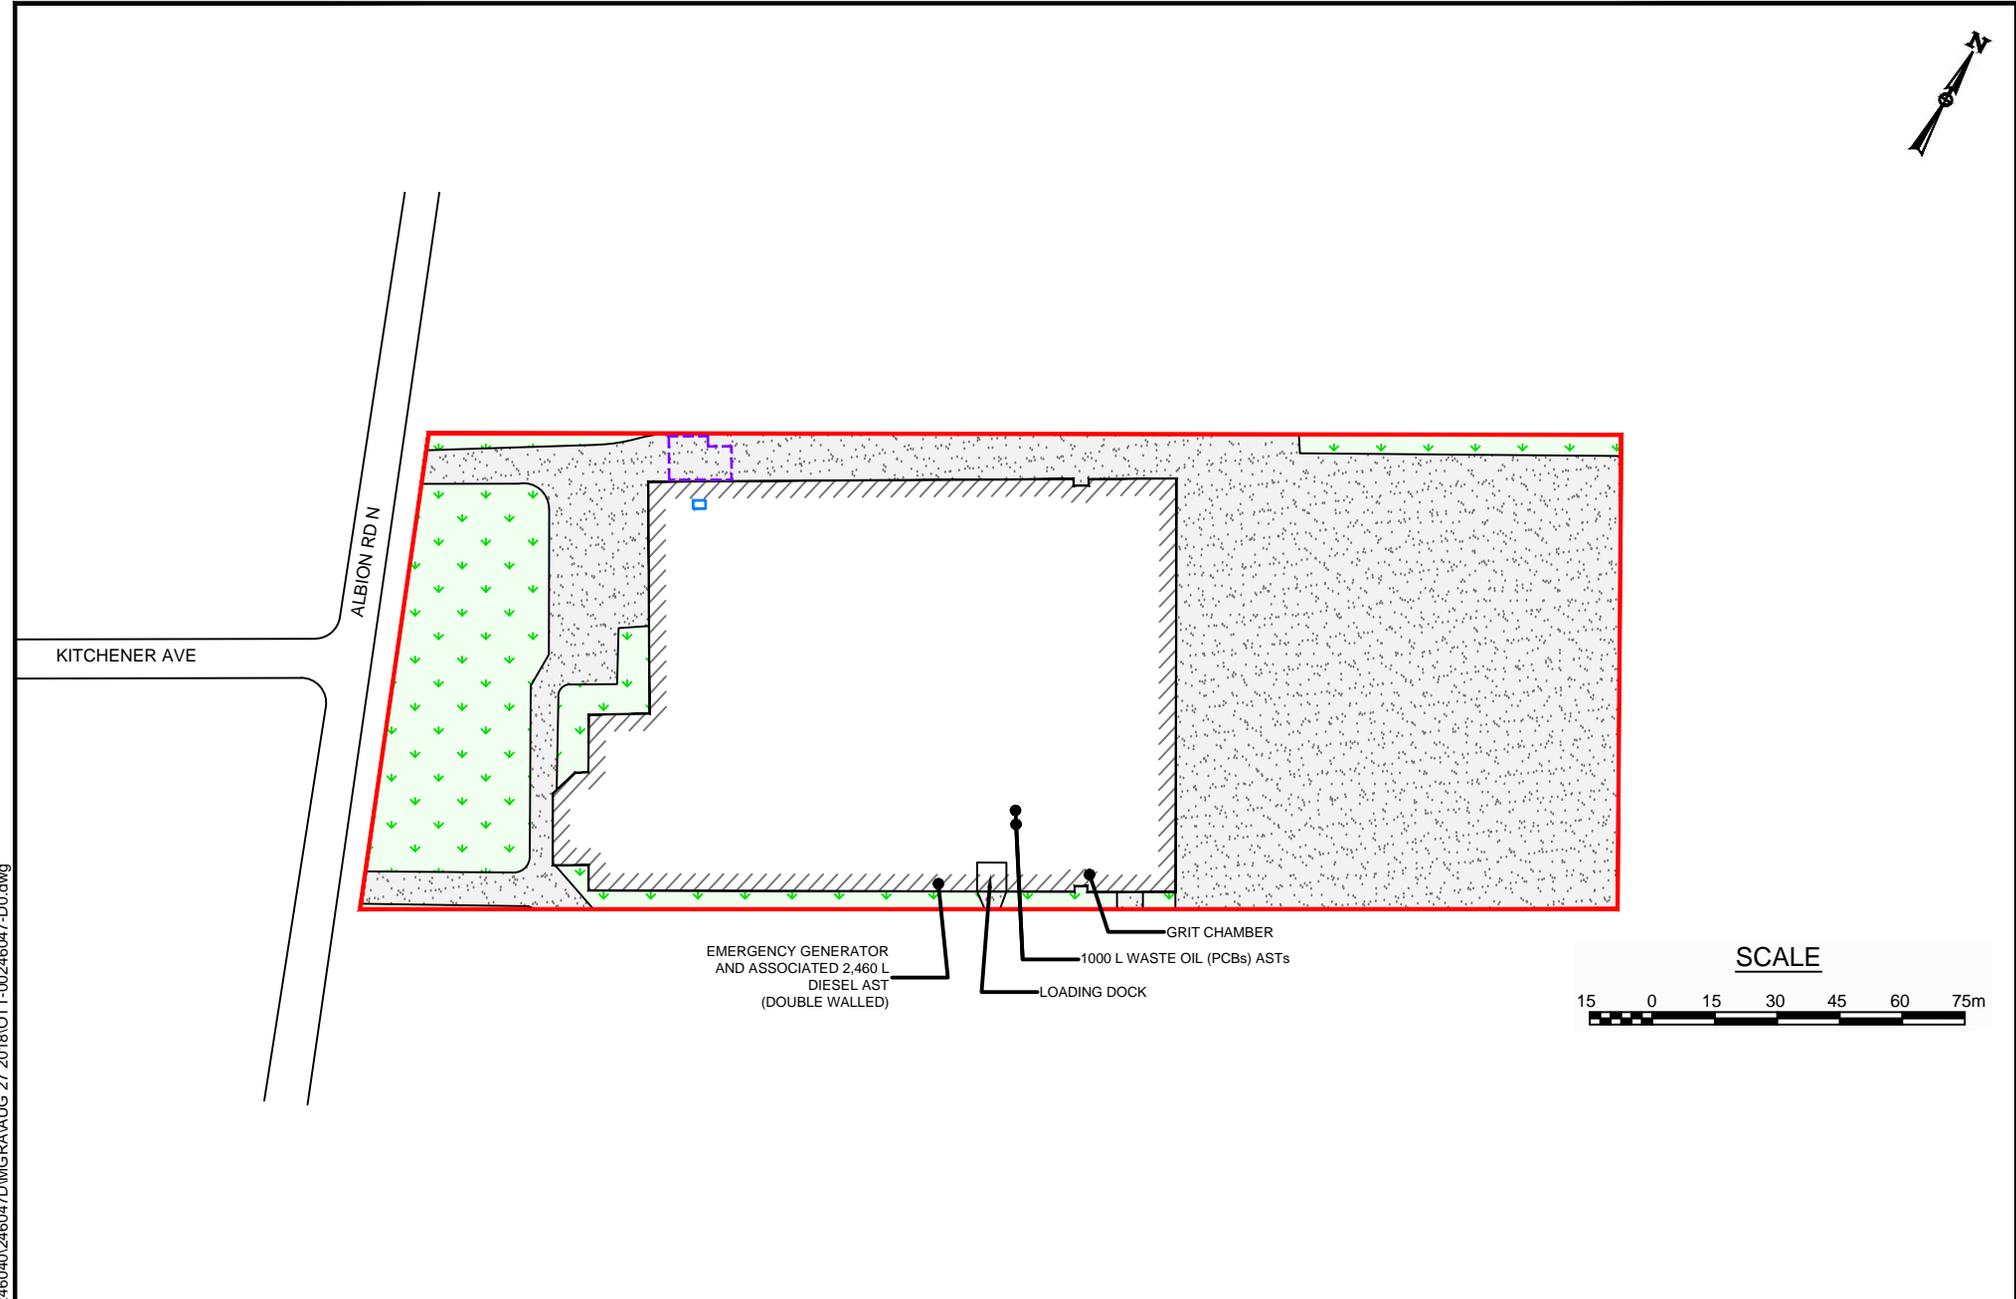
PROJECT NO.:	OTT-00246047-D0	DWN.:	DP
SCALE:	AS NOTED	CK:	PV
DATE:	DECEMBER 2018	FIG. NO.:	3

EMERGENCY GENERATOR AND ASSOCIATED 2,460 L DIESEL AST (DOUBLE WALLED)

LOADING DOCK

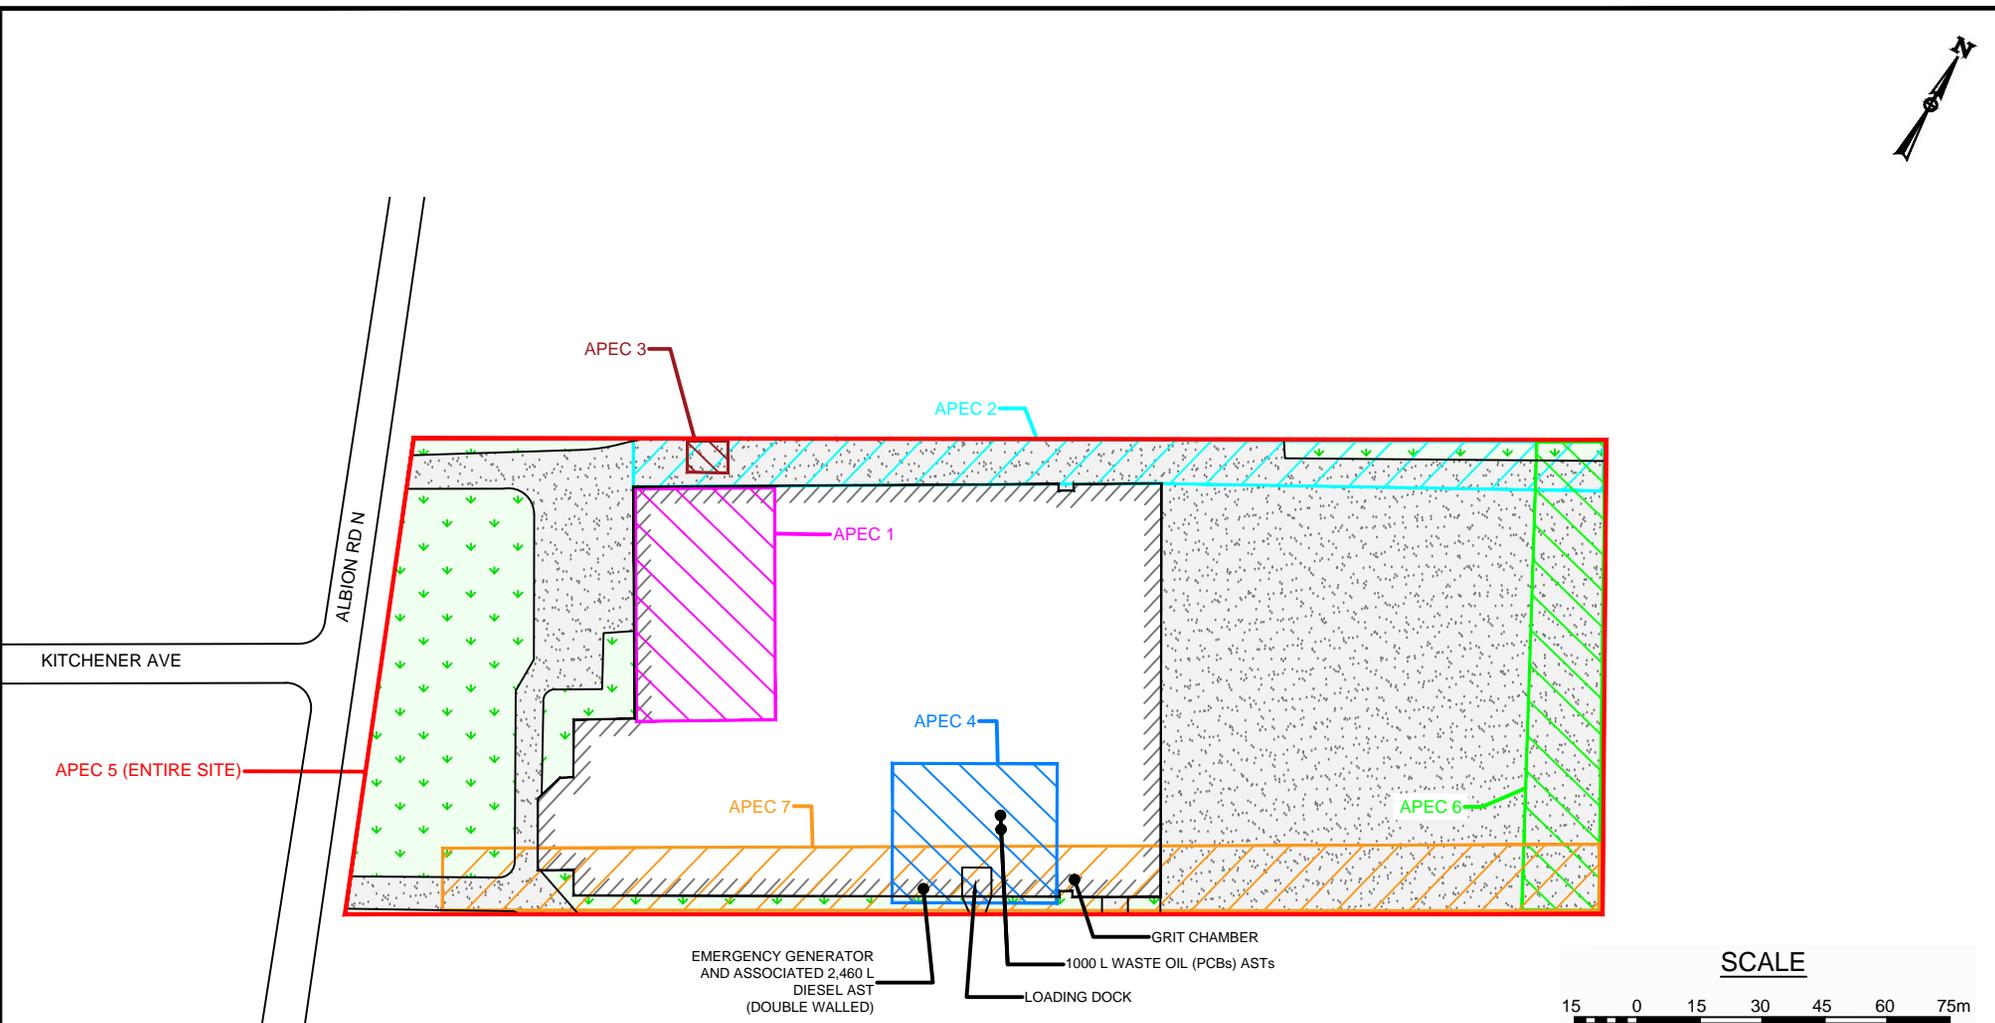
Areas of Potential Environmental Concern (APECs)

Based on the findings and conclusions of the Phase One ESA, a Phase Two ESA was recommended to investigate the above PCAs within the APECs. The APECs are shown on Figure 4.

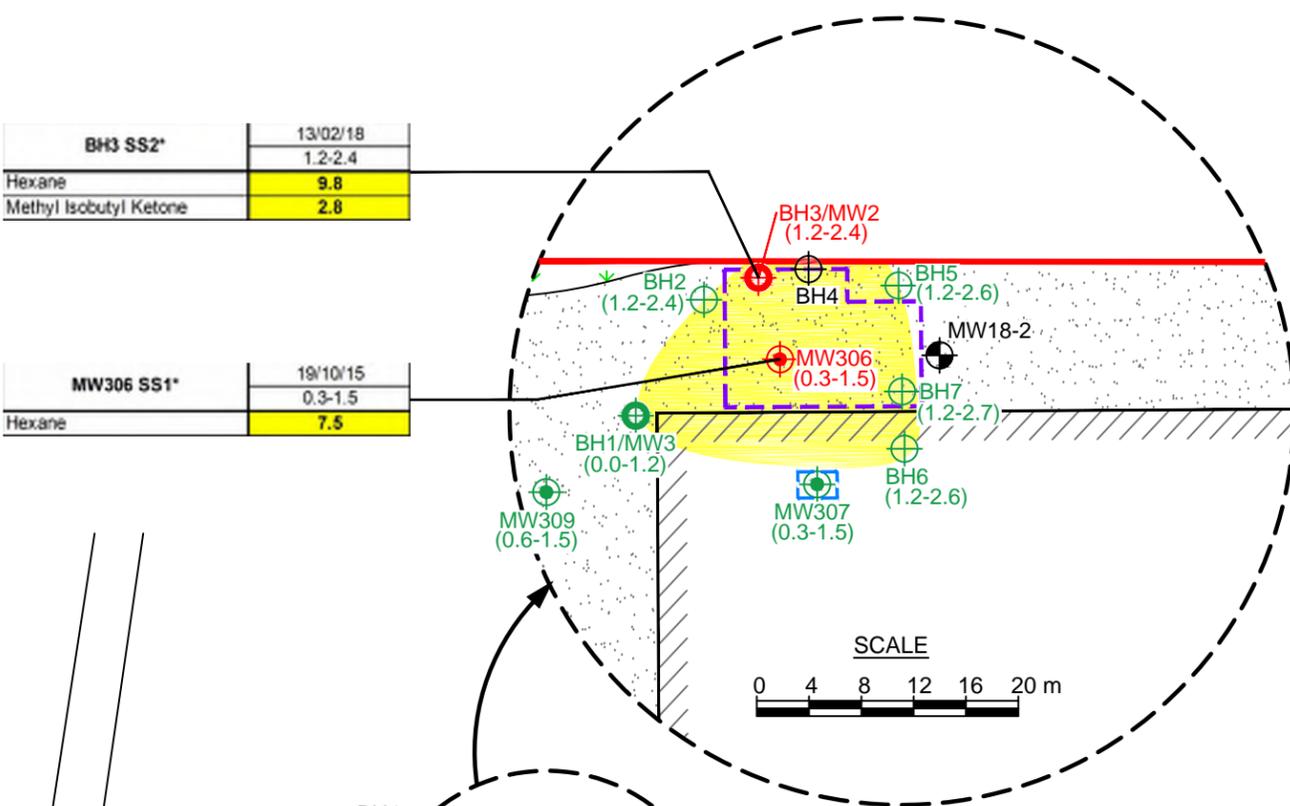
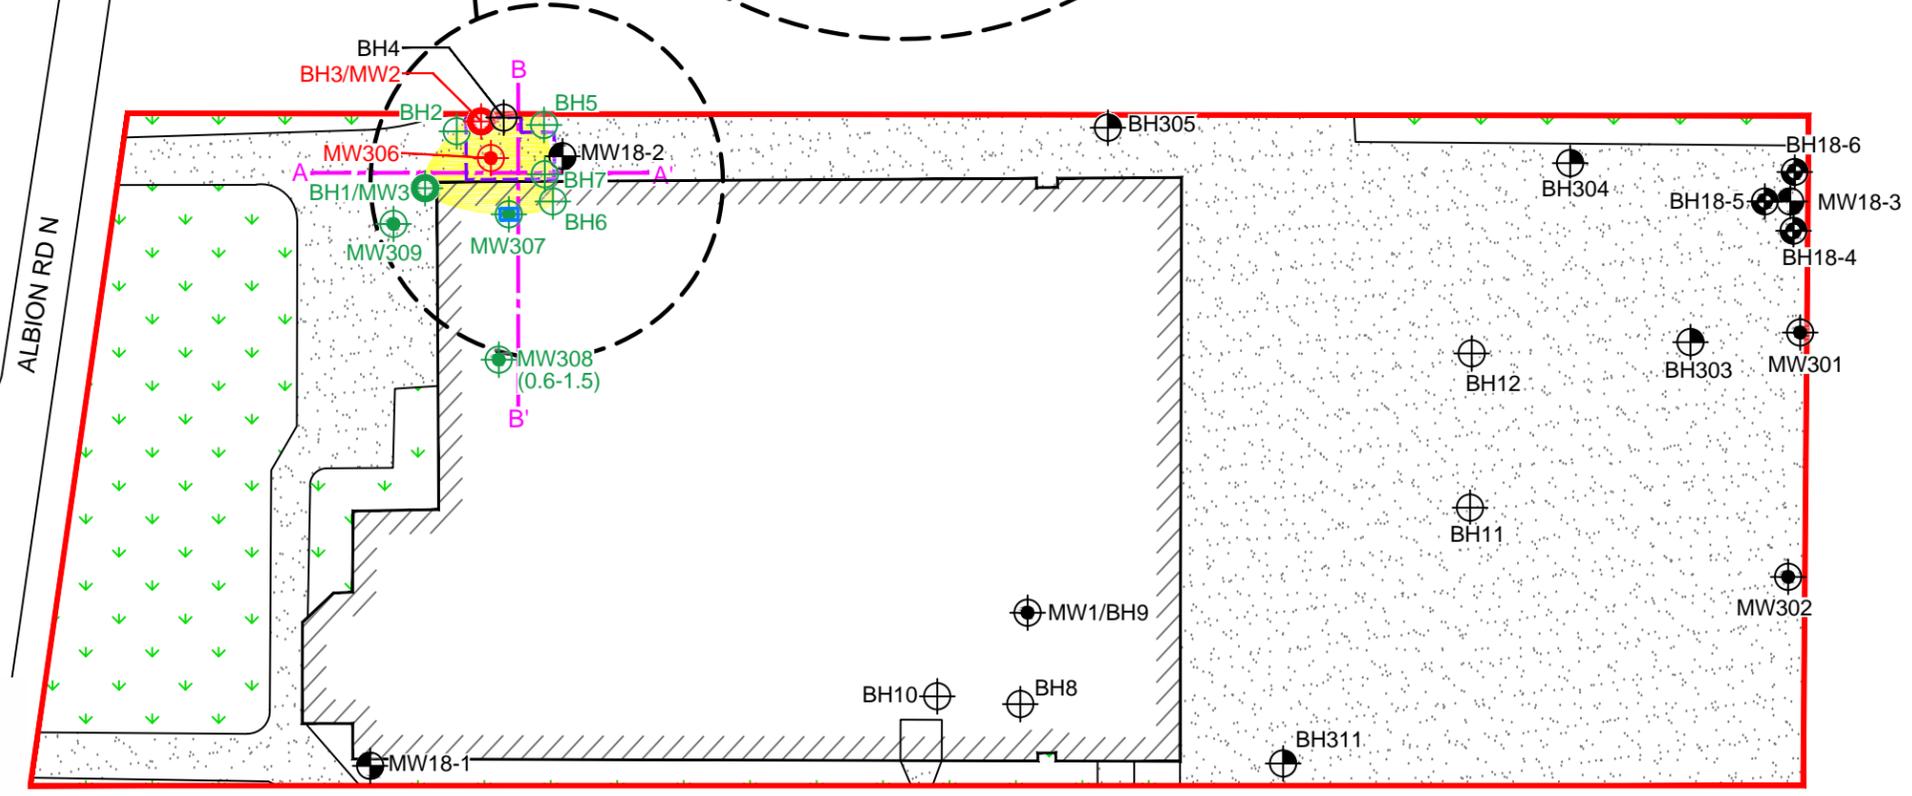
JOB NO.:	OTT-00246047-D0	DRAWN BY:	DP
SCALE:	AS NOTED	CHECKED BY:	PV
DATE:	DECEMBER 2018	FIG NO.:	9A

The only location where impacted soil was found was at MW306, which had PHC impacted soil. This borehole is located at the former location of the pump island and gasoline UST at the northwest corner of the building. The gasoline impact to soil was not identified in MW307, located within the building to the south but was undelineated to the east, west, and north. It was recommended that the impacted soil in this area be delineated.

MW306 SS1*	19/10/15
Hexane	7.5

Parameter	MECP Table 3 SCS (µg/g)
Hexane	2.8
Methyl Isobutyl Ketone	1.7

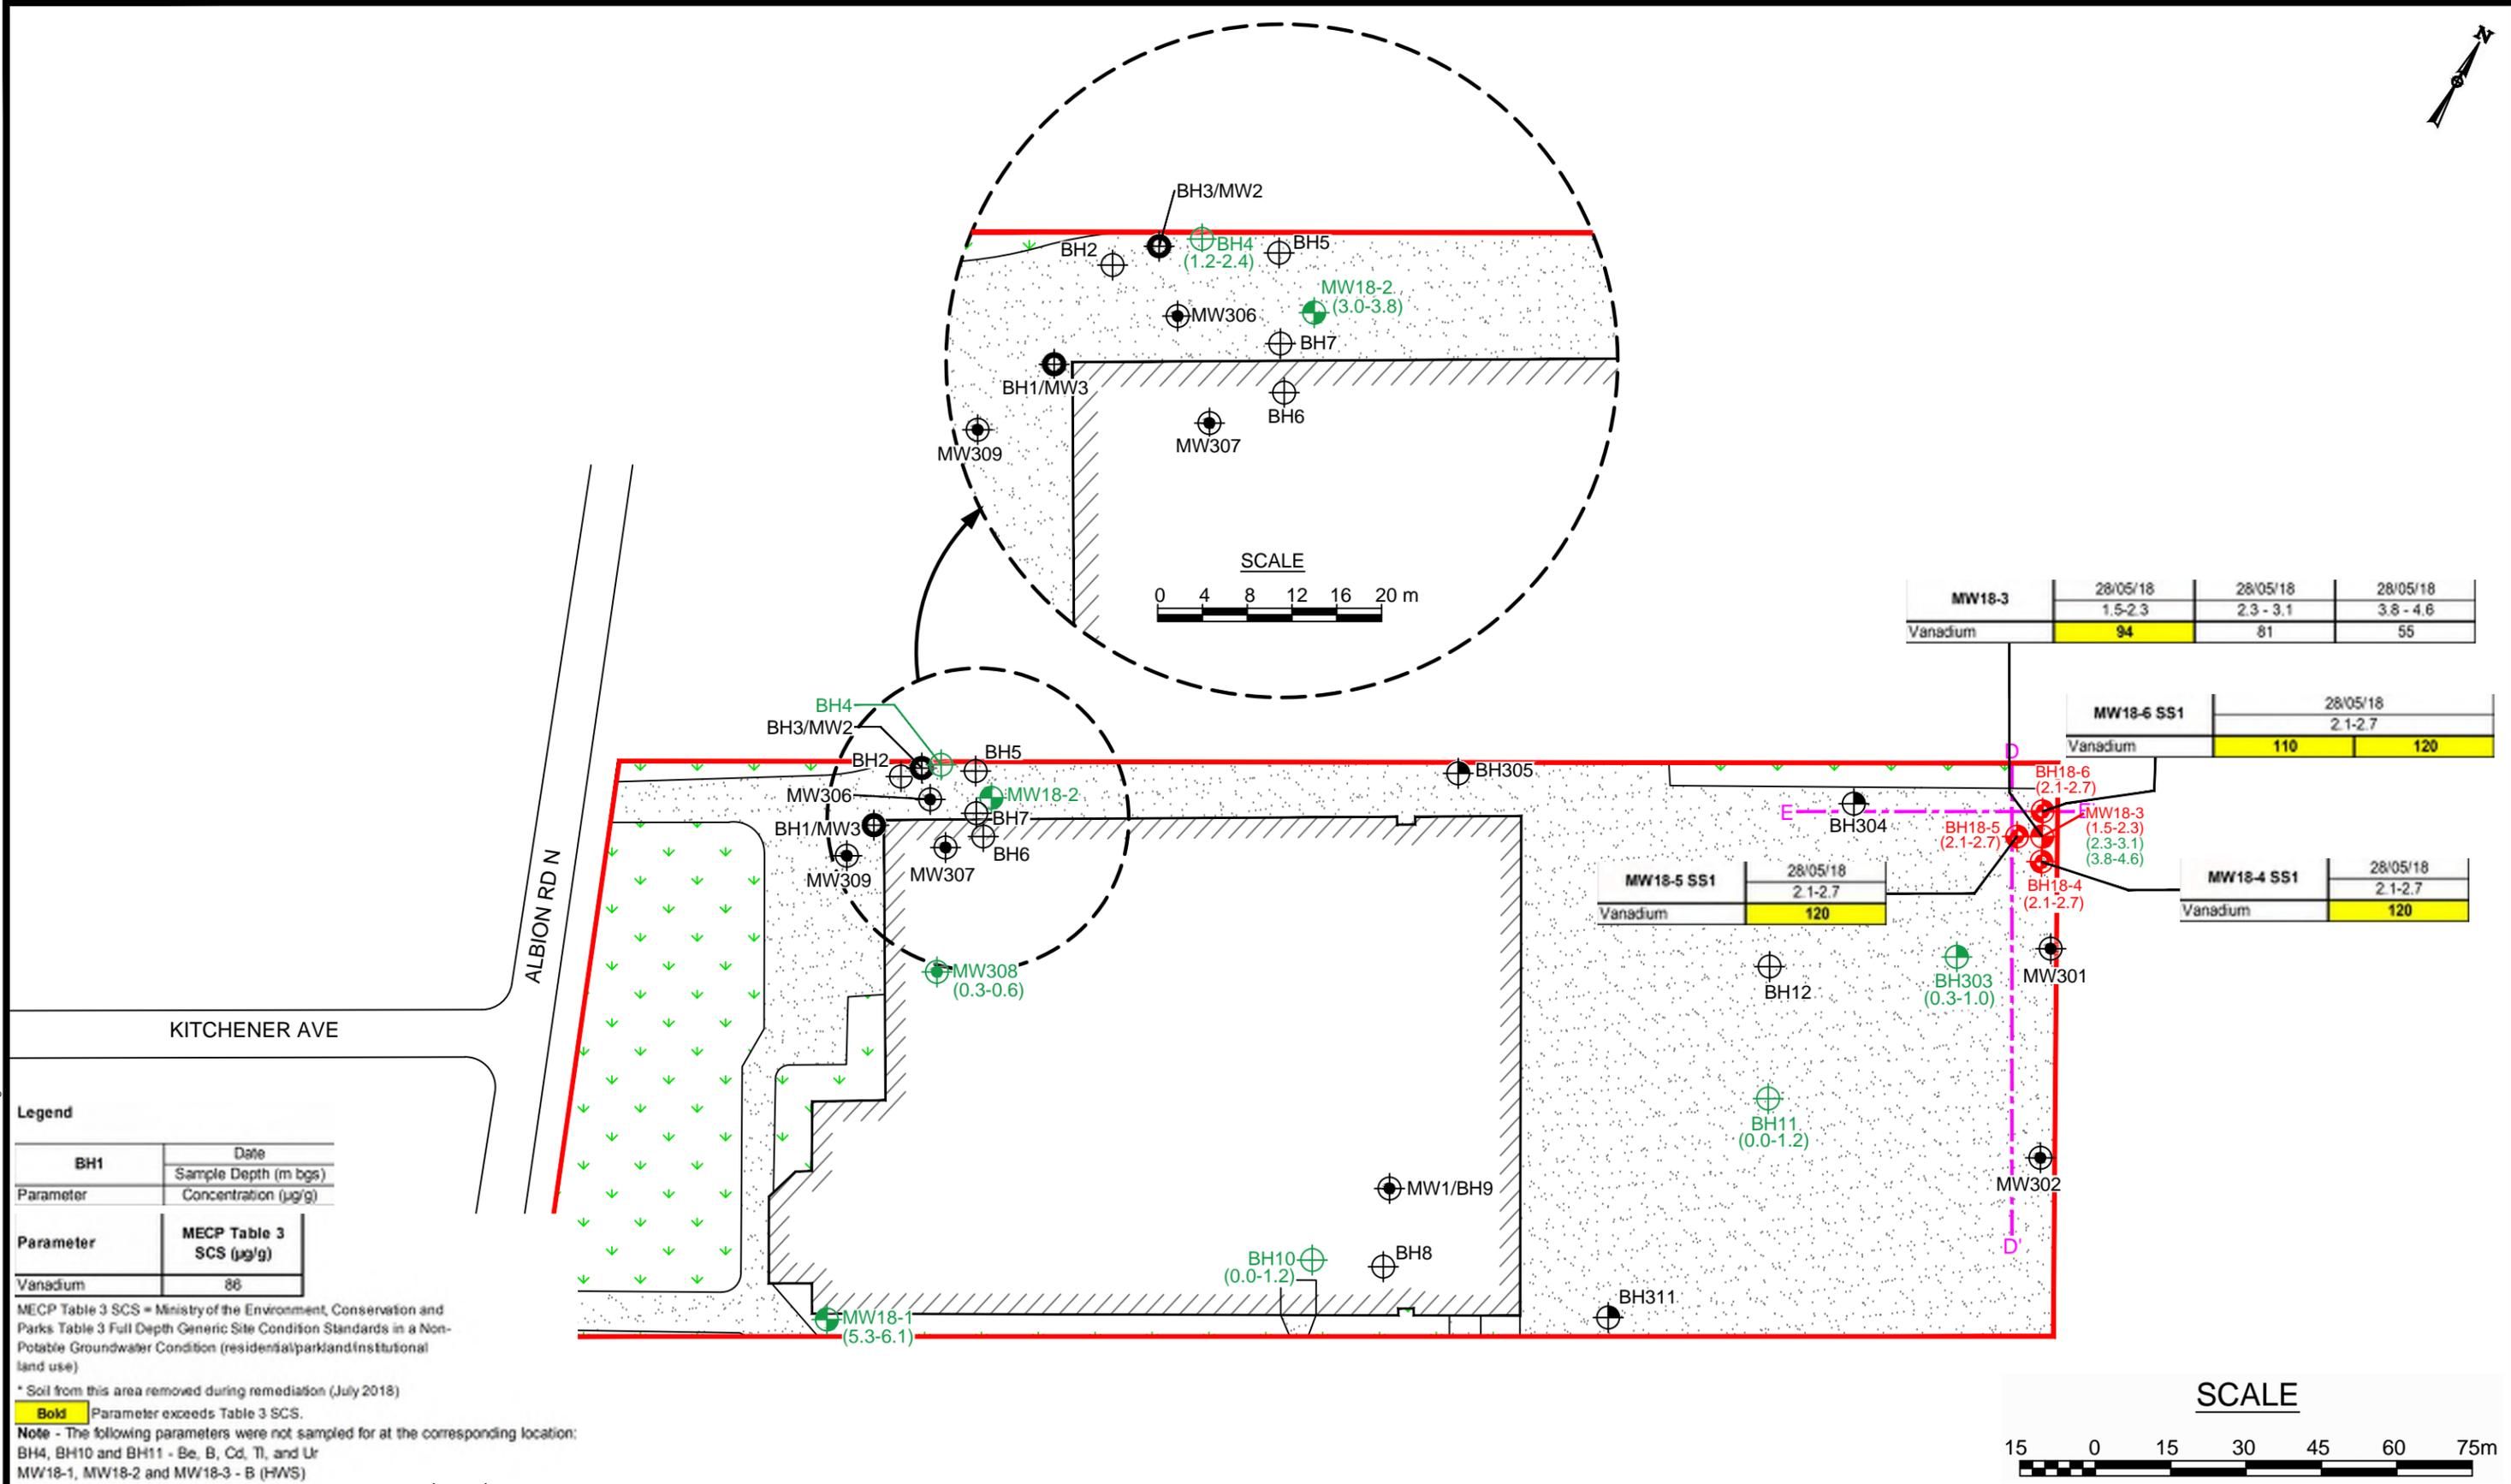
JOB NO.: OTT-00246047-D0	DRAWN BY: DP
SCALE: AS NOTED	CHECKED BY: PV
DATE: DECEMBER 2018	FIG NO.: 12

The soil sampling during the completion of this Phase Two ESA was undertaken in accordance with the Sampling and Analysis Plan presented in Appendix F. Three additional boreholes (BH18-4 to BH18-6) were drilled in the northeast corner of the Phase Two Property on September 20, 2018 to delineate vanadium in soil that was found in MW18-3.

MW18-3	28/05/18	28/05/18	28/05/18
Vanadium	1.5-2.3 94	2.3 - 3.1 81	3.8 - 4.6 55

Based on the results of the Phase Two ESA, PHC and vanadium impacted soil remain on the Phase Two Property and are being addressed through the completion of an MGRA. The groundwater on the Phase Two Property has concentrations of the contaminants of concerns noted in the Phase One ESA that meet the applicable MECP Table 3 SCS. No further remedial action is recommended at this time.
