**PHASE ONE ENVIRONMENTAL  
SITE ASSESSMENT**

**FAIRMONT CHÂTEAU LAURIER  
1 RIDEAU STREET  
OTTAWA, ONTARIO**

March 2017  
Reference No. 16-0148.02

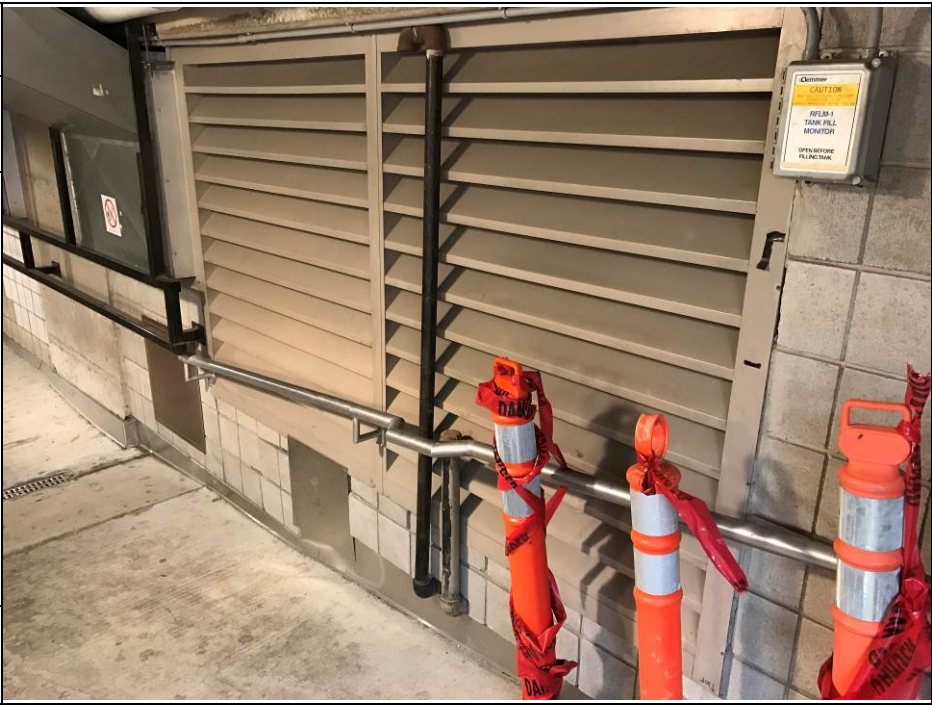
Photograph No. 3

Date Taken: December 14, 2016	
Description: Fill and vent pipes at the west side of the Site building for the diesel aboveground storage tanks.	
Looking Towards: North

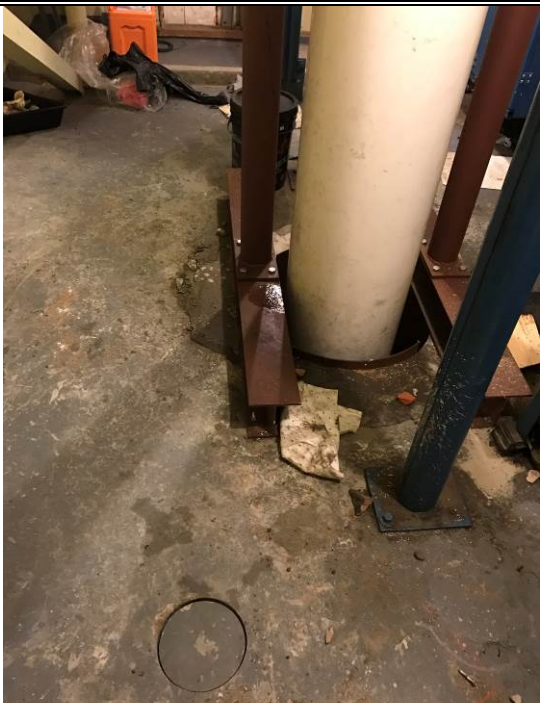
Photograph No. 4

- Elevator Room #8, associated with one of the two hydraulic elevators (discussed further in Section 5.2.5), had an adjacent catchment surrounding a larger internal drainage pipe. Upon inspection, the catchment (built into the Sub-Basement level slab) was found to contain collected oil, and according to the Site representatives, this material was not conveyed outside of the catchment, and likely collected over a long period of time. Cleaning of the catchment would require pumping/vacuuming to remove oily materials;

Date Taken: December 13, 2016	
Description: Metal catchment in Elevator Room #8.	
Looking Towards: N/A

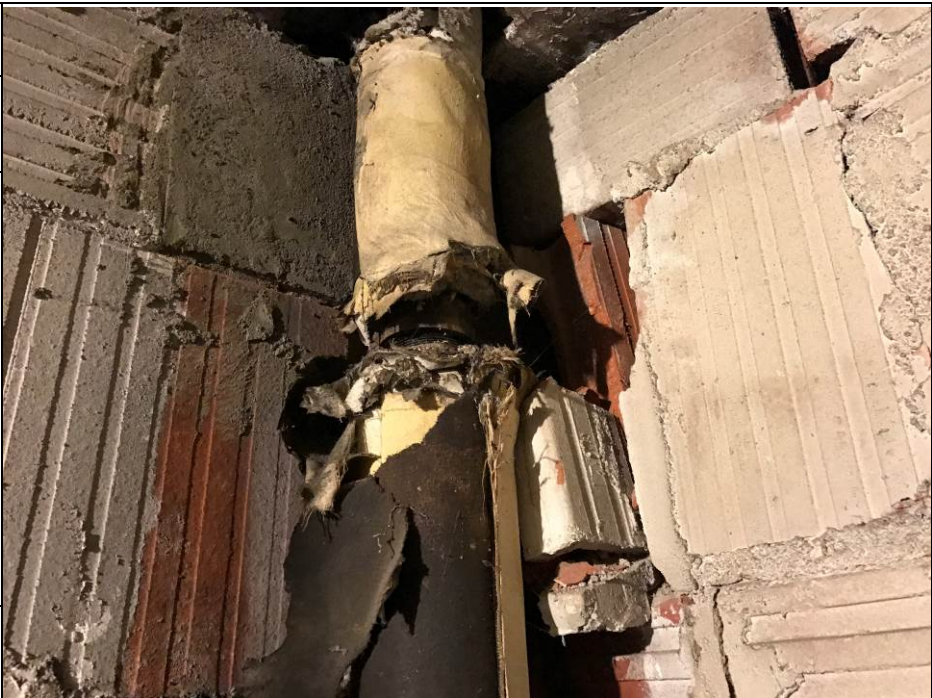
Photograph No. 5

Date Taken: December 15, 2016	
Description: Poor condition asbestos-containing material in Fan Room #11.	
Looking Towards: N/A

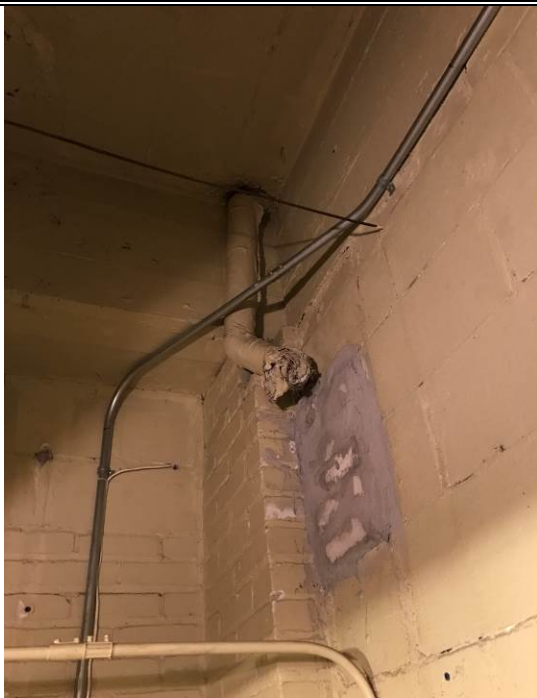
Photograph No. 6

Date Taken: December 13, 2016	
Description: Poor condition asbestos-containing material in Elevator Room #8.	
Looking Towards: N/A

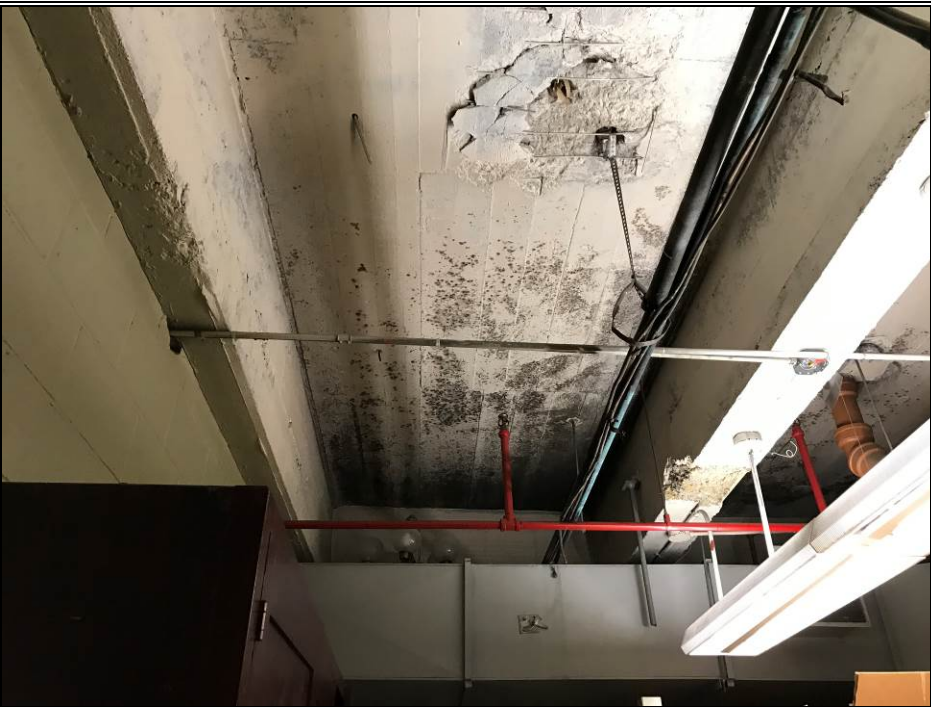
Photograph No. 7

Date Taken: December 12, 2016	
Description: Suspected mould growth on the ceiling in the Engineering Storage Room.	
Looking Towards: N/A

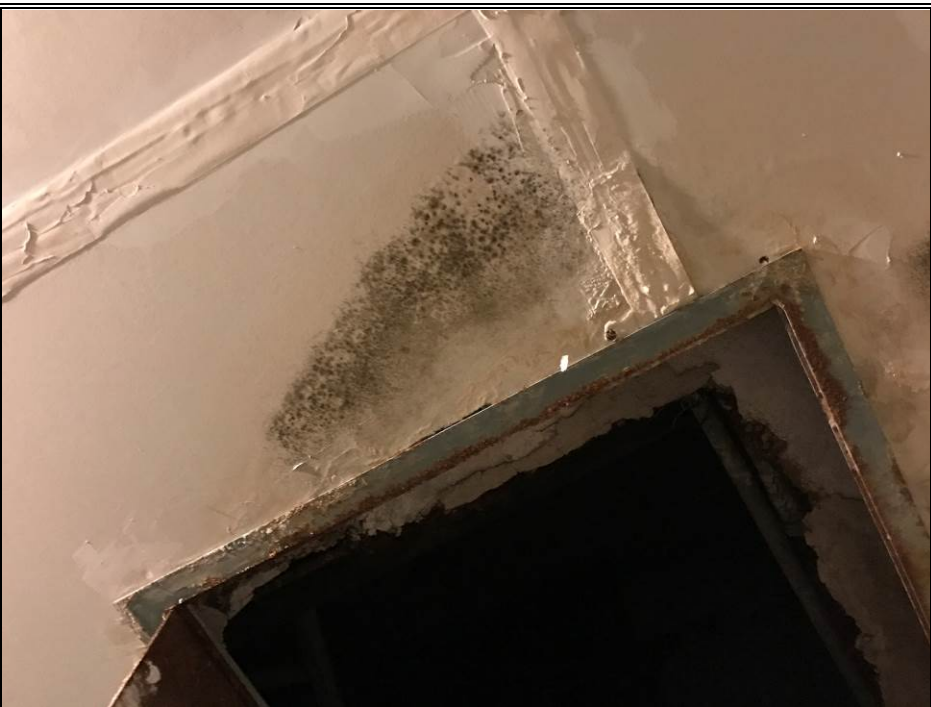
Photograph No. 8

Date Taken: December 14, 2016	
Description: Suspected mould growth beside a ceiling hatch in Fan Room #18.	
Looking Towards: N/A

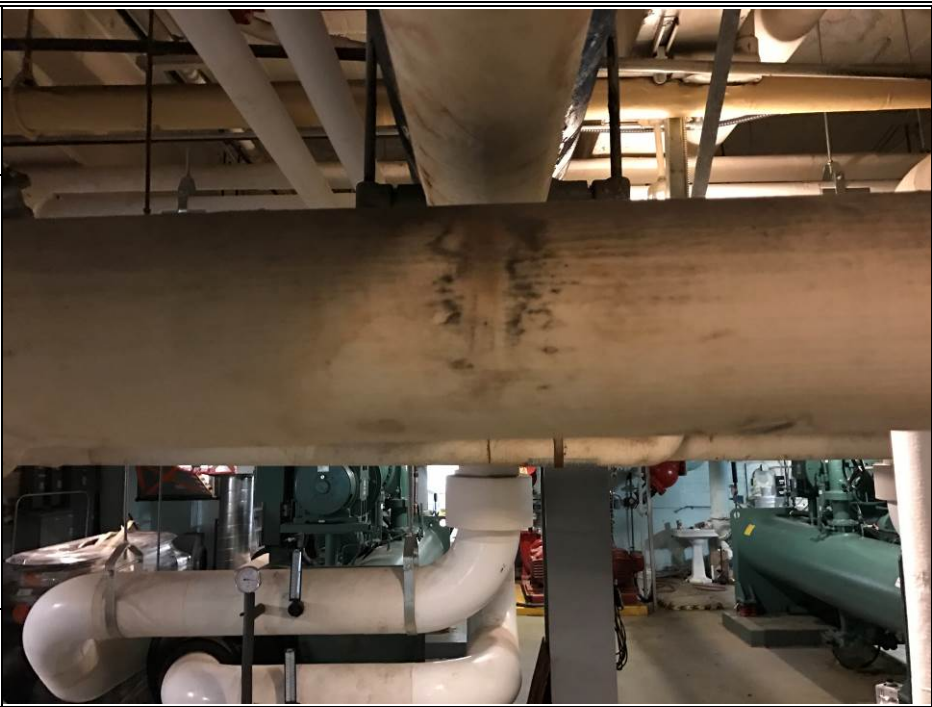
Photograph No. 9

Date Taken: December 12, 2016	
Description: Suspected minor mould growth on pipe wrap insulation in the Chiller Room.	
Looking Towards: N/A

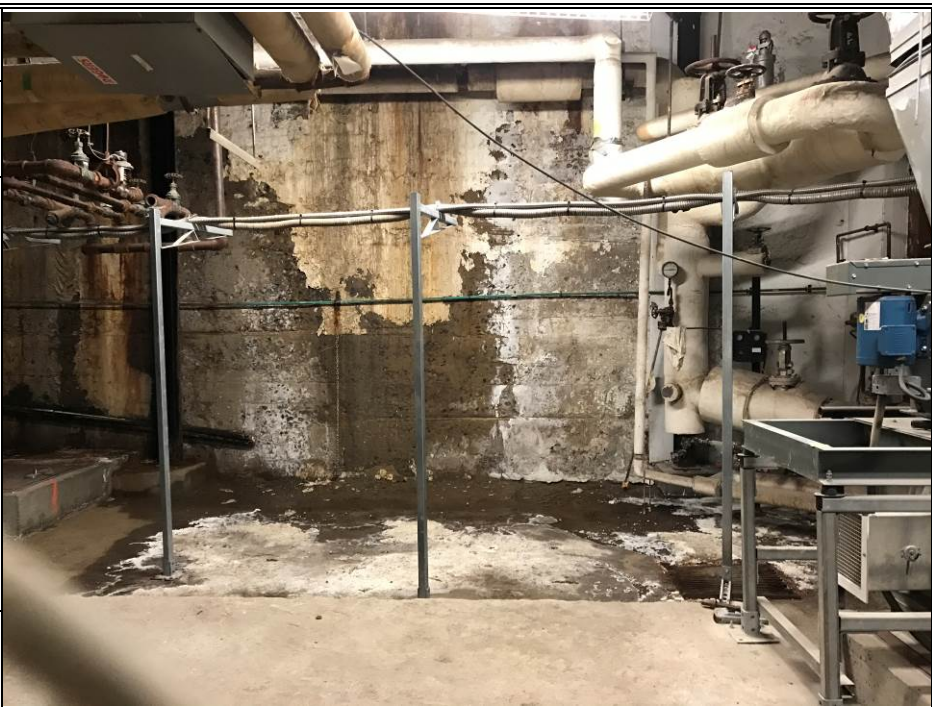
Photograph No. 10

Date Taken: December 12, 2016	
Description: Water intrusion on the south wall in the steam cage area in the Sub-Basement.	
Looking Towards: N/A
