**Letter Report  
Scoped EIS**

**Re: Scoped EIS Chateau Laurier**

Project: Chateau Laurier Scoped EIS

Location: 1 Rideau St. Ottawa

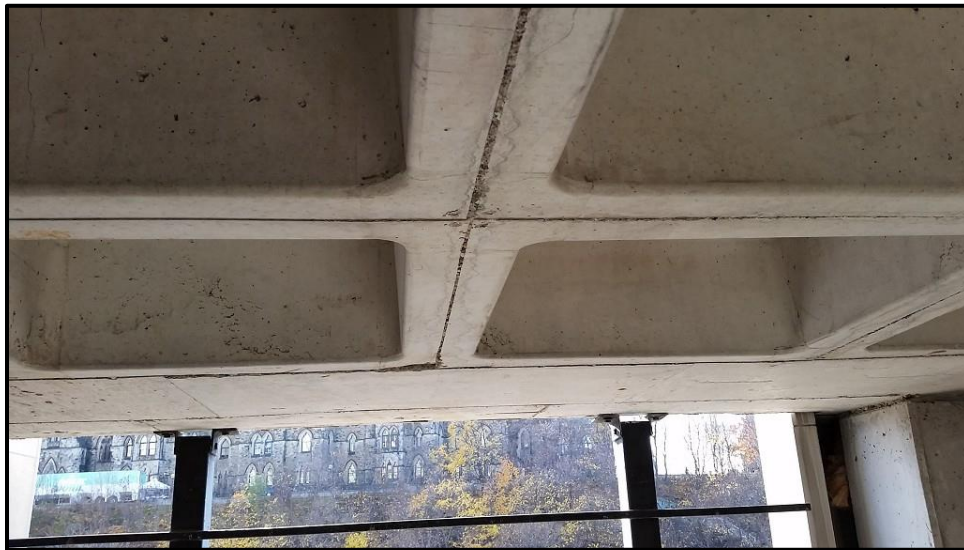
As illustrated in **Photograph 1**, the ceiling of each of the four levels has a gridded structure with cells 0.76 x 0.76 m with a depth of 0.3 m. Because of the limited visibility imposed by this structural characteristic it was necessary to systematically walk transects under accessible areas of the ceiling to visually confirm the absence of Barn Swallow nesting material. Portions of the ceiling were covered by fine netting (**Photograph 2**) to prevent debris from falling and these areas were not assessed as they were not accessible to birds. Additional areas that were not assessed were primarily on the first level and corresponded to parking spots occupied by large vehicles. Approximately 90% of the gridded ceiling could be visually assessed and all ceilings and walls adjacent to openings to the outside (e.g., **Photograph 3**) were assessed.

**Photograph 1. View of gridded ceiling (cells 0.76 x 0.76 m with a depth of 0.3 m)**

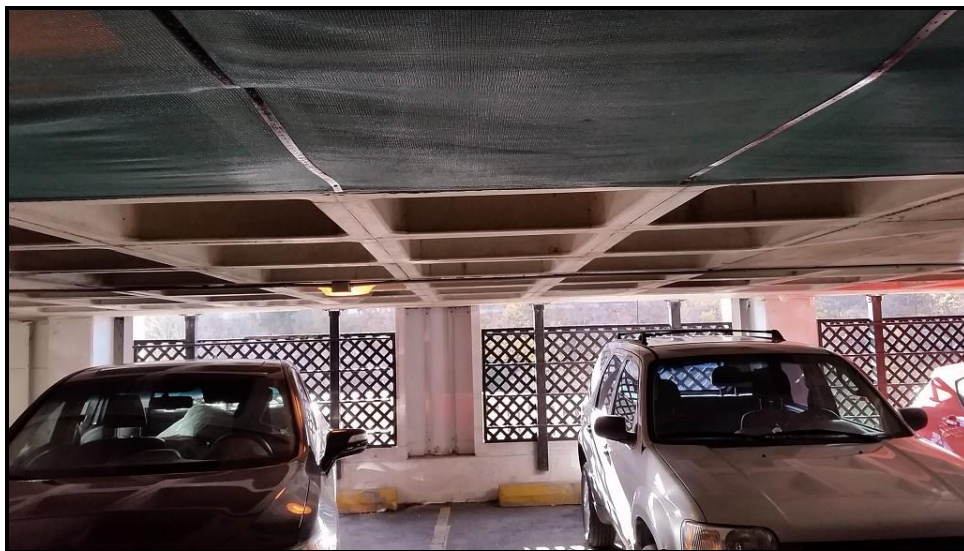
**Photograph 2. View of netting in the foreground that covered portions of the ceiling**

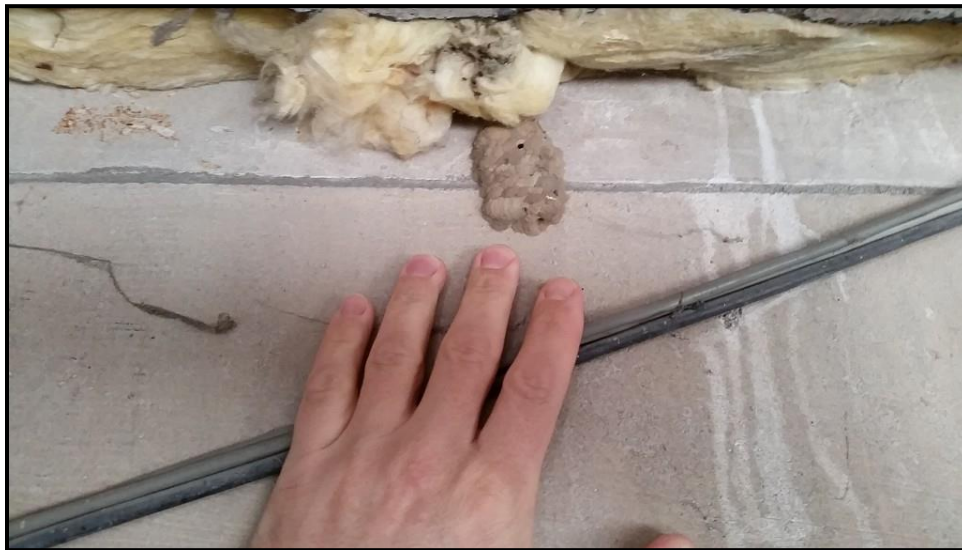
No evidence of Barn Swallow nests or nesting activity were found.

Mud nests of wasps (**Photograph 4**) were found in numerous locations on the ceiling and evidence of one American Robin (*Turdus migratorius*) nest and one Rock Pigeon (*Columba livia*) nest were observed.

**Photograph 4. View of mud nests of unidentified mud-daubing species of wasp**

1. Complete construction activities outside of the breeding season for Barn Swallow (breeding season is April through August);
2. If it is not possible or practical to complete construction activities outside of the breeding season for Barn Swallow (April through August) then the following options should be considered:

- a. Install exclusion netting prior to April in the areas where construction will occur to prevent Barn Swallows from nesting;

- b. Conduct three site visits during the Barn Swallow's breeding season between May and June of the year when construction is to occur to confirm that the species is absent;
  - i. If nesting activity by Barn Swallows is observed, then the Ministry of Natural Resources and Forestry (MNRF) should be contacted to determine appropriate mitigation measures;
  - ii. If Barn Swallows are absent then no mitigation is necessary.
