**Phase One Environmental Site  
Assessment, 3856, 3866 & 3876  
Navan Road, Ottawa, Ontario**

**Project No. 122511332**

October 3, 2016

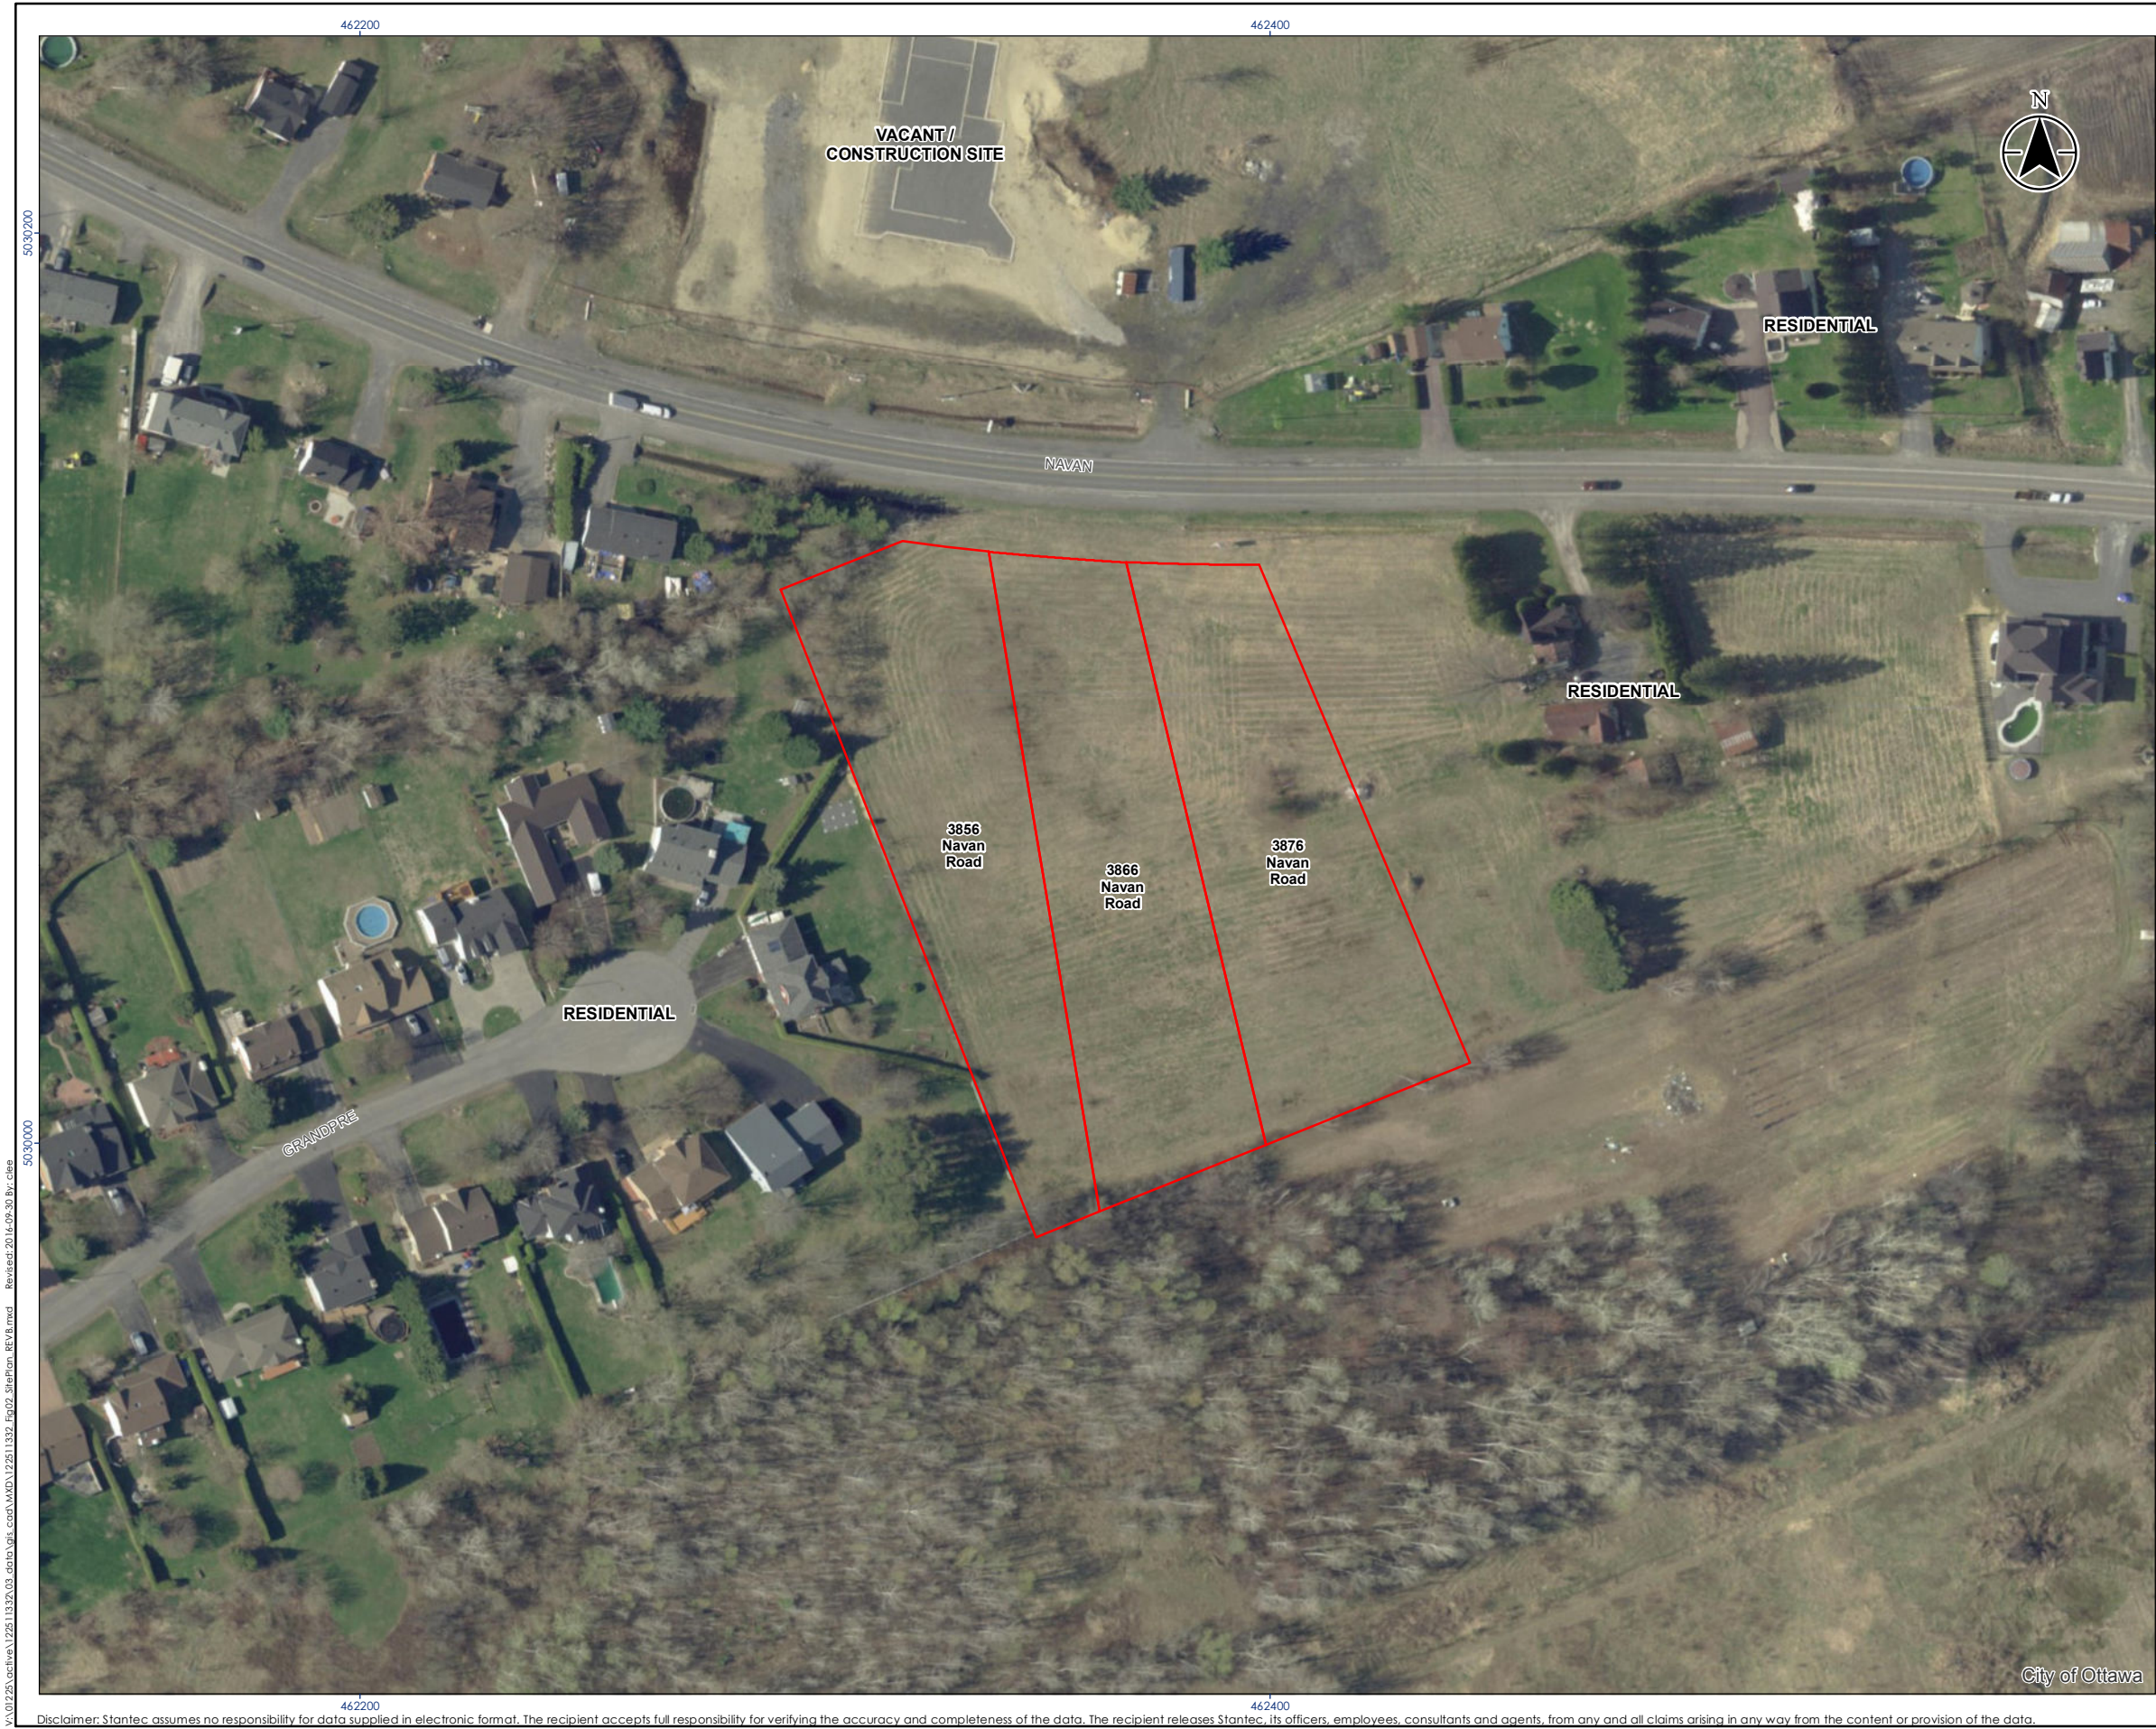
Figure No.  
**2**

Title  
**Site Plan**

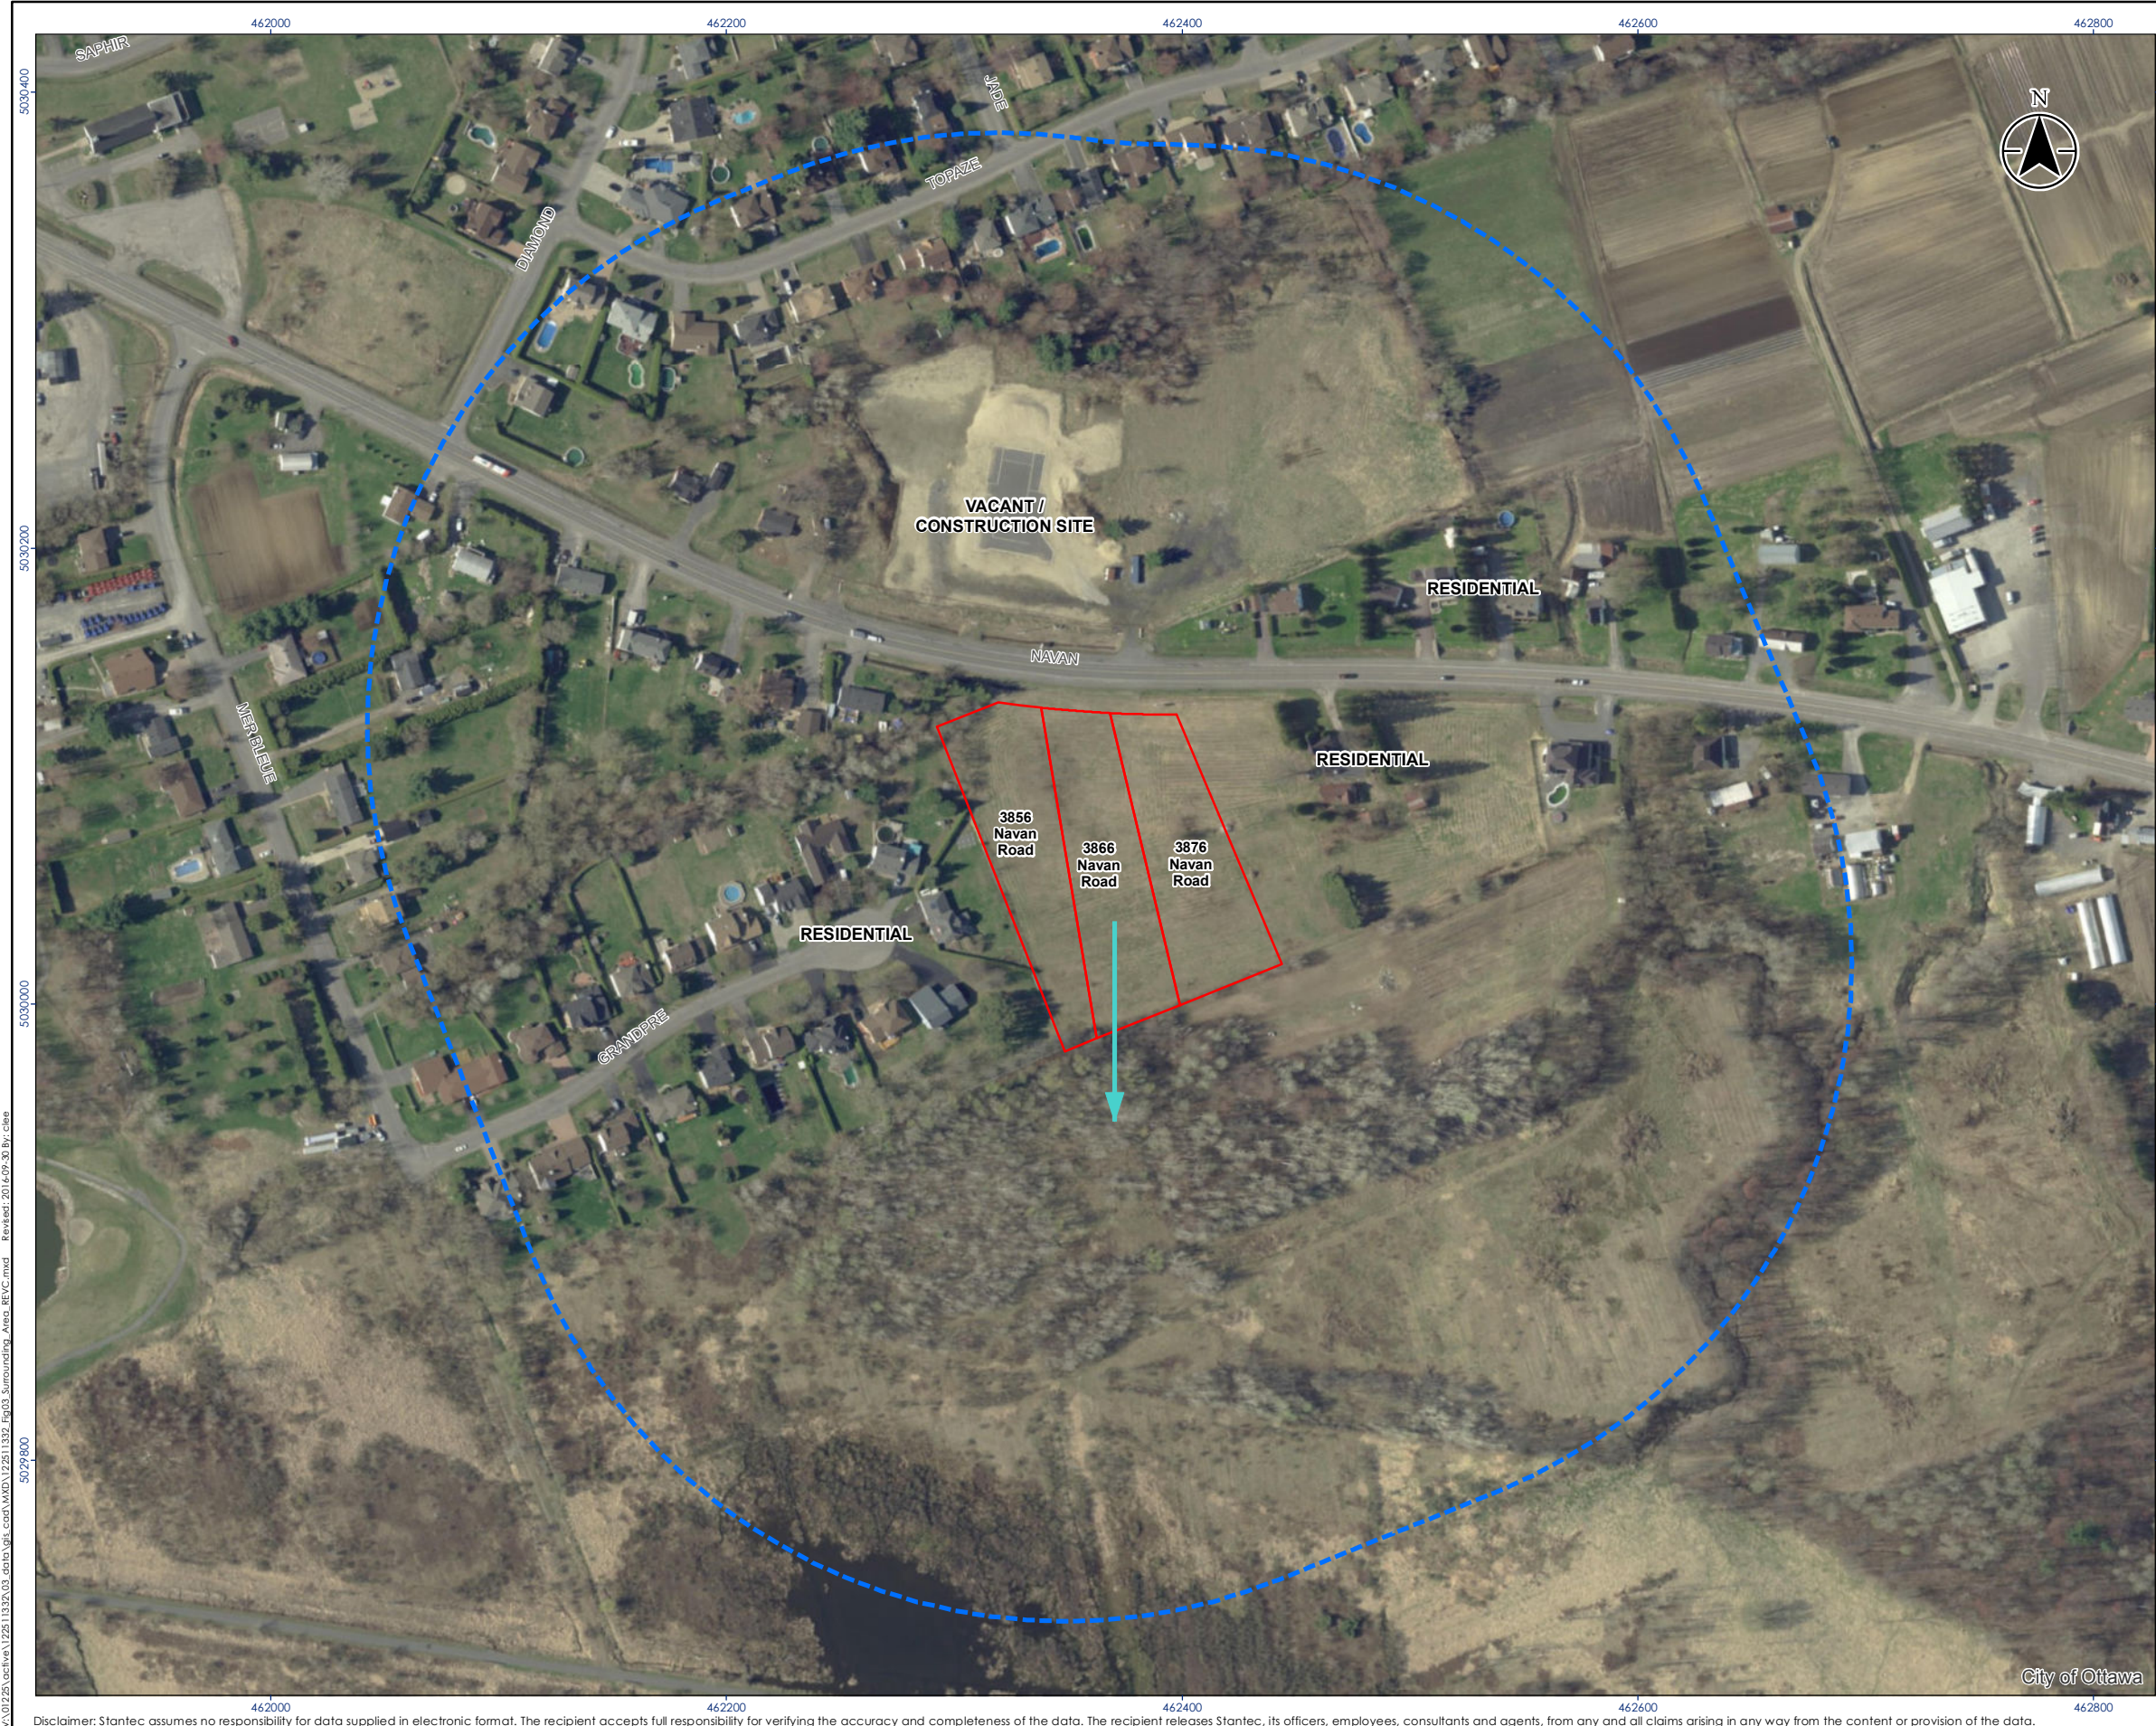
Based on Natural Resources Canada topographic map 31 G/5, and the observed topography in the vicinity of the Phase One Property, regional surface drainage (inferred shallow groundwater flow direction) appears to generally flow in a southerly direction.

- Legend
- Inferred Groundwater Flow
  - Site Boundary
  - Study Area

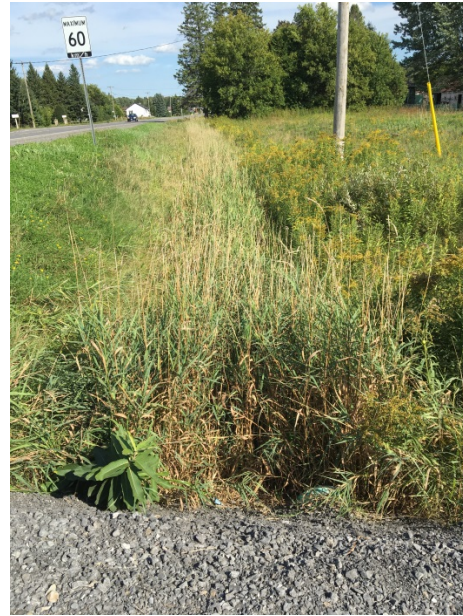
**Photo 2:** Ditch along Navan Road

The Phase One Property is a vacant lot. Storm water is anticipated to drain primarily by infiltration and overland flow to the ditch along Navan Road, to the north of the Site.

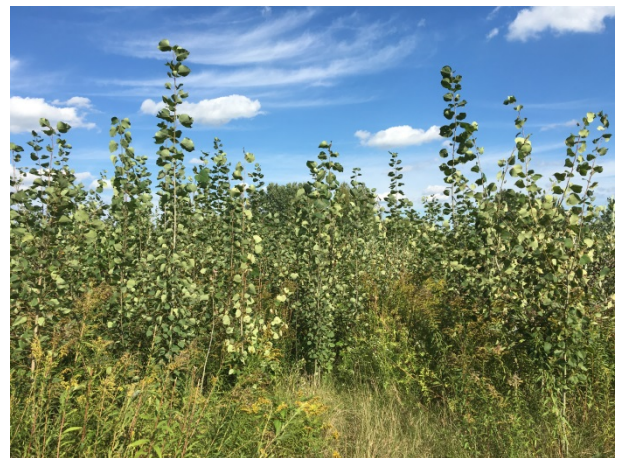
**Photo 10:** Vegetation on the Site

No stained surficial materials or stressed vegetation were observed at the Phase One Property.

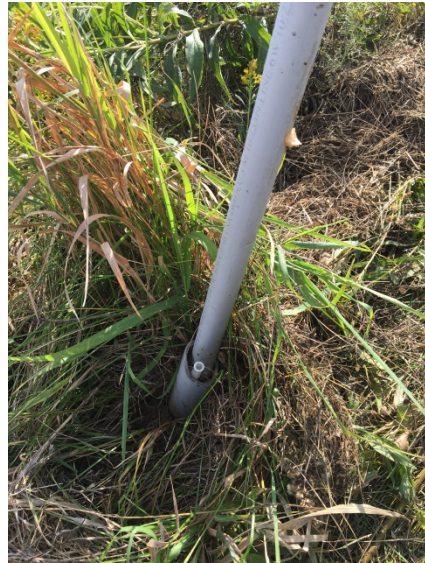
**Photo 12:** Groundwater monitoring well

A groundwater monitoring well, possibly installed during a geotechnical investigation, was observed in the northeastern portion of the Phase One Property.
