Geotechnical Investigation Report

New Church
3856, 3866 and 3876 Navan Road
Ottawa, ON

Project No. 160410200

July 12, 2019

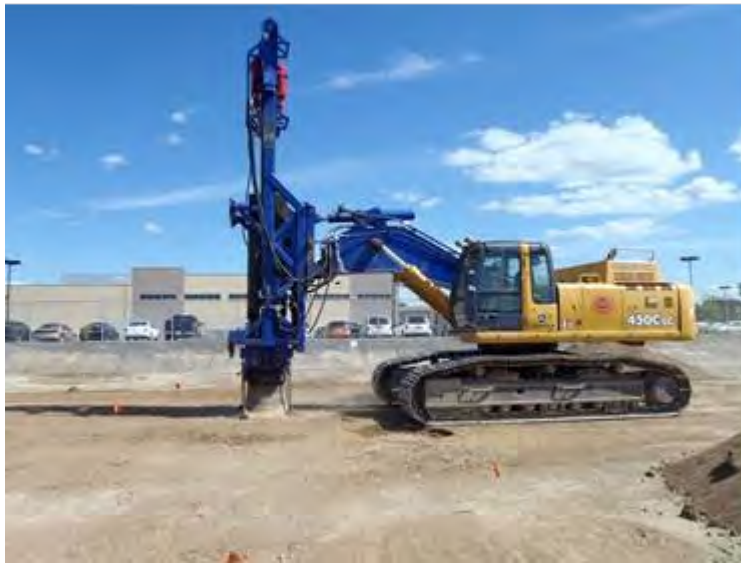
Photo 1: Rapid Impact Compaction Equipment (Source: Menard Canada)

Rapid Impact Compaction systems typically provide controlled impact compaction using a 9-ton weight capable of compacting 40 blows per minute or more. The resulting force can typically densify the soils to up to 6 m in depth. The photo below shows the RIC readily available by Menard Canada in Ontario.

It is considered that Rapid Impact Compaction (RIC) is a feasible technique to densify the loose sand deposit encountered at the site. The appropriate methods/equipment shall be selected by a specialist contractor. The compaction work should ultimately be monitored on a full-time basis by a qualified and experienced geotechnical personnel.

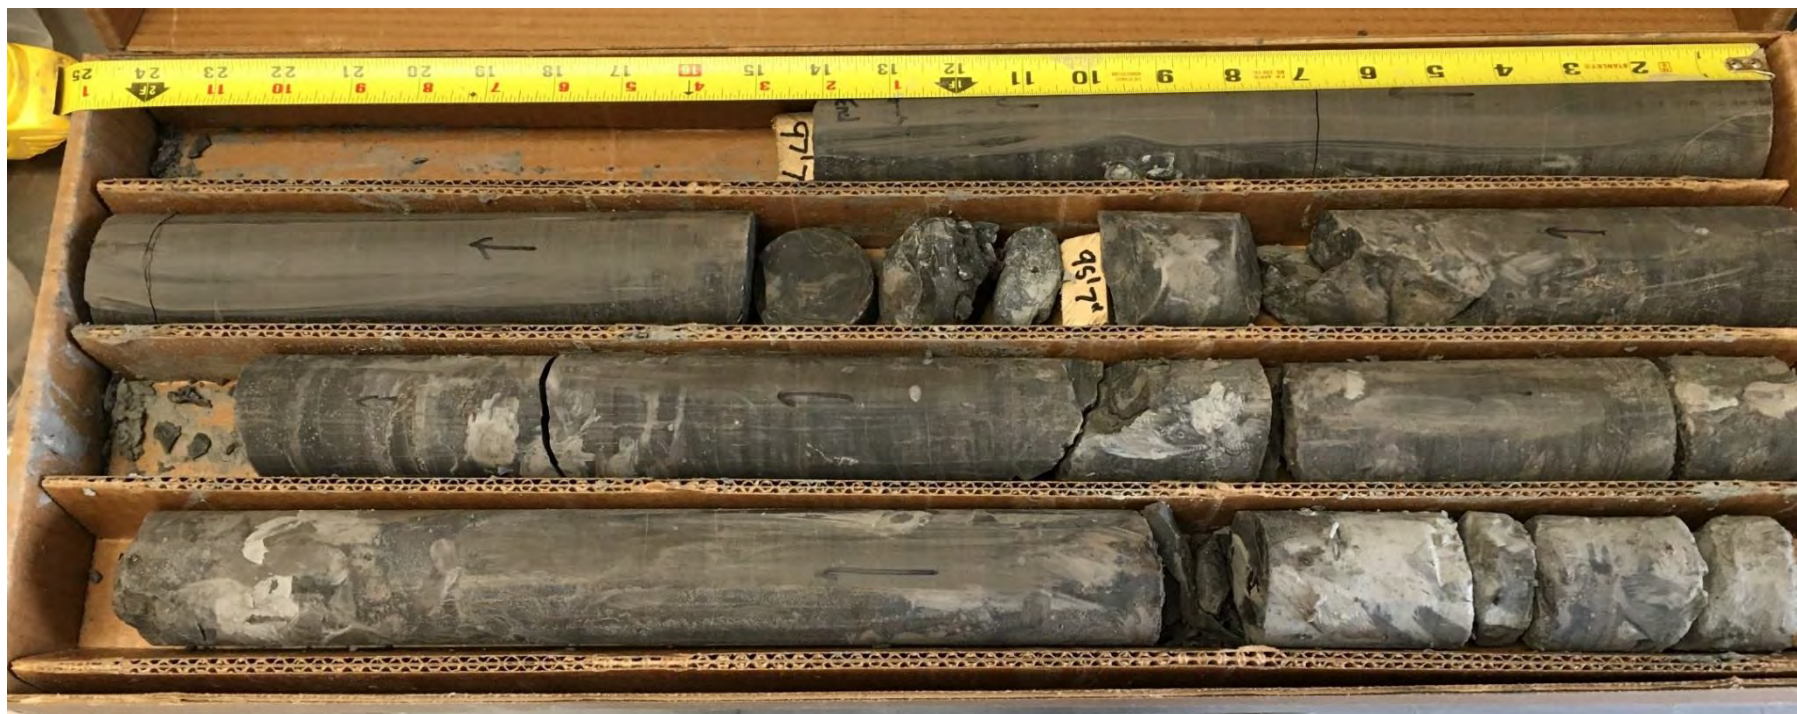
Rock Core Photo No.:

Rockcore
Photographs

Detailed descriptions of the subsurface soil and bedrock conditions are presented on the Borehole Records, Bedrock Core Log, and Rock Core Photographs provided in Appendix C. Documents providing explanations of the symbols and terms used on the borehole records are also provided in Appendix C. Laboratory test results are presented in Appendix D as well as on the borehole records.

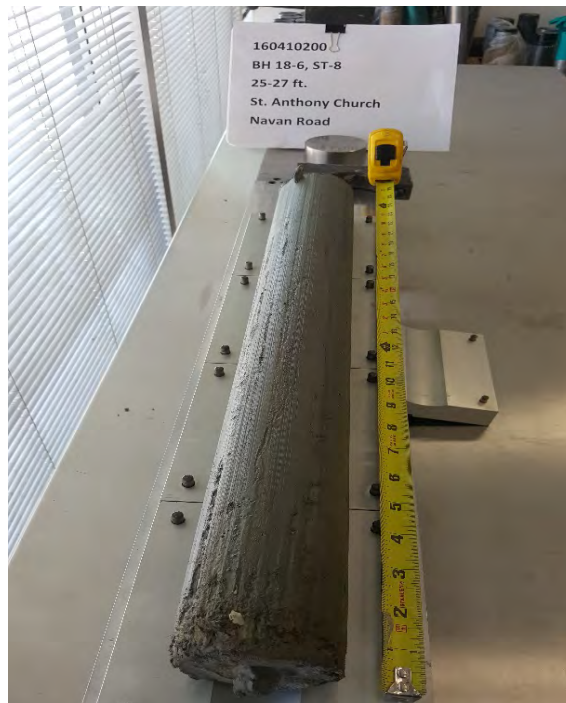
Photo No.: 2 | Borehole: BH 18-6, ST-8 | Depth: 25 – 27 ft.

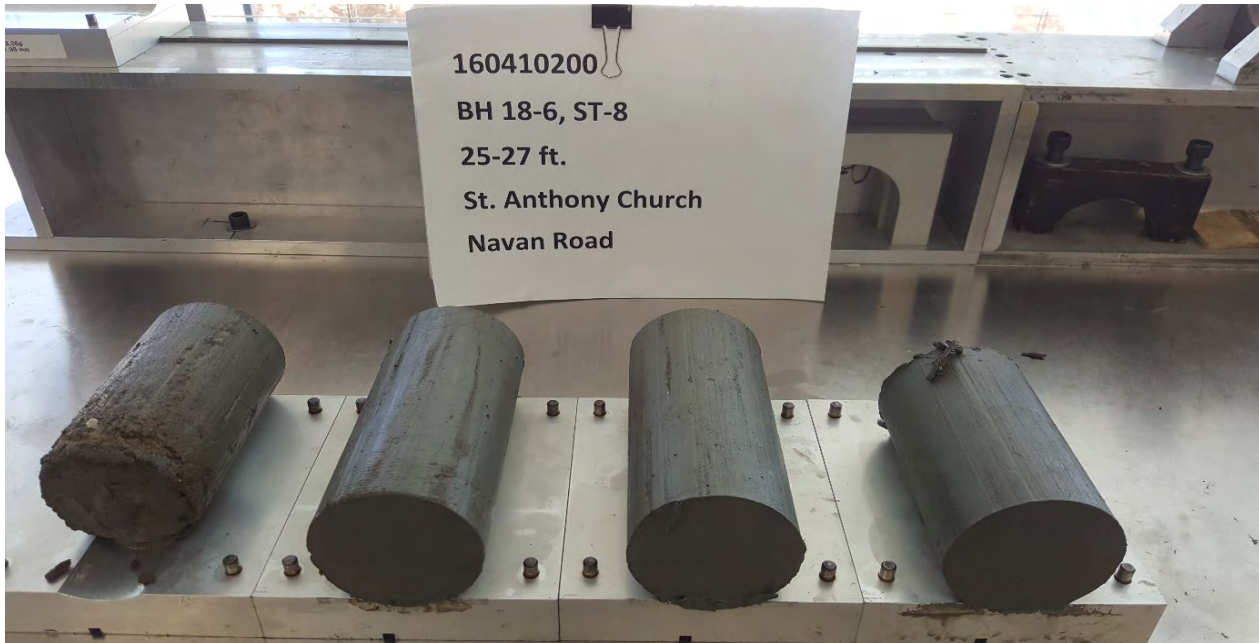
Photo No.: 3 | Borehole: BH 18-6, ST-8 | Depth: 25 – 27 ft.

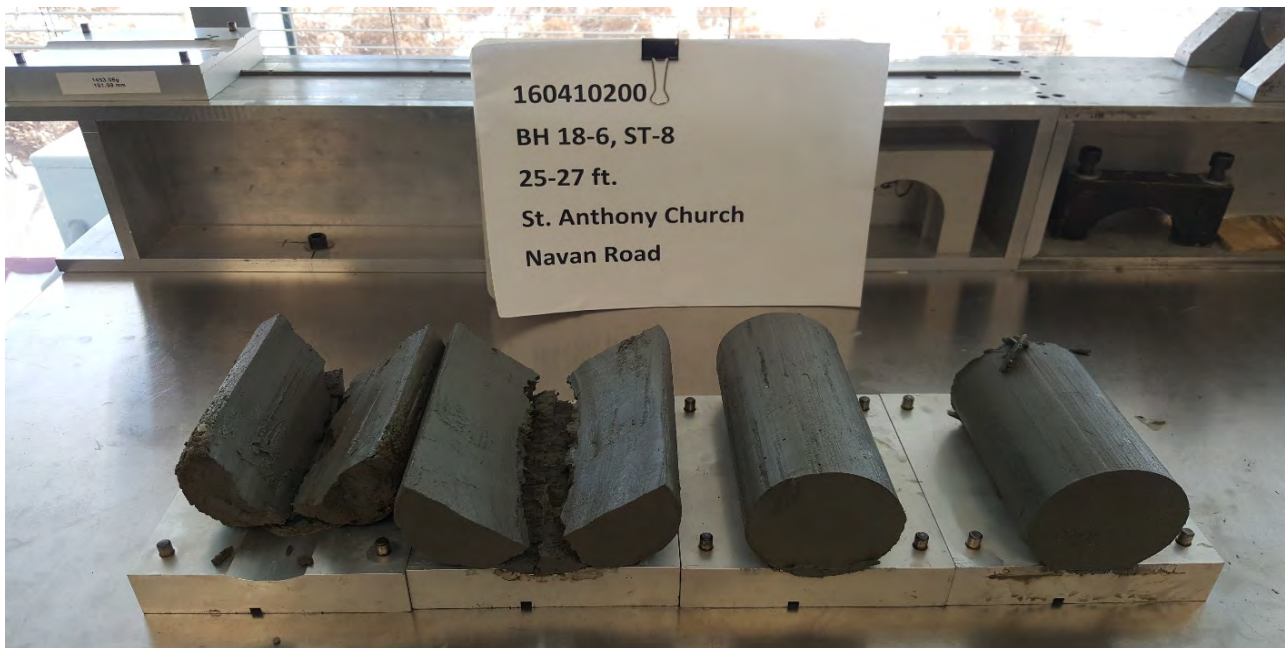
Photo No.: 4 | Borehole: BH 18-6, ST-8 | Depth: 25 – 27 ft.

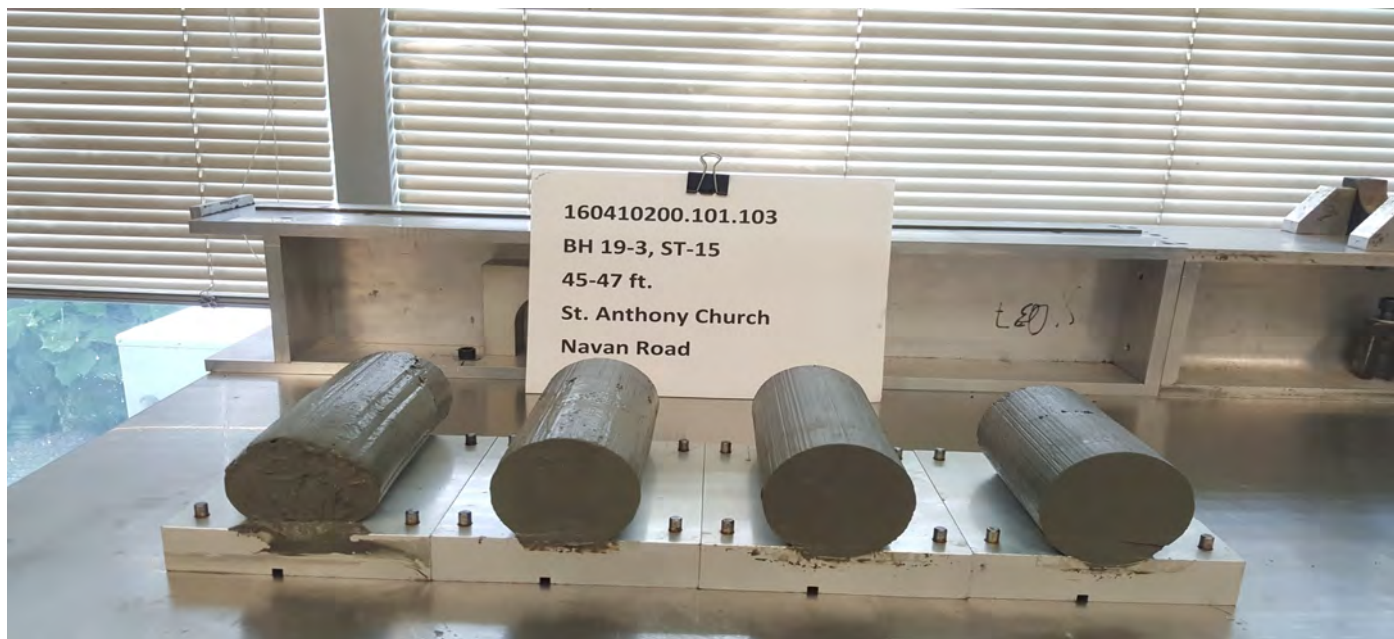
2

Borehole: BH19-03 ST15

Depth: 45 – 47 ft
