## Phase I Environmental Site Assessment

Vacant Land  
1125 Colonel By Drive  
Ottawa, Ontario

November 25, 2014

Report: PE3367-1

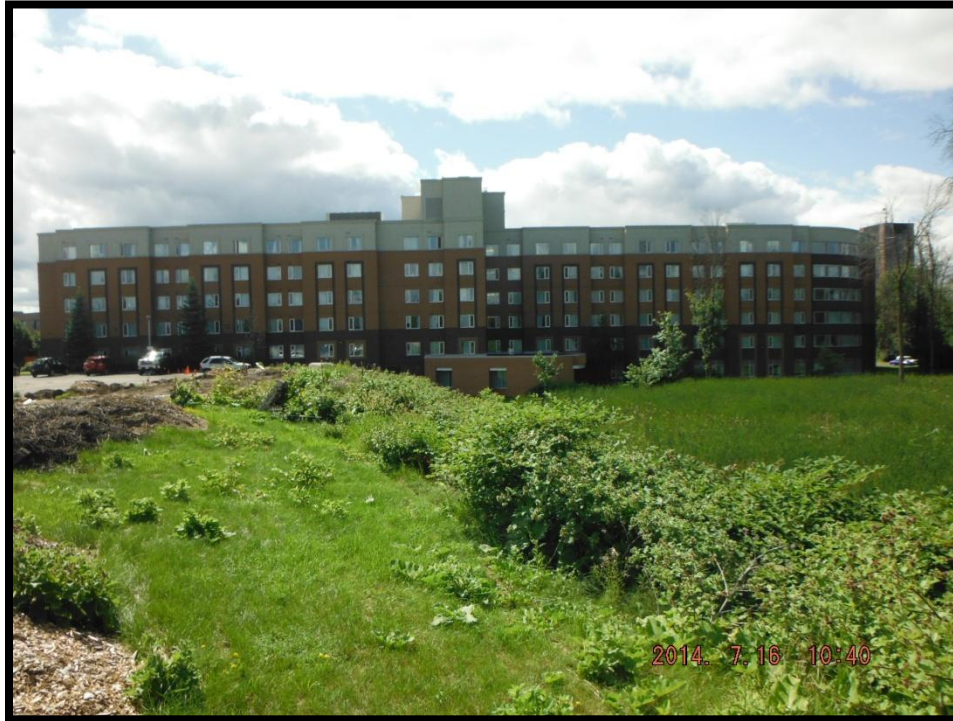
Photograph 1: View from north of the subject site, looking south along escarpment. Photograph illustrates elevation change between marsh area to the west and the parking area to the east.

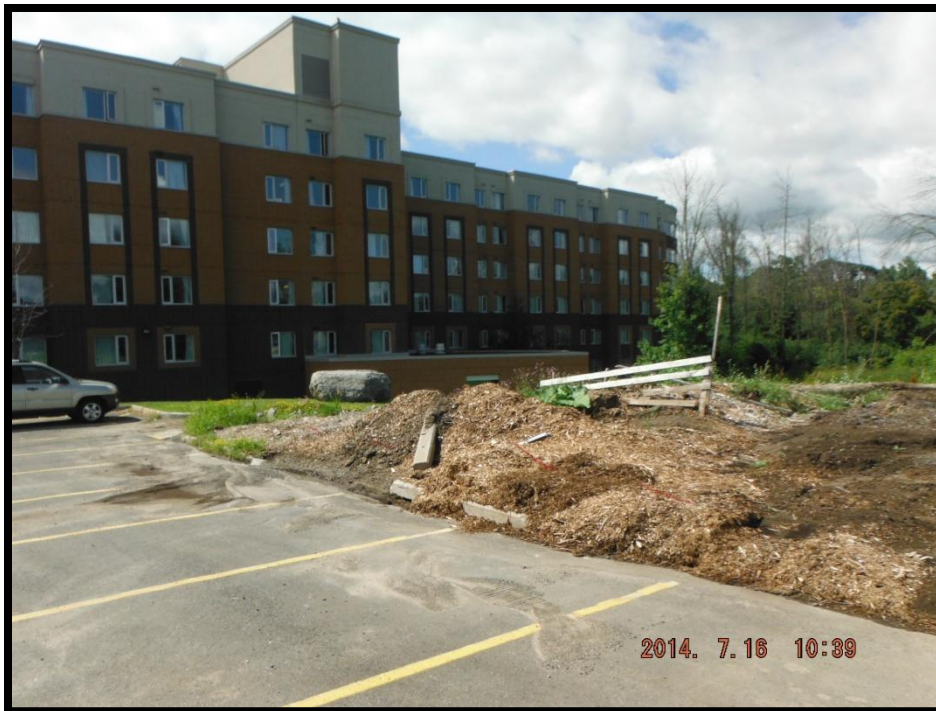
Photograph 2: View of southwest portion of the parking lot. Photograph depicts fill at apex of the escarpment, as well as, the location where surface sheet flow is diverted.

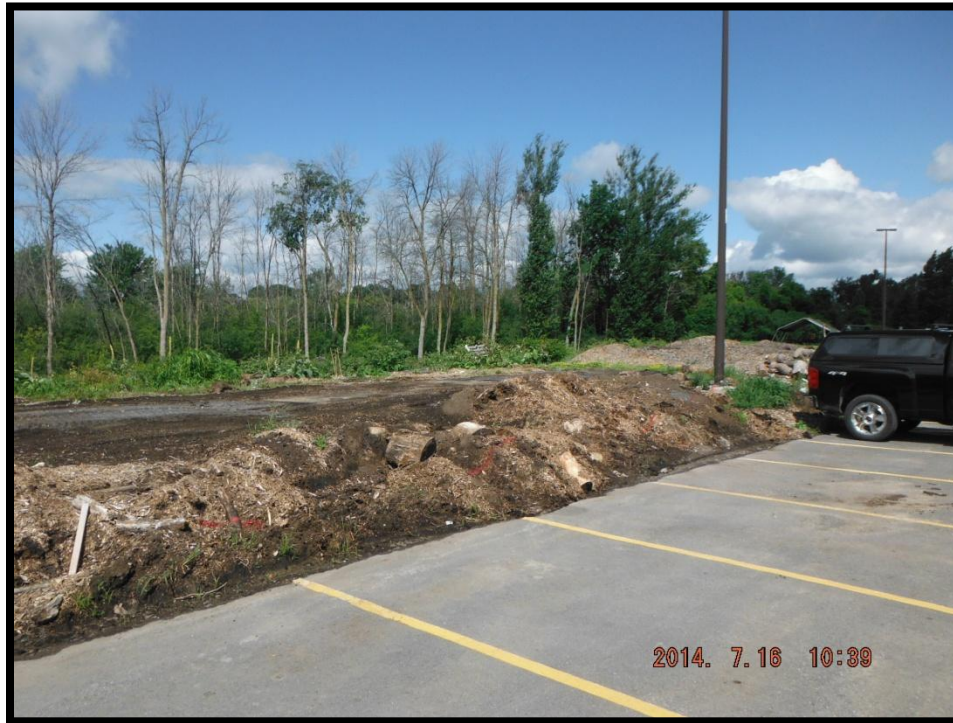
Photograph 3: View of top of escarpment on west side of parking area. Photograph illustrates fill on top of escarpment.

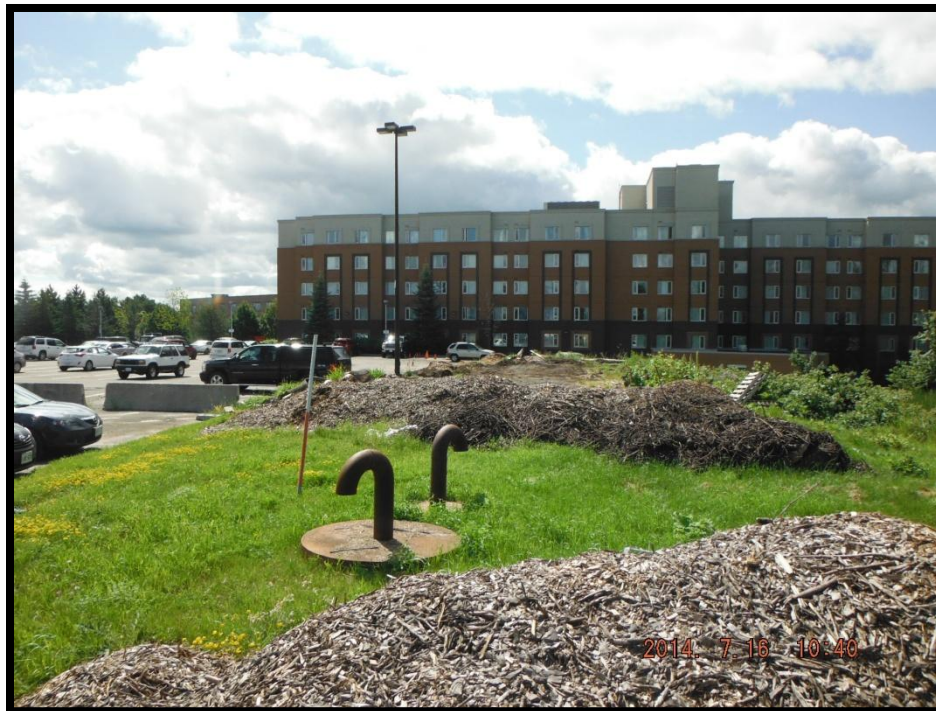
Photograph 4: View from north of the subject site. Photograph illustrates the nearby air conditioning well (used for tunnel ventilation), as well as the parking area on the east side of the subject site and general neighbouring property use.
