**Claridge Homes
Wurtemberg Street Condominium Development
Ottawa, Ontario**

April 19, 2010

Project Number: GP 10106

1.0 INTRODUCTION

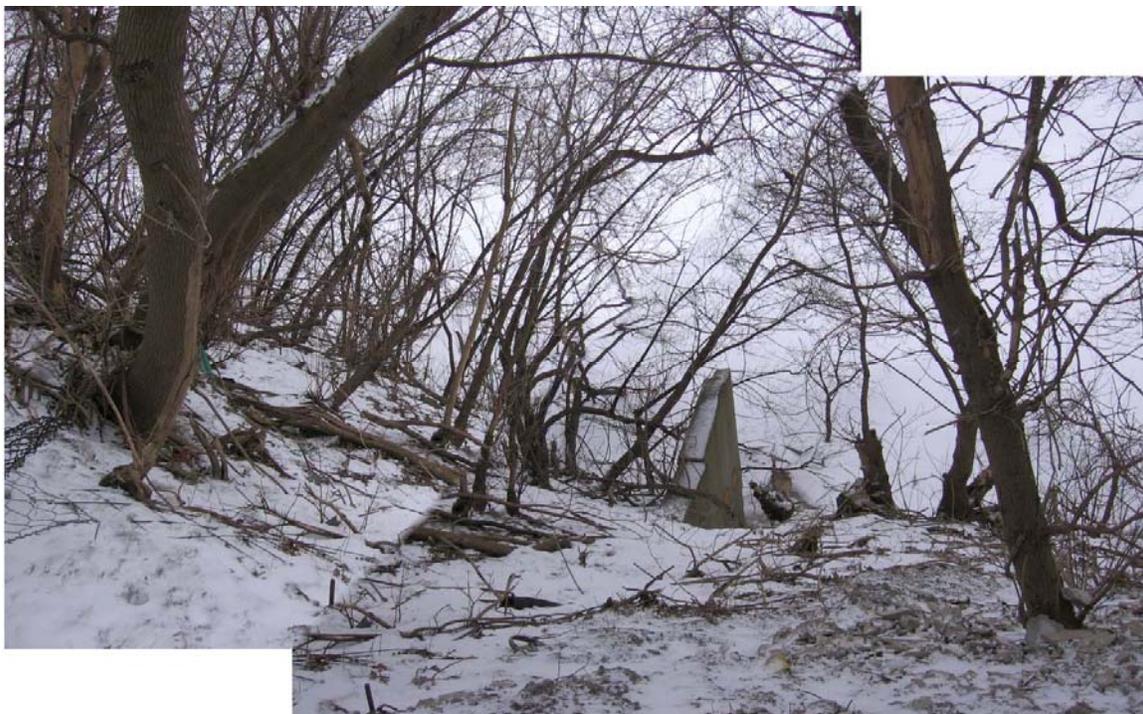
Photo 1. View down slope to the Rideau River on February 21, 2010. The concrete abutment is the upstream extent of the development property.

Photos 1, 2 and 3 in Appendix 1 depict the slope of the property and foreshore along the Rideau River on February 21, 2010. On the side adjacent to the Rideau River, the property slopes steeply toward the river as indicated in Photos 1 and 2. The slope is vegetated with trees and shrubs. Although it did not appear as though there was extensive ground cover, the ground was covered with snow on February 21, 2010 and this was difficult to confirm.

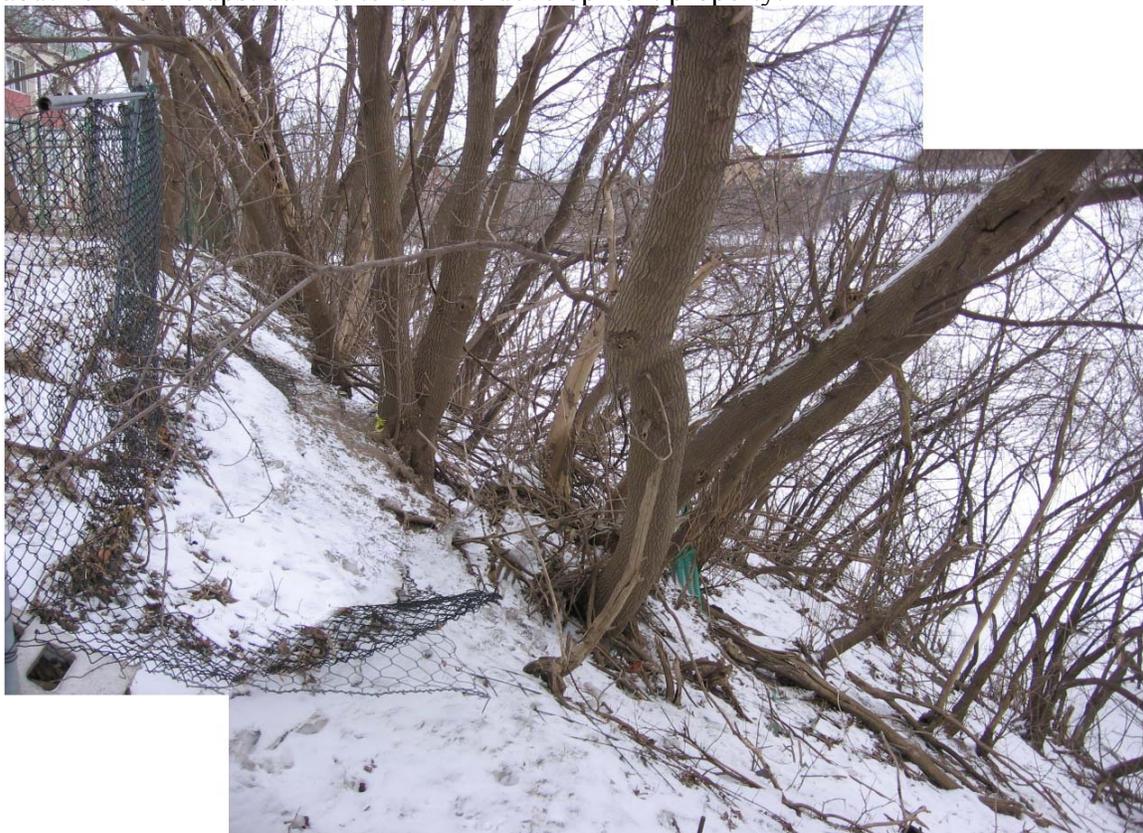
Photo 2. View across the slope on February 21, 2010. The fence represents the top of the slope on the development property.

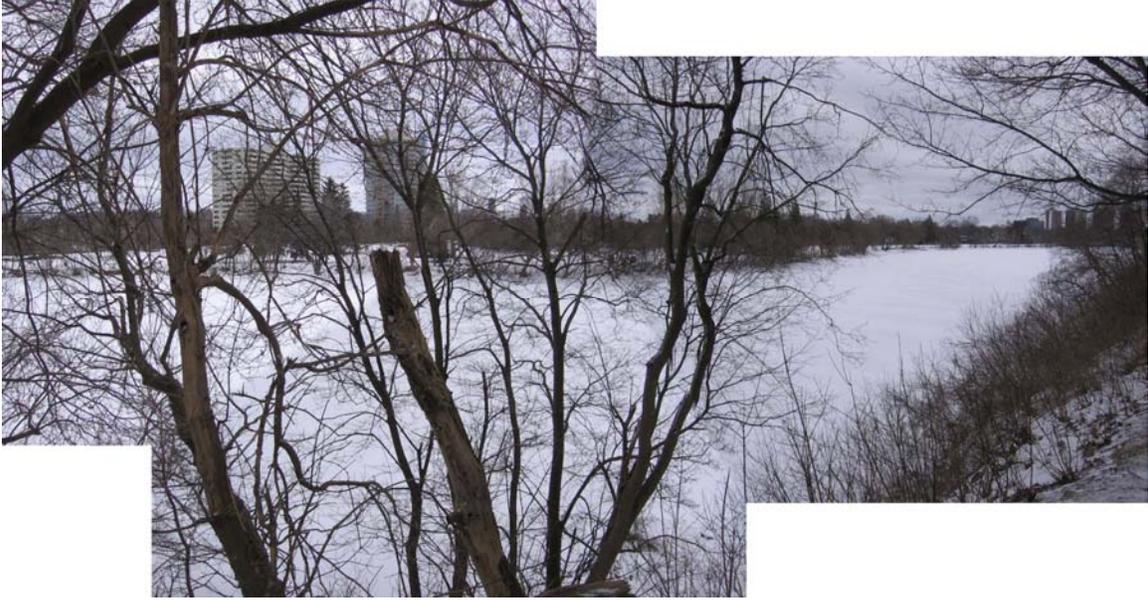
Photo 3. View along the Rideau River looking upstream from the upstream side of the development property, on February 21, 2010.

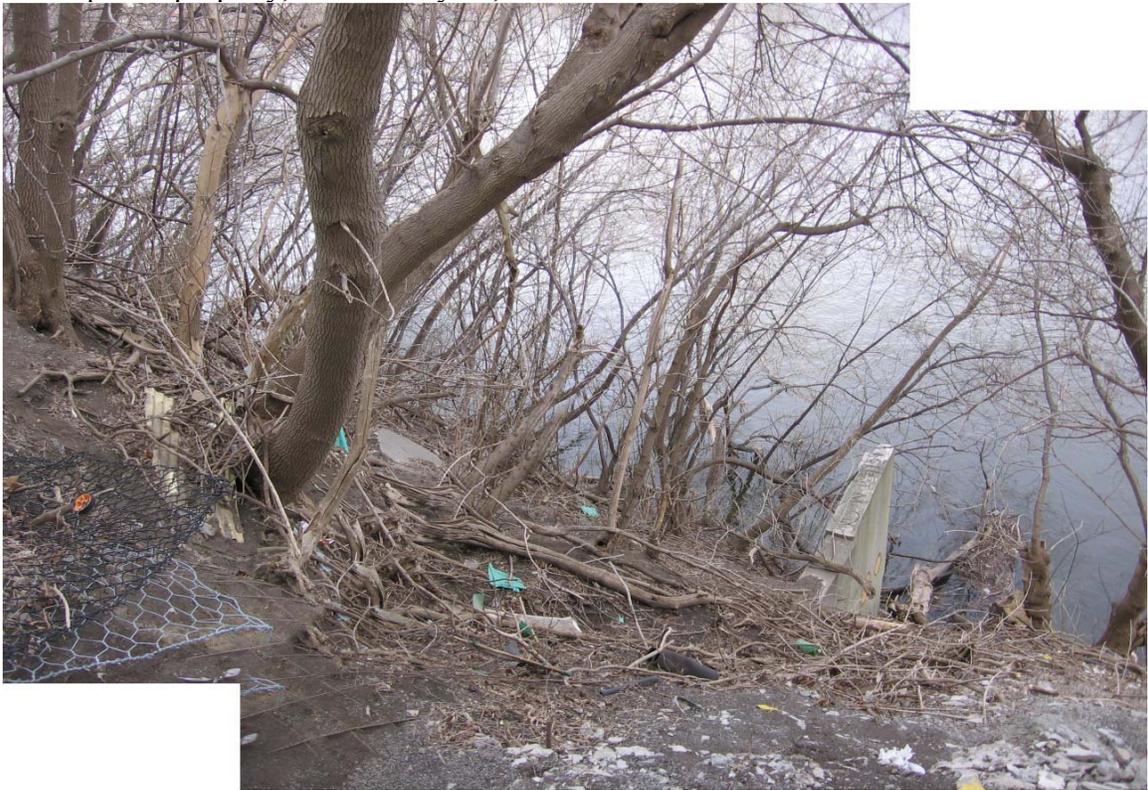
Photo 4. View down slope to the Rideau River on March 25, 2010. The concrete abutment is the upstream extent of the development property.

On the side adjacent to the Rideau River, the property slopes steeply toward the river. Photos 4 through 9 in Appendix 1 depict the slope of the property and foreshore along the Rideau River on March 25, 2010. Photos 9 and 10 provide overviews of the property and adjacent foreshore from the opposite bank of the Rideau River.

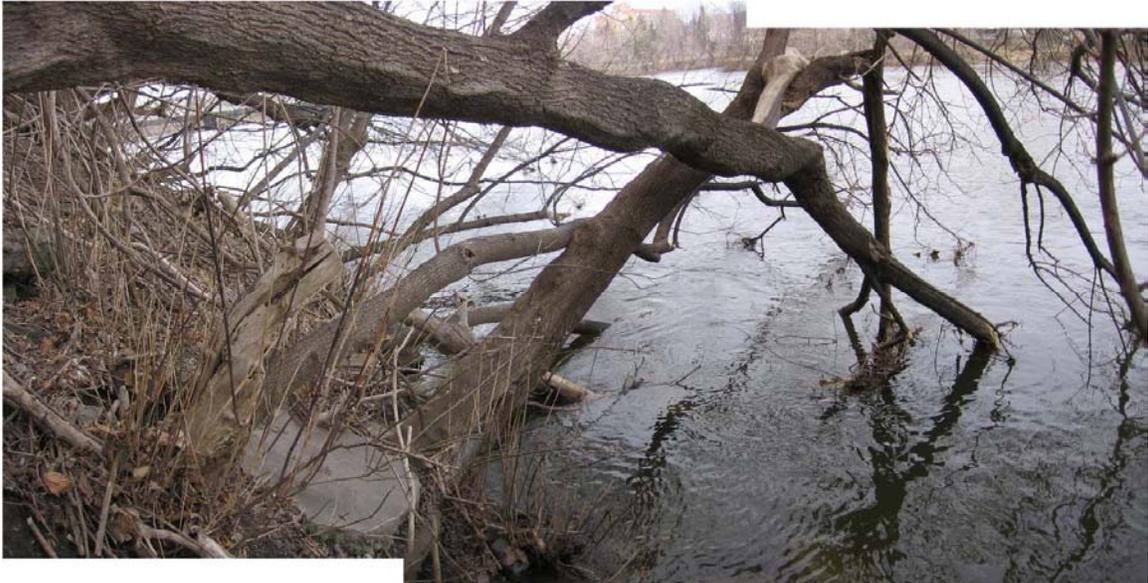
Photo 5. View along the foreshore of the Rideau River, looking downstream from the upstream side, on March 25, 2010.

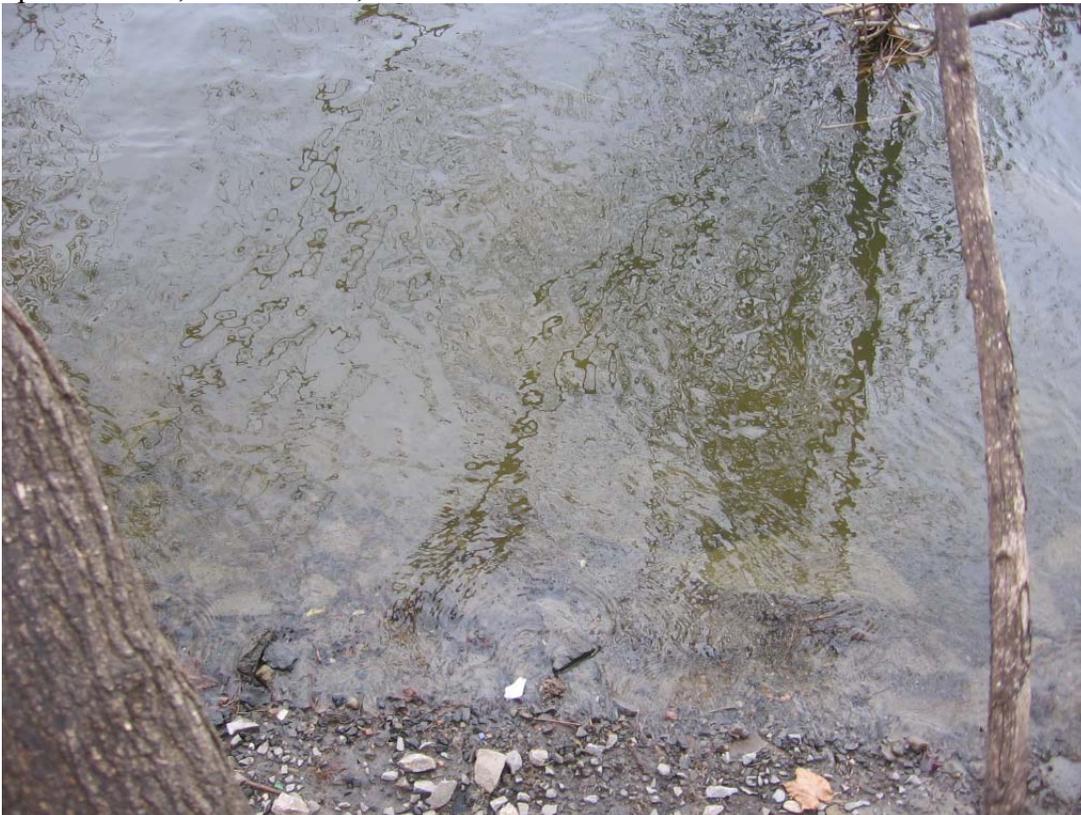
Habitat Resiliency	<ul style="list-style-type: none"> • The shoreline habitat currently present at the site is a mix of broken concrete and related granular material, along with a mix of fine particle substrate and gravel, as indicated in Photos 6, 7 8, 12, 13 and 16 in Appendix 1. It can be seen from the photos that the gravel is fairly embedded. • The shallow littoral habitat is comprised of a sloping silty substrate (Photos 14 and 15), with some large woody debris present. • The Manitoba maples overhang the shoreline providing shade. There is virtually no understory. • Generally, along this section of river, the littoral habitat (Photos 10 and 11) is similar to that depicted in Photos 6, 7 and 8 in Appendix 1. The property immediately downstream has a concrete retaining wall however (Photo 10). • Golder Associates (2010) indicates that the existing bank is erosional and the slope is unstable. This was also noted in the site visits reported upon in this report. Placement of rip-rap is intended to correct this ongoing source of habitat alteration. • Structure provided by large woody debris can be replaced by rip-rap. If necessary, large woody debris could be placed with the rip-rap. • Overhanging vegetation can be replaced with appropriate species of shrubs.

Photo 6. Close-up of the littoral zone along the front of the property showing substrate and degree of embeddedness - March 25, 2010

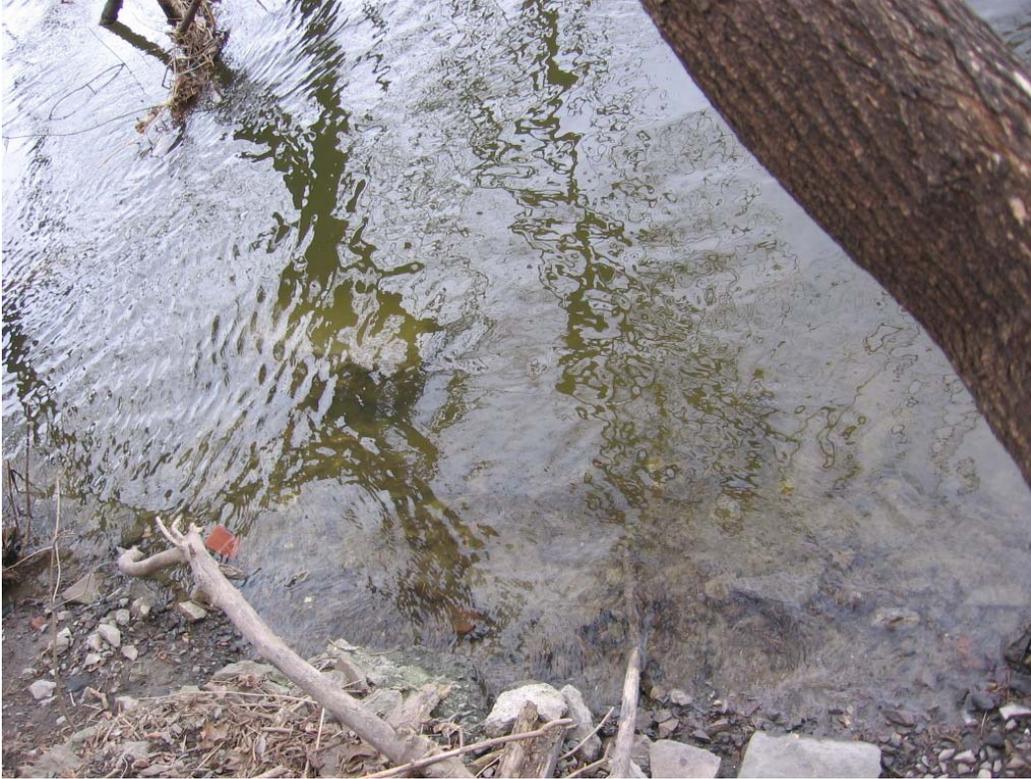
Photo 7. Close-up of the littoral zone along the front of the property showing substrate, habitat structure and degree of embeddedness - March 25, 2010.

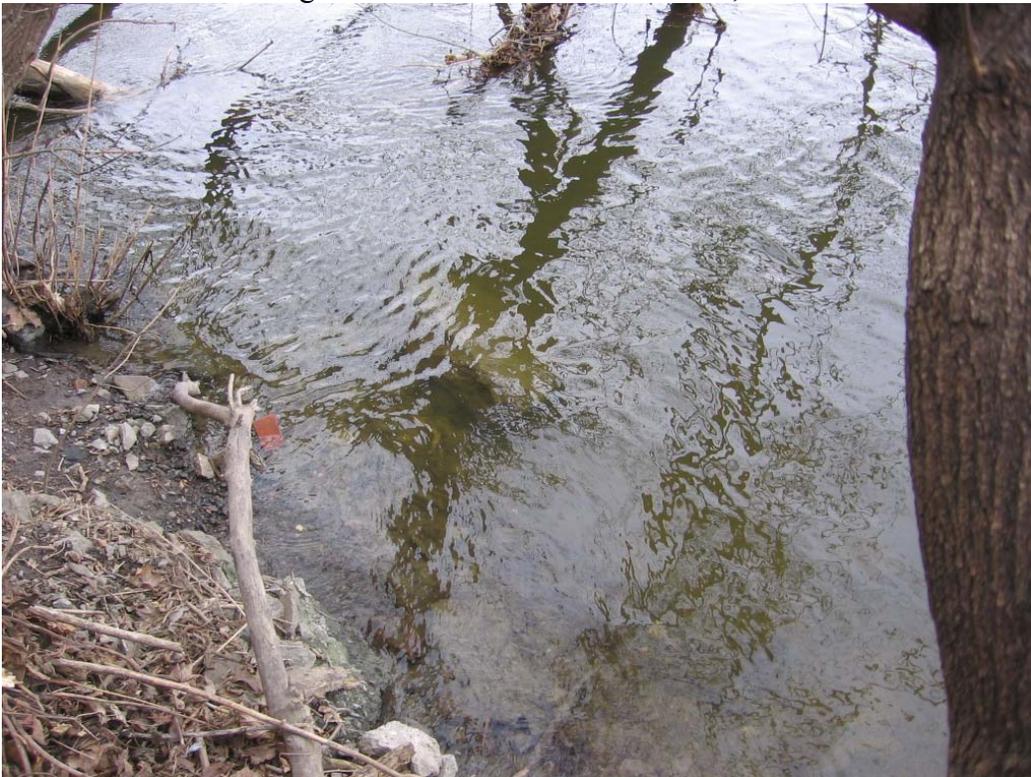
Photo 8. Close-up of the littoral zone along the front of the property showing substrate, habitat structure and degree of embeddedness - March 25, 2010.

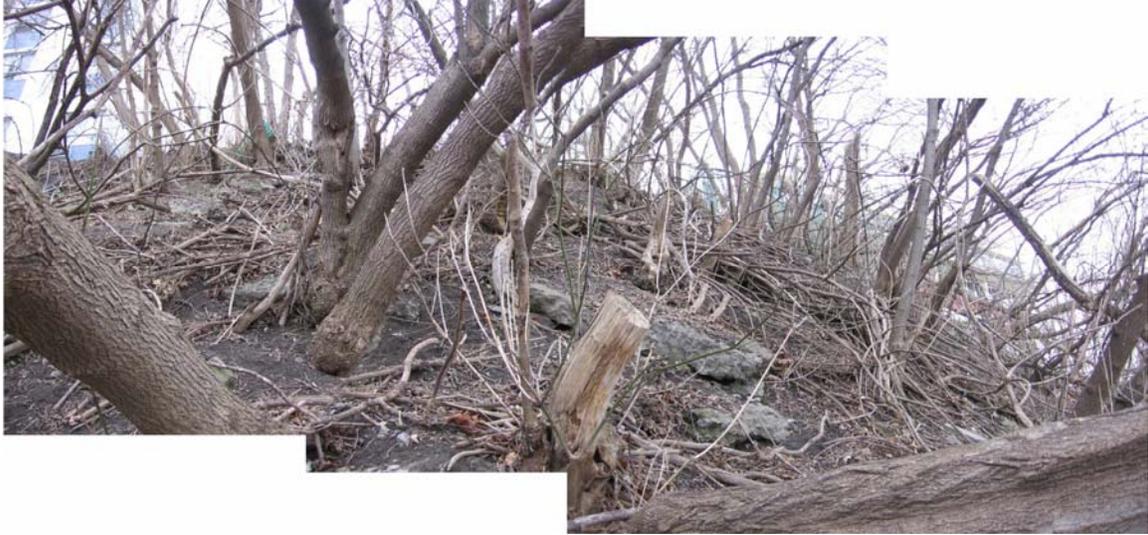
Photo 9. View from the water looking upslope - March 25, 2010.

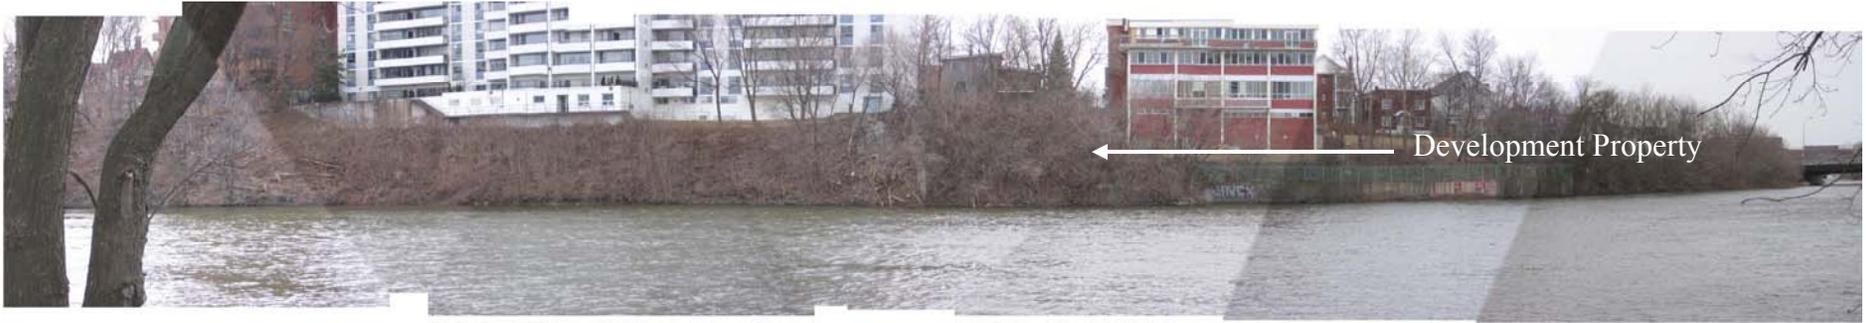
Photo 10. View of the property and adjacent shoreline from across the Rideau River - March 25, 2010.

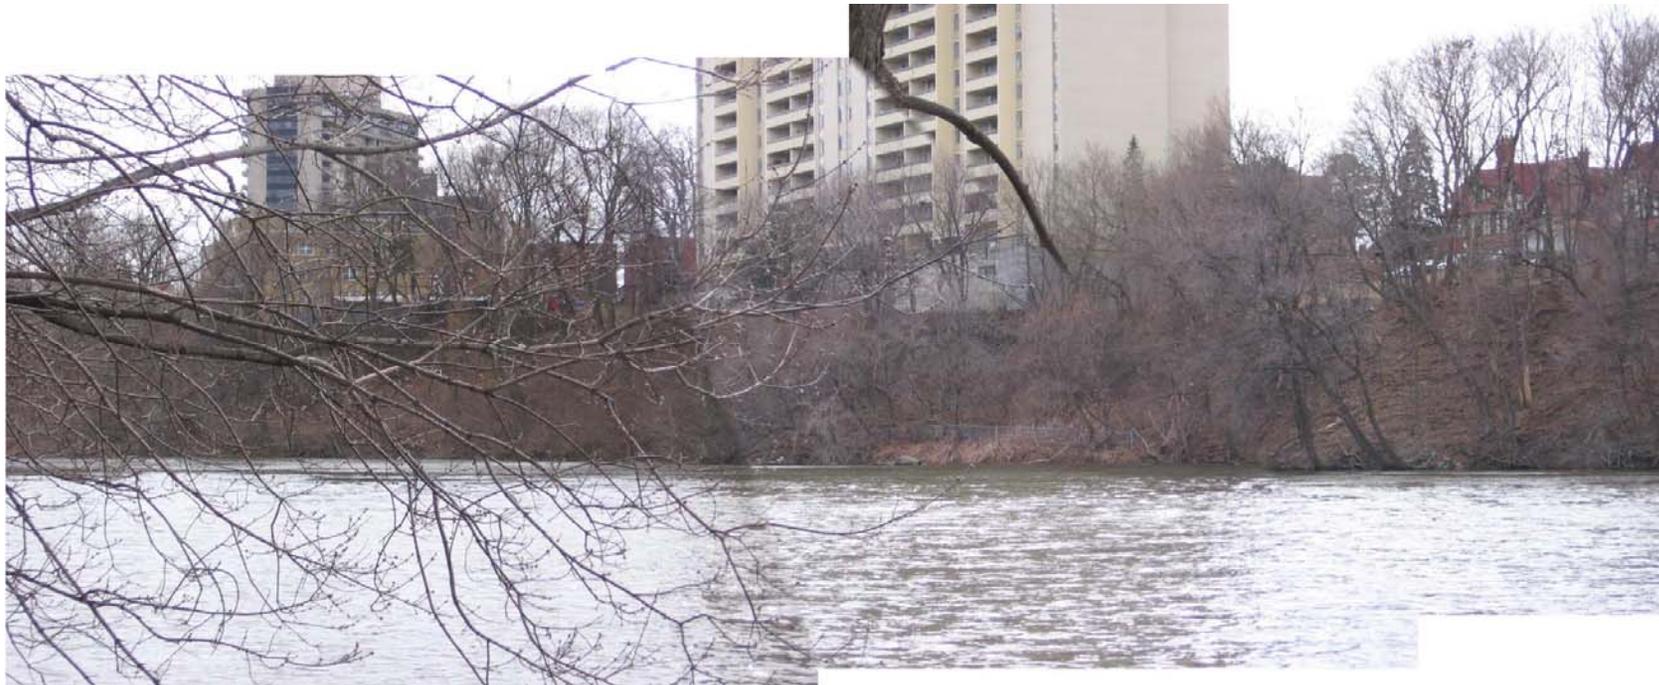
Photo 11. View of the upstream shoreline from across the Rideau River - March 25, 2010.

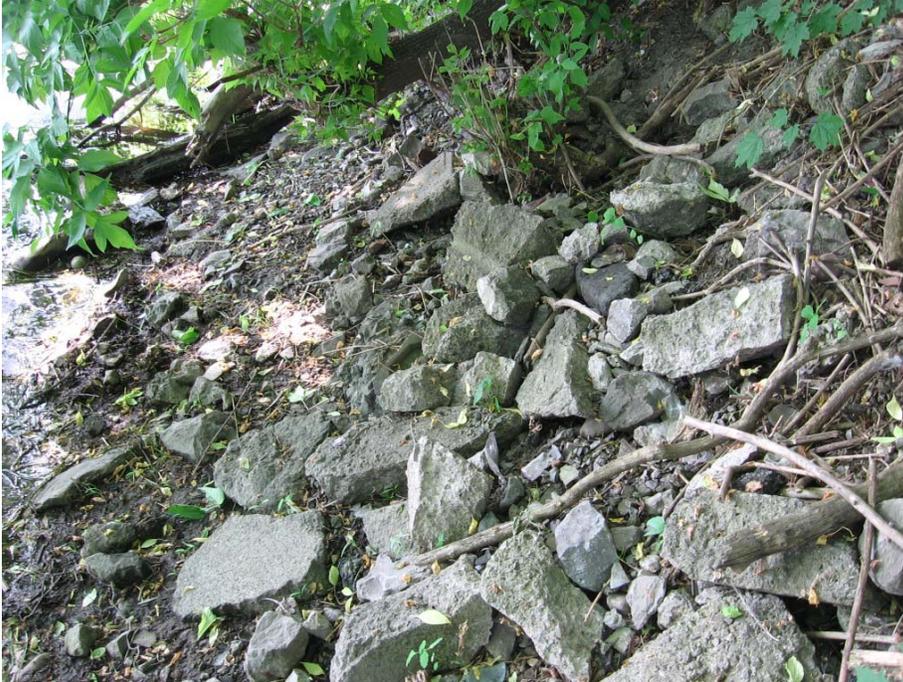
Photos 12 through 16 in Appendix 1 depict the Rideau River shoreline and shallow littoral zone along the property on May 25, 2010. From Photos 12, 13 and 16 it is apparent that the shoreline has a substantial component that is comprised of broken concrete and granular material. Photos 14 and 15 show the shallow littoral zone where the substrate is comprised of silty material. Some submergent aquatic vegetation and a minor amount of large woody debris were present.

Photo 12. Shoreline showing broken concrete that has been moving downslope toward the river – May 25, 2010.

Rip-rap at the toe of the slope would extend approximately 2 meters into the littoral areas of the adjacent Rideau River for a distance of 17.3 meters. Approximately 35 square meters of fish habitat would be altered by the placement of rip-rap at the toe of the slope. Rip-rap would also be placed on the slope itself, meaning that existing vegetation would be removed. Trees would be planted along the toe of the slope, through spaces between the rip-rap.

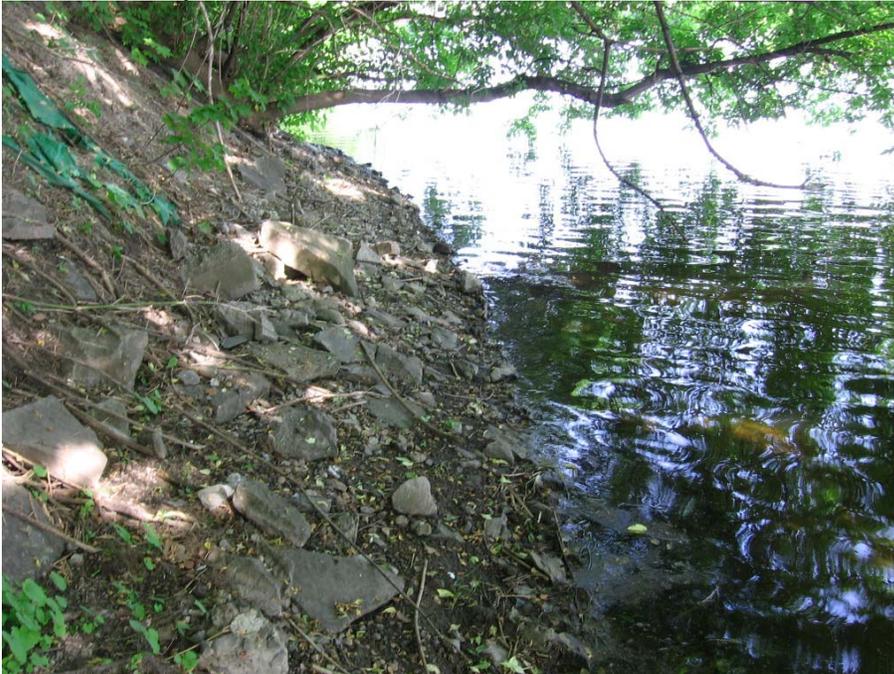
Photo 13. Shoreline showing broken concrete and unconsolidated material that has been moving downslope toward the river. While the Manitoba maples provide overhead shade, the shoreline itself lacked riparian vegetation – May 25, 2010.

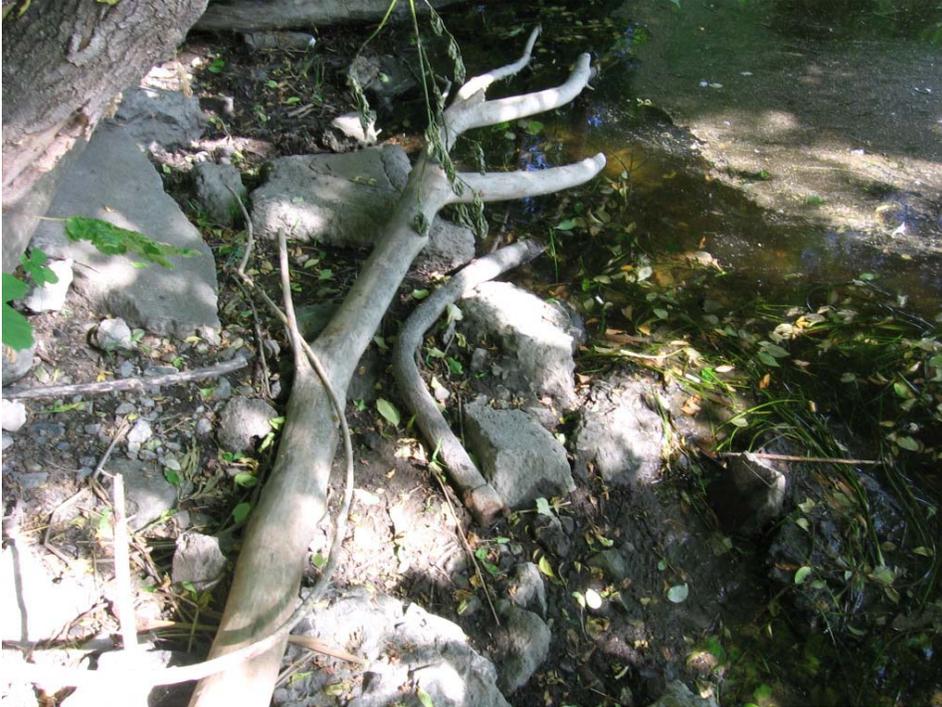
Photo 16. Riparian zone – May 25, 2010.

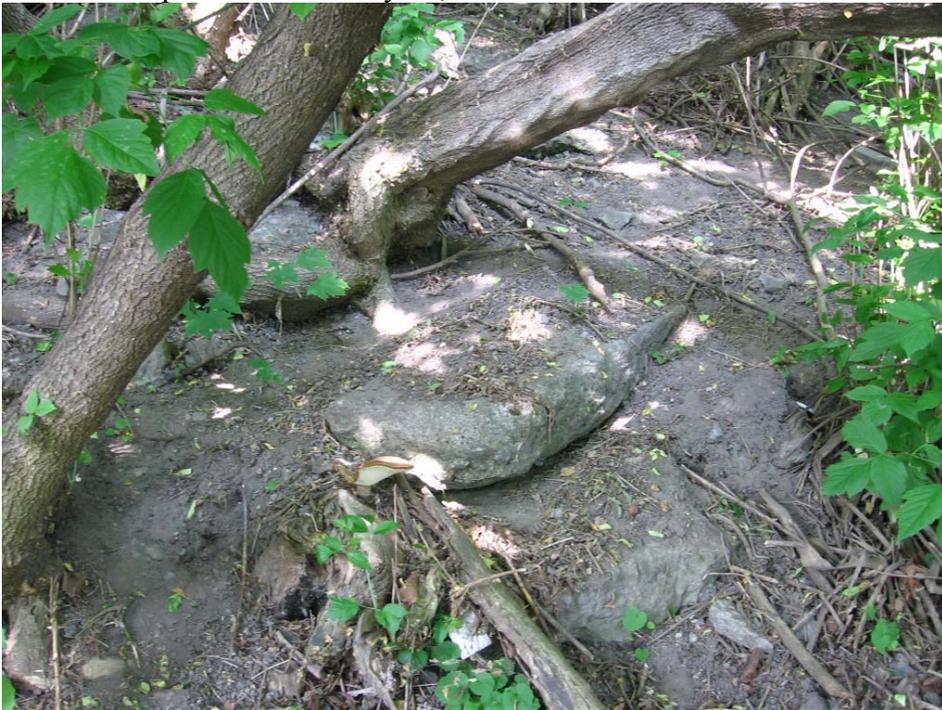
Photo 17. Eroding slope above the shoreline – May 25, 2010.

- Grading the slope to the angle required to ensure stability;
- Stabilizing the slope with rip-rap; and
- Stabilizing the toe of the slope at the Rideau River with rip-rap.
