**Phase I Environmental Site Assessment**

Vacant Property - Oak Ridge Gate Subdivision  
Chinon Place at Breezewood Street  
Ottawa, Ontario

December 6, 2017

Report: PE2326-2

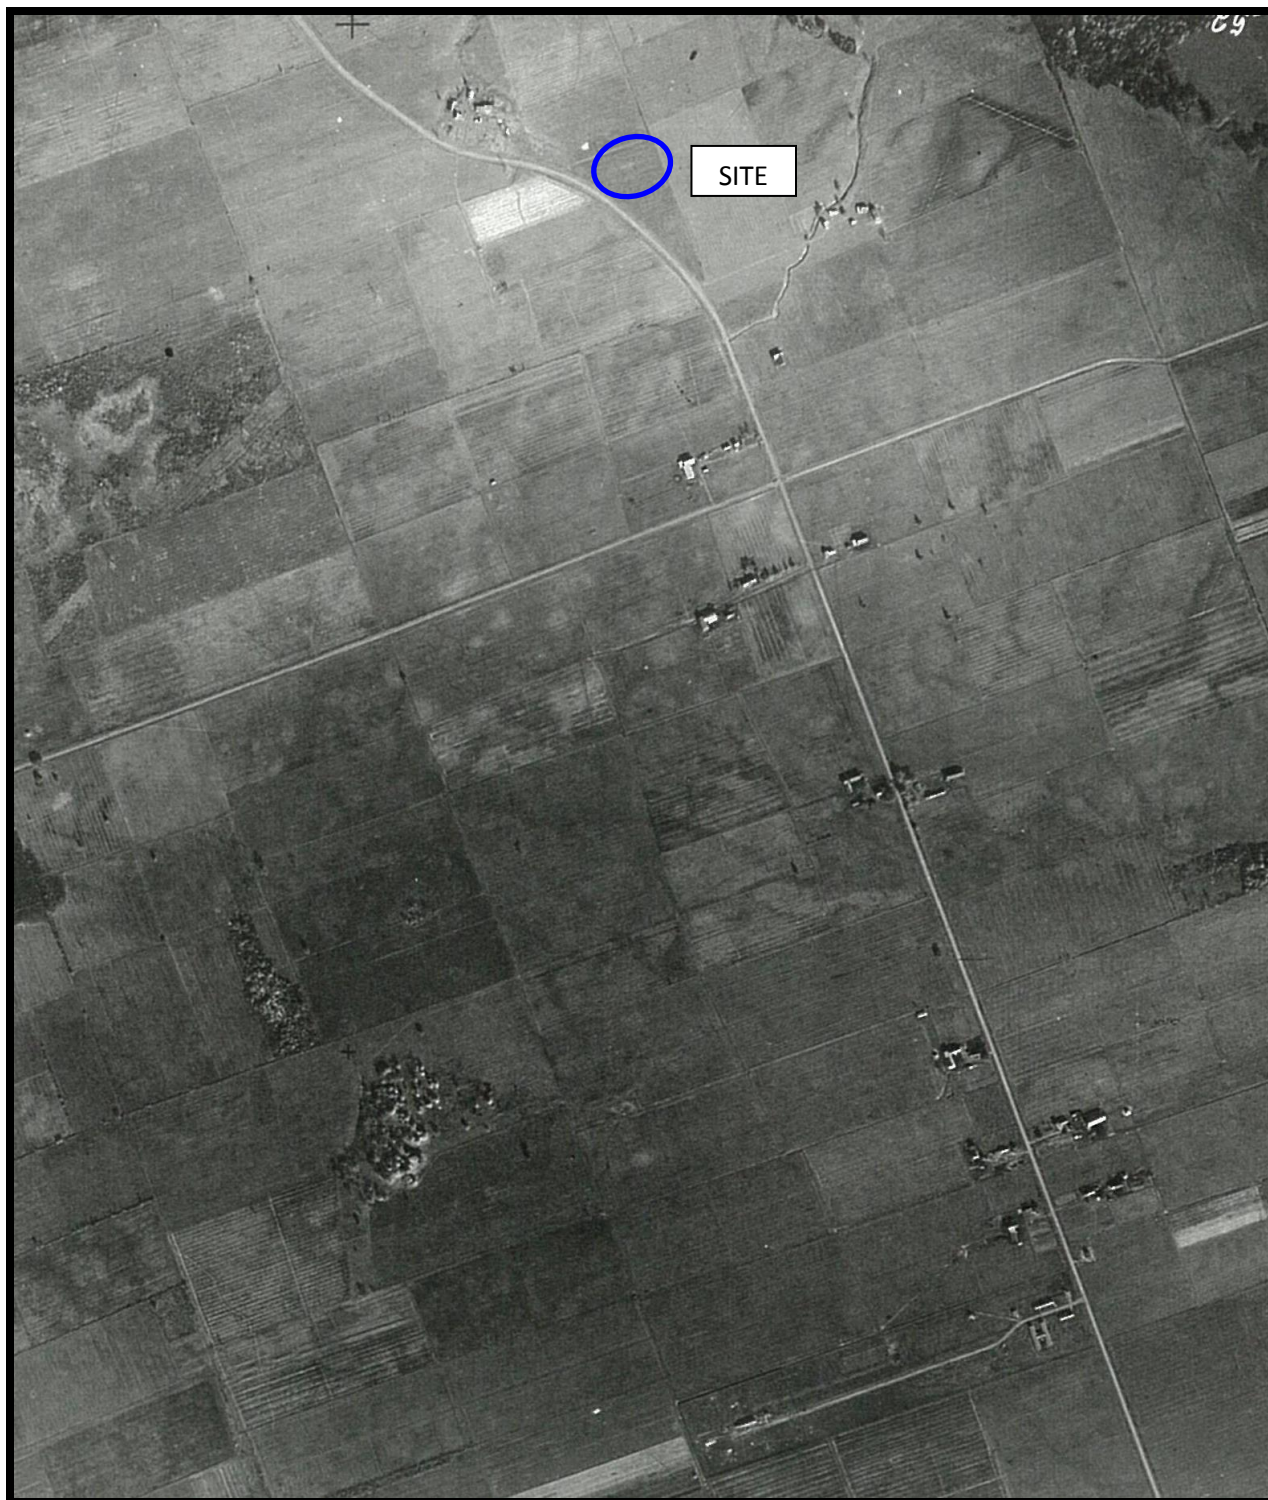
AERIAL PHOTOGRAPH  
1945

| 1945 | The subject site and surrounding properties appear to be used for agricultural purposes. Scattered farmsteads are present in the general area of the subject site. |

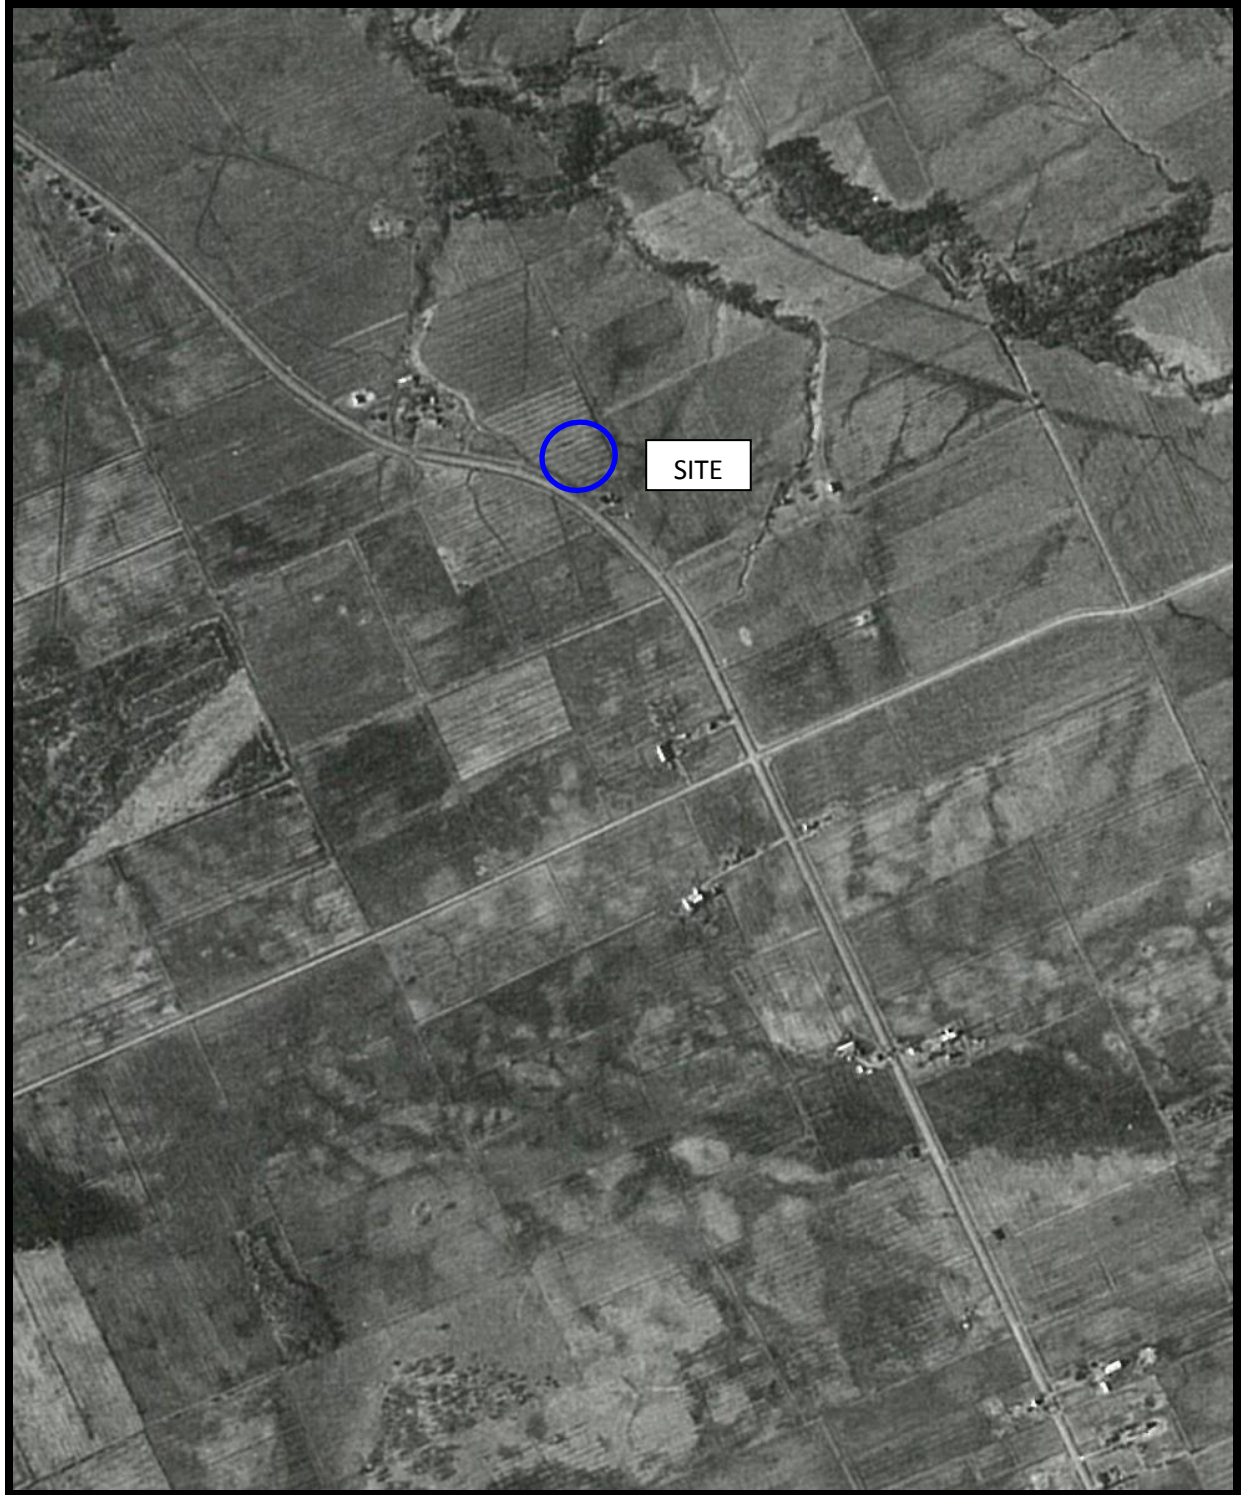
AERIAL PHOTOGRAPH  
1973

| 1973-85 | No apparent changes have been made to the subject site or majority of surrounding properties. The property to the south appears to have been developed with a residential dwelling. |

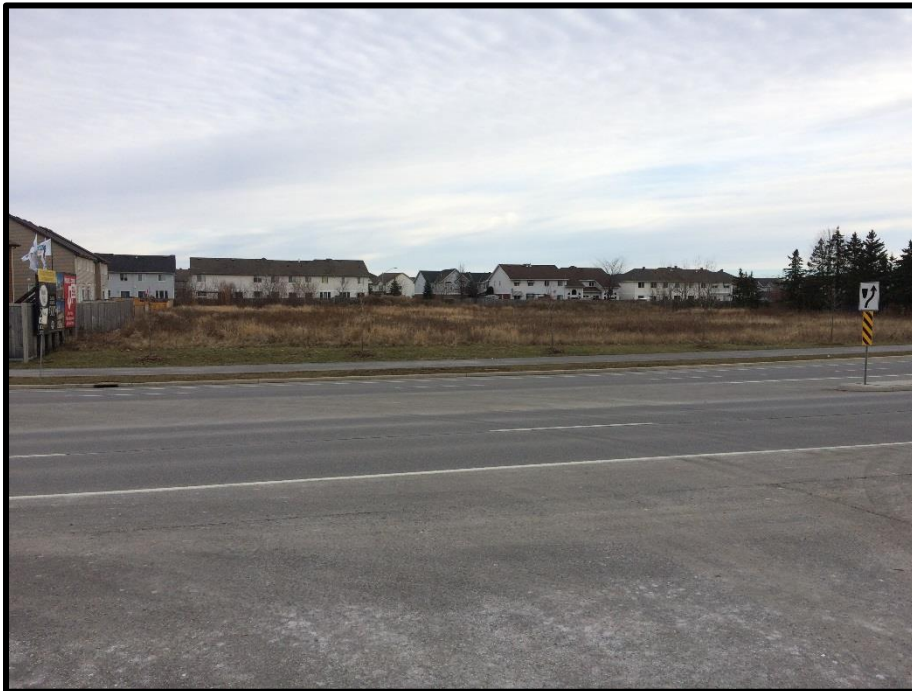
Photograph 1: View of the subject site, facing east. Trim Road is present in the foreground. The subject site is currently vacant grassed land.

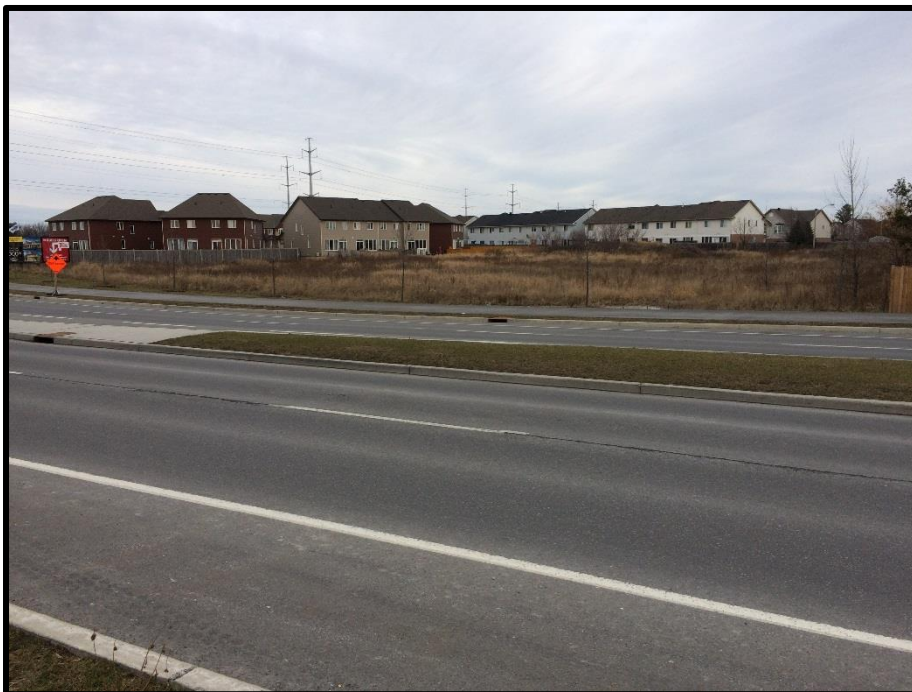
Photograph 2: View of the subject site, facing northeast. The subject site is flanked to the north and east by newer residential properties.

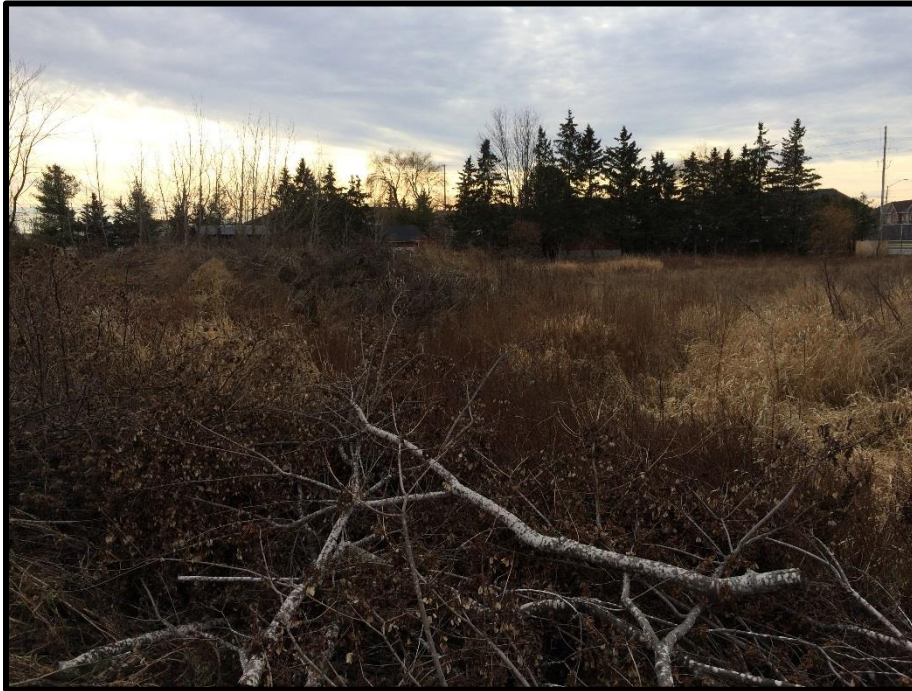
Minor amounts of non-hazardous municipal solid waste and compostable material was present on the subject site at the time of the site visit. These items are not considered an environmental concern.

Photograph 3: View of the subject site, facing southwest. The east portion of the subject site was observed to have some tree clippings and minor amount of non-hazardous solid waste present.
