- **Phase I Environmental
Site Assessment
112 Montreal Road, Ottawa, Ontario**

Type of Document:
Final

Project Number:
OTT-00214936-A0

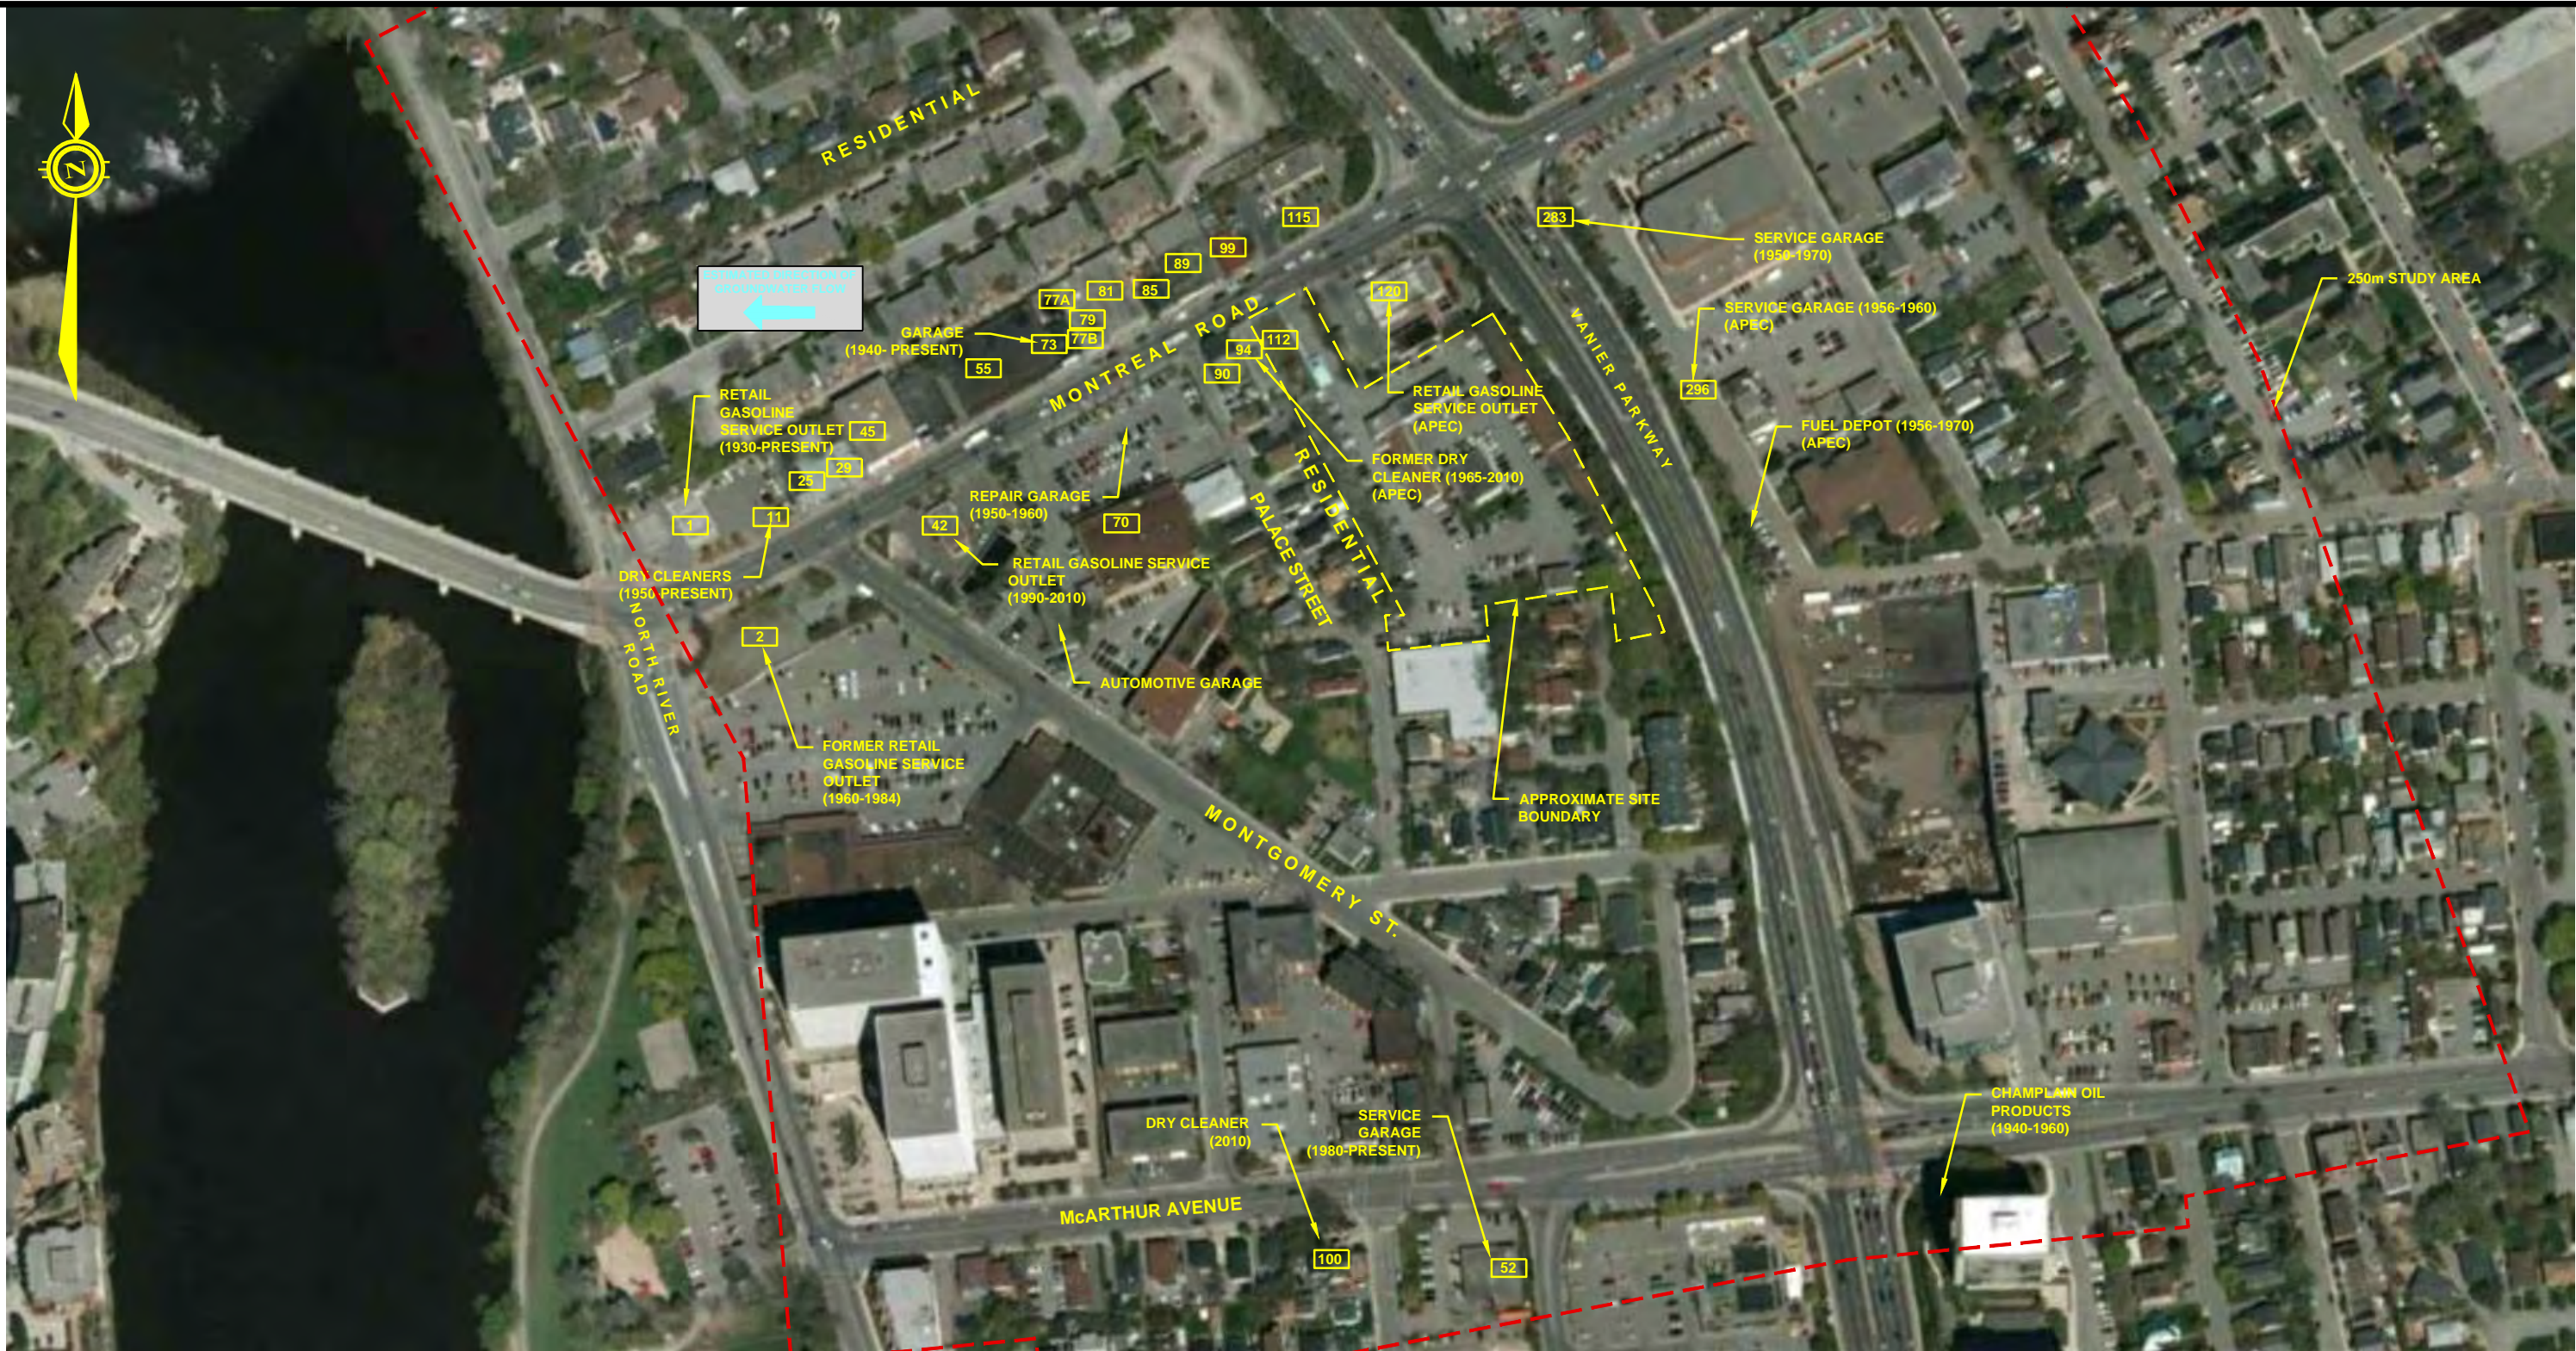
FIG 3

Historical land uses are shown on Figure 3.

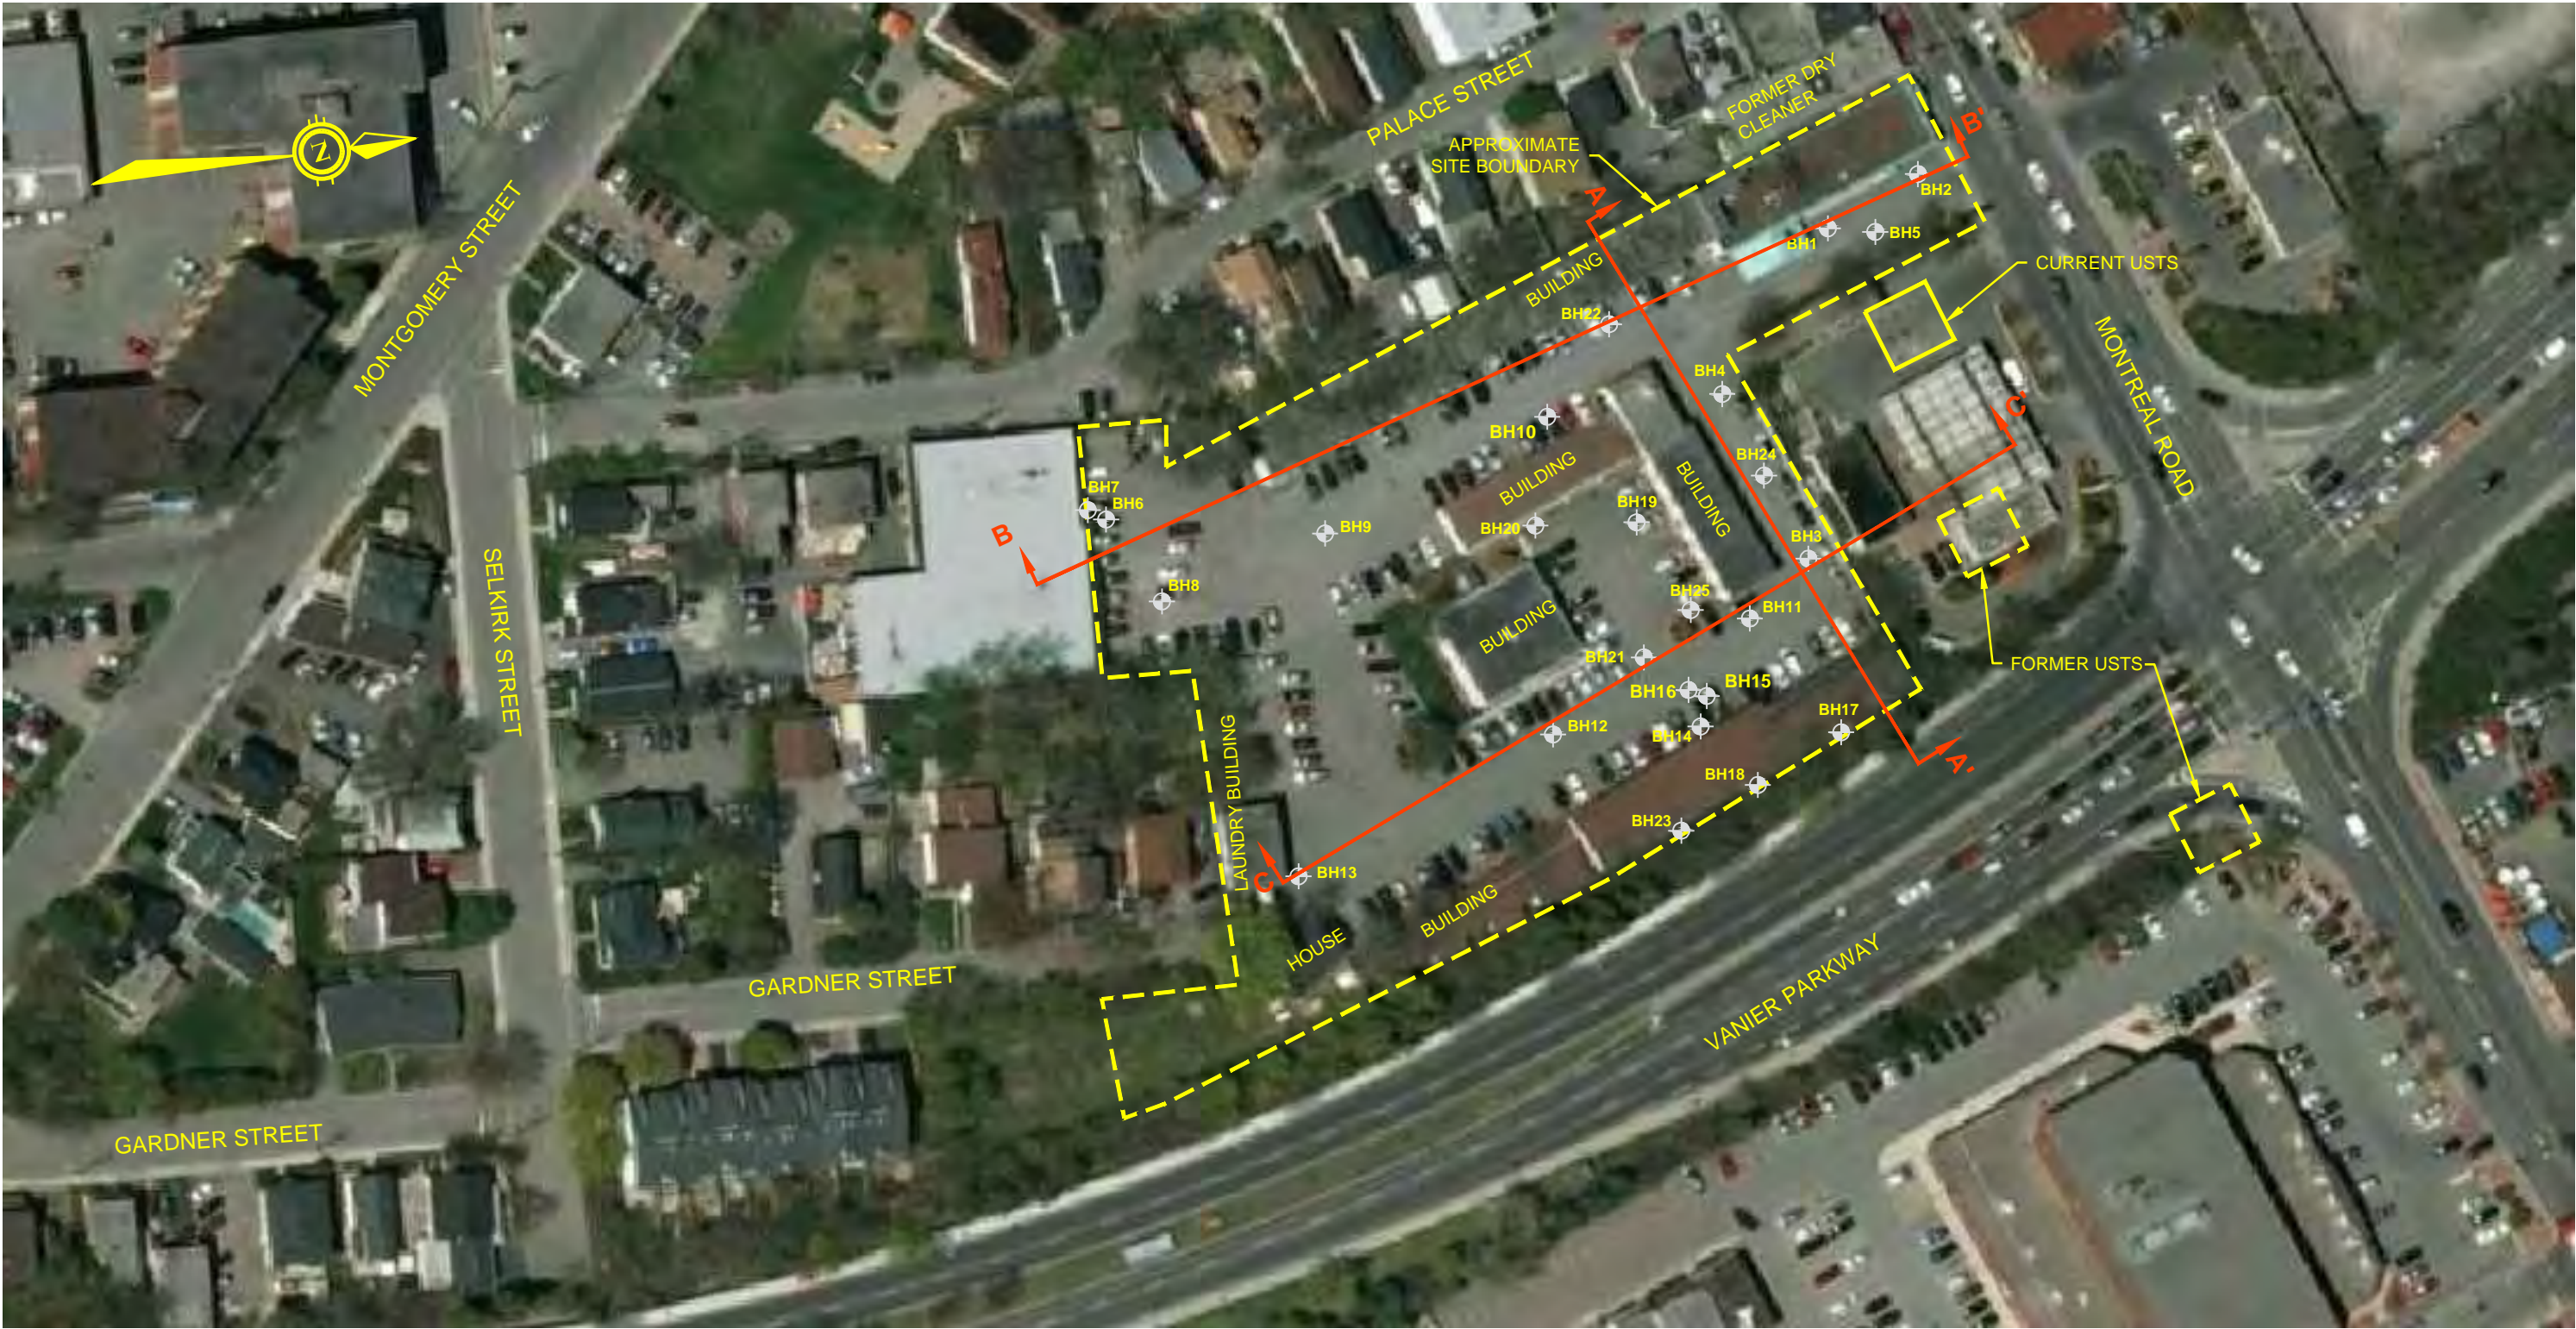
project no.	OTT-00214936-A0
date	DECEMBER 2013
drawing no.	FIG 4

In order to develop a conceptual model for the subject site and surrounding study area, the following physical characteristics and pathways were considered in light of the identified APECs. The APECs to the site are shown on Figures 4 and 5.

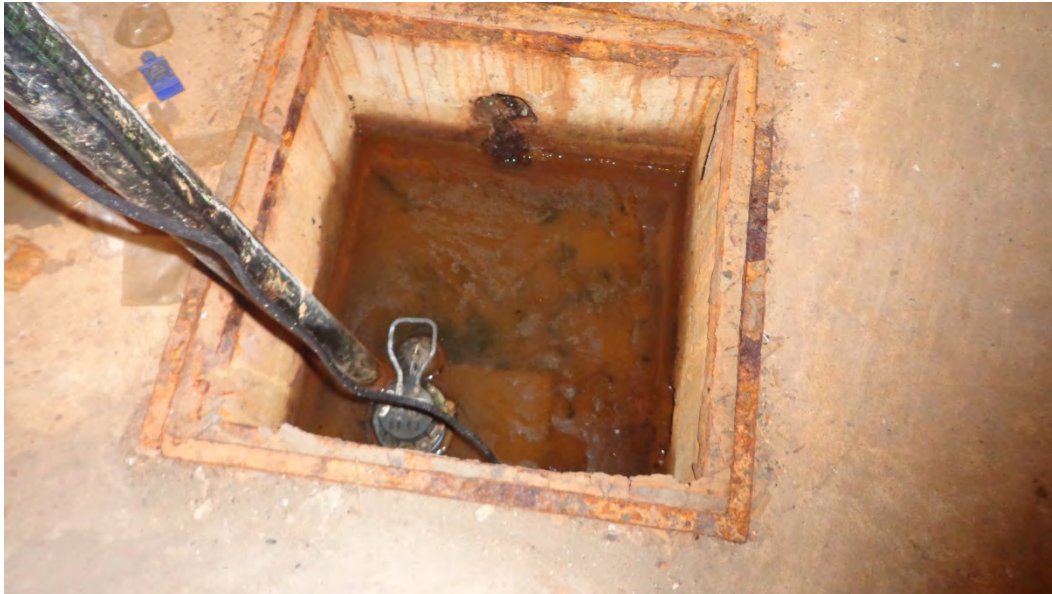
Photograph No. 5

Site drainage is provided via the storm water sewer drains. The main building also has two sump pits located in the basement levels. No sheens were observed in these sumps

View of the sump in the main building to the South

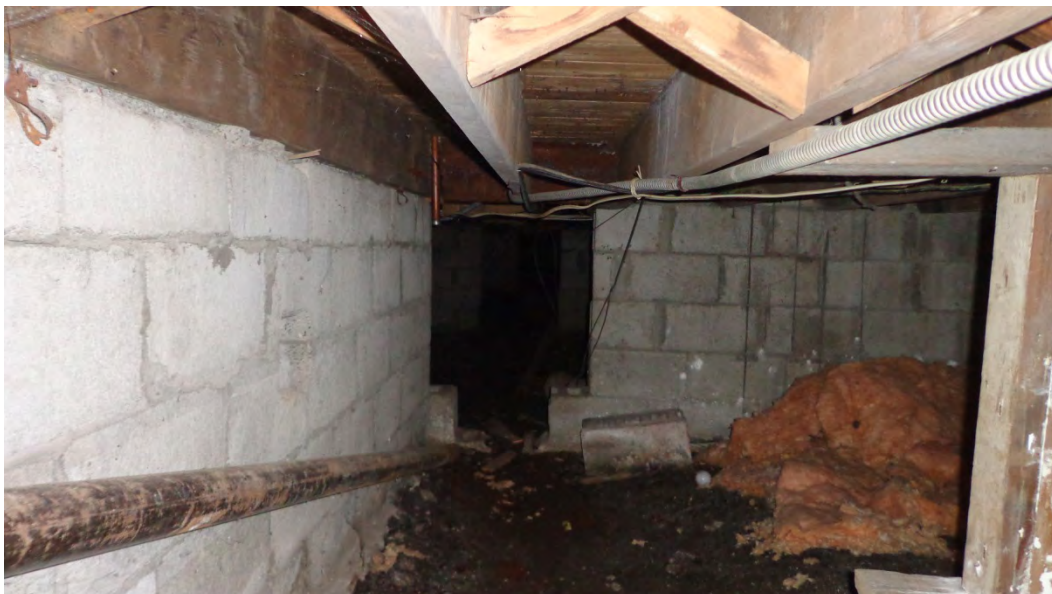
Photograph No. 6

Arsenic levels in surface soil sample from TP-5 (AS2 from 0.04 to 0.1m) exceeded the 1996 soil quality criteria. The elevated levels of arsenic found in surficial materials in the crawlspace under Building B was a concern as the area was accessed by maintenance personnel for repair work. Mitigation measures to remove the impacted soil were recommended. Alternatively, a site specific risk assessment was recommended to determine if the levels of arsenic adversely impact the current use of the site and, if necessary, advise on methods to isolate the impacted soil from human contact.

View of the crawl space in the building closest to the parkway that is out of service

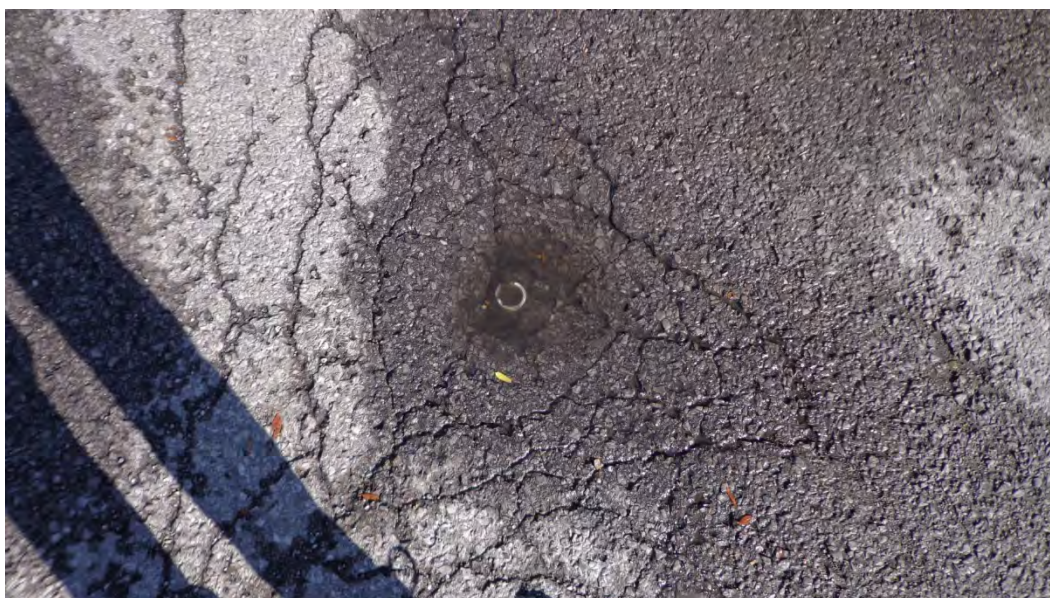
Photograph No. 8

There appeared to be three badly damaged monitoring wells at the site in the parking lot. They did not have protective covers and appeared to be filled in with sediment.

A view of an existing monitoring well that should be decommissioned

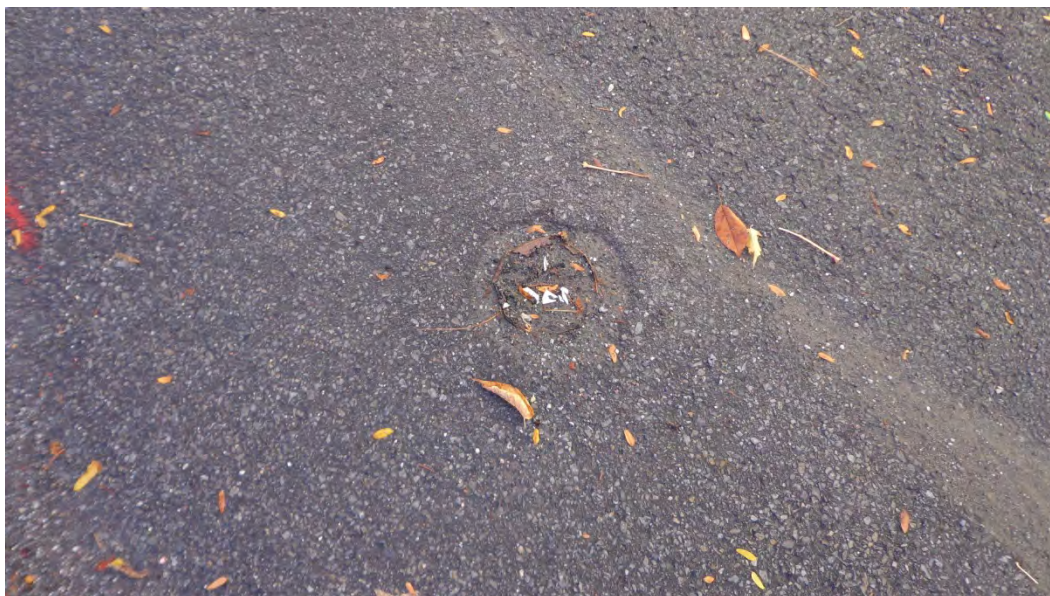
Photograph No. 9

A view of an existing monitoring well that should be decommissioned

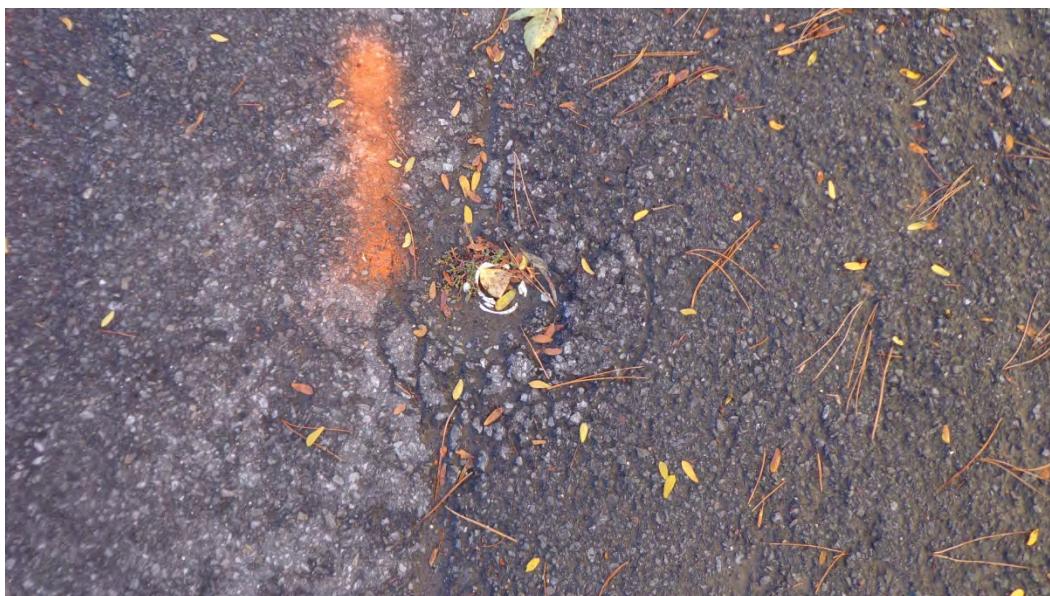
Photograph No. 10

A view of an existing monitoring well that should be decommissioned
