Phase I Environmental Site Assessment

Vacant Land
590 Rideau Street
Ottawa, Ontario

March 9, 2016

Report: PE2706-2

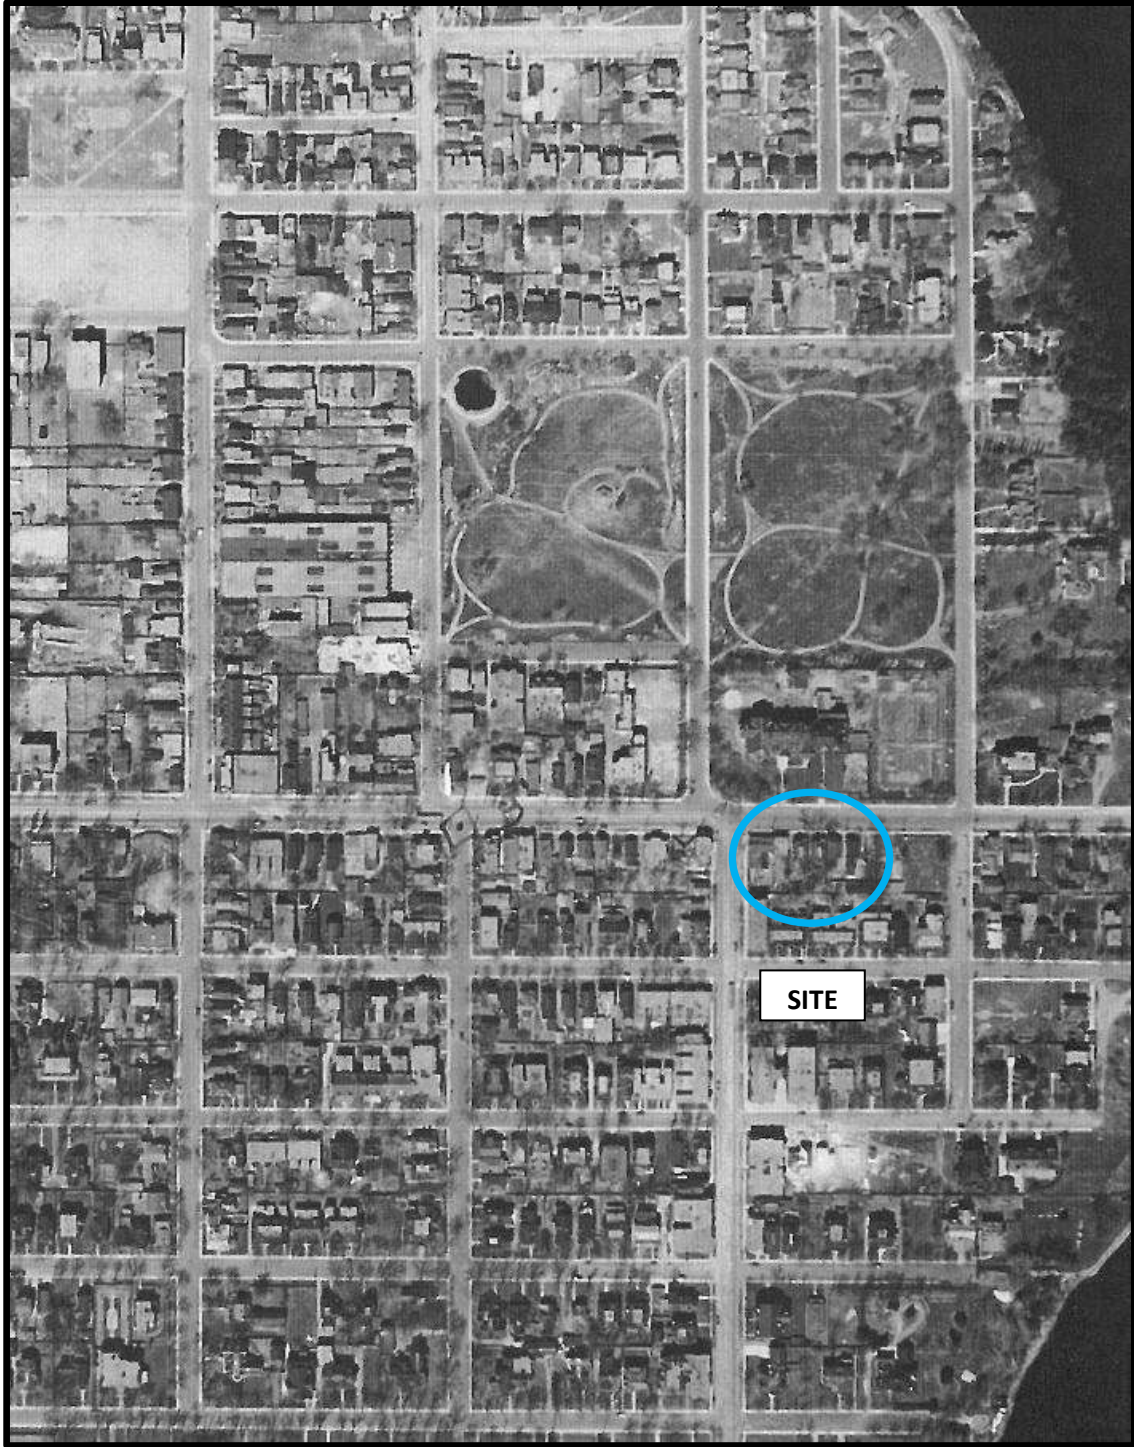
AERIAL PHOTOGRAPH
1928

| 1928 | The subject property is occupied by four (4) structures. Adjacent buildings to the south are occupied by residential buildings. The property to the north, across Rideau Street, is occupied by a residential or possibly institutional building. The adjacent property to the east is occupied by a residential dwelling. The property to the west, across Charlotte Street, is occupied by a residential or commercial building. |

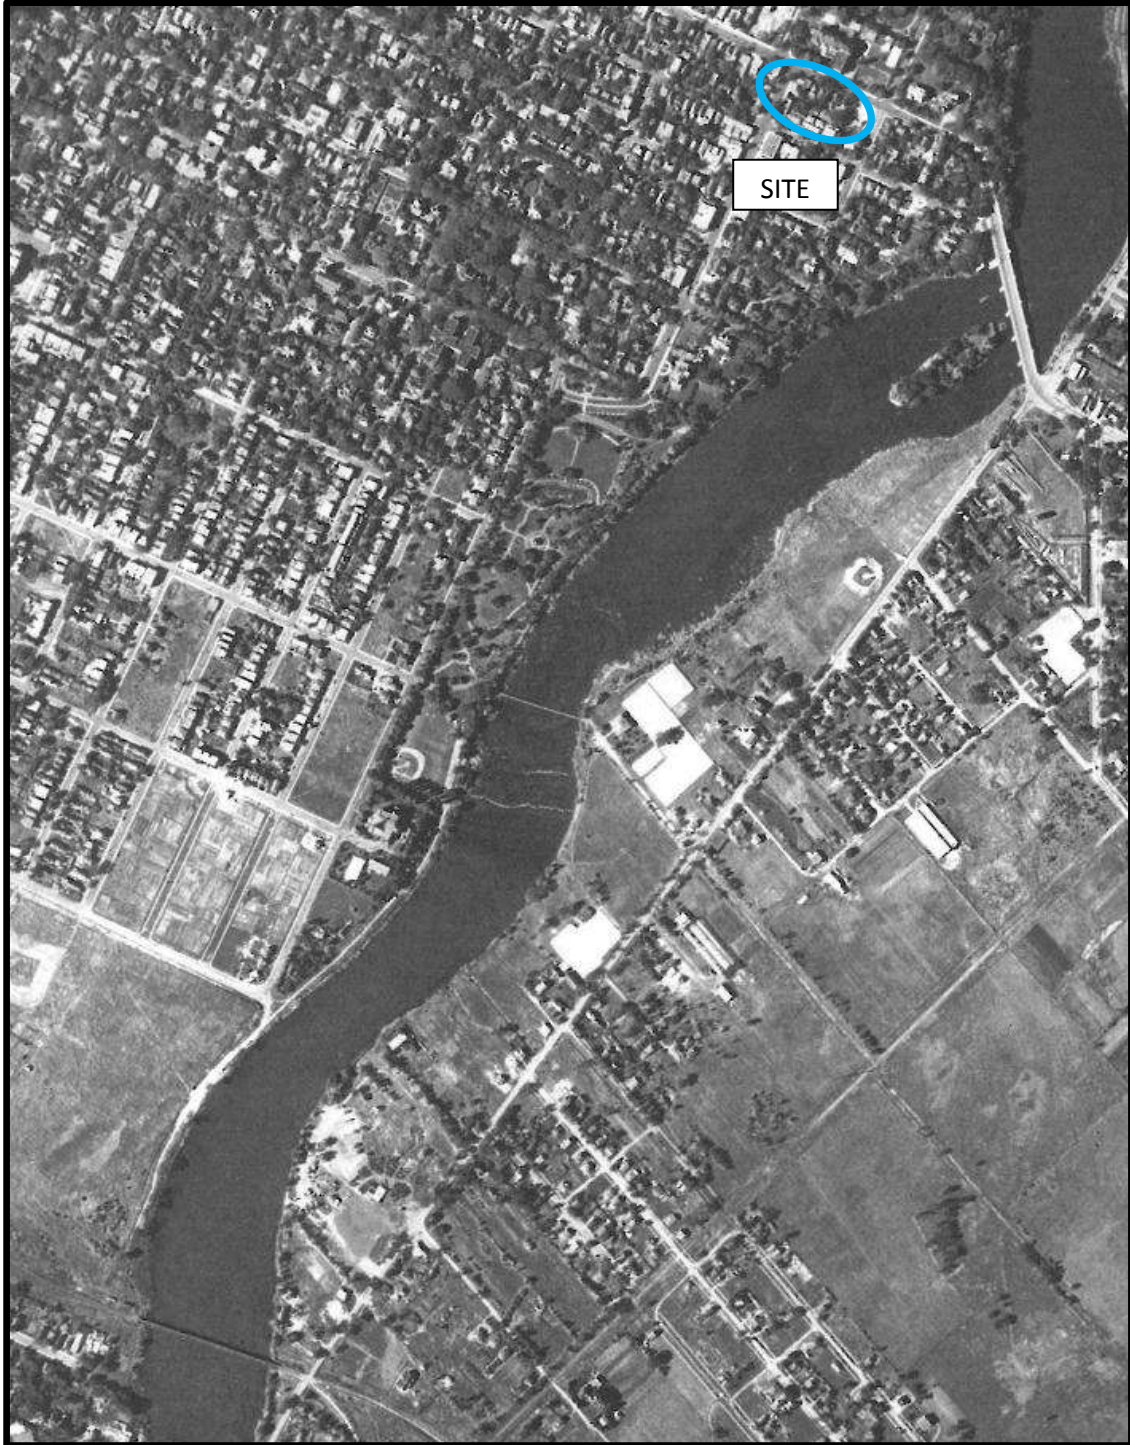
AERIAL PHOTOGRAPH
1938

| 1938 | No significant changes have been made to the subject site or neighbouring properties. |

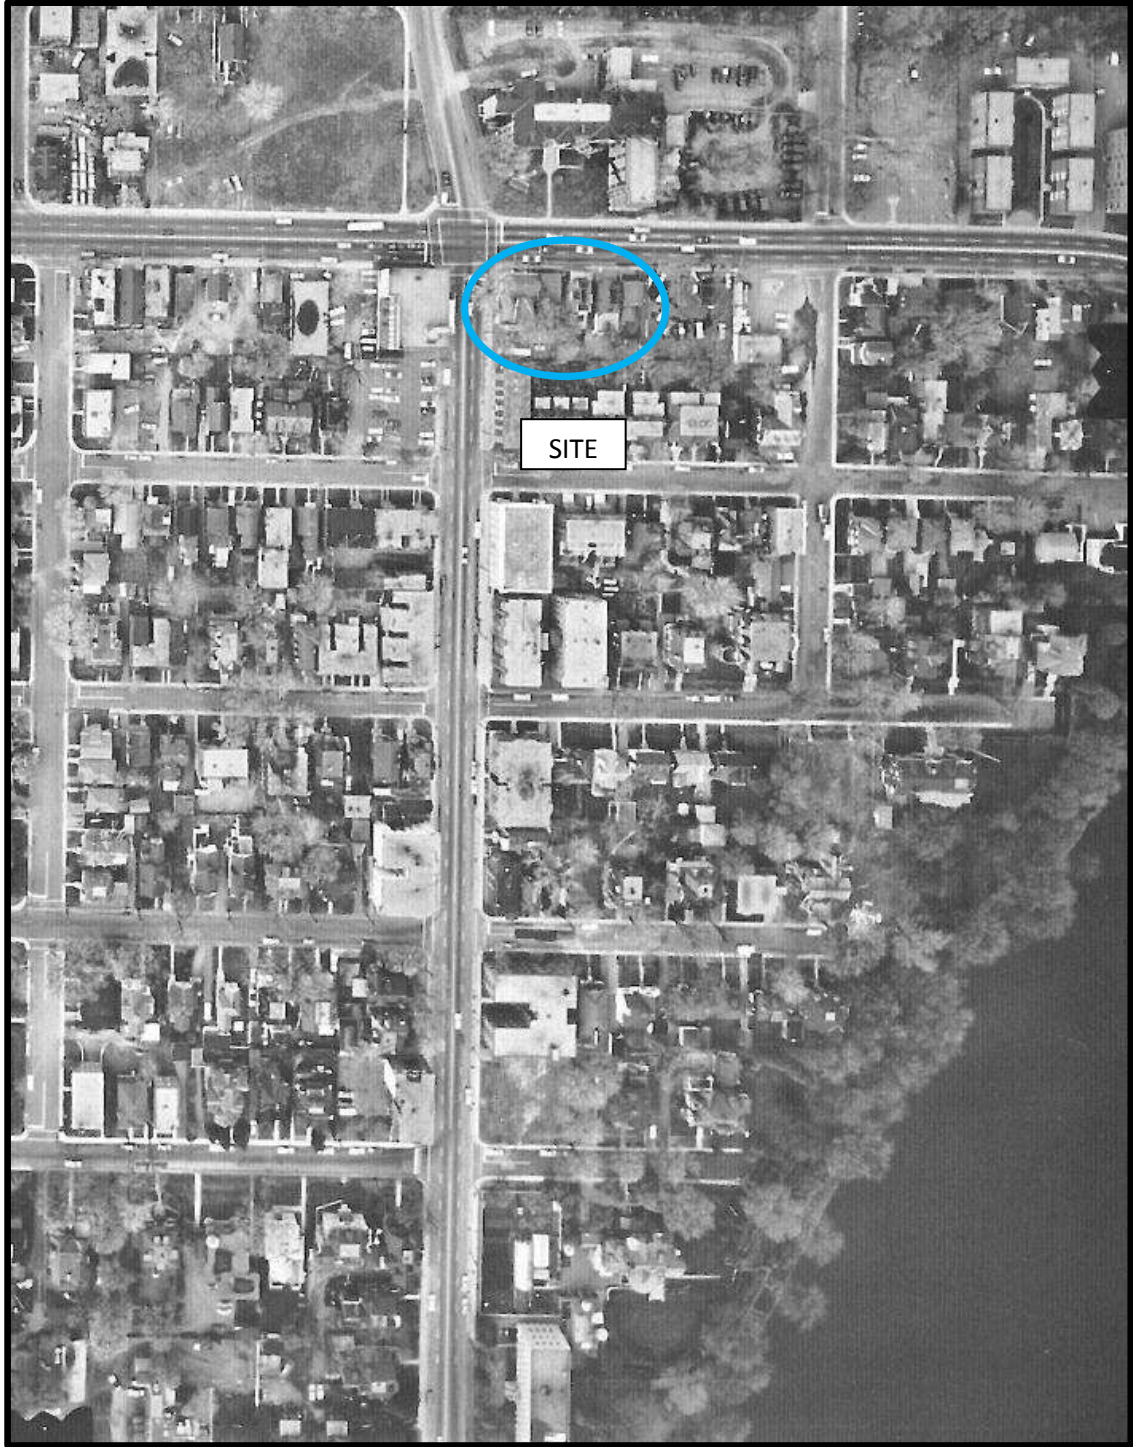
AERIAL PHOTOGRAPH
1968

- 1968 No significant changes have been made to the subject site. Structures on a neighbouring property to the northwest, across the Rideau Street and Charlotte Street intersection, have been demolished and the land is vacant.
