REPORT ON

**PHASE I
ENVIRONMENTAL SITE ASSESSMENT
1344 BARFIELD ROAD
OSGOODE WARD, GREELY
CITY OF OTTAWA
ONTARIO**

DATE August 31, 2010

100667

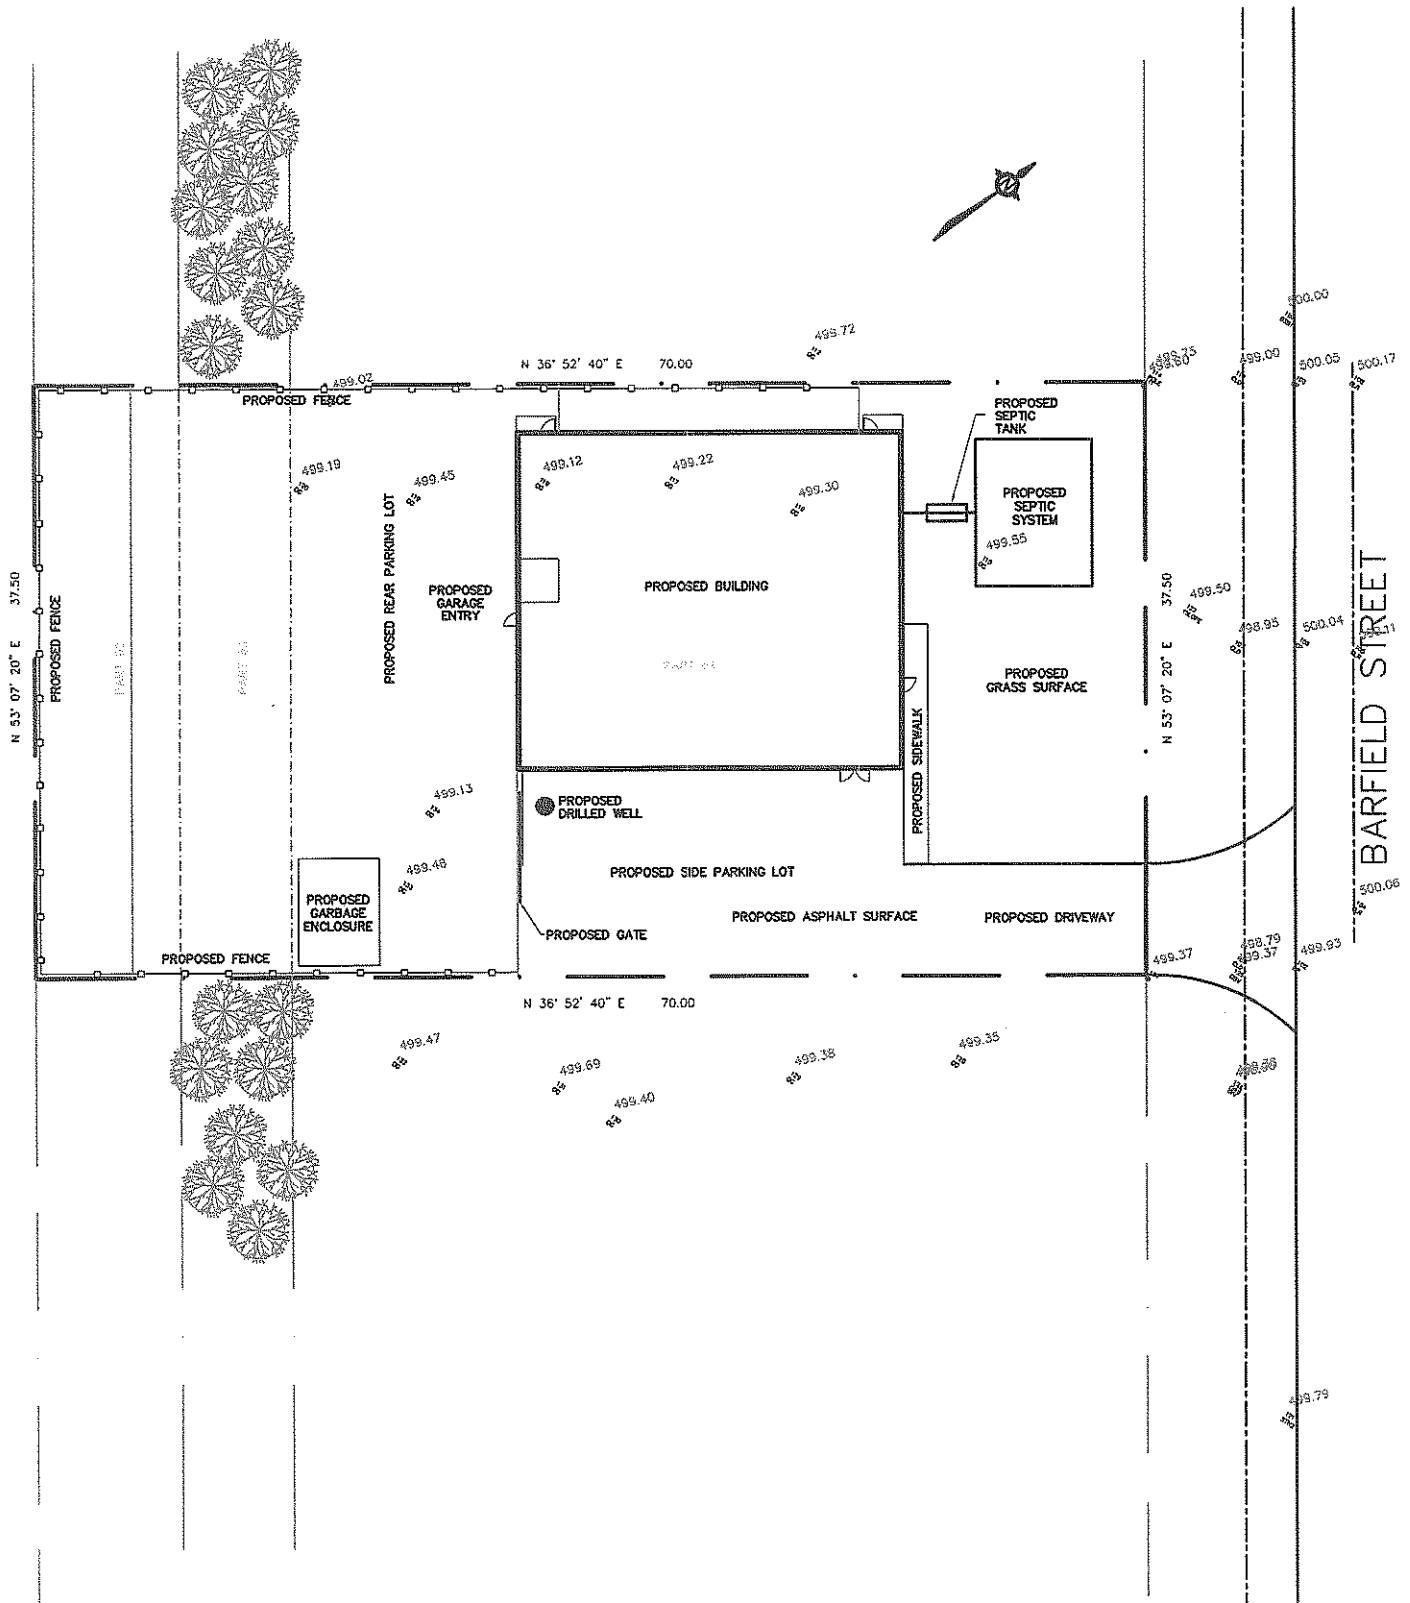
The attached Key Plan, Figure 1, Site Plan, Figure 2 and air photographs (Attachment B) show the relative location of the subject site with respect to the surrounding land and the existing roadway network. The site is located within an area of industrial development. Currently, the site consists of vacant, undeveloped land.

The ground surface across the site is relatively flat lying. A ditch exists along the east side of the site adjacent to Barfield Road.

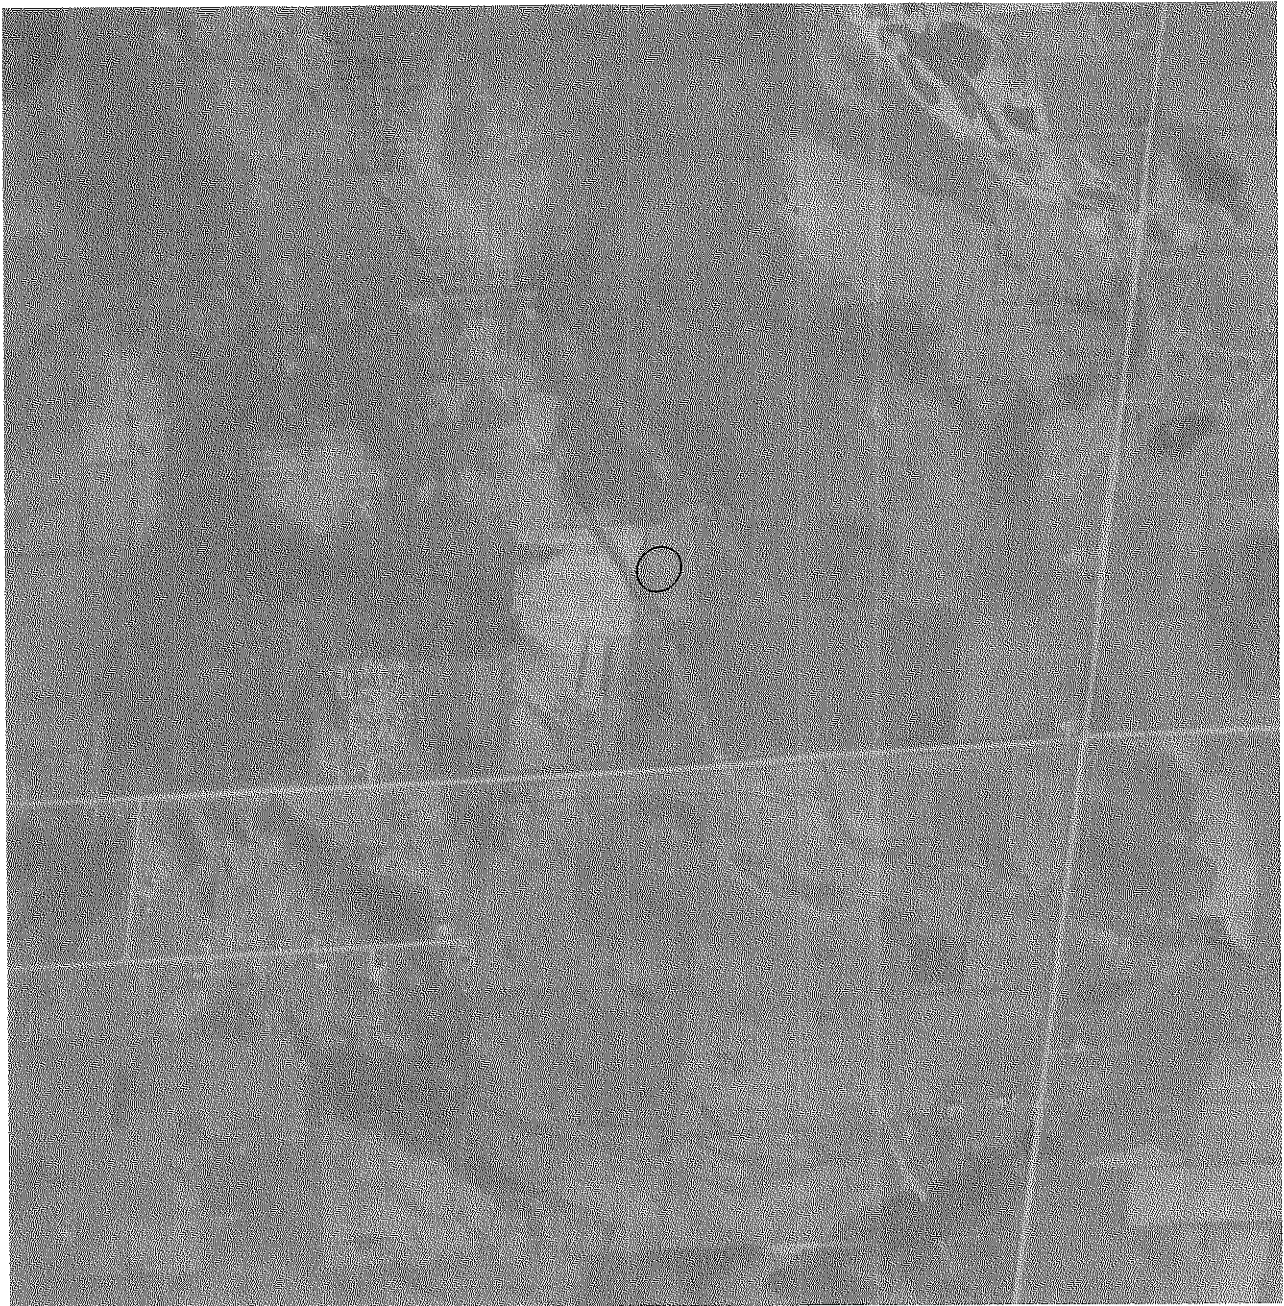
1969

A review of air photographs for the site for the years 1969, 1975, 1989, 1997, 2002, 2005 and 2008 was carried out as part of this Phase I ESA (see Attachment B). An auto wrecker yard and an oil pipeline, located west of the site, and a hydro corridor, located east of the site, are visible in all of the air photographs. The 1969, 1975 and 1989 air photographs indicate the site and most of the surrounding area in use for agriculture, with progressive residential development visible east and west of the site. The 1989 air photograph indicates roadways have been constructed for the industrial park. The 1997, 2002, 2005 and 2008 air photograph indicates development has occurred within the industrial park, however, the subject site has remained vacant and has become partially tree covered. The 2002 air photograph indicates some tree clearing and/or possible fill placement near the south property line at the site, possibly on the adjacent property.
