Preliminary Phase II Environmental Site Assessment

667 Bank Street
Ottawa, Ontario

August 8, 2016

Report: PE3865-2

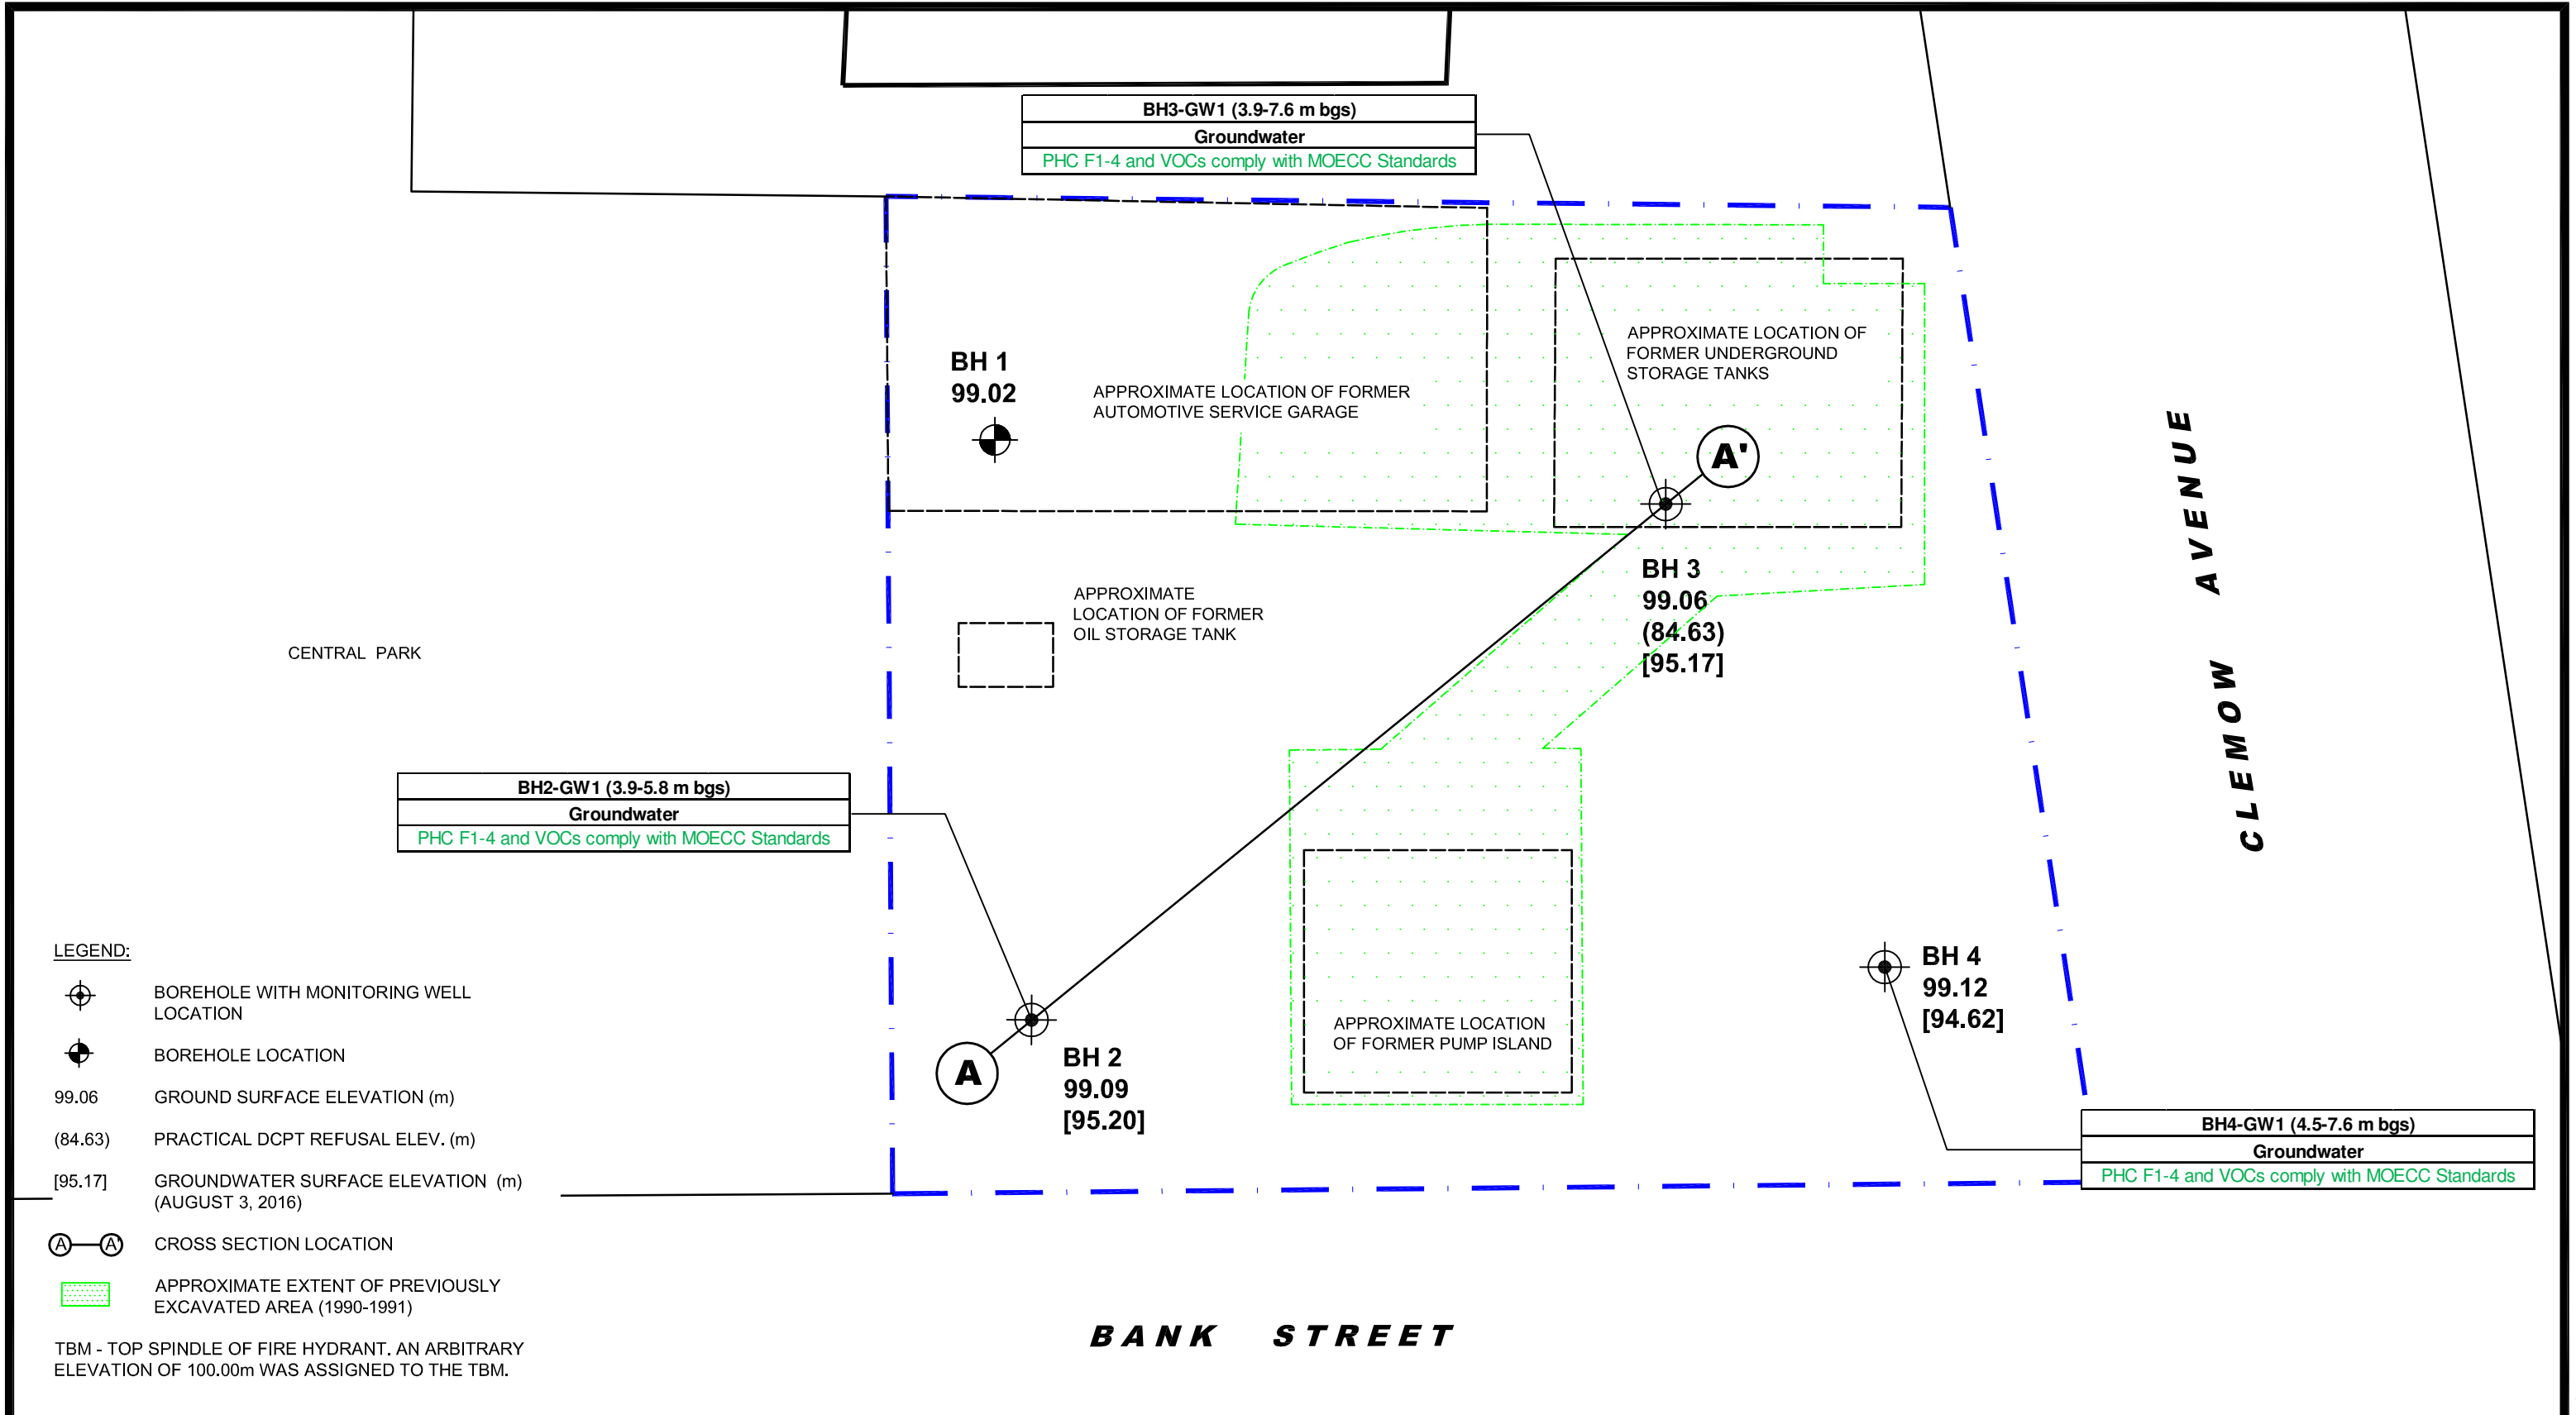
Scale:	1:100	Date:	08/2016
Drawn by:	AG	Report No.:	PE3865
Checked by:	MD	Dwg. No.:	PE3865-3
Approved by:	MD	Revision No.:	0

An investigation, conducted primarily for geotechnical purposes, was conducted on May 18, 2016. The investigation consisted of four (4) boreholes advanced to a maximum depth of 14.4 m below ground surface. Groundwater monitoring wells were installed in three of the boreholes to allow groundwater quality to be assessed. The test hole locations were selected in a manner as to provide general coverage of the proposed development site. The borehole locations are illustrated on Drawing No. PE3865-3 - Test Hole Locations Plan.

The subsurface investigation was conducted in May 2016, and consisted of the placement of four (4) boreholes (BH1 to BH4) on the subject property. Groundwater monitoring wells were installed in BH2, BH3 and BH4. The borehole locations are illustrated on Drawing No. PE3865-3 - Test Hole Location Plan. The boreholes were advanced using a truck mounted drill rig under the full time supervision of Paterson personnel.

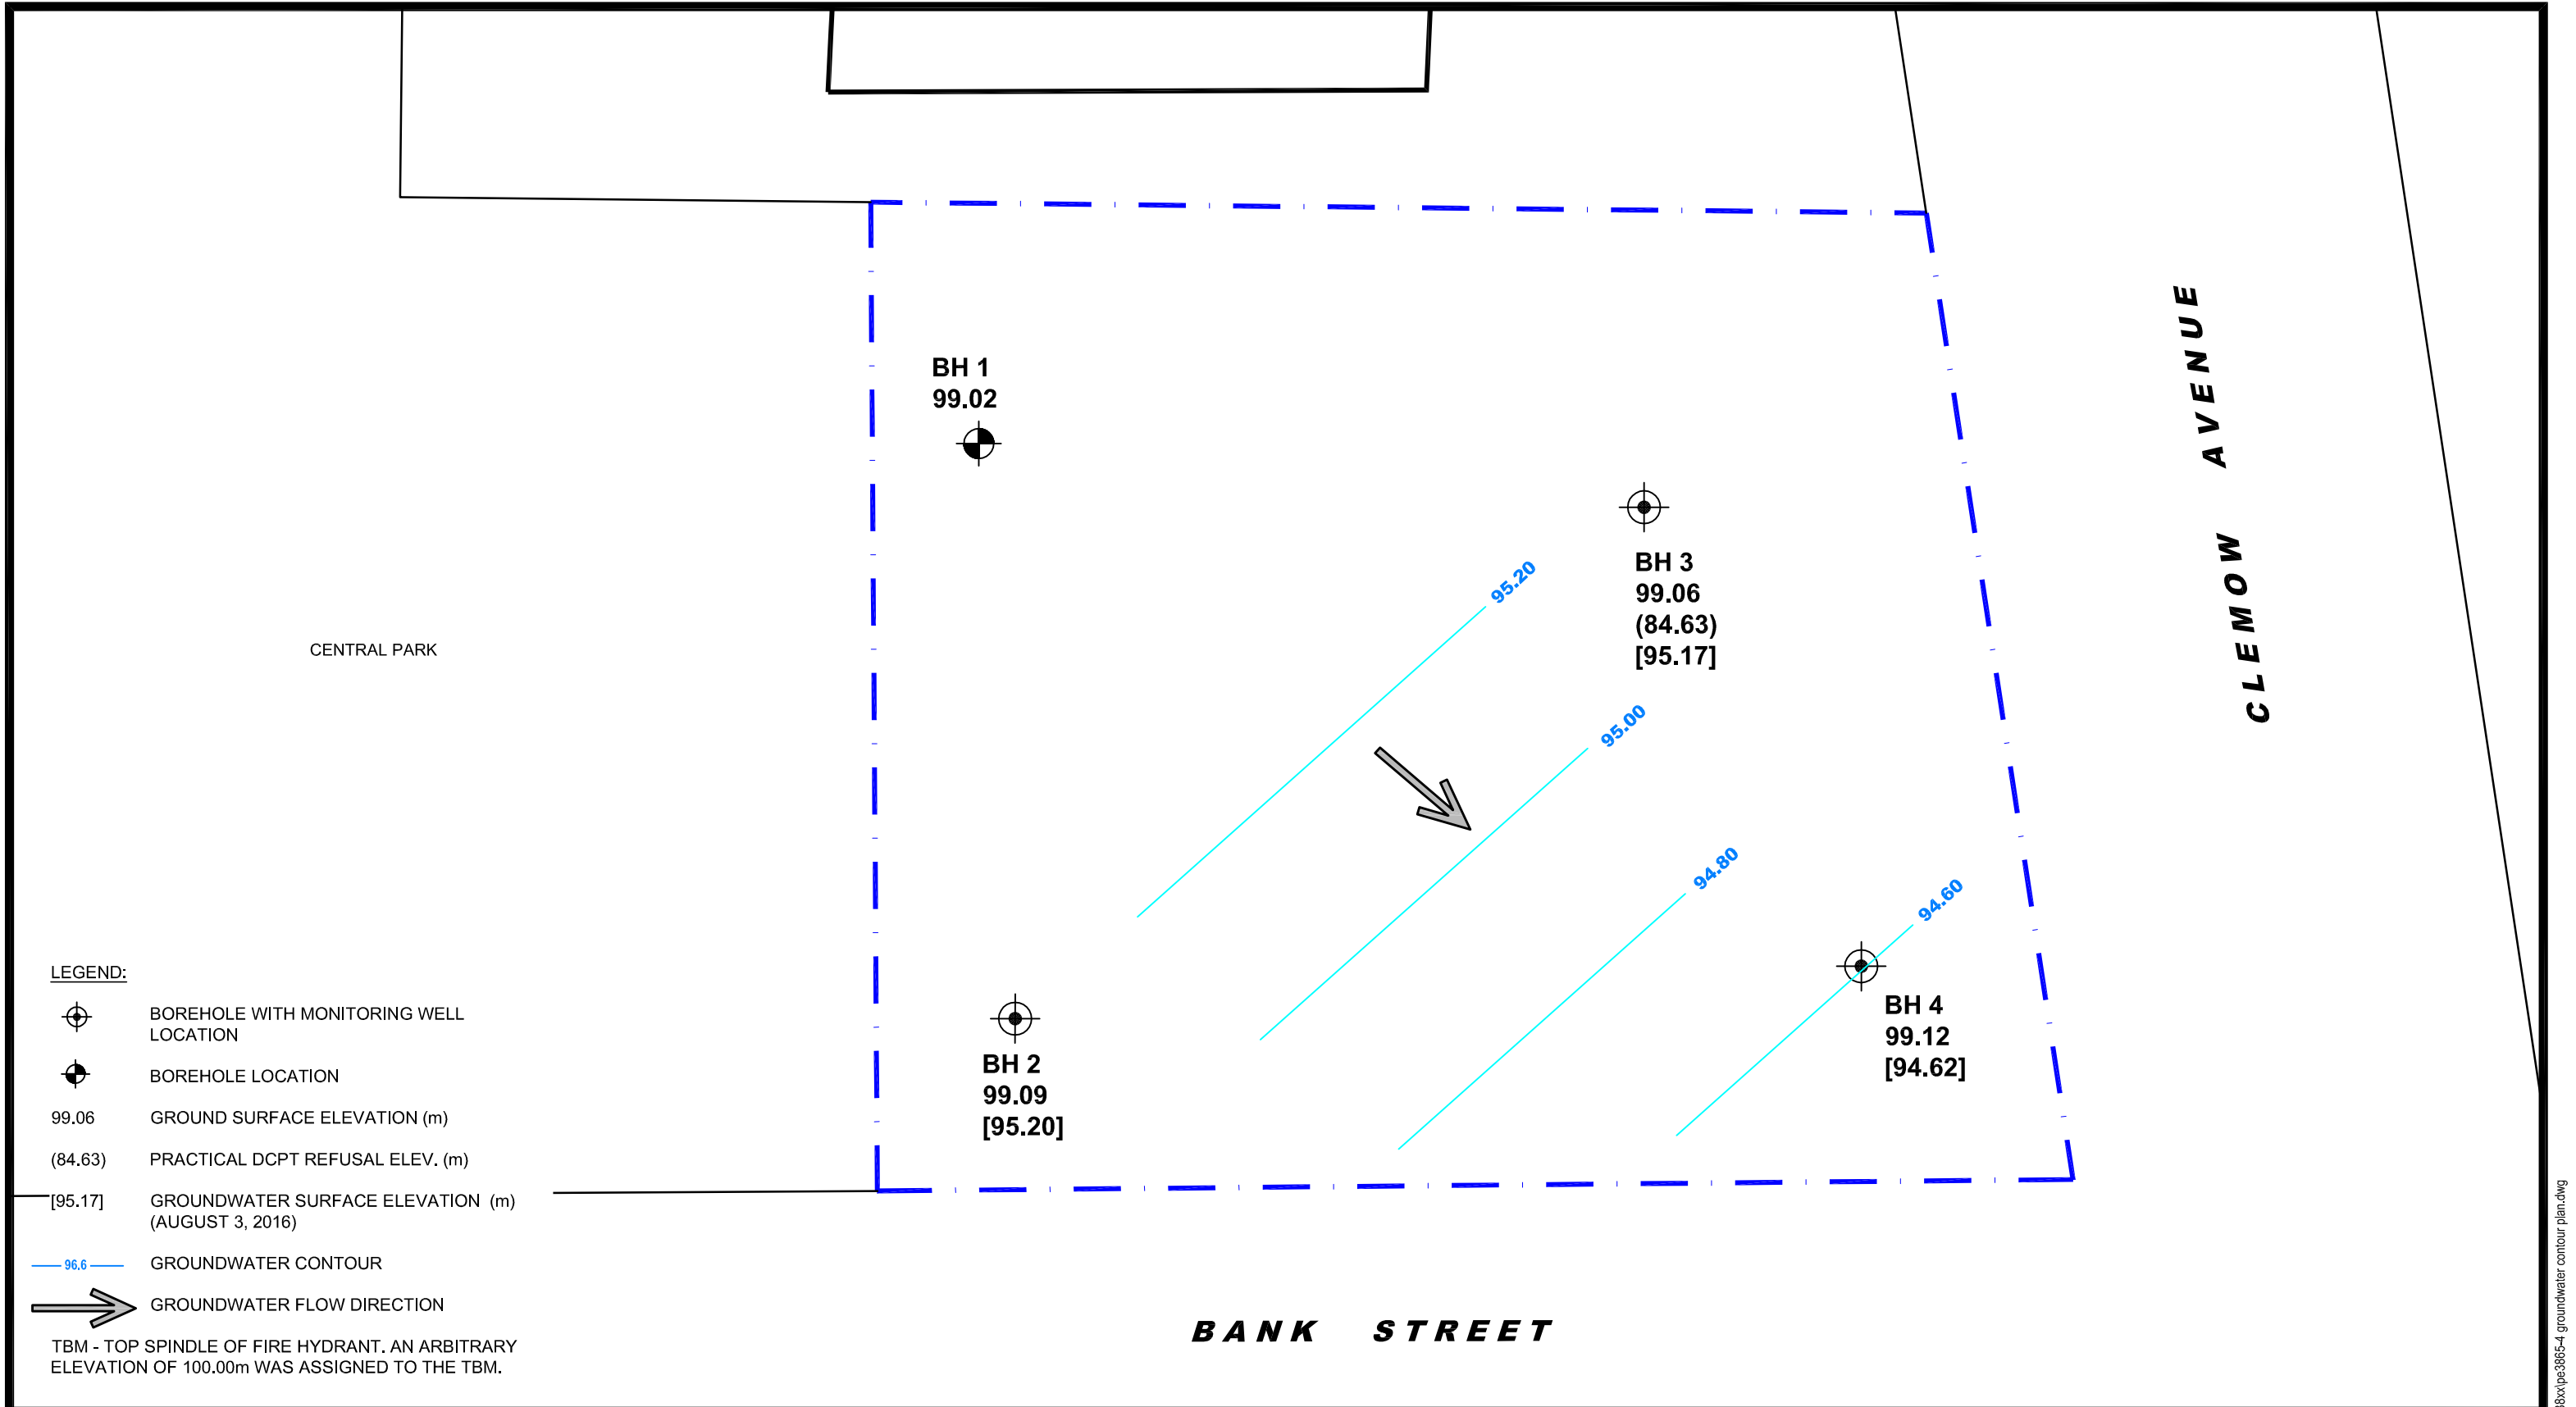
Scale:	1:100	Date:	08/2016
Drawn by:	AG	Report No.:	PE3865
Checked by:	MD	Dwg. No.:	PE3865-4
Approved by:	MD	Revision No.:	0

Water level measurements from the most recent groundwater monitoring event collected in August 2016 were used to determine groundwater flow direction. Based on this information, the groundwater flow was determined to be in a southeasterly direction; however, it is suspected that the groundwater level in BH4 may be affected by services located in the adjacent roadways, since it is our expectation that the groundwater flows northward in this general area.

Groundwater levels were measured on August 3, 2016 using an electronic water level meter. Elevations are relative to surveyed ground surface elevations at each monitoring well location. Groundwater elevations are summarized below in Table 3. All elevations are relative to the assumed fire hydrant spindle elevation (100.00 m ASL).

Monitoring Well	Water Level (m below grade)	Water Level Elevation (m ASL - assumed)	Screened Interval (m below grade)	Date of Measurement
BH2	3.89	95.2	2.8 - 5.8	August 3, 2016
BH3	3.89	95.17	4.6 - 7.6	August 3, 2016
BH4	4.51	94.62	4.6 - 7.6	August 3, 2016

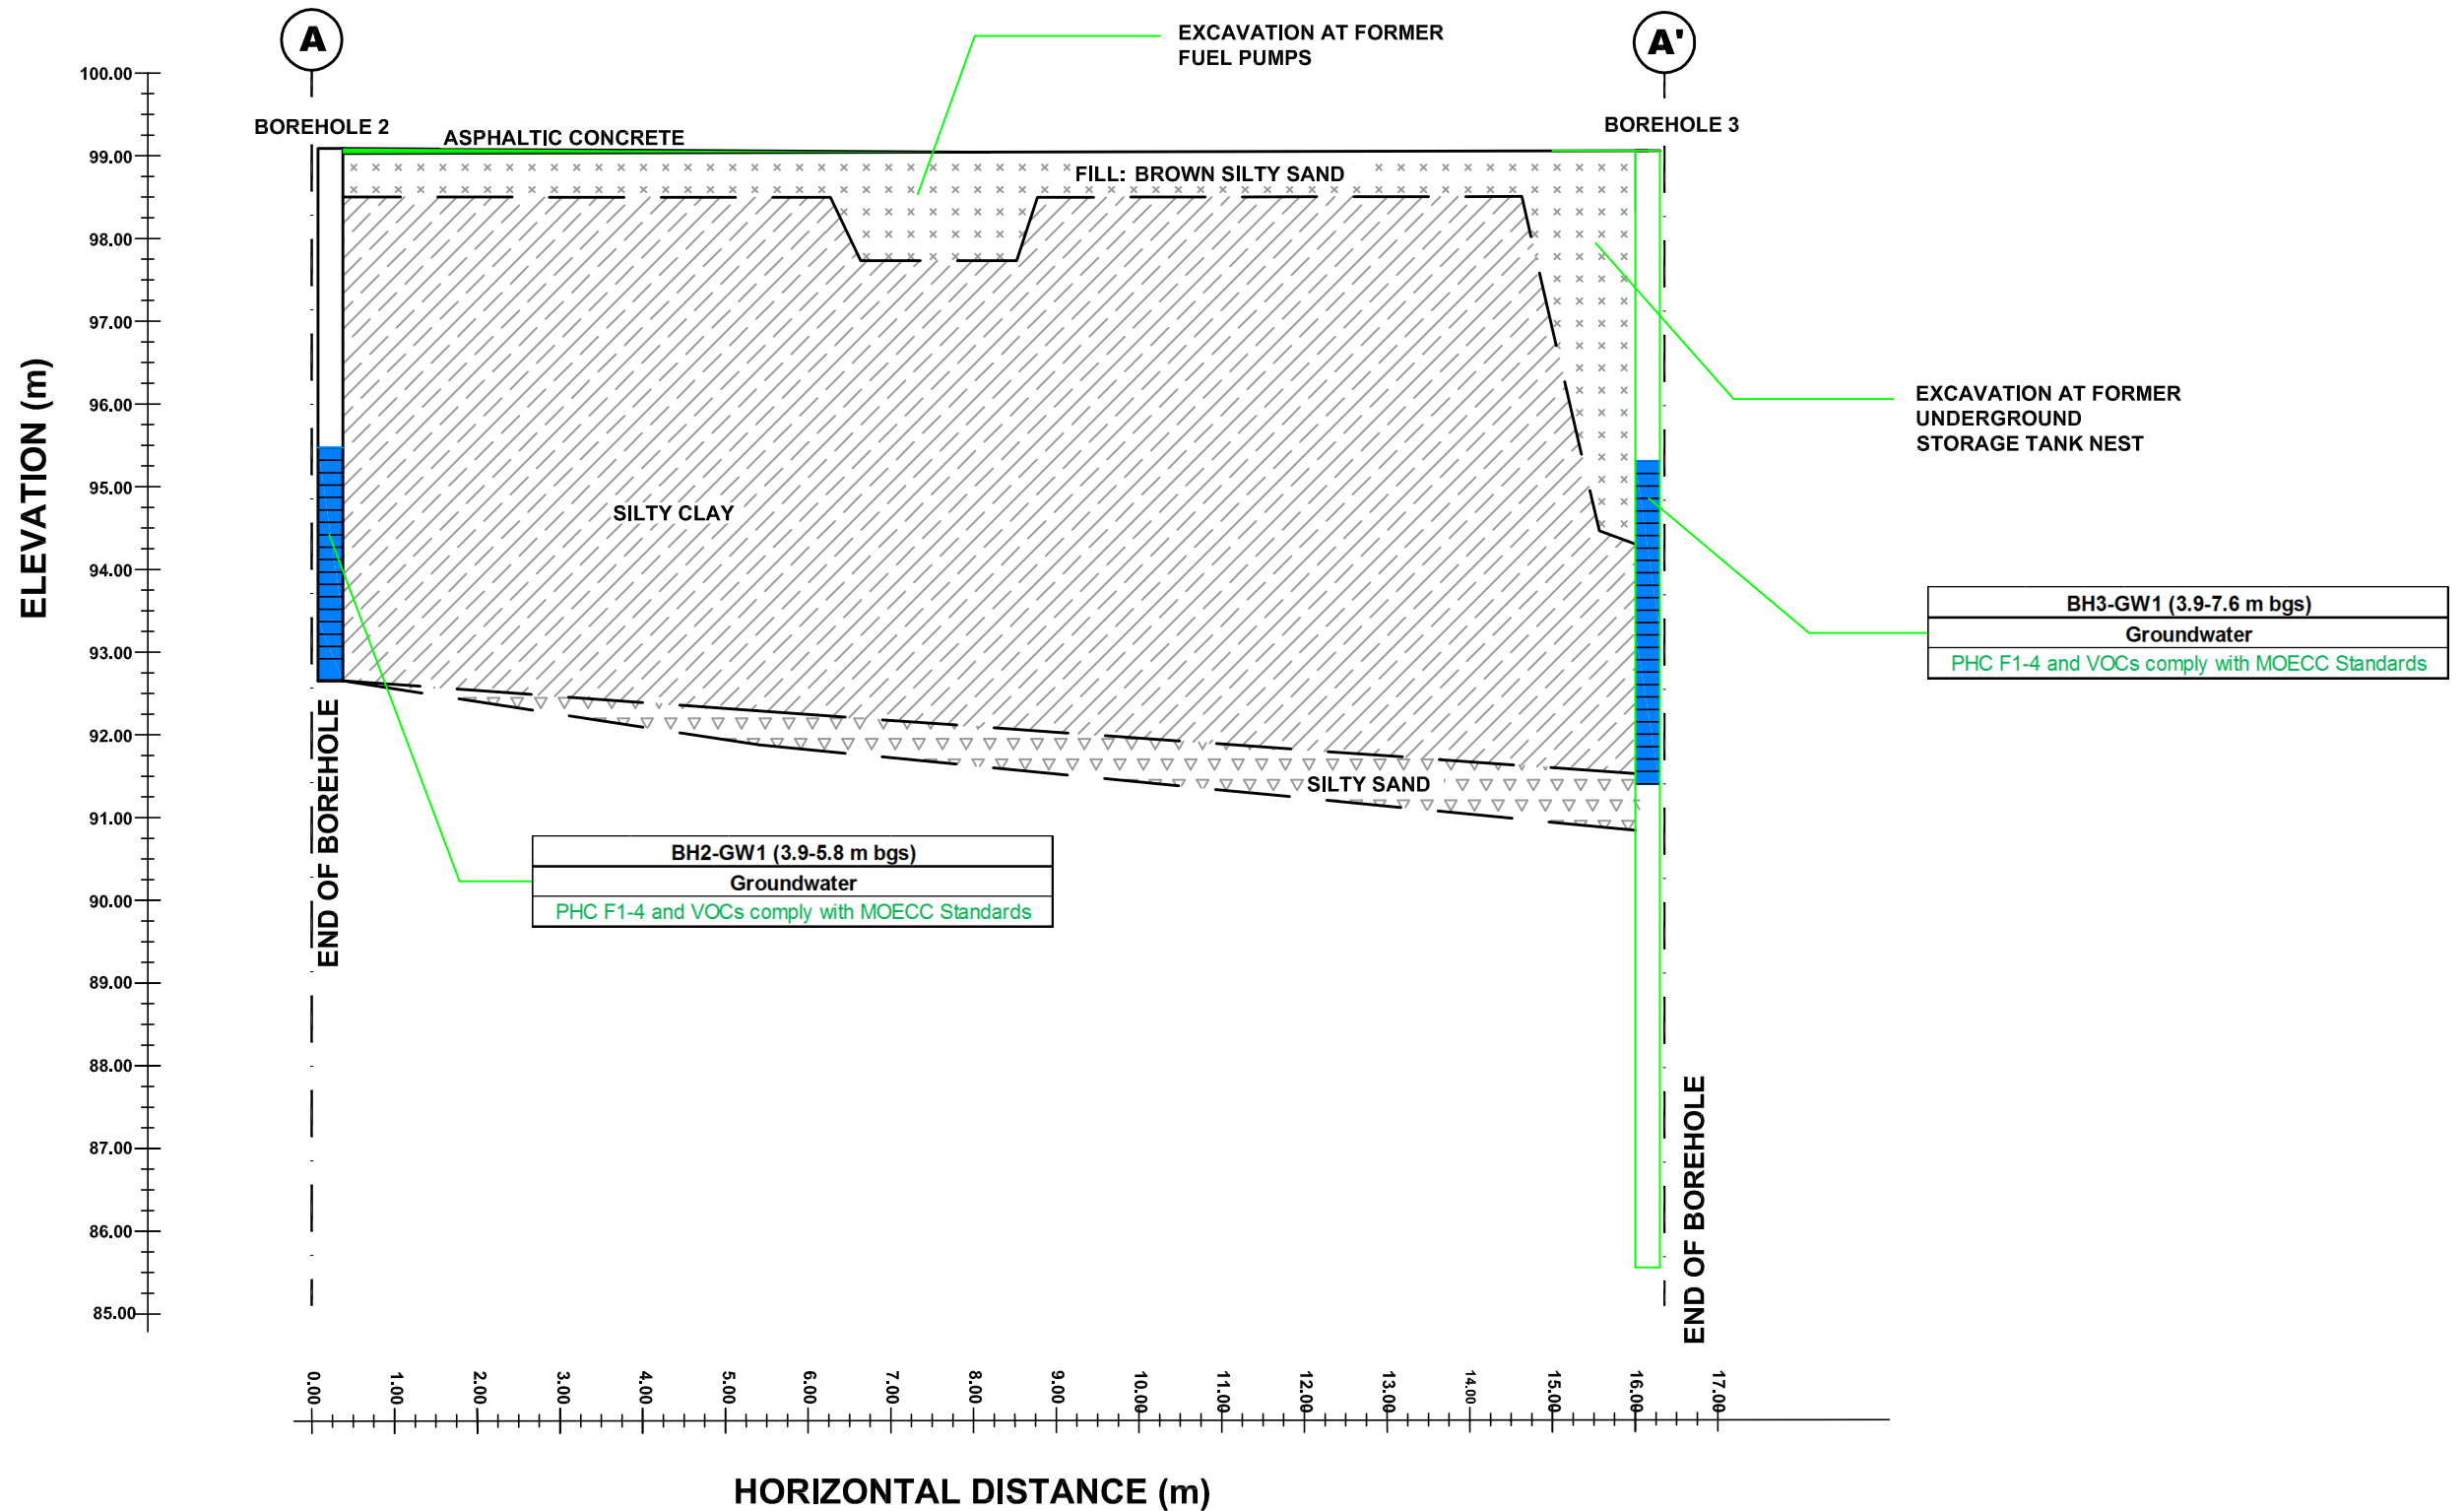
DRAWING PE3865-5 - CROSS SECTION A-A'

Site stratigraphy is shown on Drawing PE3865-5 - Cross Section A-A'.

The soil profile encountered at the borehole locations consisted of silty sand with crushed stone fill material at BH1, BH3, and BH4 (asphaltic concrete at the surface in BH2), followed by additional brown, silty sand fill material, with some limited demolition concrete and glass at BH1. The sand fill extended to varying depths as a result of the former remediation excavation work conducted on site. The fill was underlain by native silty clay. Specific details of the soil profile at the test hole location can be seen on the Soil Profile and Test Data sheet in the Appendix.

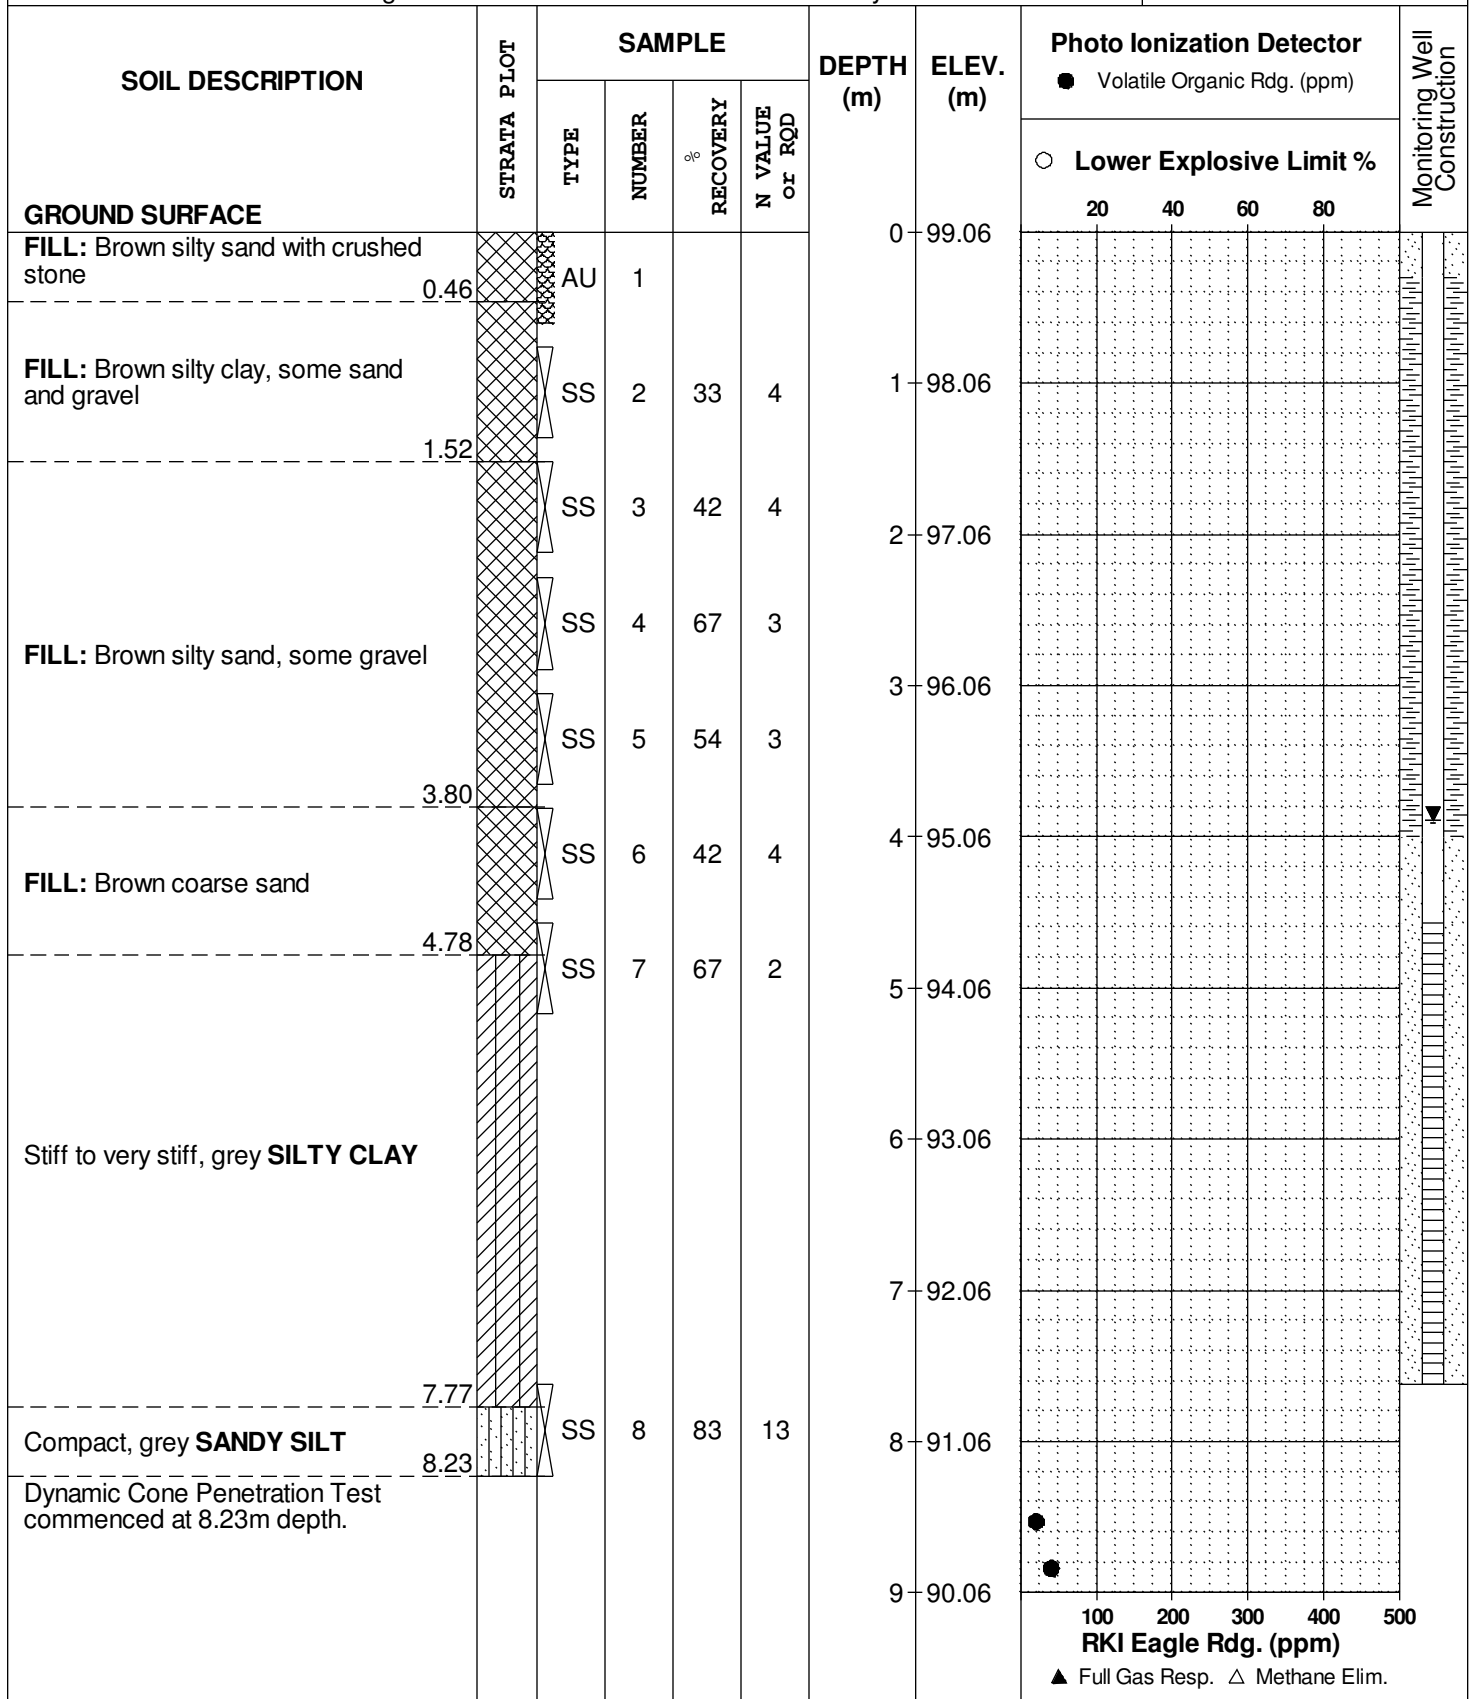
SOIL DESCRIPTION	STRATA PLOT	SAMPLE				DEPTH (m)	ELEV. (m)	Photo Ionization Detector		Monitoring Well Construction
		TYPE	NUMBER	RECOVERY	N VALUE or RQD			● Volatile Organic Rdg. (ppm)	○ Lower Explosive Limit %	
						9	90.06			
						10	89.06			
						11	88.06			
						12	87.06			
						13	86.06			
						14	85.06			
End of Borehole							14.43			
Practical DCPT refusal at 14.43m depth (GWL @ 3.89m-Aug 3, 2016)

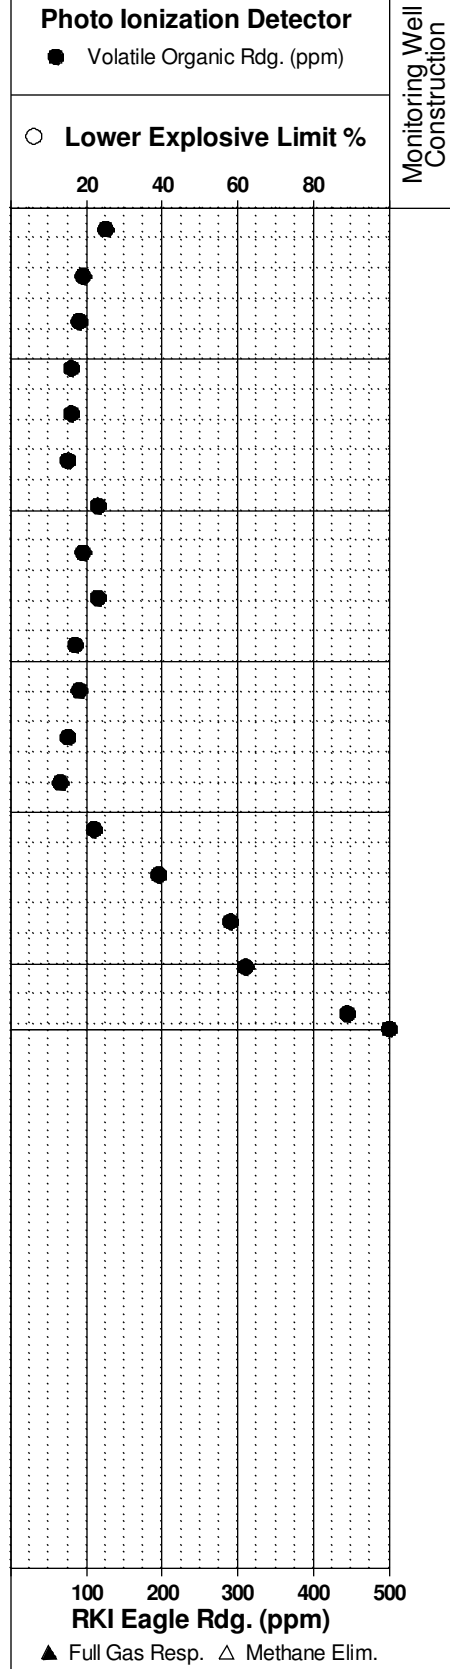
SOIL DESCRIPTION	STRATA PLOT	SAMPLE				DEPTH (m)	ELEV. (m)	Photo Ionization Detector				Monitoring Well Construction	
		TYPE	NUMBER	RECOVERY %	N VALUE or RQD			● Volatile Organic Rdg. (ppm)					
GROUND SURFACE								○ Lower Explosive Limit %					
								20	40	60	80		
FILL: Brown silty sand with crushed stone 0.60		AU	1			0	99.12						
Loose, brown SILTY SAND 1.12		SS	2	75	6	1	98.12						
Very stiff to stiff, brown SILTY CLAY		SS	3	100	7	2	97.12						
		SS	45	100	3	3	96.12						
- stiff to very stiff and grey by 4.6m depth						4	95.12						
						5	94.12						
						6	93.12						
						7	92.12						
End of Borehole (GWL @ 4.51m-Aug 3, 2016)													
								100	200	300	400	500	
								RKI Eagle Rdg. (ppm)					
								▲ Full Gas Resp. △ Methane Elim.
