Greenbank (Burnett Municipal Drain)

Headwaters Report

Claridge Homes (South Nepean) LP

March 2016

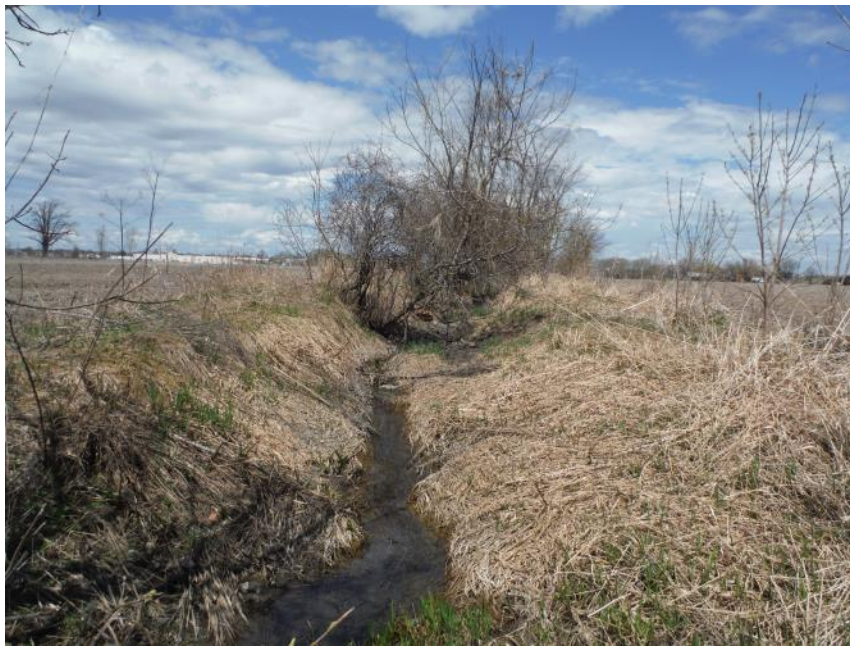
Photo 3 Station 1 looking upstream from the downstream end (May 1, 2015)

Station 1 was located approximately 74 m upstream of the confluence with the Jock River and was 55 m in length. The average channel and wetted widths were 2.1 m and 0.3 m respectively. The average bankfull depth was approximately 16 cm. The average water depth on May 21st was 2 cm (range 1-5 cm). The site was dry by July 27th, 2015 (Table 4). The habitat type consisted of glide morphological units. The substrate consisted of fines. The in-water cover consisted of overhanging vegetation. The canopy cover was poor. There were no signs of erosion throughout the station.

During the May 1st, 2015 site visit the station was shocked for 255 seconds over an area of approximately 72 m². The average wetted width and water depth present during the spring sampling were 1.3 m and 5 cm (range 3-12 cm), respectively. No fish were captured.

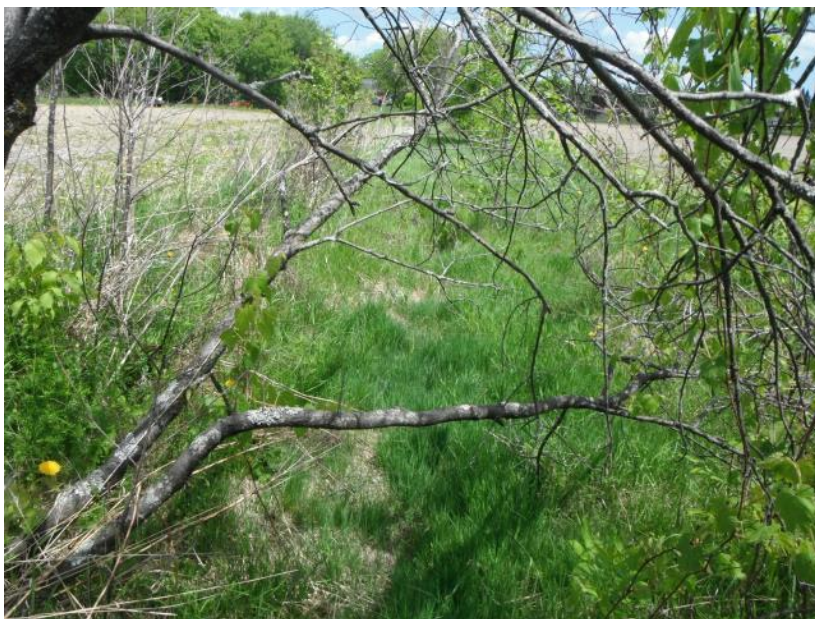
Station 2 was located approximately 30 m upstream of the confluence with Burnett Municipal Drain and was 50 m in length. The station was dry. The average channel width and average bank height were 1.1 m and 18 cm. The substrate consisted of fines. Cover consisted of aquatic vegetation, (reed canary grass). There was no canopy cover present. The station had no signs of erosion.

Photo 6 Station 2 looking upstream from the downstream end (May 21, 2015)

Photo 7 Station 2 looking upstream from the downstream end (July 27, 2015)

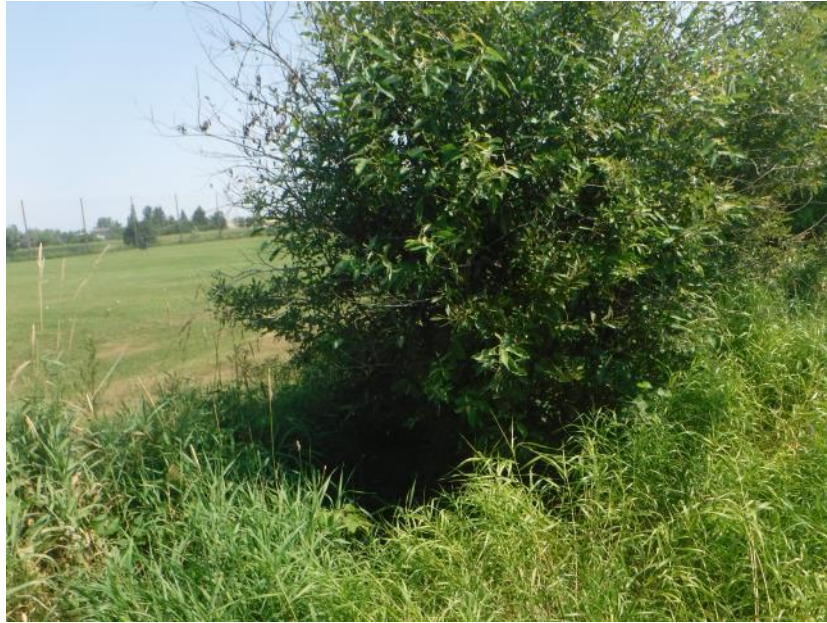
Station 4 was located approximately 10 m upstream of the confluence with Burnett Municipal Drain and was 95 m in length. The station was completely dry during all visits. The average channel width and bank height were 1.6 m and 24 cm respectively. The substrate consisted of fines. Cover consisted of aquatic vegetation (reed canary grass). The canopy cover was poor. There were no signs of erosion throughout the station.

Photo 10 Tributary 3 (Station 4) looking upstream from the downstream end (May 1, 2015)

Photo 11 Station 4 looking downstream from the upstream end (July 27, 2015)
