# **Mer Bleue Area 10 Urban Expansion Area**

## **Headwaters Report**

**March 2017**

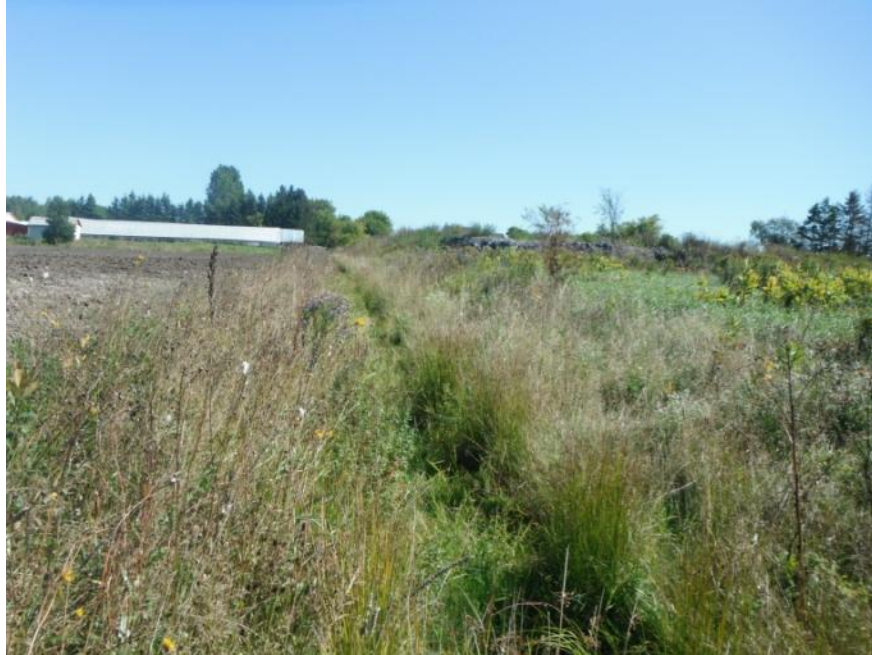
**Photo 2 Drain 1 (Station 4) looking upstream from the downstream end.  
September 17, 2013**

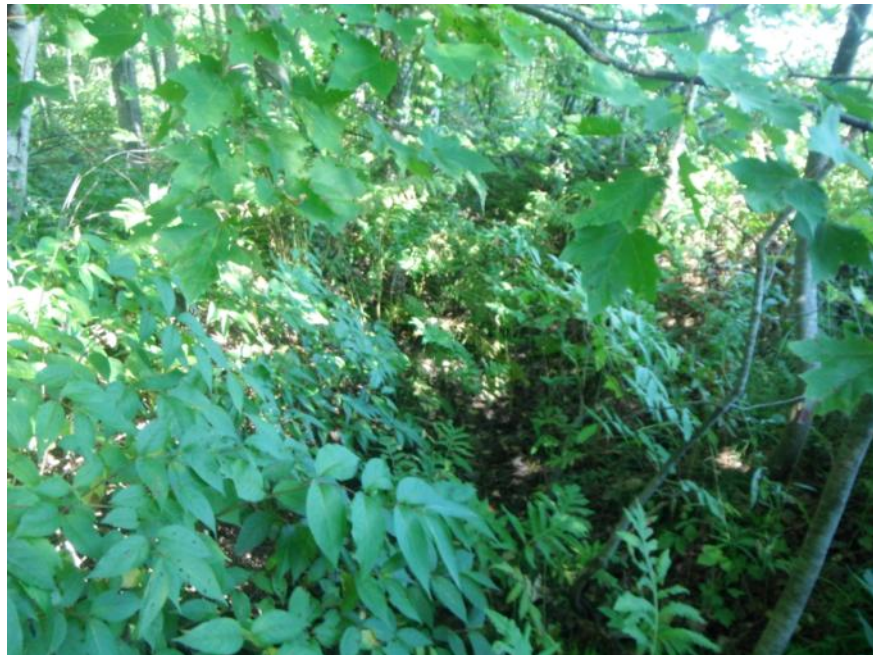
**Photo 4 Drain 2 (Station 5) looking upstream from the downstream end. September 17, 2013**

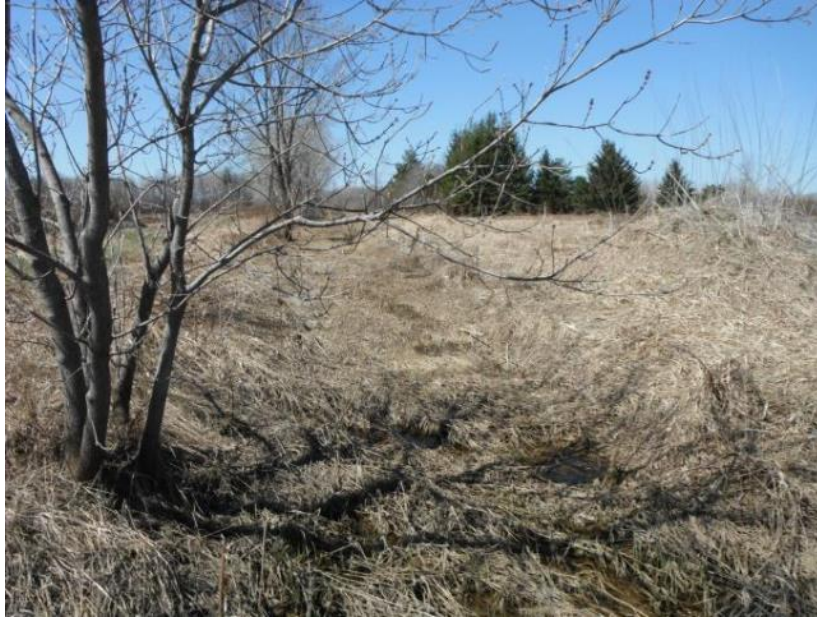
The substrate was composed of fines. The entire channel was choked with aquatic vegetation (reed canary grass and purple loosestrife). There were no signs of erosion.

The banks were fully vegetated with herbaceous vegetation and poorly vegetated with woody species. Herbaceous vegetation consisted of reed canary grass, New England aster and daisy fleabane. Woody species included American elm and trembling aspen. There was very sparse canopy cover.

During the spring visit in April 2014, the site was dipped 50 times as it was too shallow and was choked with remnant vegetation to shock. The average wetted width and water depth obtained in April were 2.0 m and 10 cm (range 6-25 cm), respectively. No fish were captured.

**Photo 5 Drain 3 (Station 6) looking upstream from the downstream end. April 28, 2014**

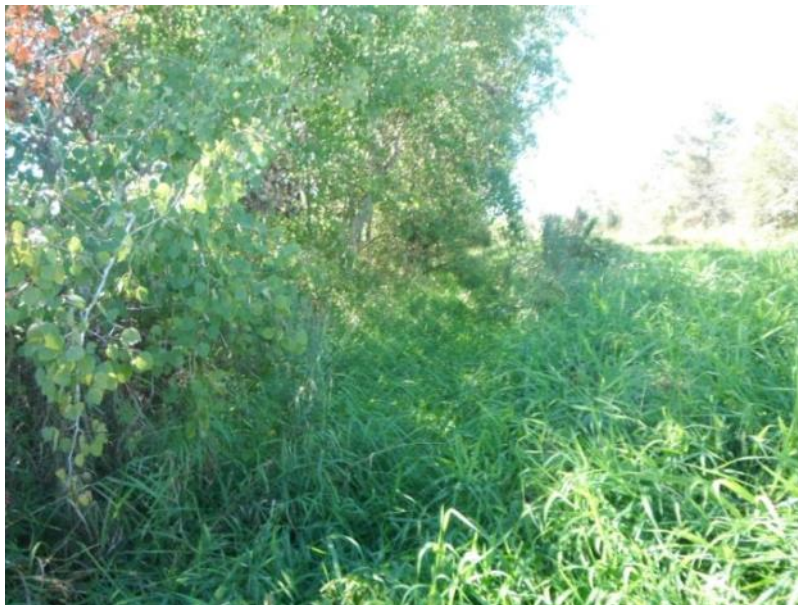
**Photo 6 Drain 3 (Station 6) looking upstream from the downstream end. September 17, 2013**

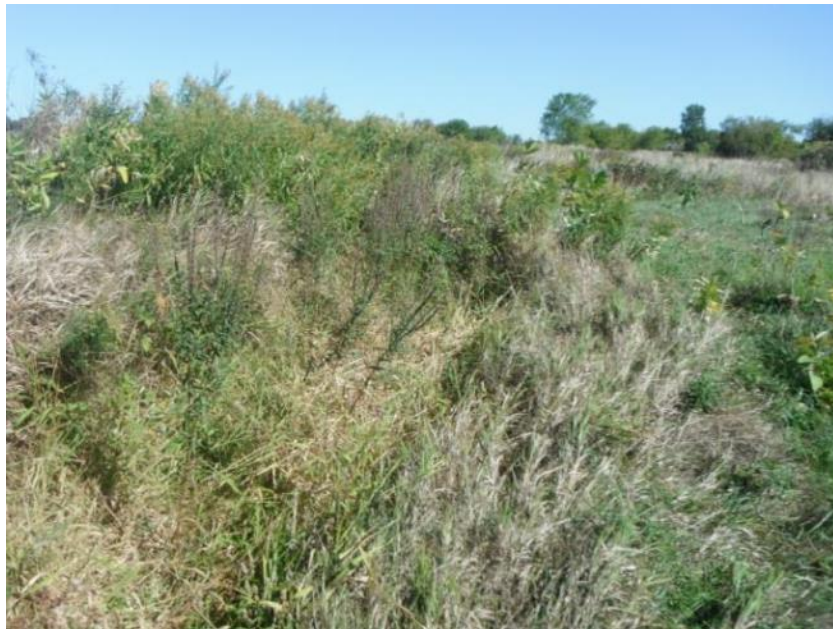
**Photo 8 Drain 4 (Station 7) looking upstream from the downstream end. September 17, 2013**

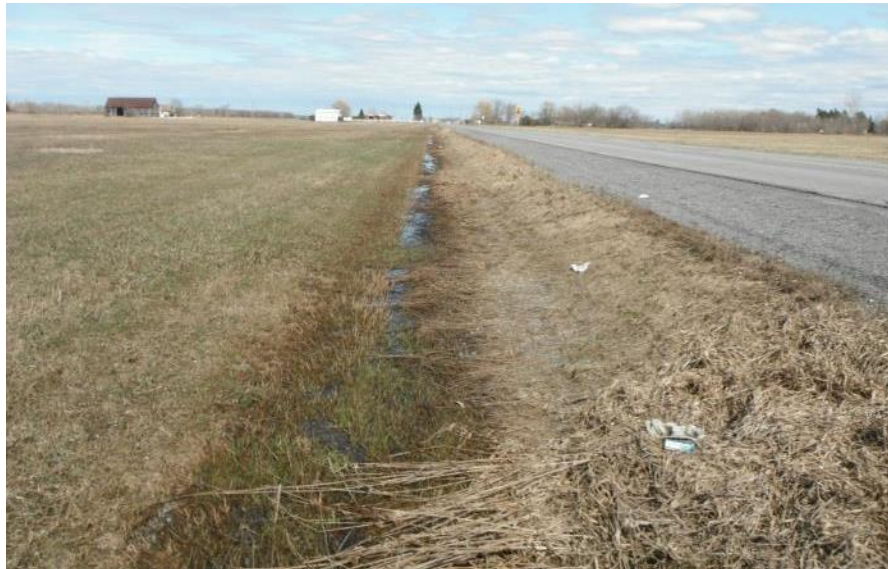
The substrate was composed of fines. The entire channel was choked with vegetation (reed canary grass, and purple loosestrife). There were no signs of erosion.

The banks were fully vegetated with herbaceous vegetation. Herbaceous vegetation consisted of grass species, common sow-thistle and purple loosestrife. There was no canopy cover.

During the spring visit in April 2014, the site was dipped 60 times as it was too shallow to shock. The average wetted width and water depth obtained in April were 1.3 m and 5 cm (range 3-12 cm), respectively. No fish were captured.

**Photo 9 Drain 6 (Station 8) looking upstream from the downstream end. April 28, 2014**

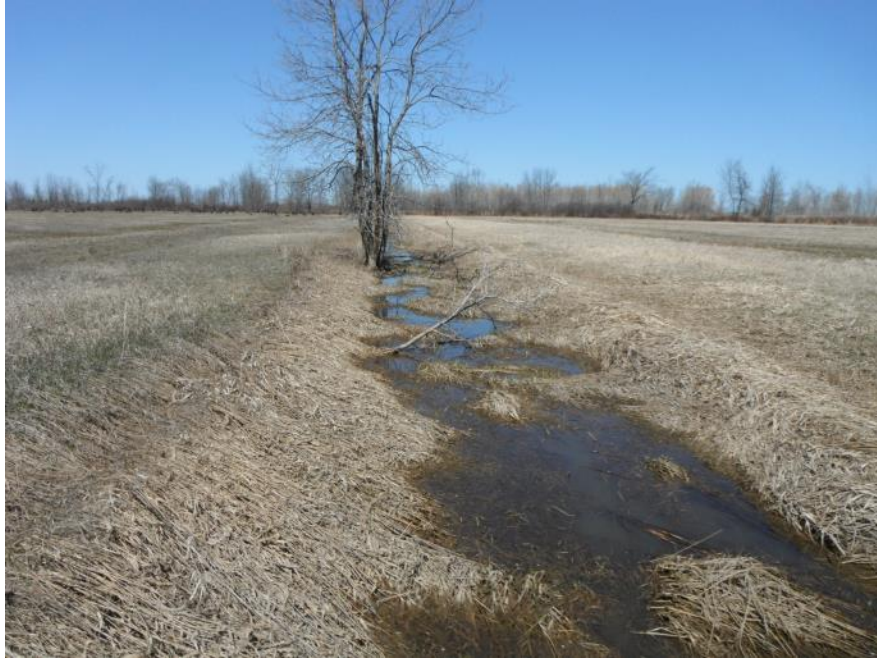
The substrate was composed of fines. The in-stream cover consisted of aquatic vegetation (reed canary grass, narrow-leaved cattail, and purple loosestrife). There were no signs of erosion.

The banks were fully vegetated with herbaceous vegetation, and very poorly with woody species. Herbaceous vegetation consisted of reed canary grass, timothy and common sow-thistle. Woody vegetation included green ash. There was no canopy cover.

During the spring visit in April 2014, the site was shocked for 328 seconds over an area of approximately 80 m<sup>2</sup>. The average wetted width and water depth obtained in April were 2.0 m and 10 cm (range 7-22 cm), respectively. No fish were captured.

**Photo 10 Drain 7 (Station 9) looking upstream from the downstream end. April 28, 2014**

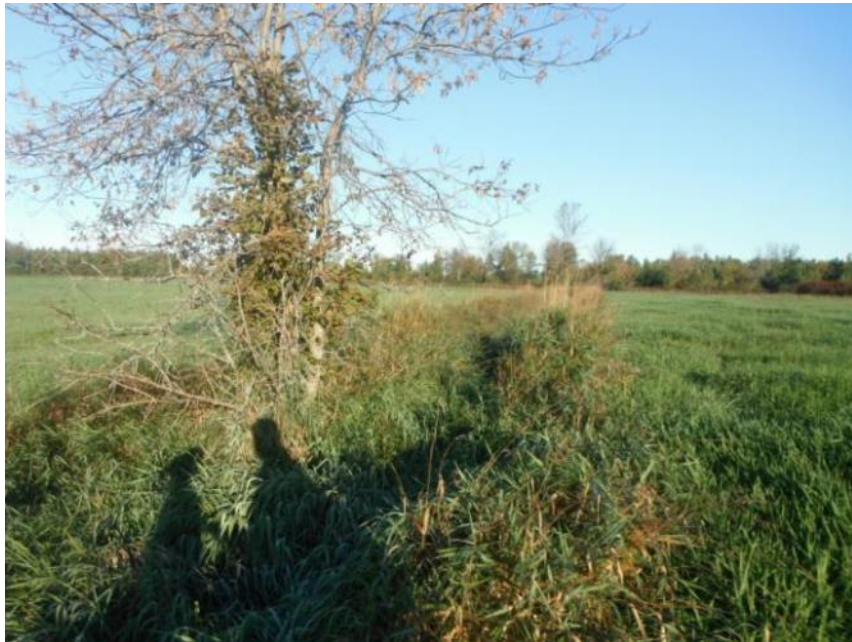
**Photo 11 Drain 7 (Station 9) looking upstream from the downstream end. September 17, 2013**

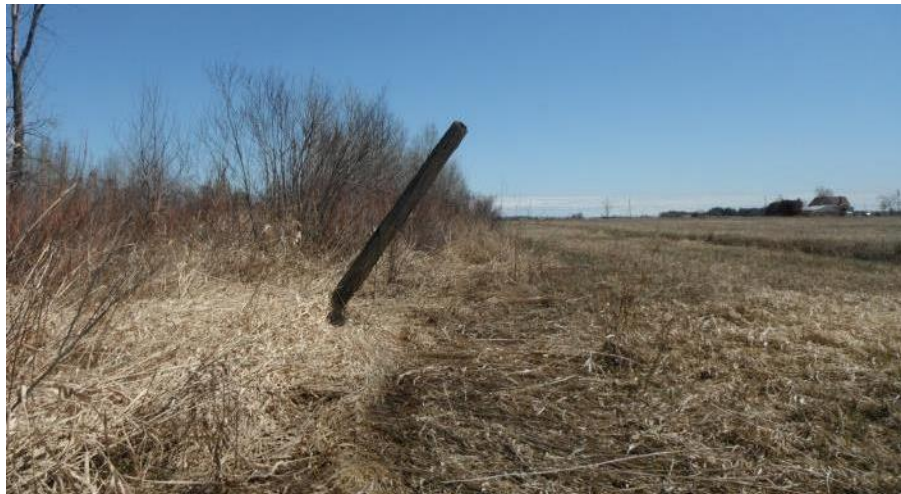
The substrate was composed of fines. The channel was heavily choked with vegetation (purple loosestrife, narrow-leaved cattail, and reed canary grass). There were no signs of erosion.

The banks were fully vegetated herbaceous vegetation and very poorly vegetated with woody species. Herbaceous vegetation consisted of New England aster, timothy and brome species. Woody species included slender willow, grey birch and trembling aspen. There was scarce canopy cover.

During the spring visit in April 2014, the site was dipped 10 times as it was too shallow to shock and was choked with vegetation. The average wetted width and water depth obtained in April were 0.7 m and 2 cm (range 1-6 cm), respectively. No fish were captured.

**Photo 12 Drain 8 (Station 10) looking upstream from the downstream end.  
April 28, 2014**

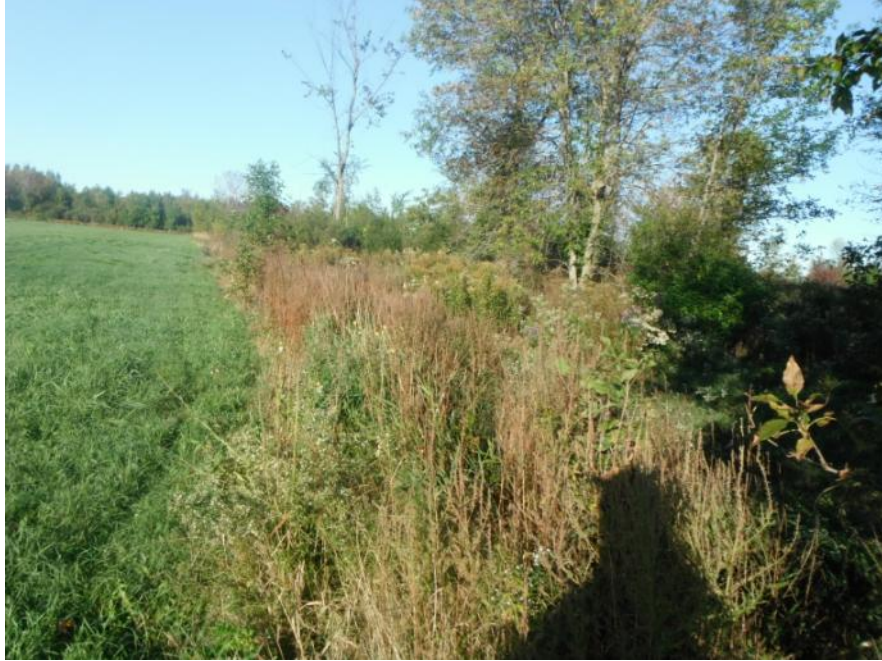
**Photo 14 Drain 9 (Station 11) looking upstream from the downstream end.  
September 17, 2013**

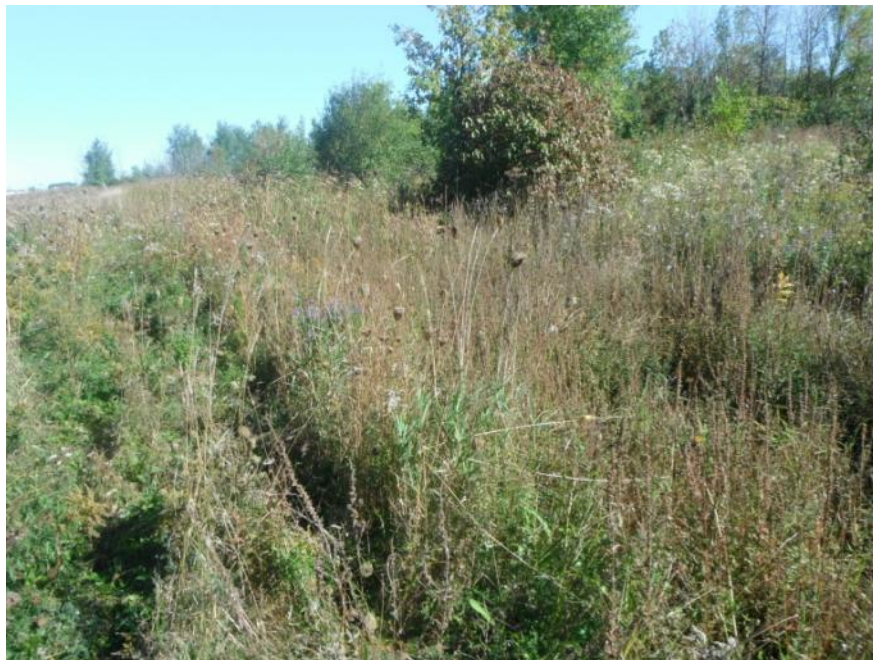
**Photo 16 Drain 10 (Station 12) looking upstream from the downstream end.  
September 17, 2013**

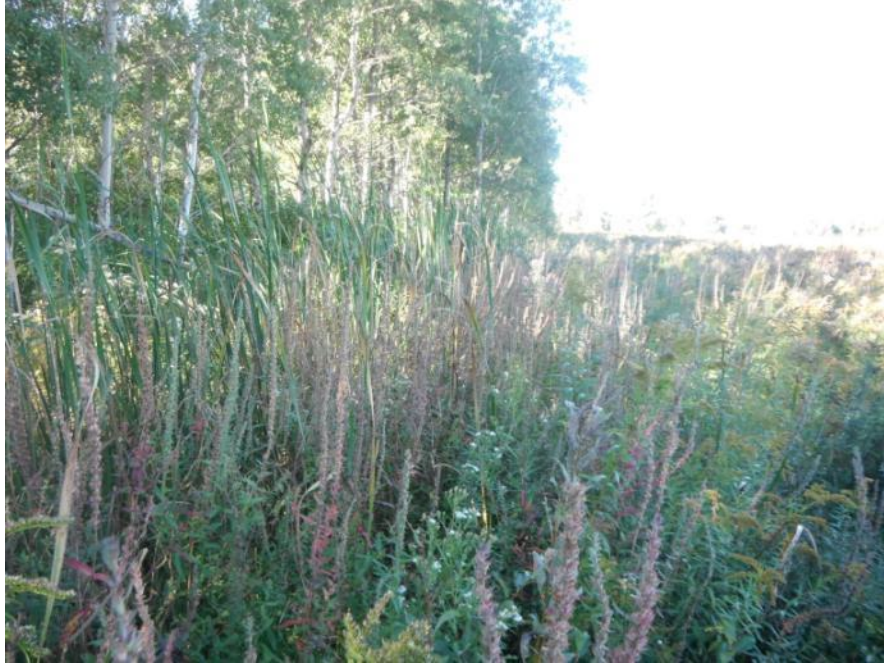
**Photo 18 Drain 11 (Station 13) looking upstream from the downstream end.  
September 17, 2013**

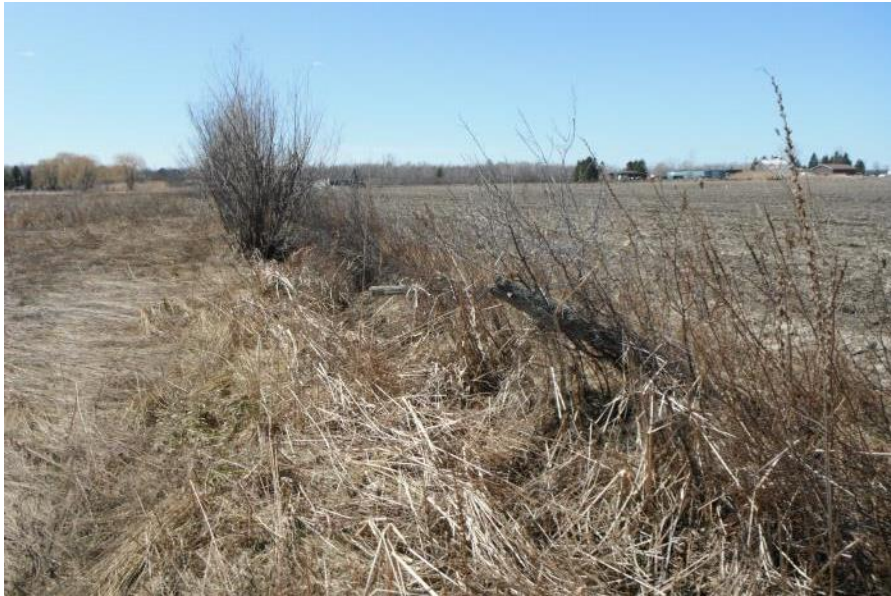
The substrate was composed of fines. The channel was entirely choked by aquatic vegetation (purple loosestrife, broad-leaved cattail, and reed canary grass). There were no signs of erosion.

The banks were fully vegetated herbaceous vegetation and poorly vegetated with woody species. Herbaceous vegetation consisted of purple loosestrife, Canada goldenrod and wild carrot. Woody species included pussy willow and common buckthorn. There was no canopy cover.

The site was dry during the visit in spring 2014; therefore no fish sampling was completed.

**Photo 19 Drain 12 (Station 14) looking upstream from the downstream end.  
April 28, 2014**

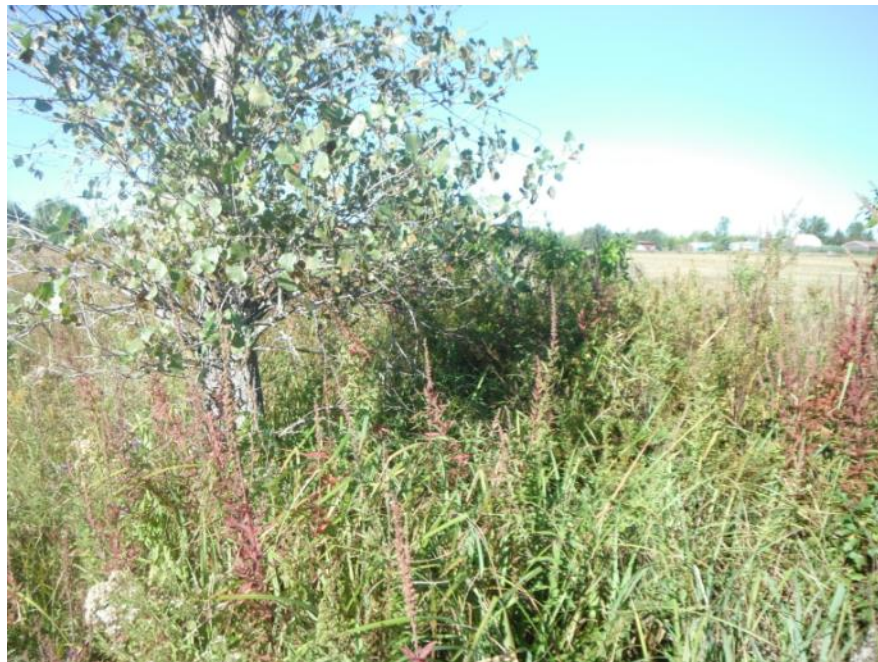
**Photo 20 Drain 12 (Station 14) looking upstream from the downstream end.  
September 17, 2013**

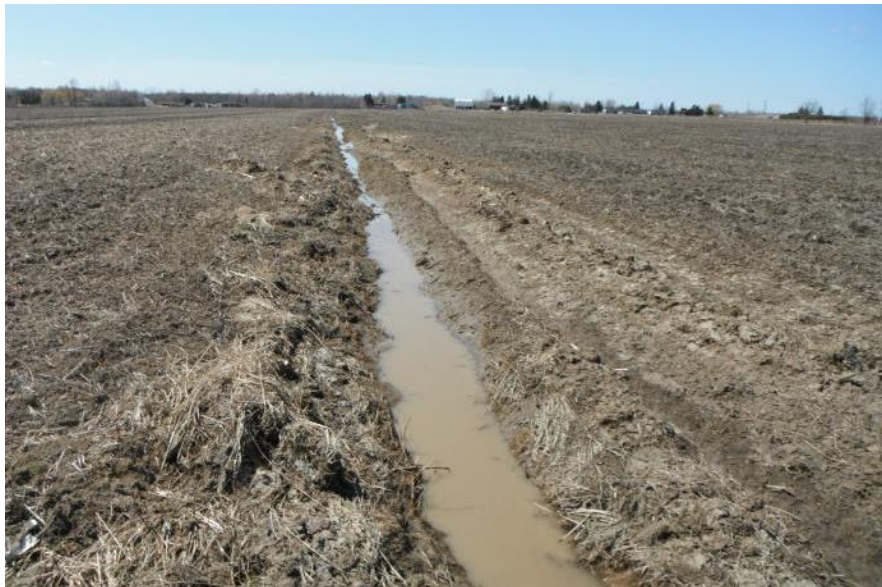
The substrate was composed of fines. The entire channel was heavily vegetated with reed canary grass, broad-leaved cattail, and purple loosestrife. There were no signs of erosion.

The banks were fully vegetated with herbaceous vegetation. Herbaceous vegetation consisted of common ragweed, common sow-thistle and reed canary grass. There was no canopy cover.

During the spring visit in April 2014, the site was shocked for 264 seconds over an area of approximately 24 m<sup>2</sup>. The average wetted width and water depth obtained in April were 0.6 m and 7 cm (range 3-19 cm), respectively. No fish were captured

**Photo 21 Drain 13 (Station 15) looking upstream from the downstream end.  
April 28, 2014**

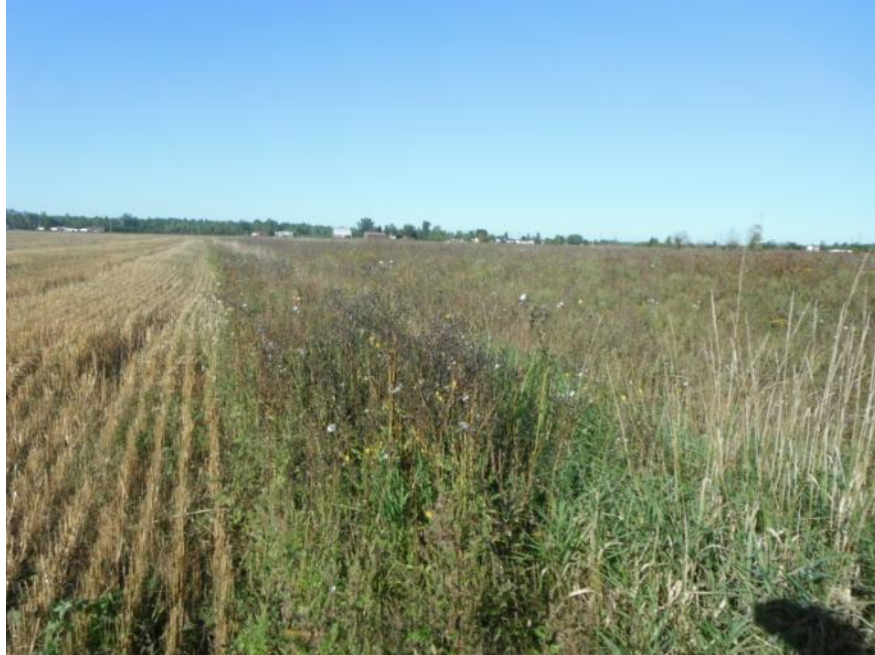
**Photo 22 Drain 13 (Station 15) looking upstream from the downstream end.  
September 17, 2013**

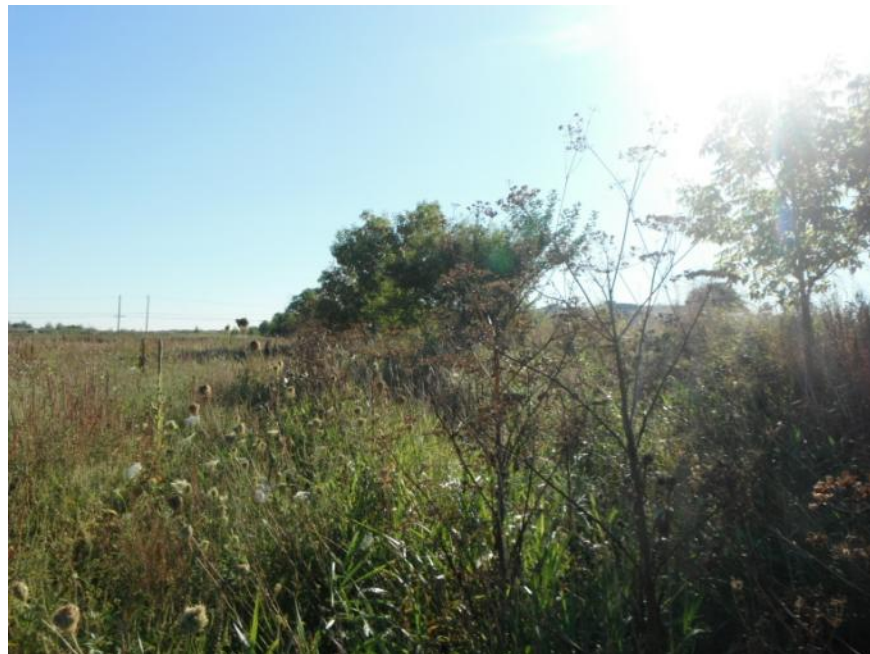
**Photo 24 Drain 14 (Station 16) looking downstream from the upstream end.  
September 6, 2013**

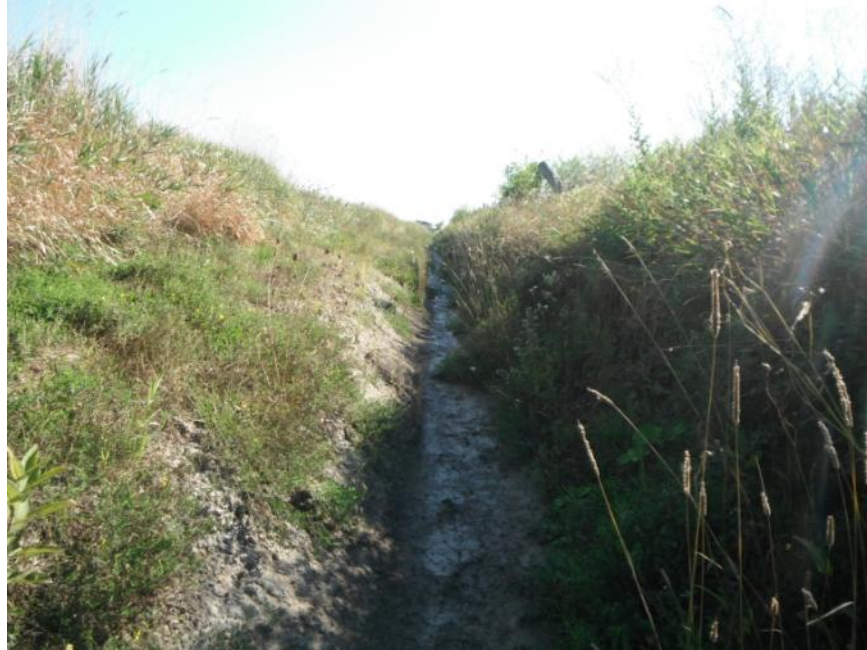
**Photo 26 Drain 15 (Station 17) looking upstream from the downstream end.  
September 6, 2013**

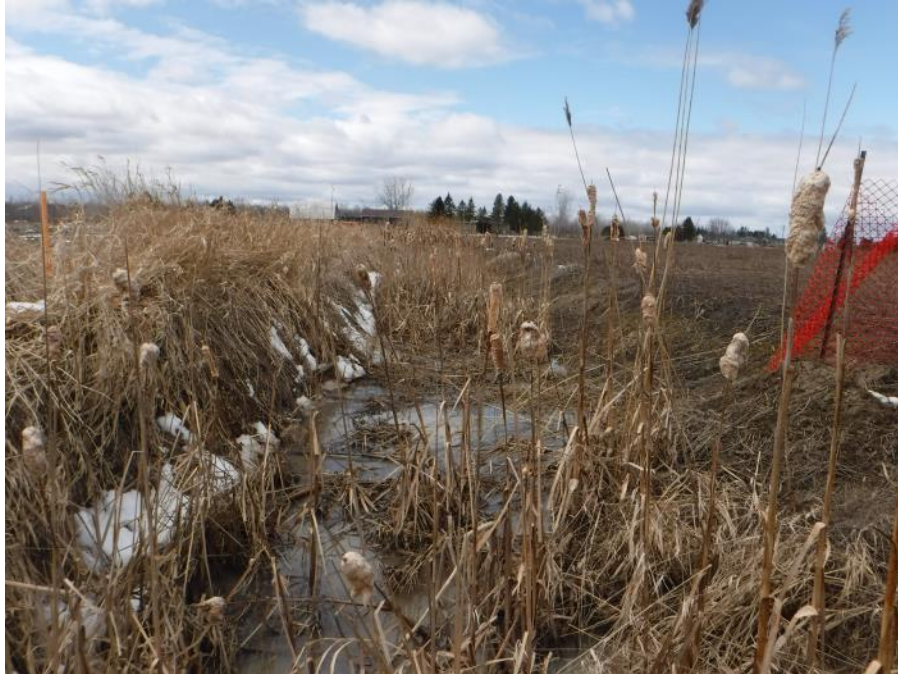
The top of banks were fully vegetated with herbaceous vegetation. Herbaceous vegetation consisted of wheat. There was no canopy cover. The banks were only partially vegetated along their sides resulting in erosion from rain events.

This drain was not sampled for fish as it was dry.

**Photo 29 Drain 18 (Station 26) looking downstream from the upstream. April 12, 2016**

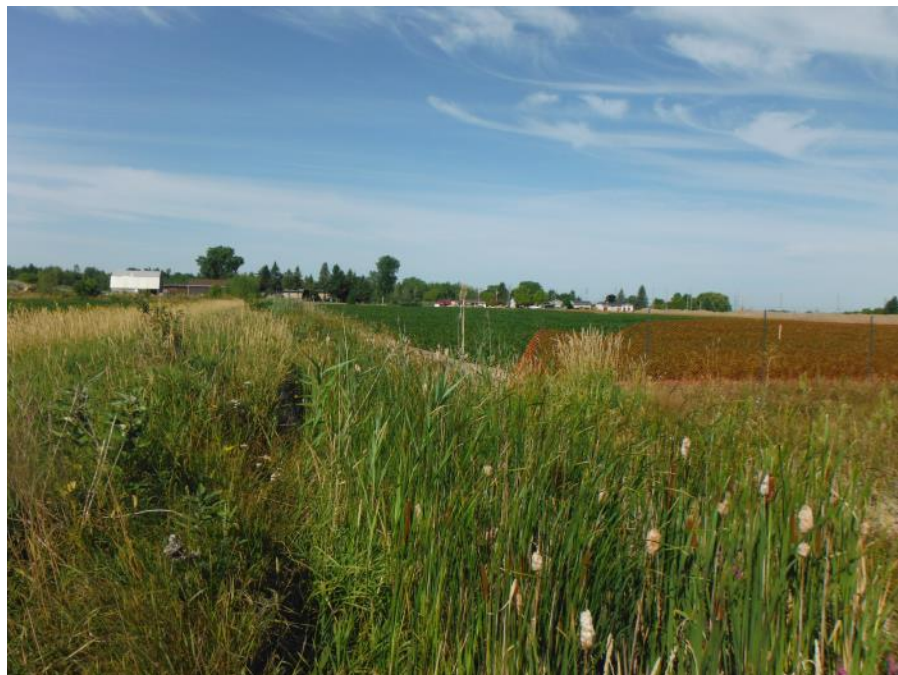
**Photo 30 Drain 18 (Station 26) looking downstream from the upstream. August 9, 2016**
