Phase I - Environmental Site Assessment

Summerside West – 2564 Tenth Line Road
Ottawa, Ontario

February 10, 2017

Report: PE3969-1

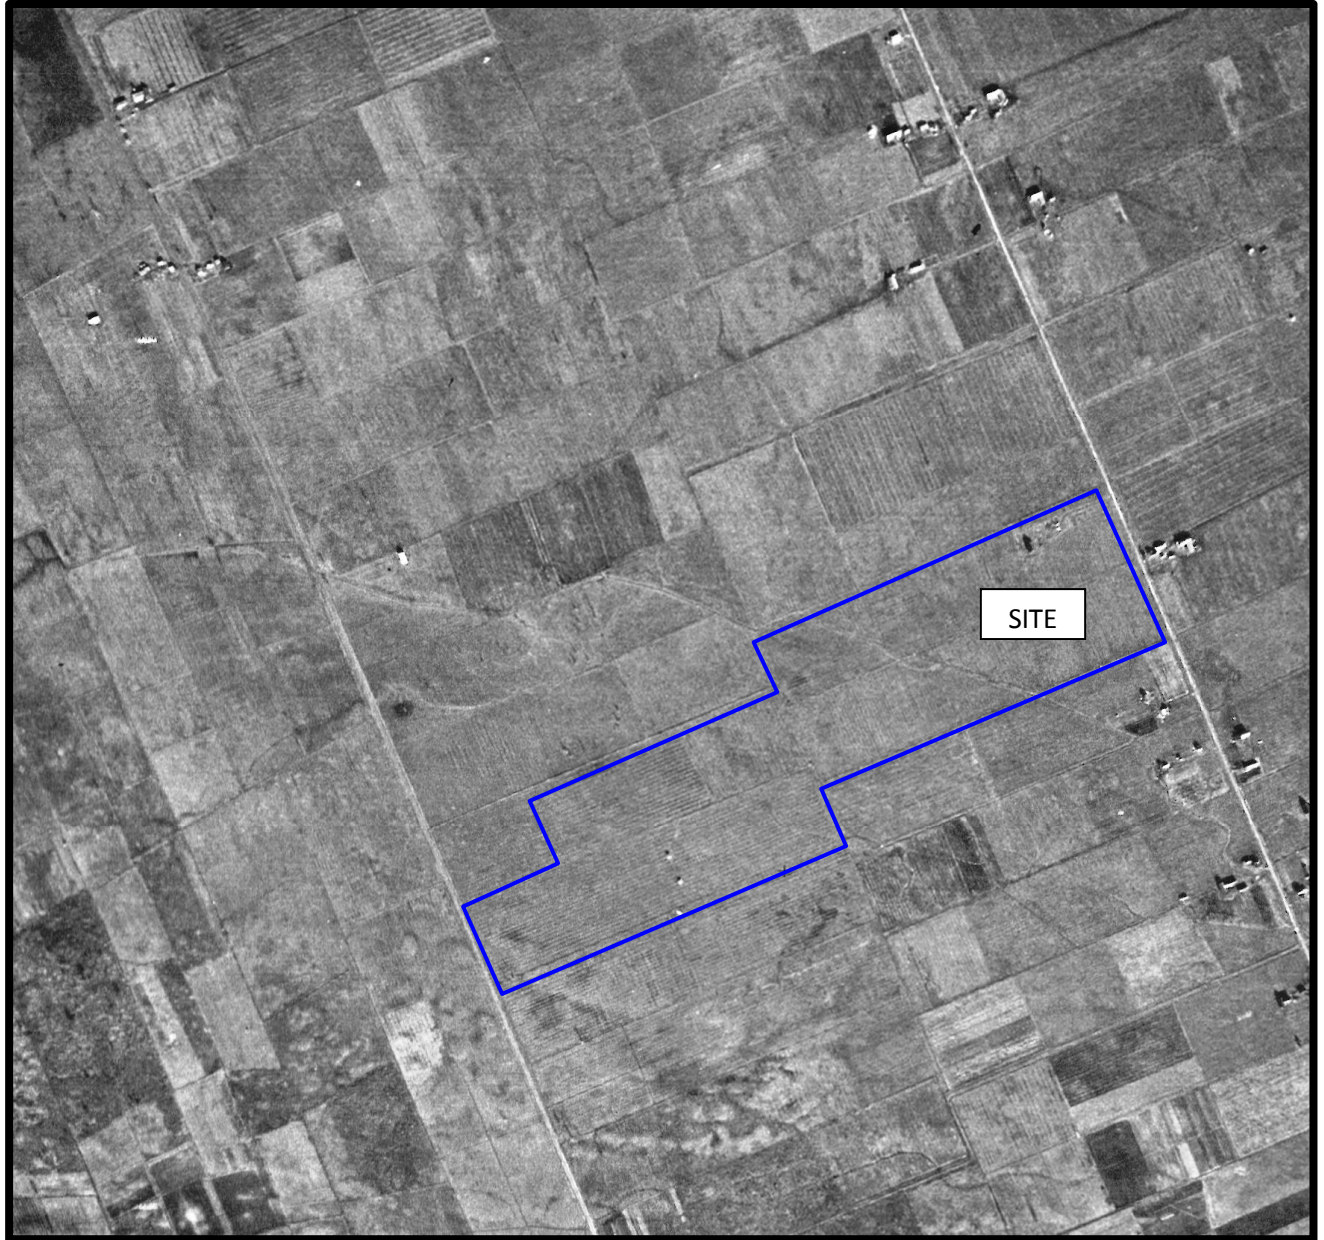
AERIAL PHOTOGRAPH
1945

| 1945 | The subject property consists of agricultural fields with what appears to be a barn at the northeast corner of the site. Surrounding properties are agricultural fields with farmstead dwellings and barns. McKinnon's Creek bisects the eastern half of the subject property. |

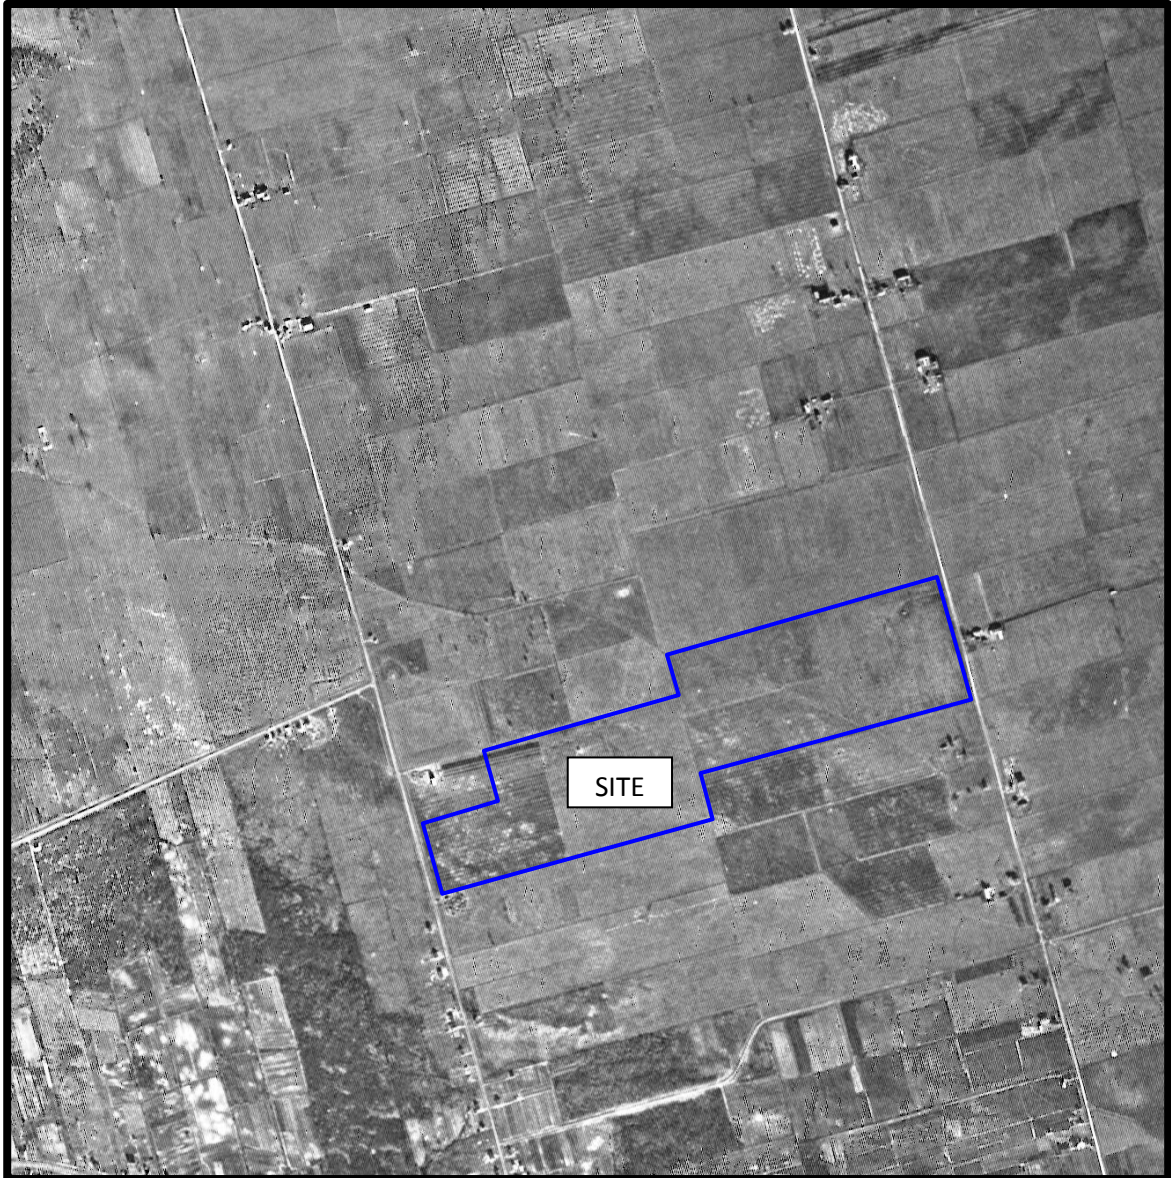
AERIAL PHOTOGRAPH
1960

| 1960 | The structure in the northeast corner of the subject site no longer appears to be present. No other changes have been made to the subject site or surrounding properties. |

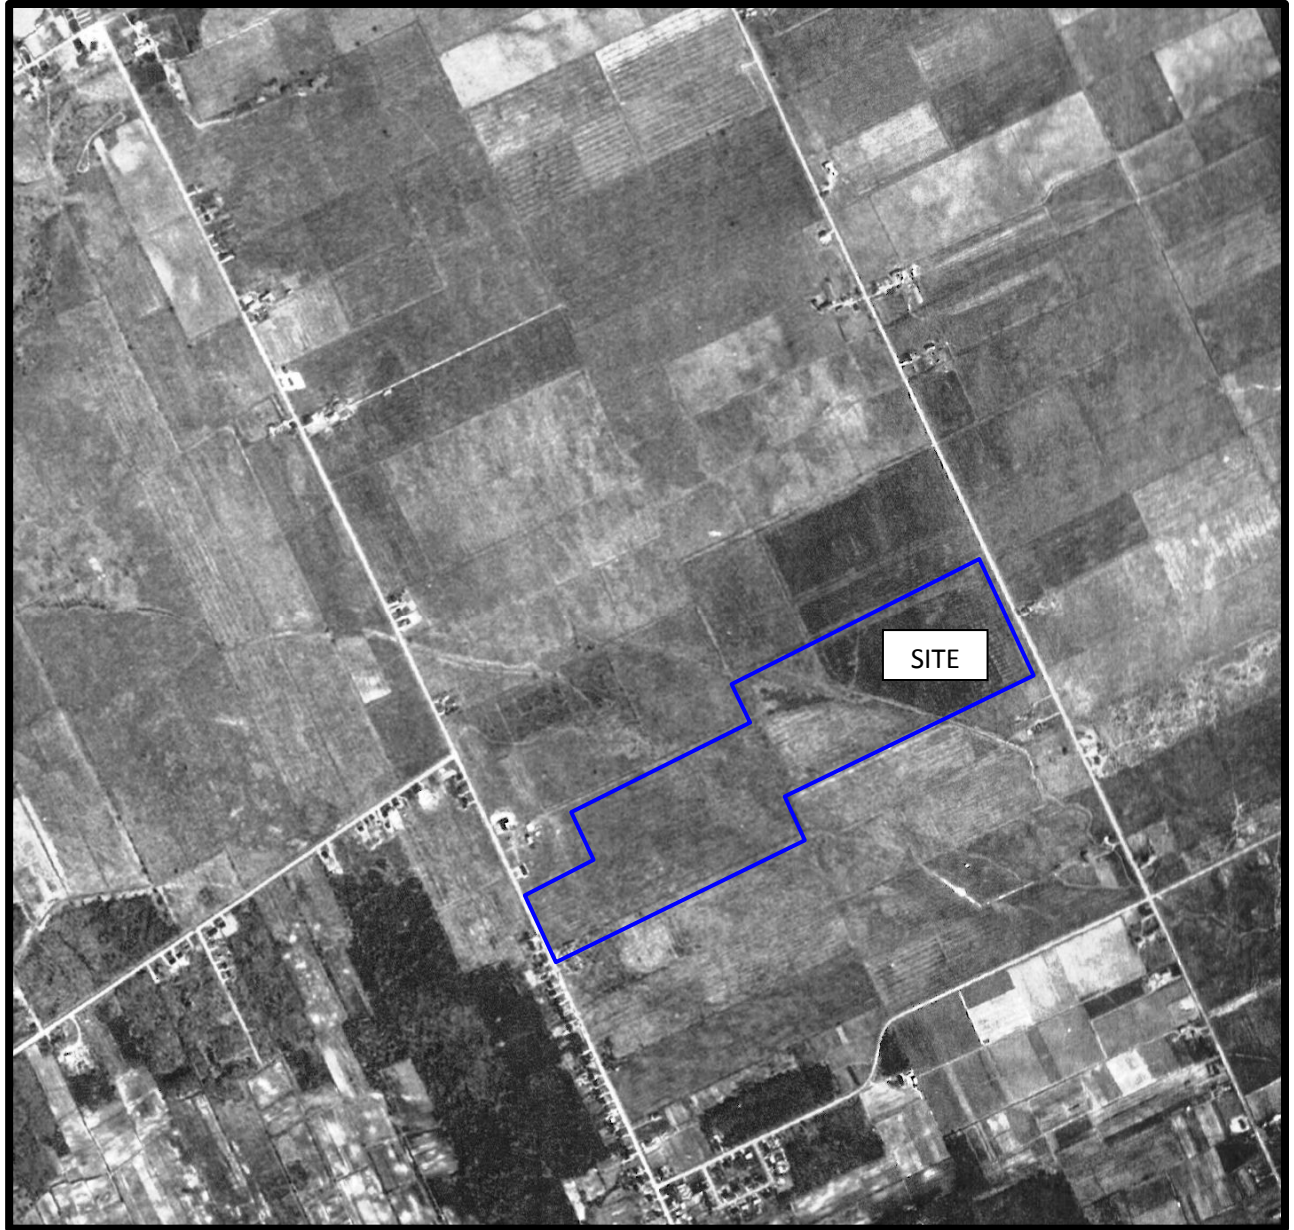
AERIAL PHOTOGRAPH
1975

| 1975 | No significant changes have been made to the subject lands or surrounding properties. |

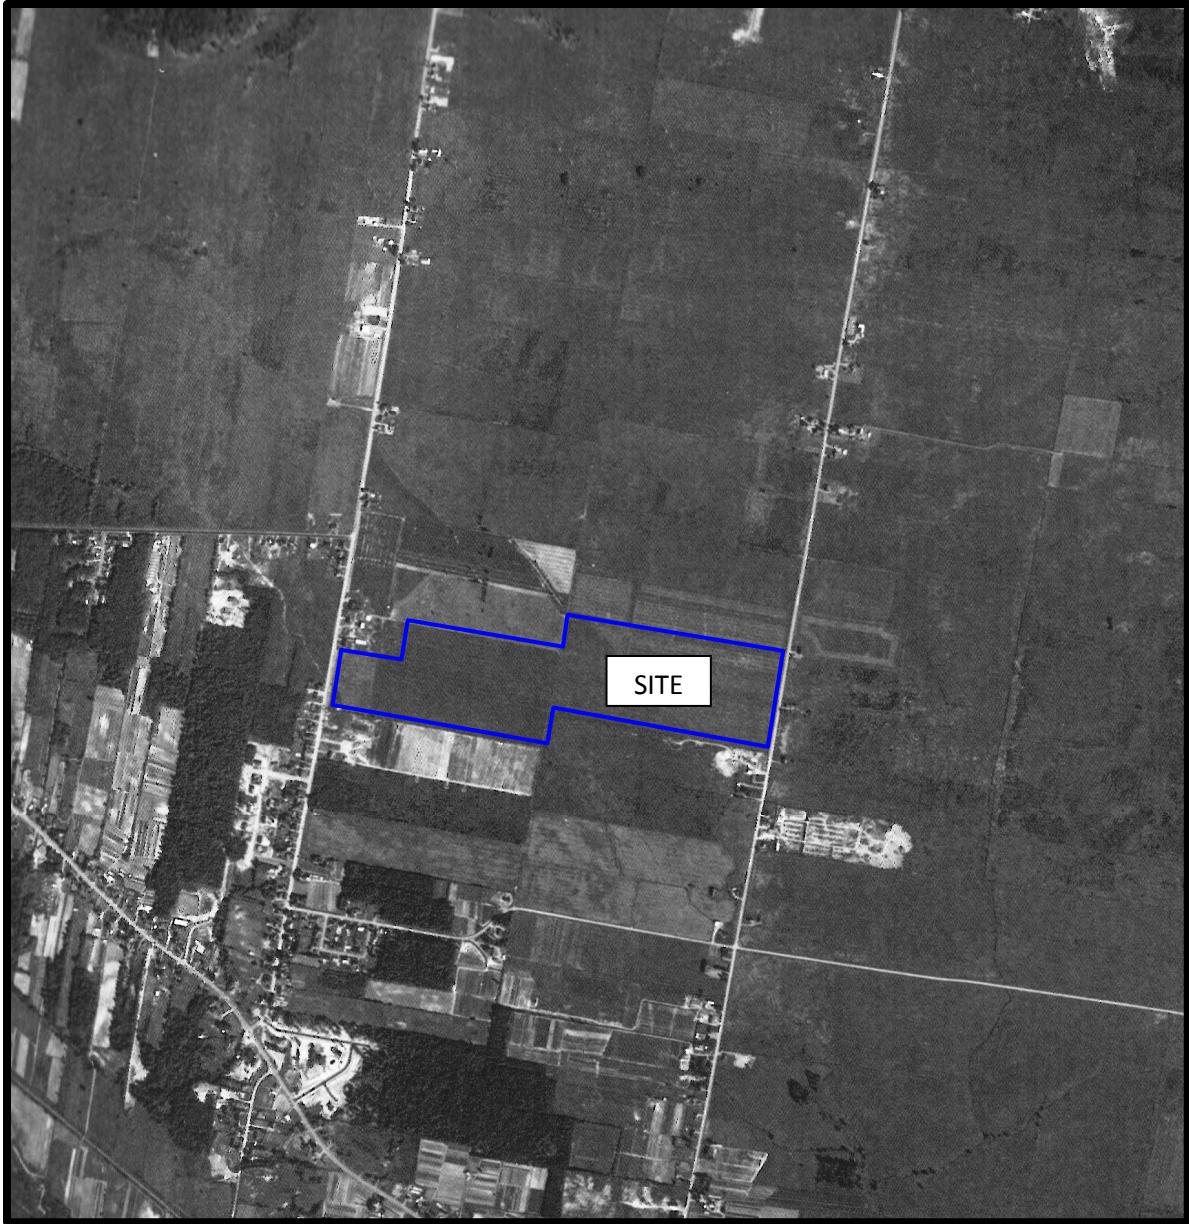
AERIAL PHOTOGRAPH
1987

| 1987 | No significant changes appear to have been made to the subject site. Residential development has occurred along the west side of Mer Bleue Road, to the southwest of the subject site. The surface of the easternmost part of the adjacent property to the south, at 2666 Tenth Line Road, has been disturbed. |

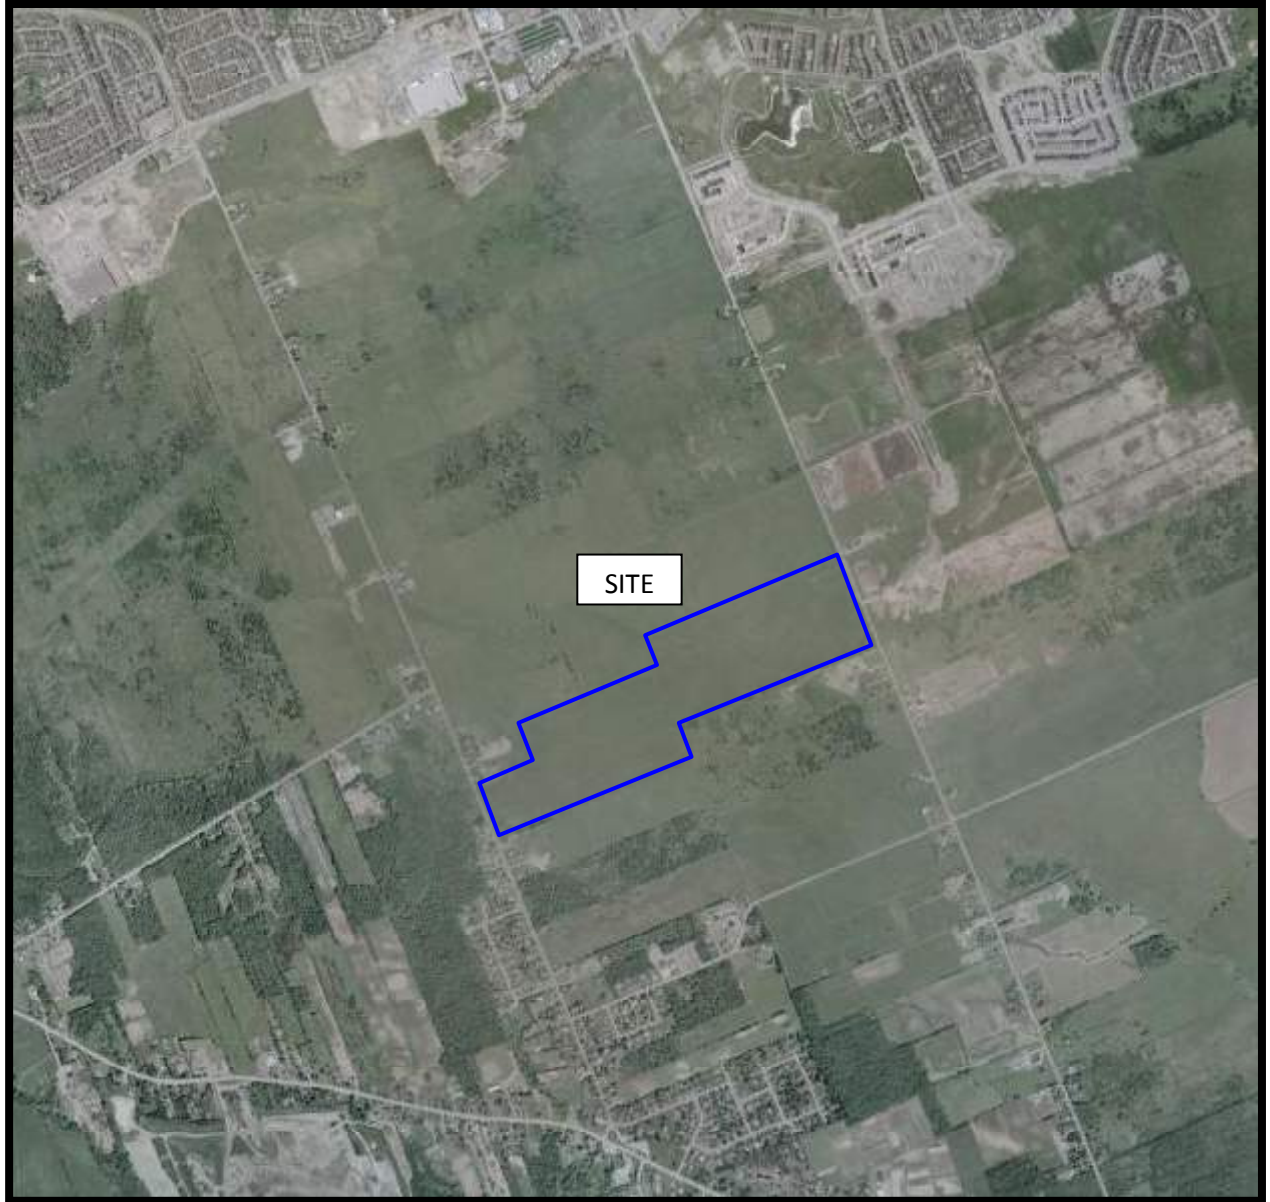
AERIAL PHOTOGRAPH
2005

| 2005 | No major changes have been made to the subject site. The gravel pad in the northeast corner of the site is overgrown. The previous activity at 2666 Tenth Line Road appears to have been abandoned. |

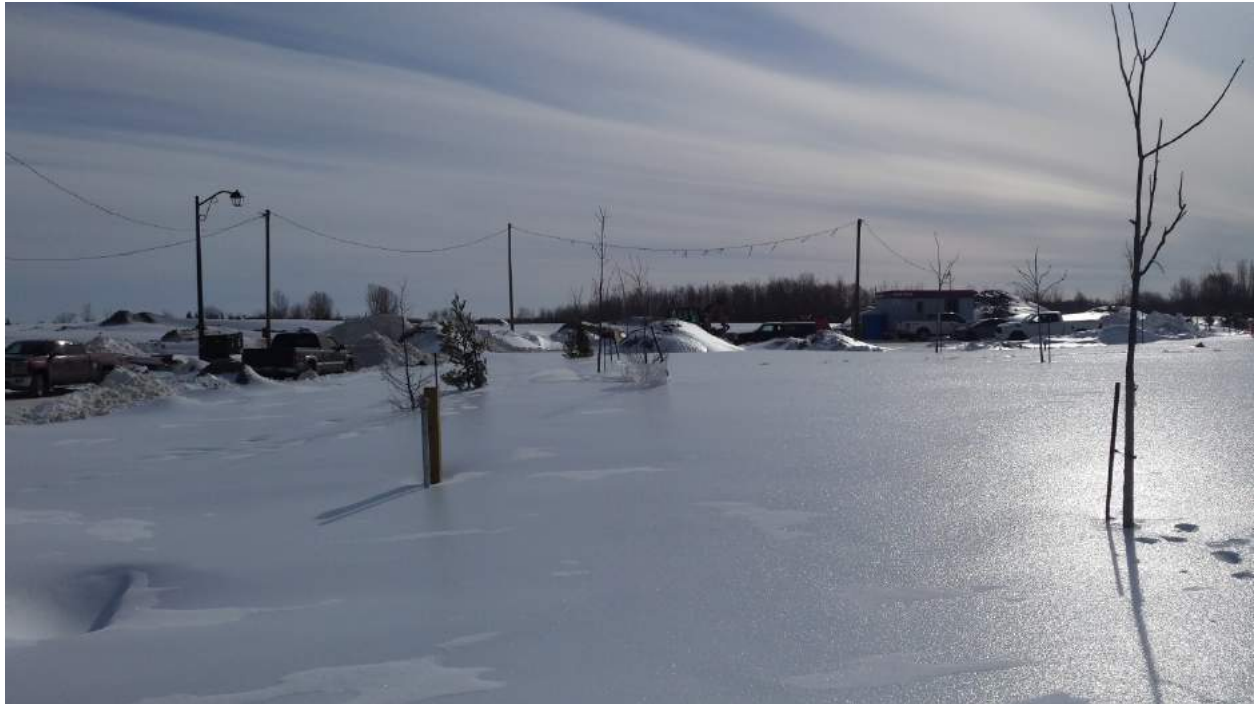
Photograph 1: View of the northeast corner of the subject site, looking south from Sweetvalley Drive.

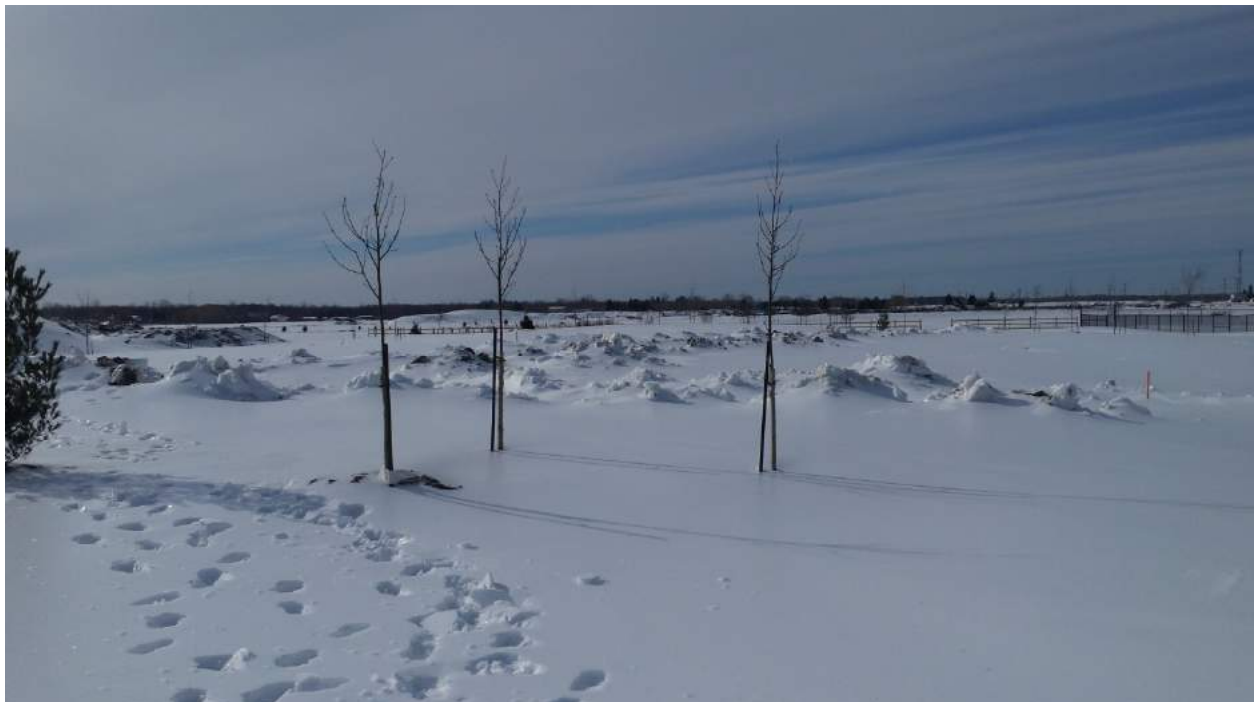
Photograph 2: View of the east side of the subject site, looking southwest from Sweetvalley Drive.

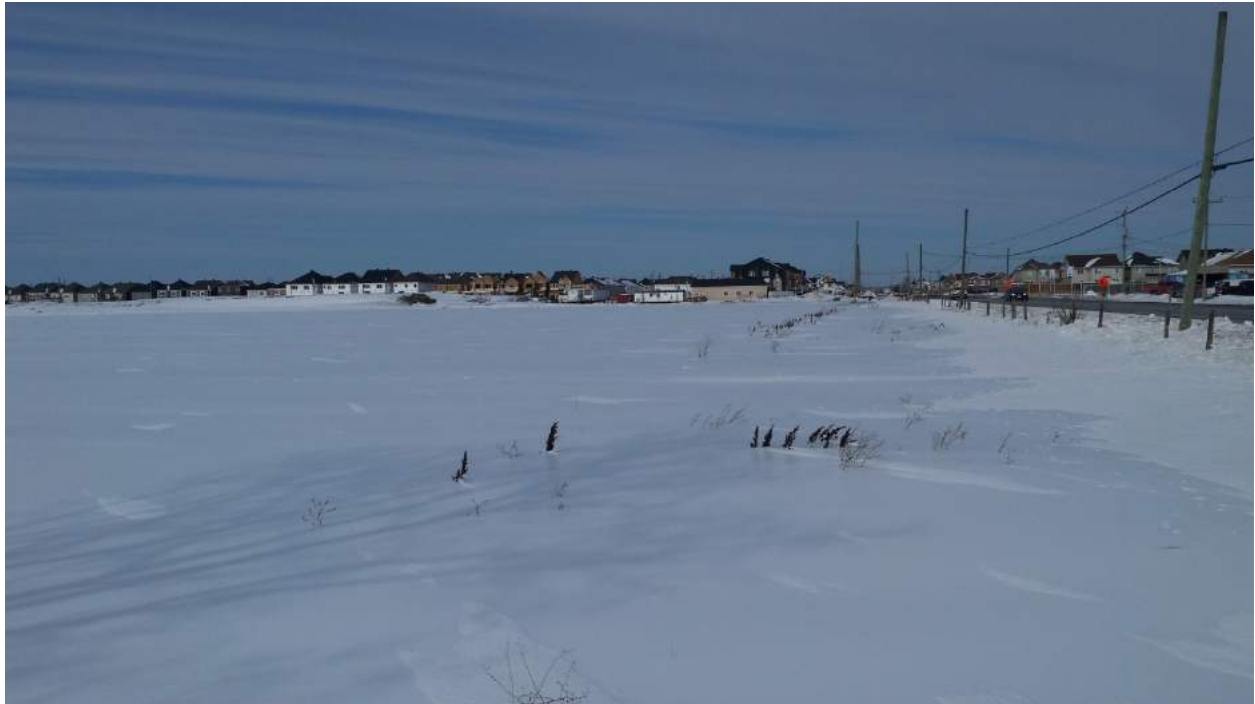
Photograph 3: View of the east side of the subject site, looking north from 2666 Tenth Line Road. Tenth Line Road is visible to the right.

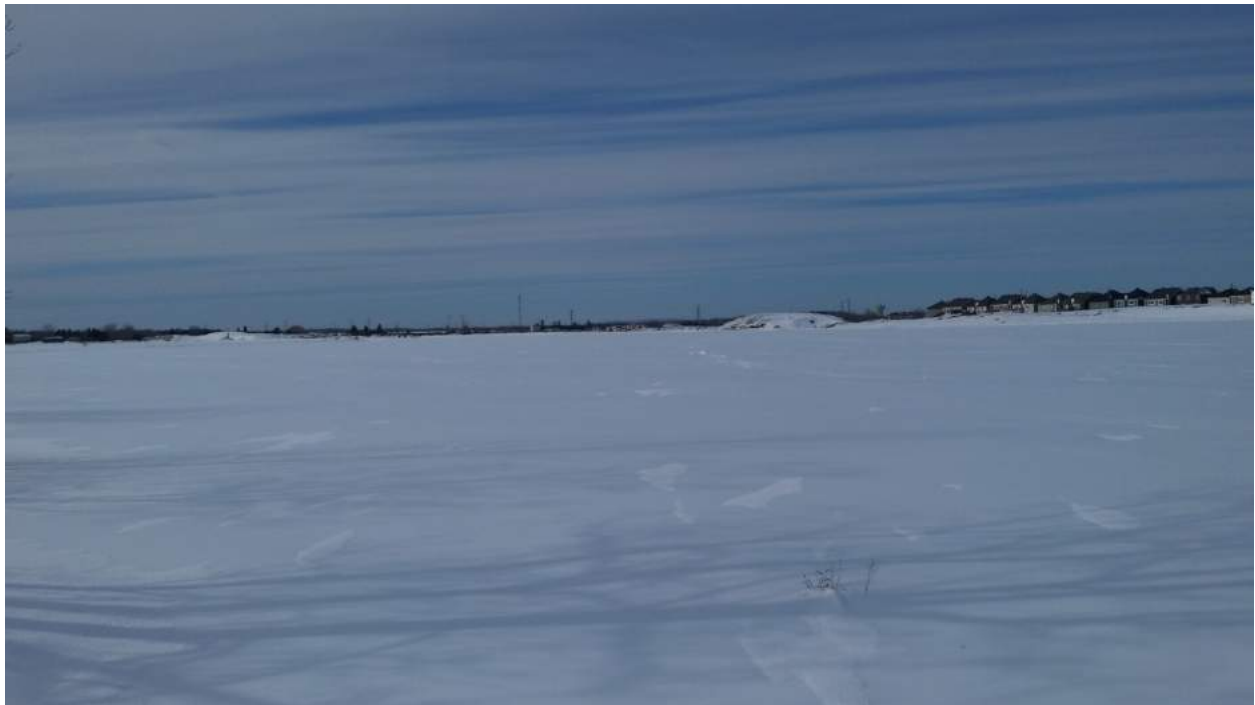
Photograph 4: View of the central part of the subject site, looking northwest from 2666 Tenth Line Road.

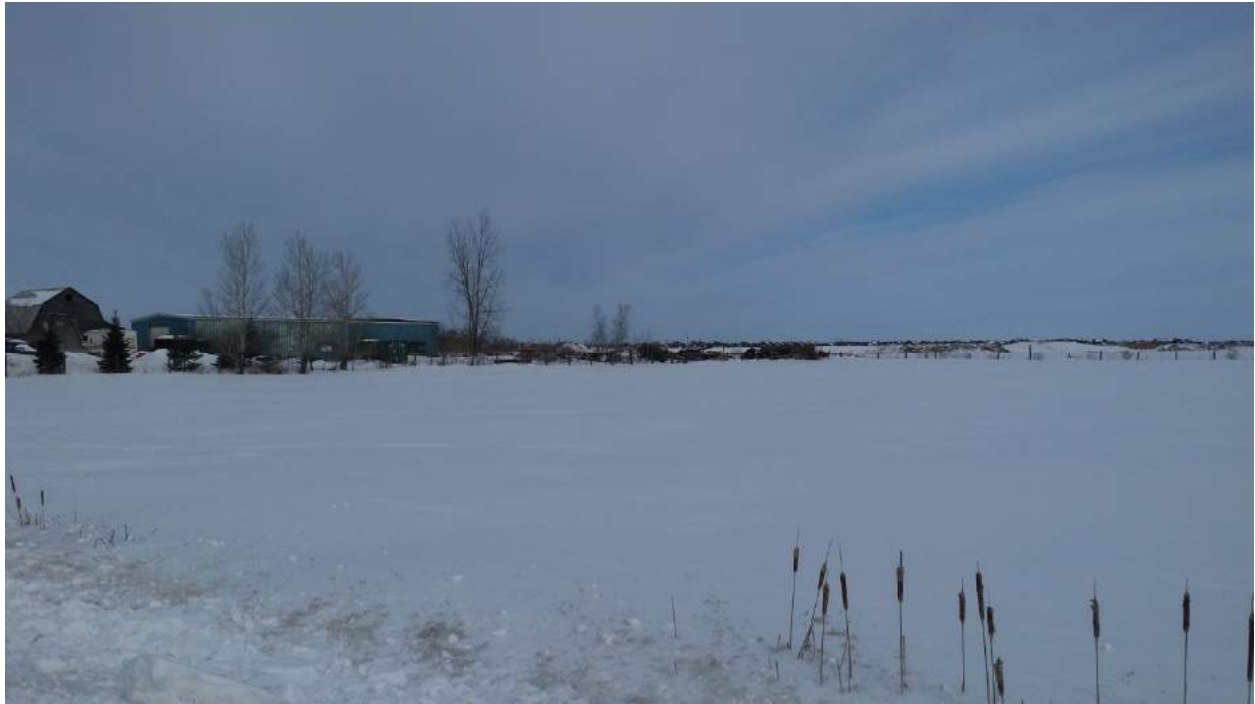
Photograph 5: View of the west side of the subject site, looking northeast from Mer Bleue Road. 2431 Mer Bleue Road is visible at left.
