**PHASE I
ENVIRONMENTAL SITE ASSESSMENT
4747 AND 4755 BANK STREET
CITY OF OTTAWA, ONTARIO**

Claridge Homes (Bank St.) LP.
2001-210 Gladstone Road
Ottawa, Ontario K2P 0Y6

DATE: August 11, 2017

170556

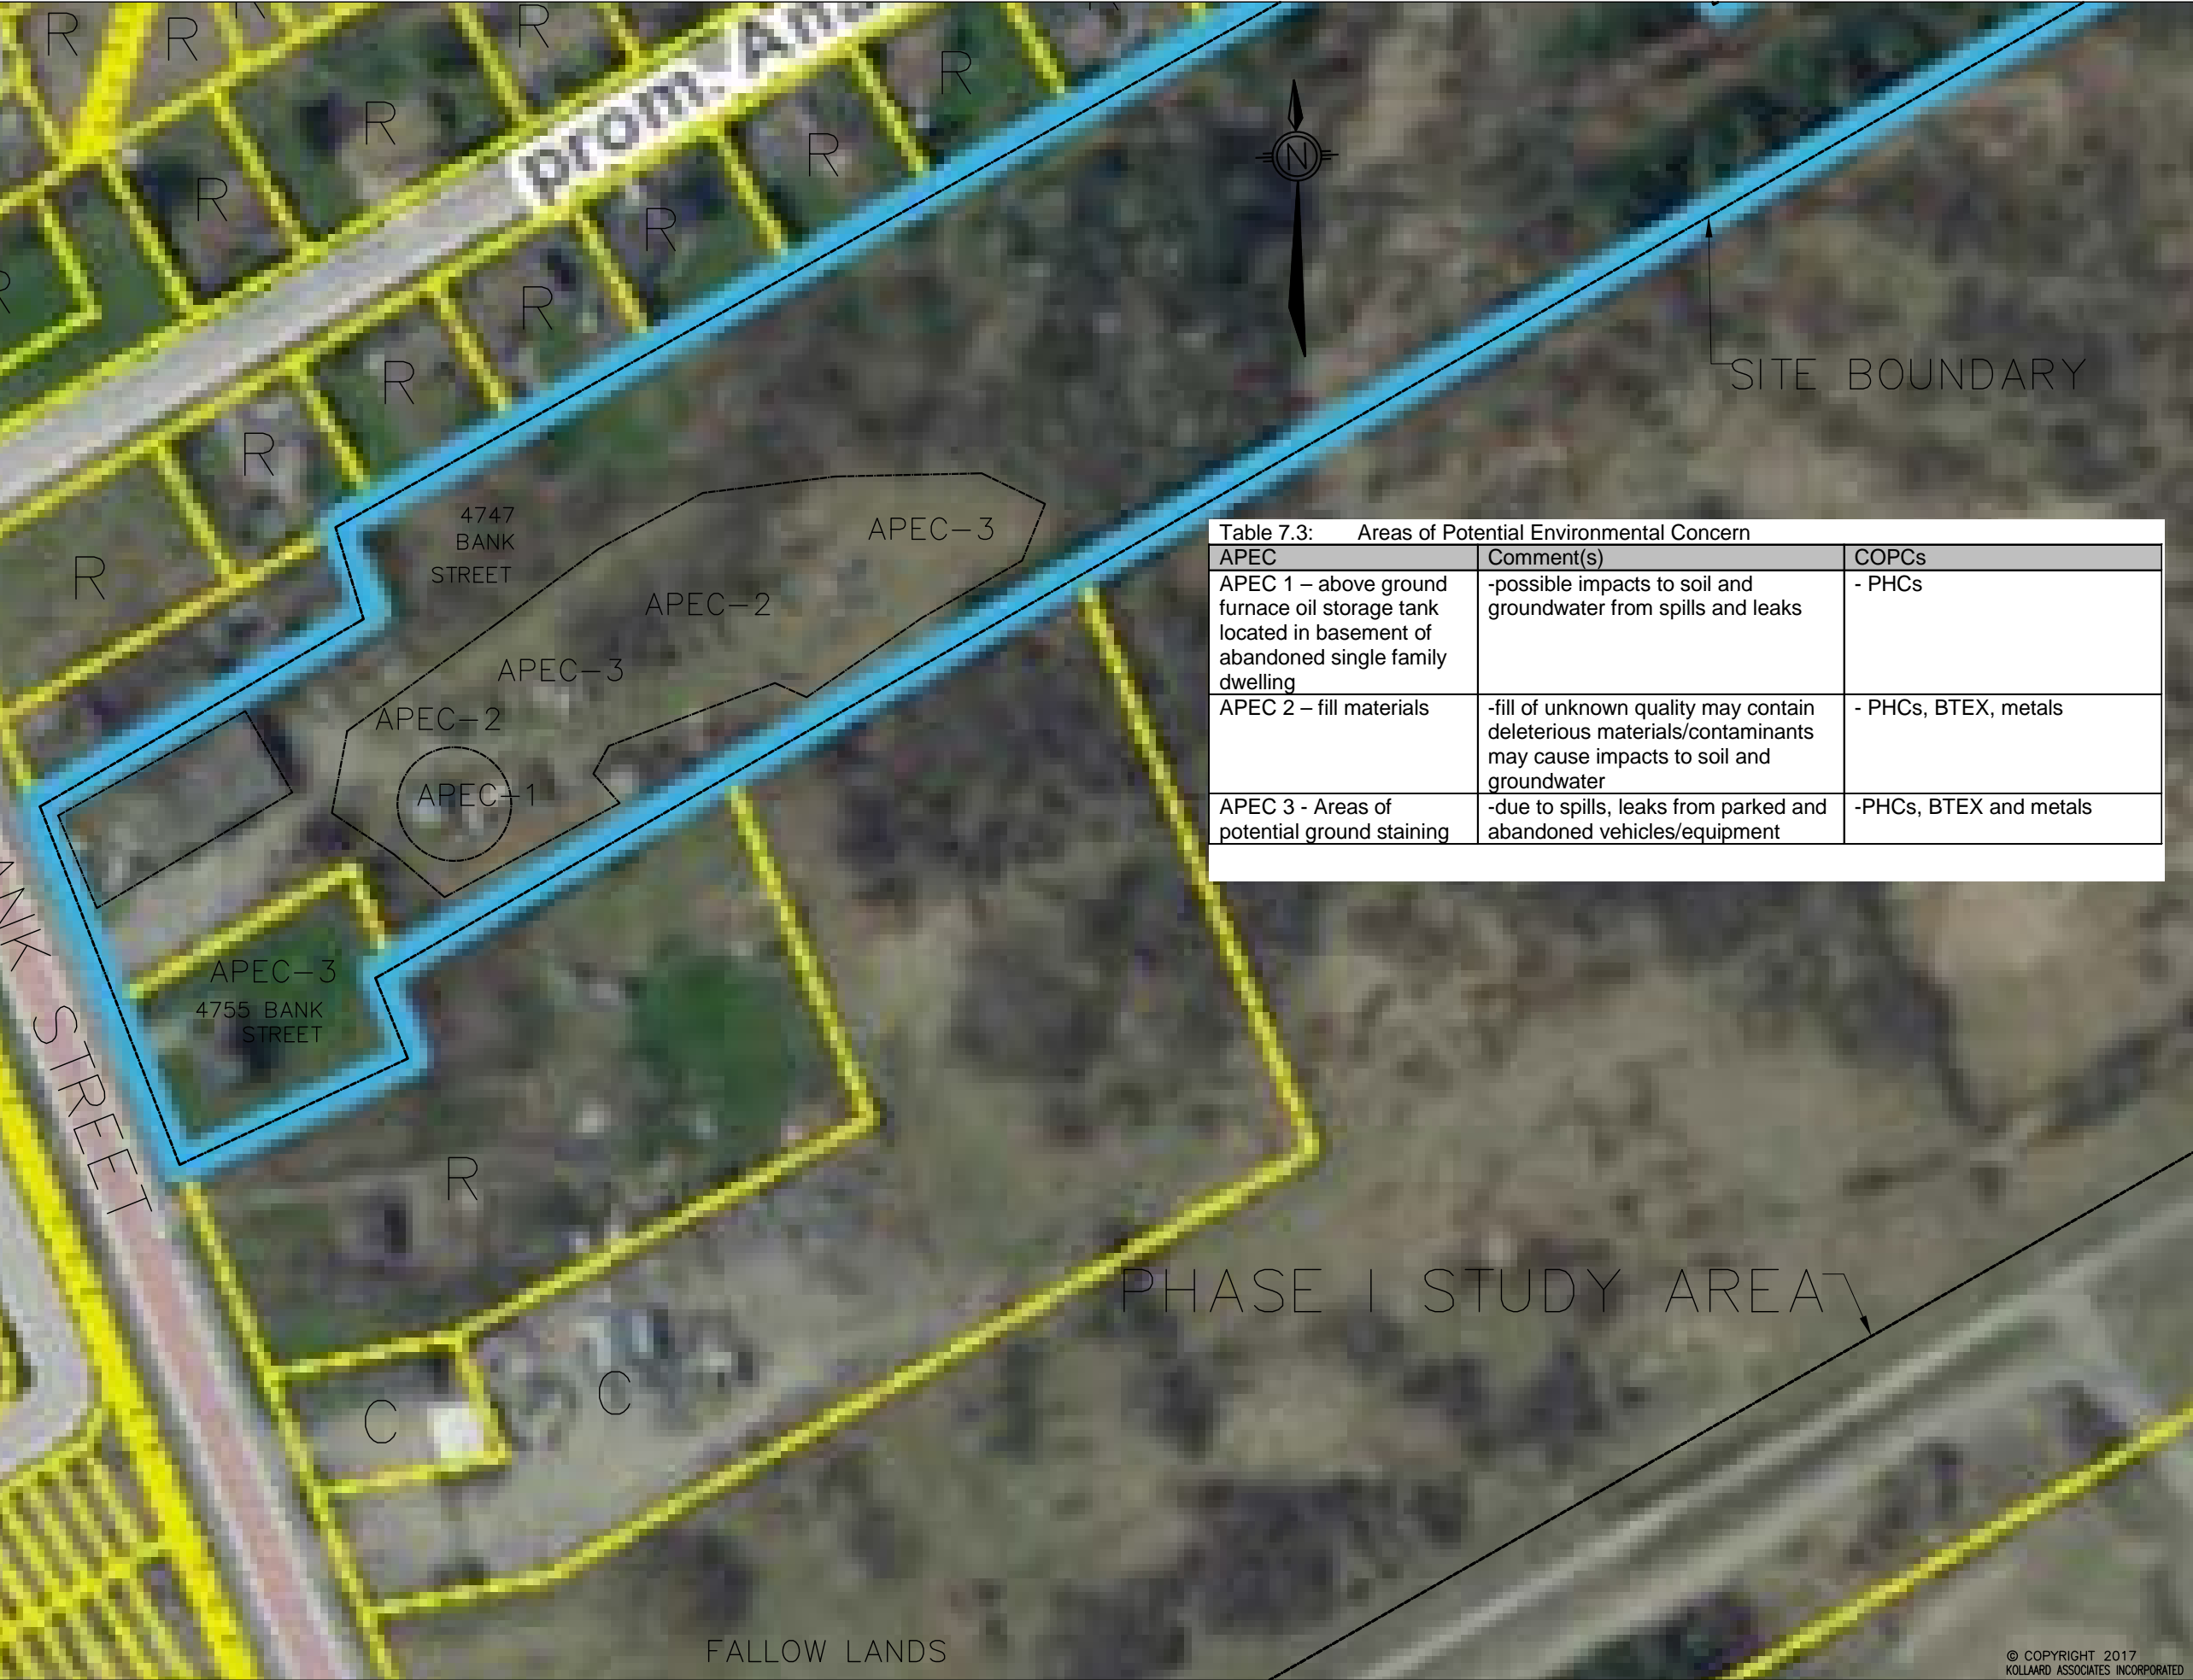
DRAWING NUMBER:
FIGURE 3

Table 7.3: Areas of Potential Environmental Concern		
APEC	Comment(s)	COPCs
APEC 1 – above ground furnace oil storage tank located in basement of abandoned single family dwelling	-possible impacts to soil and groundwater from spills and leaks	- PHCs
APEC 2 – fill materials	-fill of unknown quality may contain deleterious materials/contaminants may cause impacts to soil and groundwater	- PHCs, BTEX, metals
APEC 3 - Areas of potential ground staining	-due to spills, leaks from parked and abandoned vehicles/equipment	-PHCs, BTEX and metals

APEC	Comment(s)	COPCs
APEC 1 – above ground furnace oil storage tank located in basement of abandoned single family dwelling	-possible impacts to soil and groundwater from spills and leaks	- PHCs
APEC 2 – fill materials	-fill of unknown quality may contain deleterious materials/contaminants may cause impacts to soil and groundwater	- PHCs, BTEX, metals
APEC 3 - Areas of potential ground staining	-due to spills, leaks from parked and abandoned vehicles/equipment	-PHCs, BTEX and metals

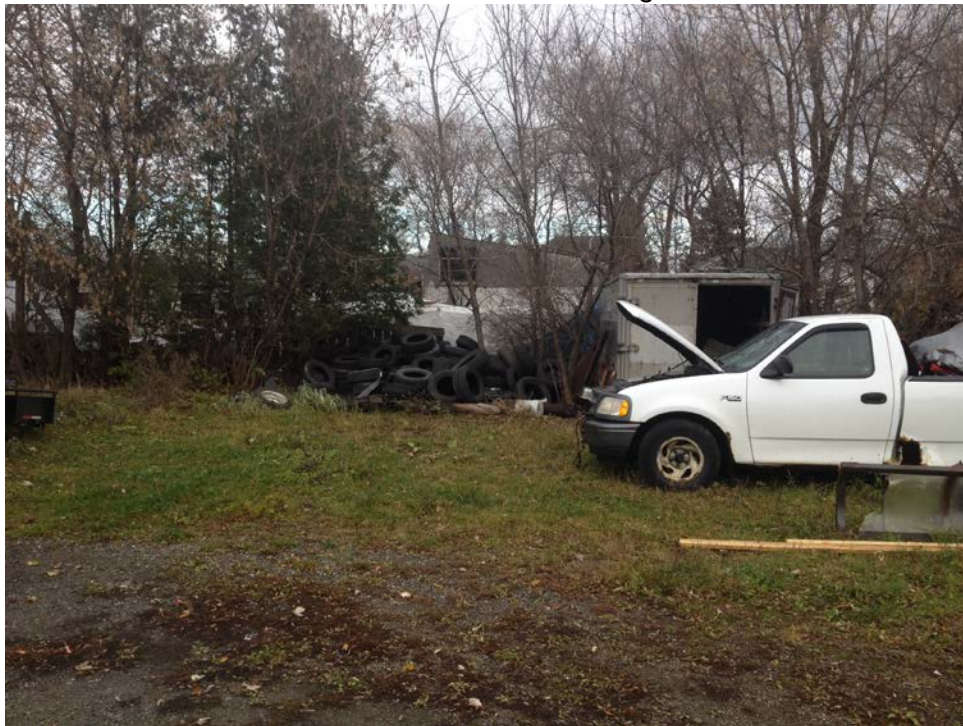
Stockpile of Tires and Parked Trailer and Vehicle located on east side of building (shop)

Numerous piles of miscellaneous debris exist within the west portion of the site including inside the abandoned single family dwelling and the existing storage buildings. Some of the items observed include rubber tires, metal and wood debris, steel beams, stockpiles of empty paint cans, drywall, abandoned metal machinery, wooden chairs, metal propane tanks, a lawnmower, a stove, furniture, wooden pallets, plastic liners for trucks, truck caps, plastic containers, abandoned lawn tractors, abandoned feces containers, etc. These items do not present a serious environmental concern, however, if removed from the site, these items should be disposed of in an environmentally acceptable manner.

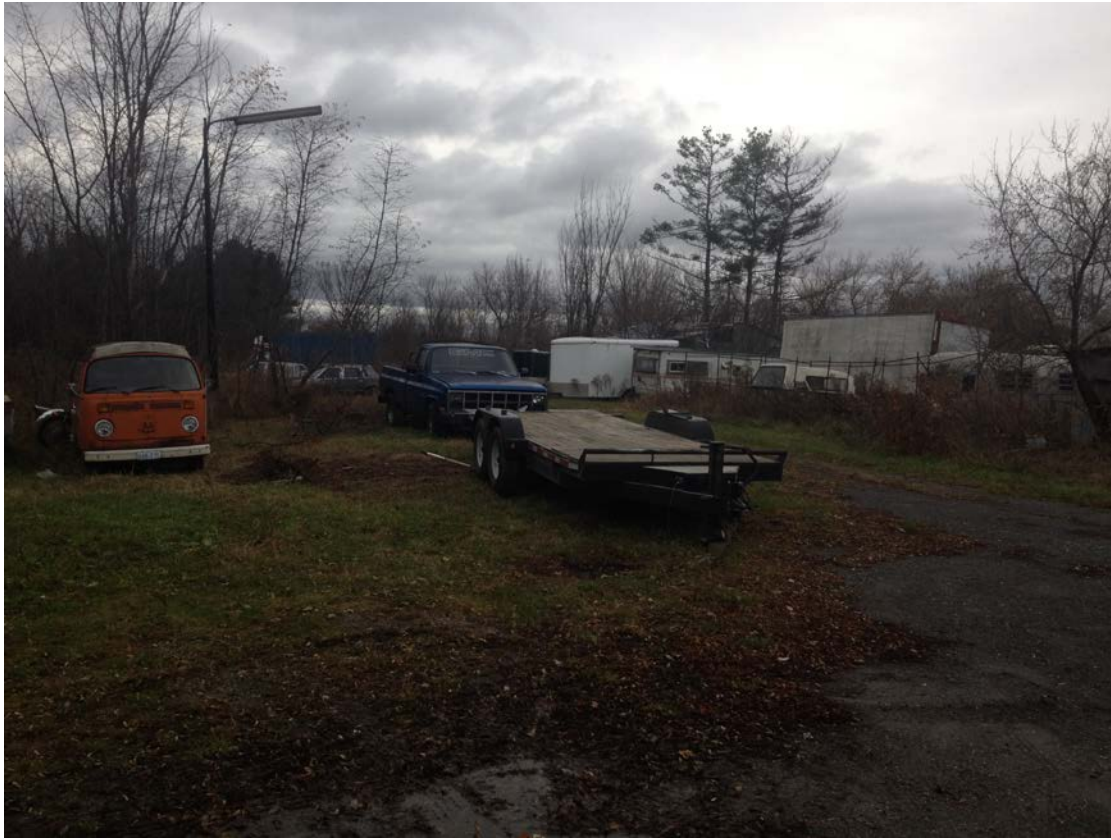
Abandoned and Parked vehicles located east of building (shop)

The presence of numerous vehicles (over 50) stored at the site is not considered a Potentially Contaminating Activity as listed in Table 2 of Schedule D of O. Reg. 153/04, however, it is possible that some spills/leaks from parked and abandoned vehicles/equipment could have caused some isolated impacts to the subsurface at the site.

The presence of numerous vehicles (over 50) stored at the site is not considered a Potentially Contaminating Activity as listed in Table 2 of Schedule D of O. Reg. 153/04. However, it is possible that some spills/leaks from parked and abandoned vehicles/equipment could have caused some isolated surficial impacts to the soils at the site.

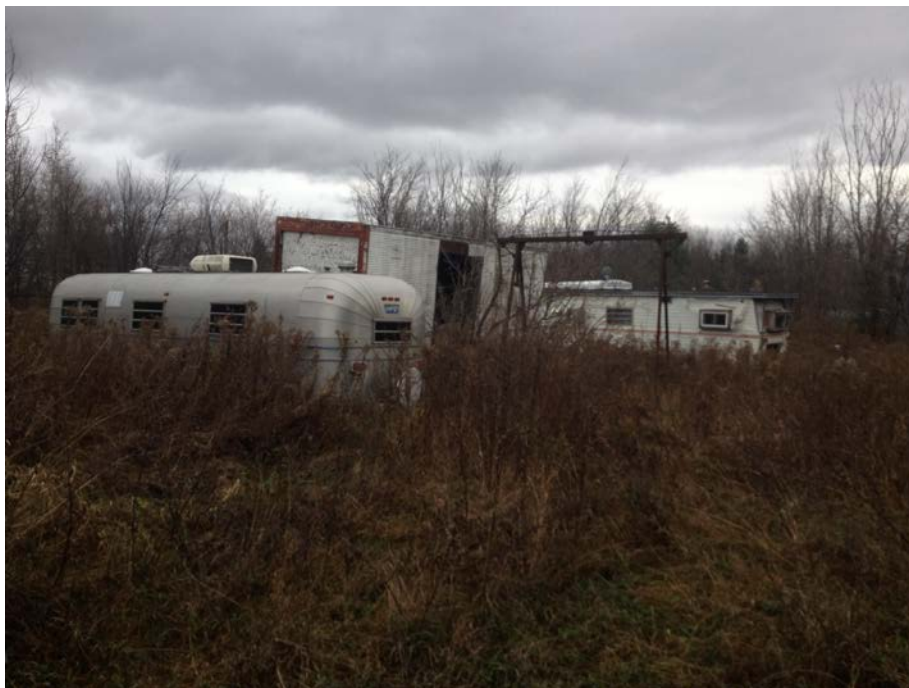
Miscellaneous Parked and Abandoned Vehicles located east of building (shop)

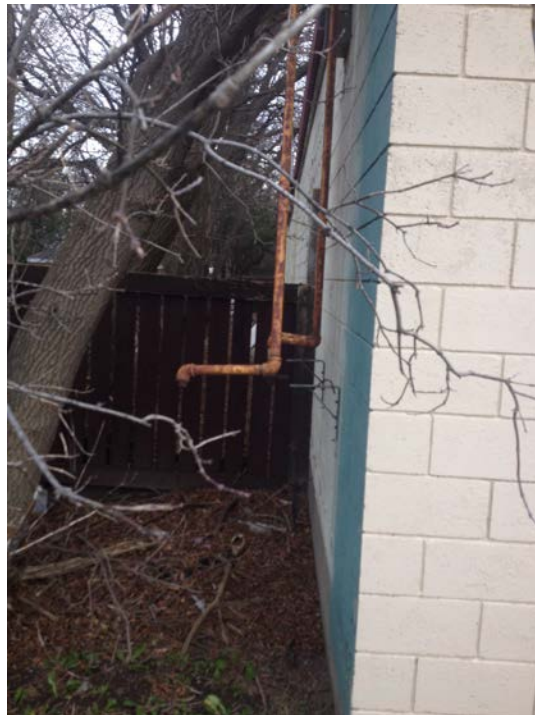
4747 Bank Street - Ceiling mounted furnaces were observed in both bays of the single storey building (Leitrim Supply and A & A Storage). Mr. McGann indicated that the building is no longer heated using natural gas as it has been disconnected. Mr. McGann indicated that the building is heated using electricity and a wood stove. Mr. McGann indicated that the abandoned single family dwelling was formerly serviced using heating oil. The owner indicated that the tank still remained within the basement of the dwelling.

Disconnected Gas located at northwest corner of building (shop)

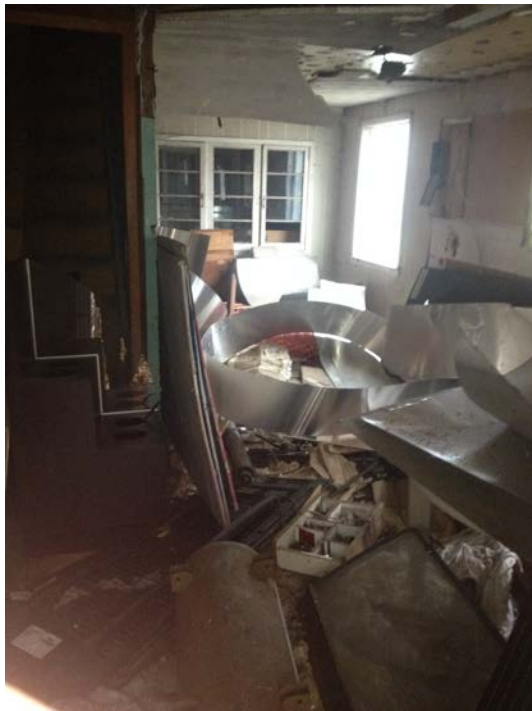
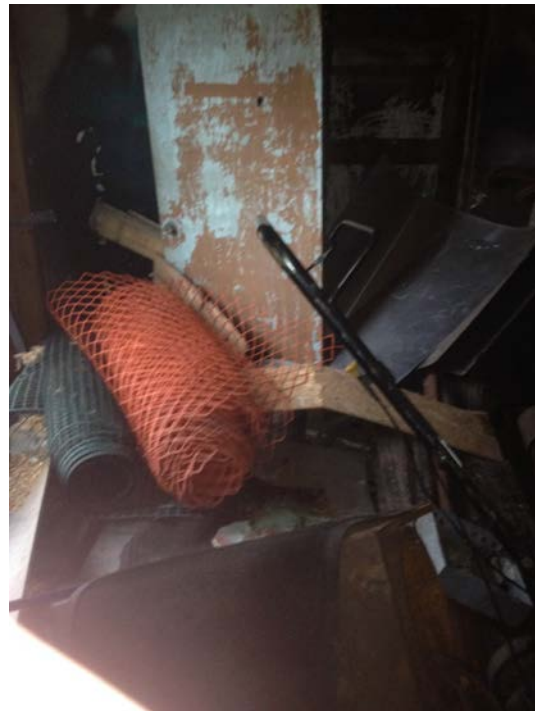
- A two storey, wood framed dwelling with concrete foundation exists south of the building (shop). It is understood the dwelling has been abandoned for at least 20 years and used for storage purposes only.
- Access within the single family dwelling was limited due to many piles of miscellaneous materials and debris stockpiled throughout.

Interior of Abandoned Single Family Dwelling

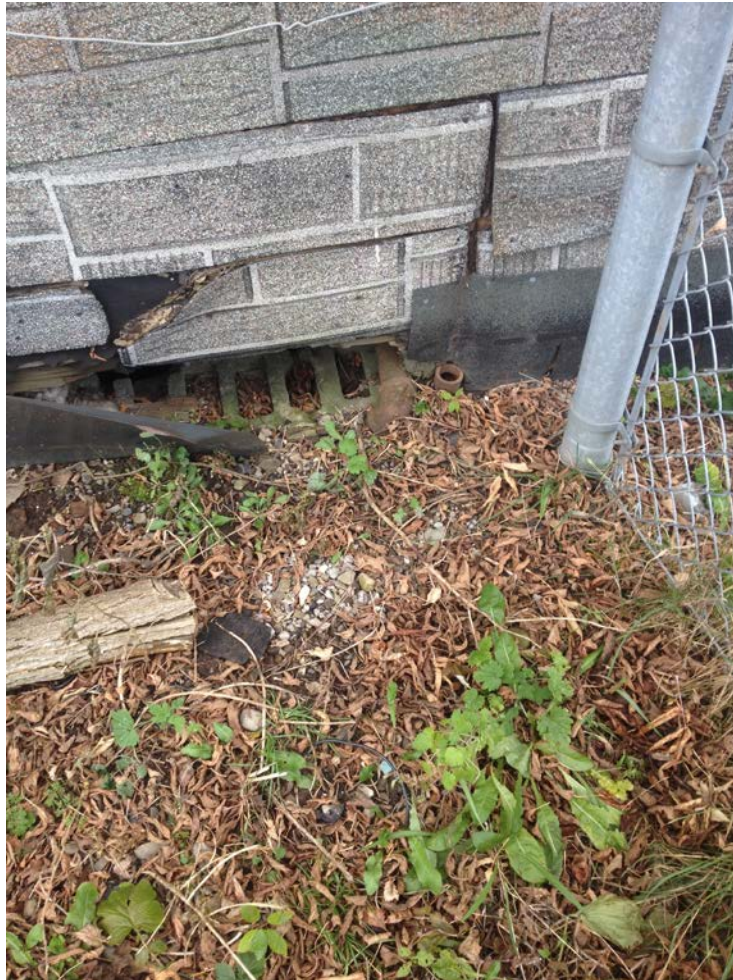
Information provided by the owner indicated that the abandoned single family dwelling was heated using oil and was serviced with an oil tank that is still present within the basement of the abandoned dwelling. At the time of the site visit, the tank could not be visually inspected for its condition due to a lack of access to its location (storage items).

Fill Pipes for Above Ground Furnace Oil Tank located in basement of abandoned single family dwelling

- Possible hydrocarbon impacts from an existing above ground furnace oil tank located in the basement of the abandoned dwelling at 4747 Bank Street
- Possible presence of metals, PHC's and BTEX due to fill of unknown quality observed east of the existing shop at 4747 Bank Street
- Possible presence of PHCs, BTEX and metals from numerous abandoned vehicles located in the west portion of the site

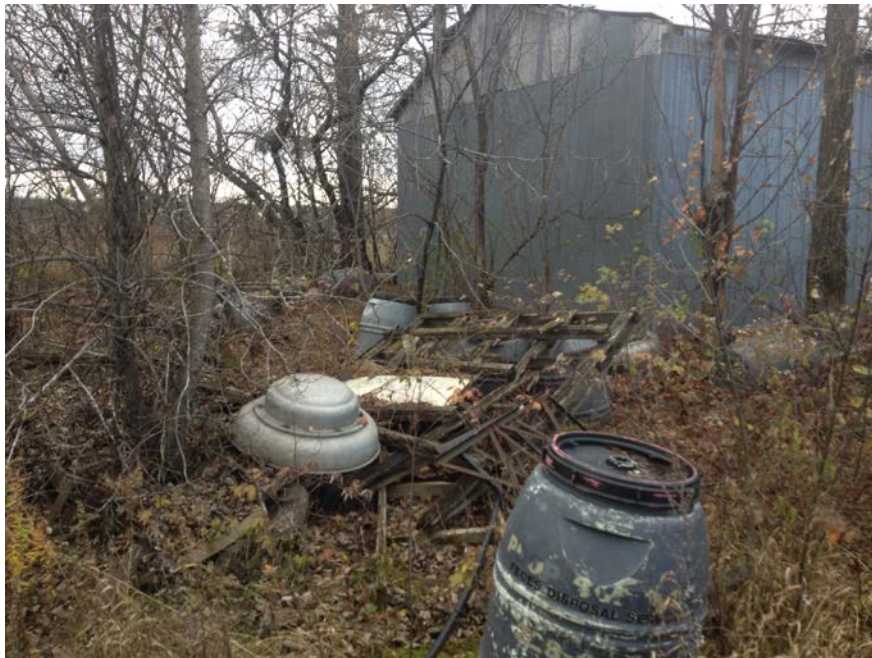
Abandoned Feces Disposal Drums

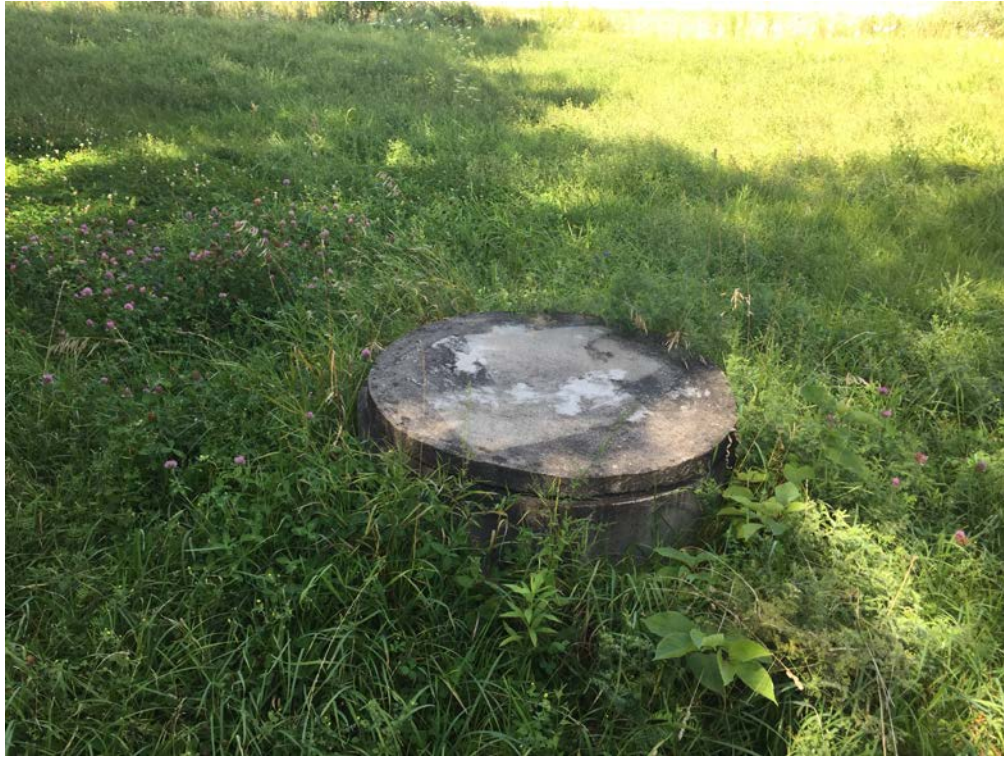
4755 Bank Street - The single family dwelling is also serviced by a municipal water supply system that exists within Bank Street. A dug well was also observed adjacent the southwest corner of the dwelling at the site. It is understood that the dug well is no longer in use. It is possible that the well was not abandoned in accordance with the requirements of Ontario Regulation 903.

Dug Well located at 4755 Bank Street

Two dug wells were observed at the site. One dug well located near the existing single family dwelling was indicated to be abandoned by the owner at 4747 Bank Street. A second dug well was observed at 4755 Bank Street. Improper abandonment could be a potential pathway for contaminants to enter the subsurface. Proper abandonment of the dug wells should be verified, confirmed and/or completed by licensed well drillers in accordance with Ontario Well Regulation 903, Section 21.

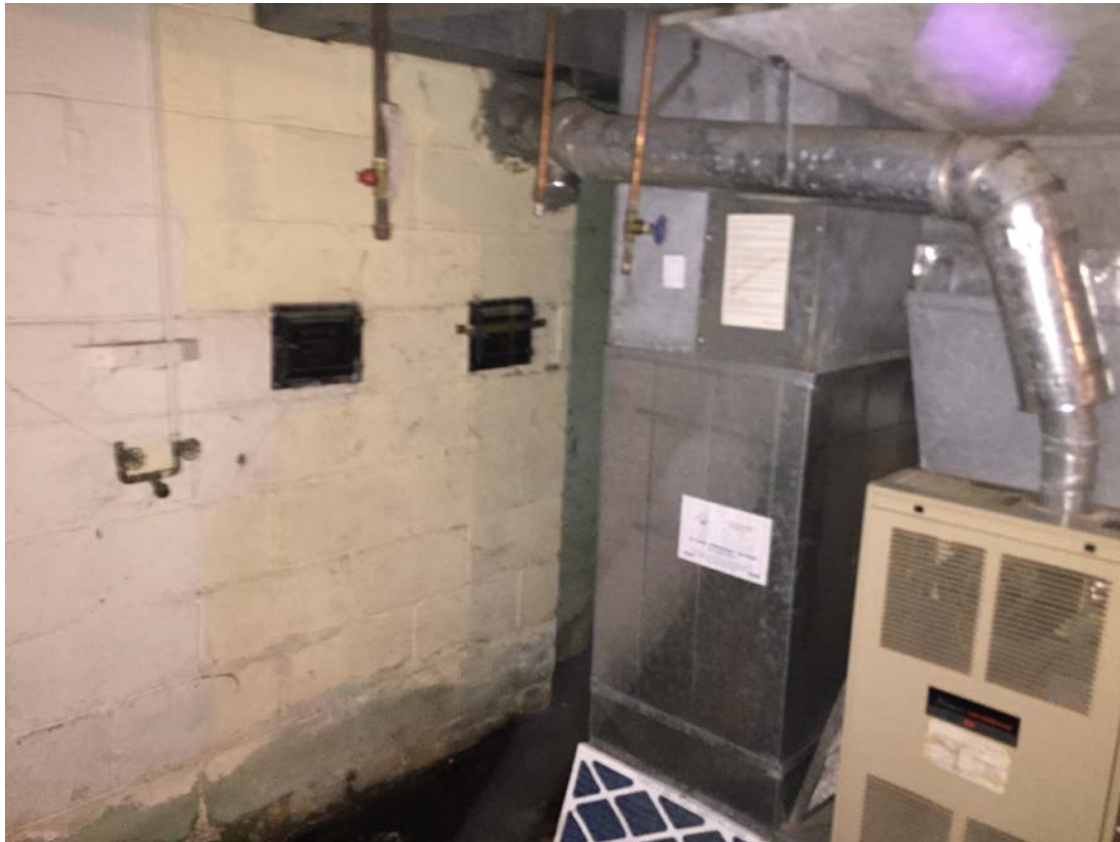
4755 Bank Street - The single family dwelling is heating using natural gas and a high efficiency furnace located in the basement of the dwelling. No air conditioning units were observed.

Natural Gas Furnace within basement at 4755 Bank Street
