Environmental Impact Statement for Barrhaven Conservancy Phase 1

May 30, 2018

KILGOUR & ASSOCIATES LTD.

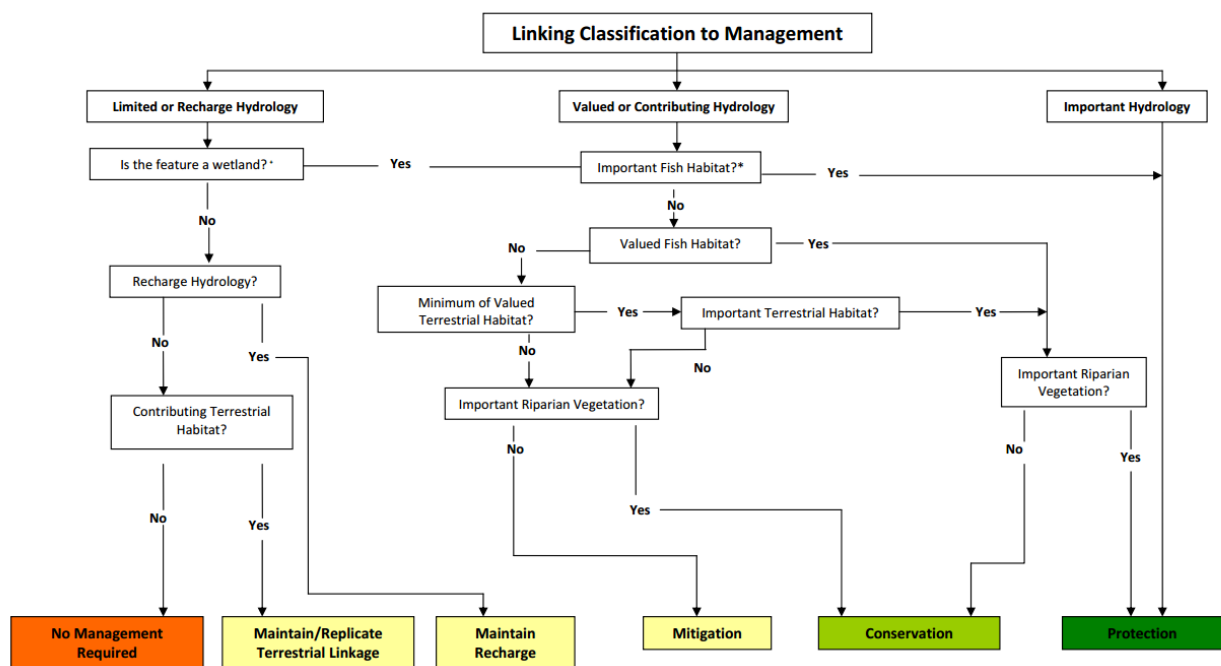
Figure 2. Headwater Drainage Feature Assessment (HDFa) flow chart providing direction on management options

The classification categories identified in Section 2 provide the basis of the management recommendations provided here. The following flow chart (Figure 2) combines and translates the classification results to management recommendations.

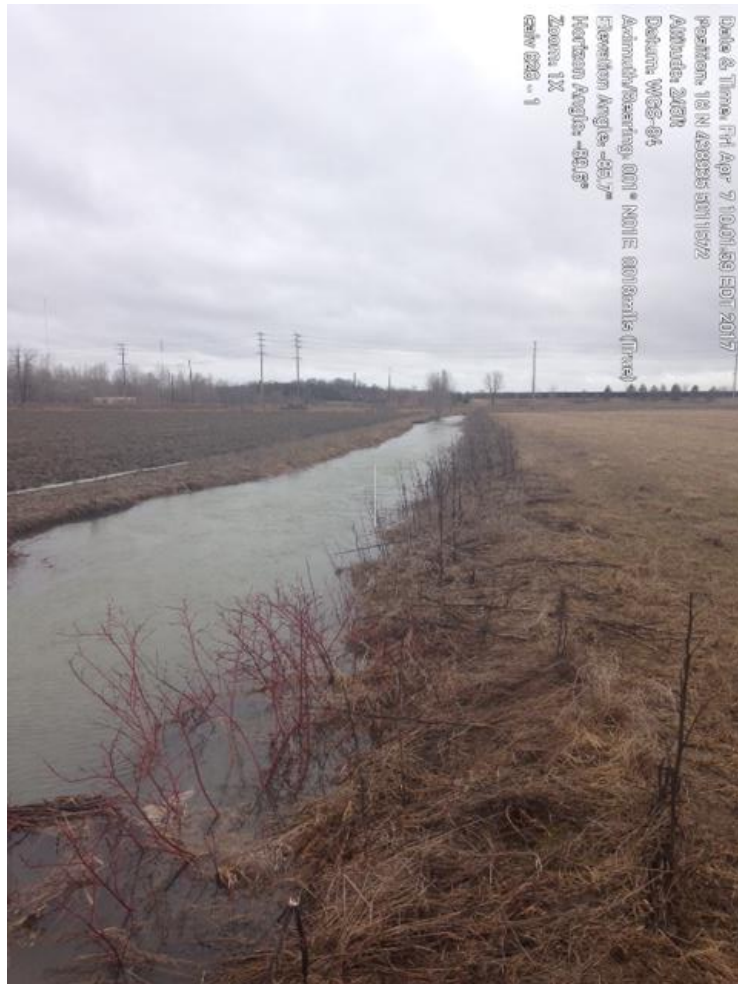
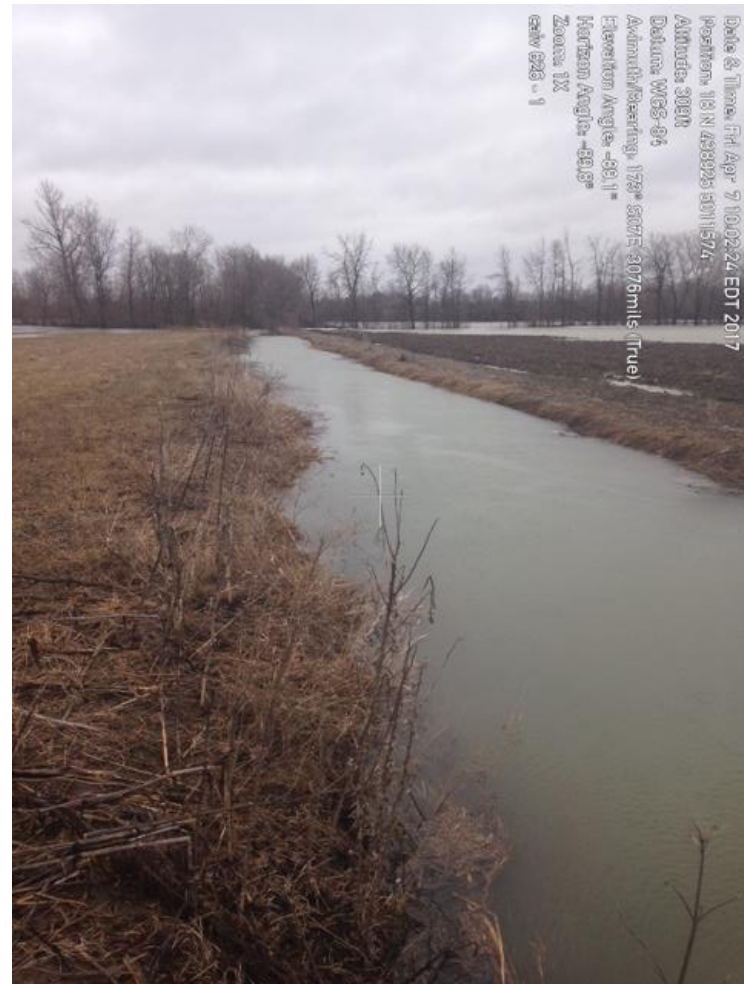
Reach 1

The substrate consisted of a mixture of clay and silt, with some sand and gravel in the upstream section. Woody debris was present in the downstream section while submergent vegetation was common in the upstream section. During the spring freshet survey in April, this reach was flooded, very deep (too deep to measure), and fast flowing. By May and July, the reach had shrunk considerably but was still fast flowing. A total of 30 fish were observed in this reach: seven Common Shiners (*Luxilus cornutus*), six Longnose Dace (*Rhinichthys cataractae*), five Creek Chub (*Semotilus atromaculatus*), four Mottled Sculpin (*Cottus bairdii*), three Banded Killifish (*Fundulus diaphanus*), three Pumpkinseed Sunfish (*Lepomis gibbosus*), and two Fathead Minnows (*Pimephales promelas*). No frogs and one Snapping Turtle (*Chelydra serpentina*) was observed in this reach.

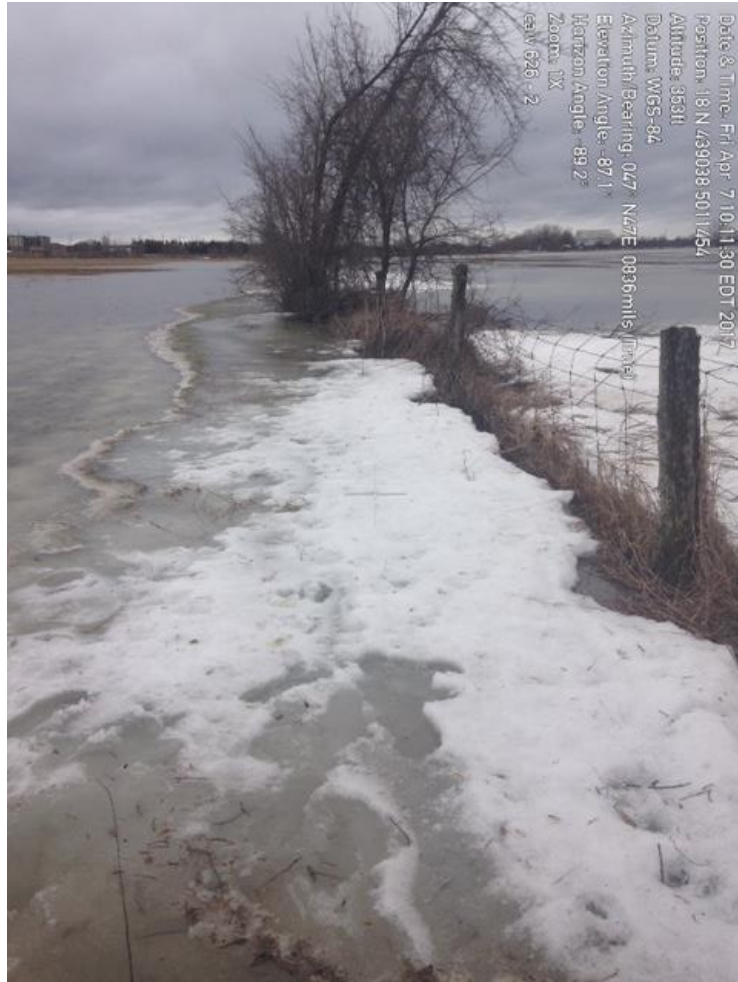
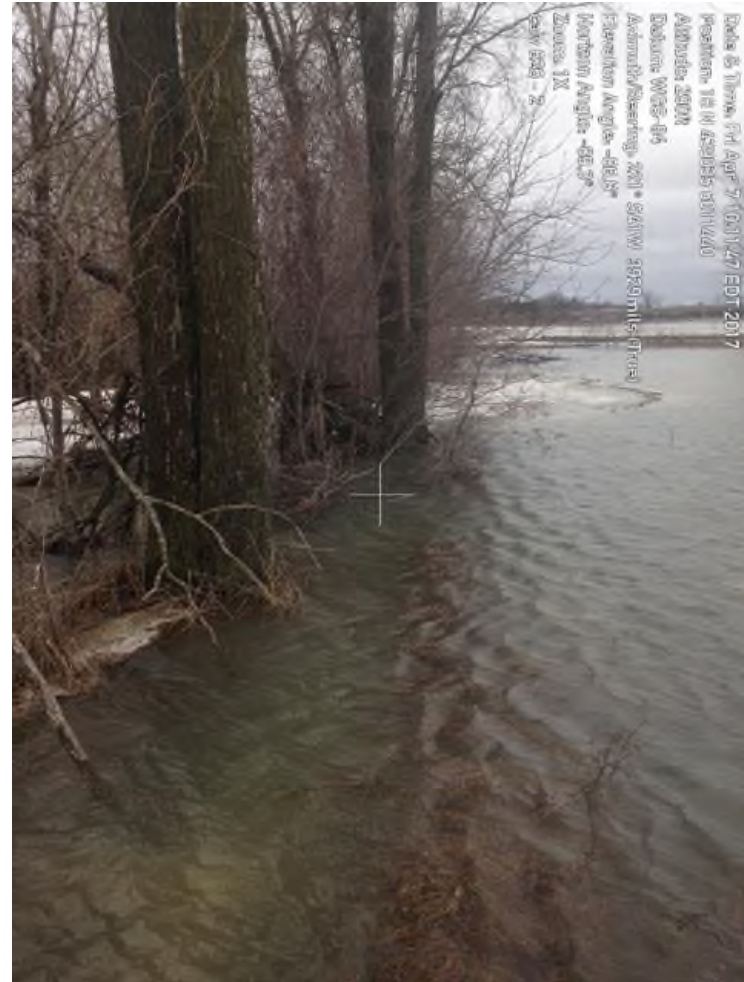
Reach 2

The substrate consisted of a mixture of clay and silt. Woody debris was abundant Reach 3 but less so in Reach 2. Submergent vegetation was not present in either reach. Both reaches were flooded but with no detectable flow during the April survey period. In May and July, both reaches were dry. No fish, frogs, or turtles were observed either in either of these reaches.

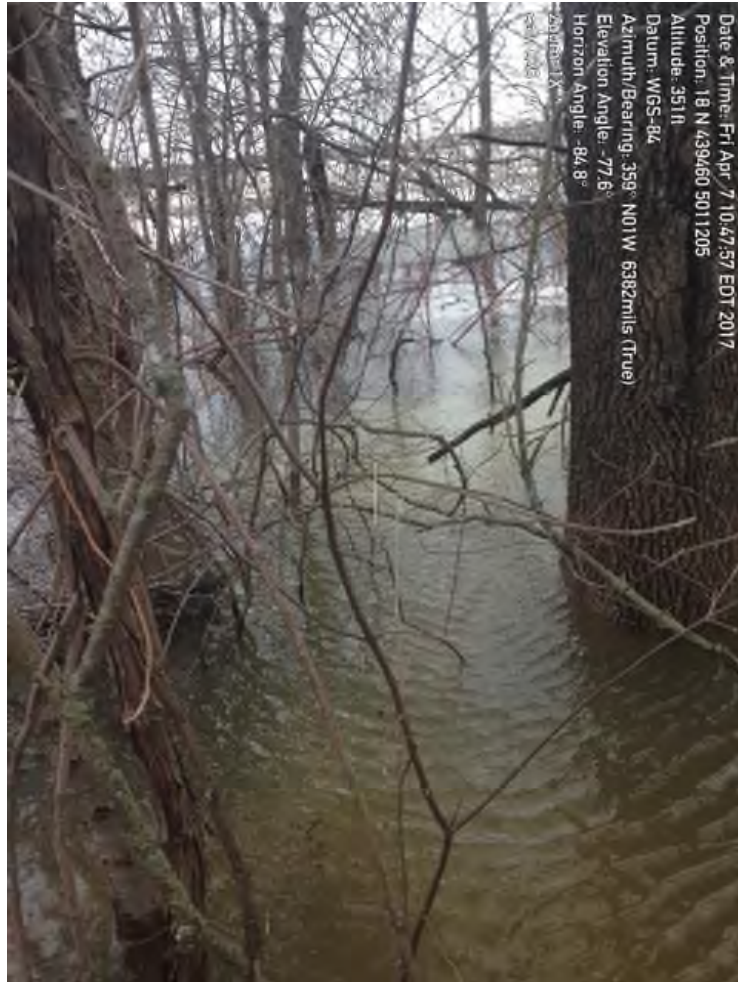
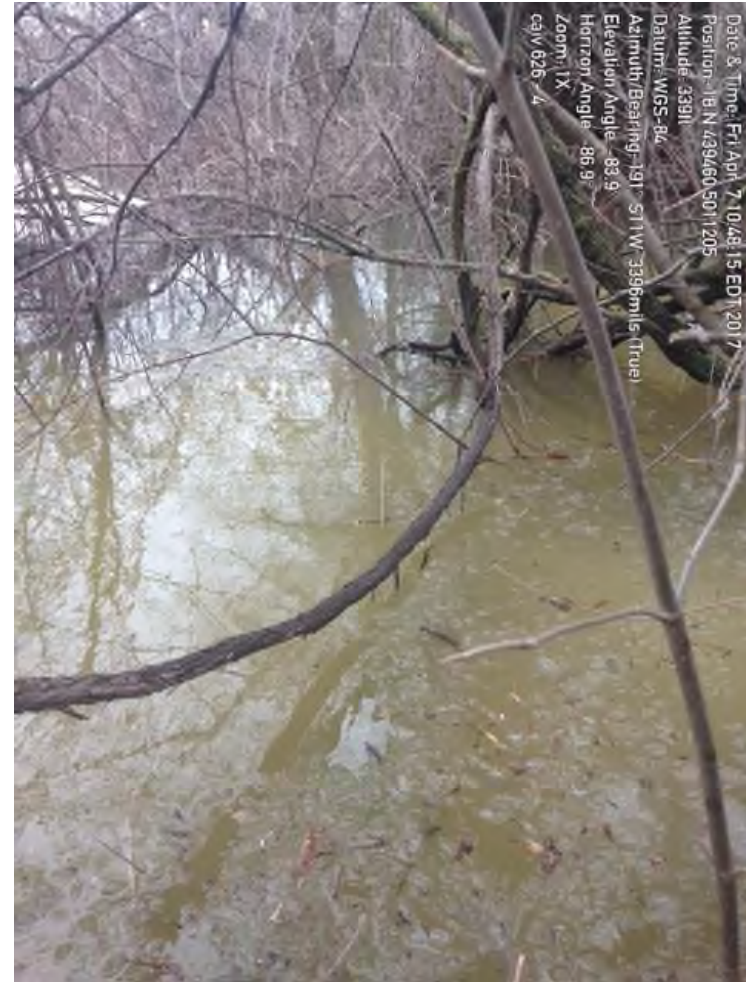
The substrate consisted of a mixture of clay and silt. Woody debris was highly abundant but submergent vegetation was absent. Reach 4 was completely flooded due to the high waters of the Jock River during the April survey period. In May, however, this reach consisted of standing water, being blocked by several woody barriers downstream. In July, this reach was characterized by remaining damp areas though likely due to ongoing rains rather than seeps. No fish, frogs, or turtles were observed in Reach 4.

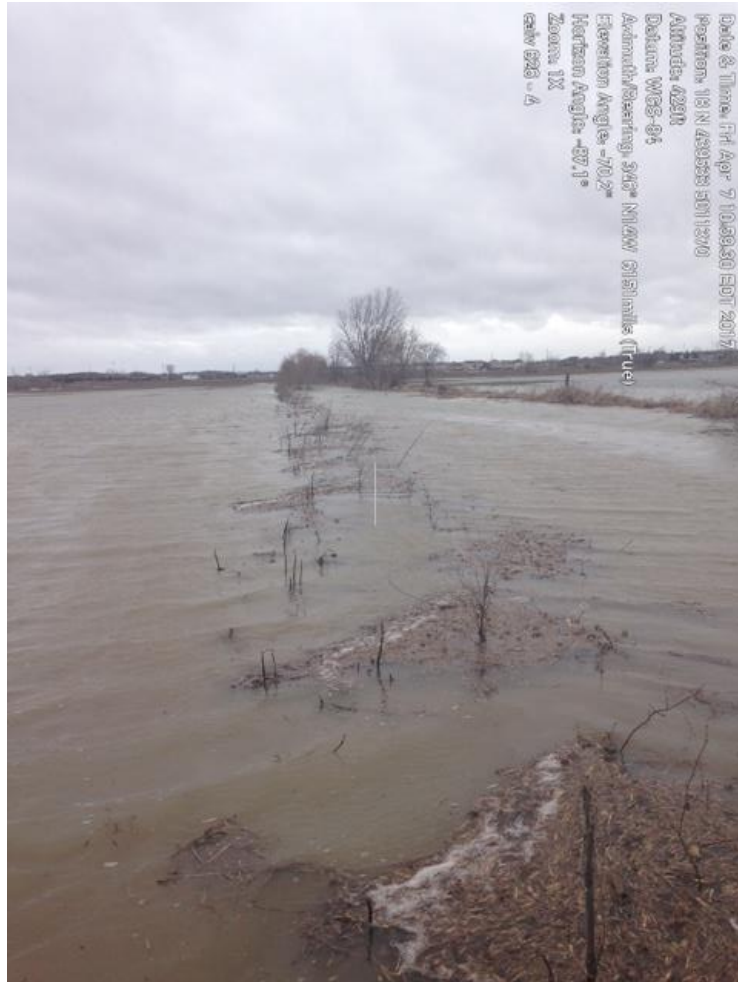
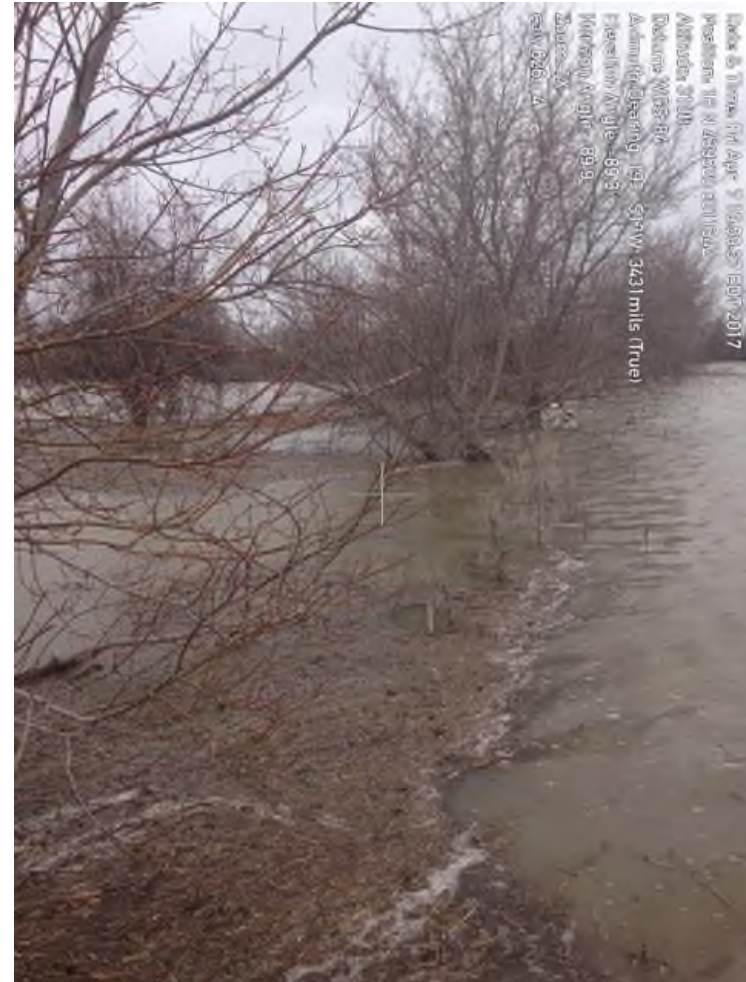
The substrate consisted of a mixture of clay and silt. Woody debris and submergent vegetation are abundant in Reach 5. During the April survey, Reach 5 was flooded by the high water levels in the Jock River. In May and July, the reach was significantly lower, yet was still too deep to fish during the fishing survey. The fish community in this reach was, however, assessed by in August 2009 (Muncaster 2009) as part of the Foster and Kennedy Burnett Stormwater Project. The authors found a limited and common fish community, albeit, still relatively diverse, including Banded Killifish (*Fundulus diaphanus*), Blacknose Dace (*Rhinichthys atractulus*), Blacknose Shiner (*Notropis heterolepis*), Bluntnose Minnow (*Pimephales notatus*), Brook Stickleback (*Culaea inconstans*), Central Mudminnow (*Umbra limi*), Common Shiner (*Luxilus cornutus*), Creek Chub (*Semotilus atromaculatus*), Fathead Minnow (*P. promelas*), Mottled Sculpin (*Cottus bairdii*), Pumpkinseed Sunfish (*Lepomis gibbosus*), Rock Bass (*Ambloplites rupestris*), and White Sucker (*Catostomus commersonii*). American Toads (*Anaxyrus americanus*), Gray Treefrogs (*Hyla versicolor*), and Northern Leopard Frogs (*Lithobates pipiens*) were heard calling in the vicinity, and one Snapping Turtle was observed in Reach 5.

***These pictures are of Reach 5, not Reach 4 which is displayed in the text photograph.**

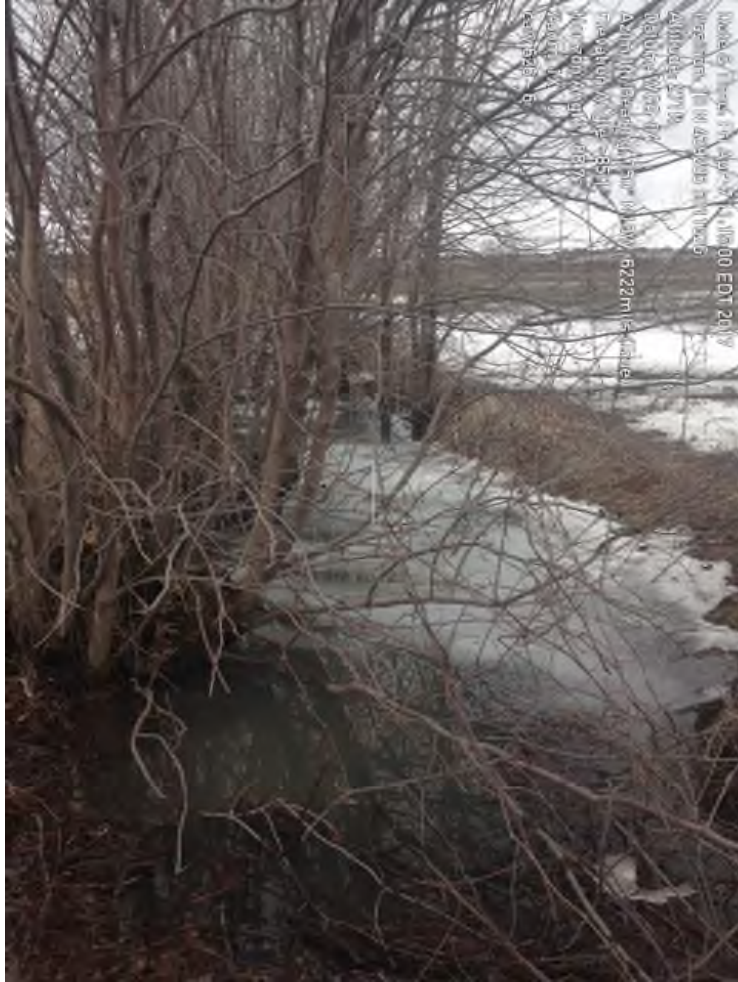
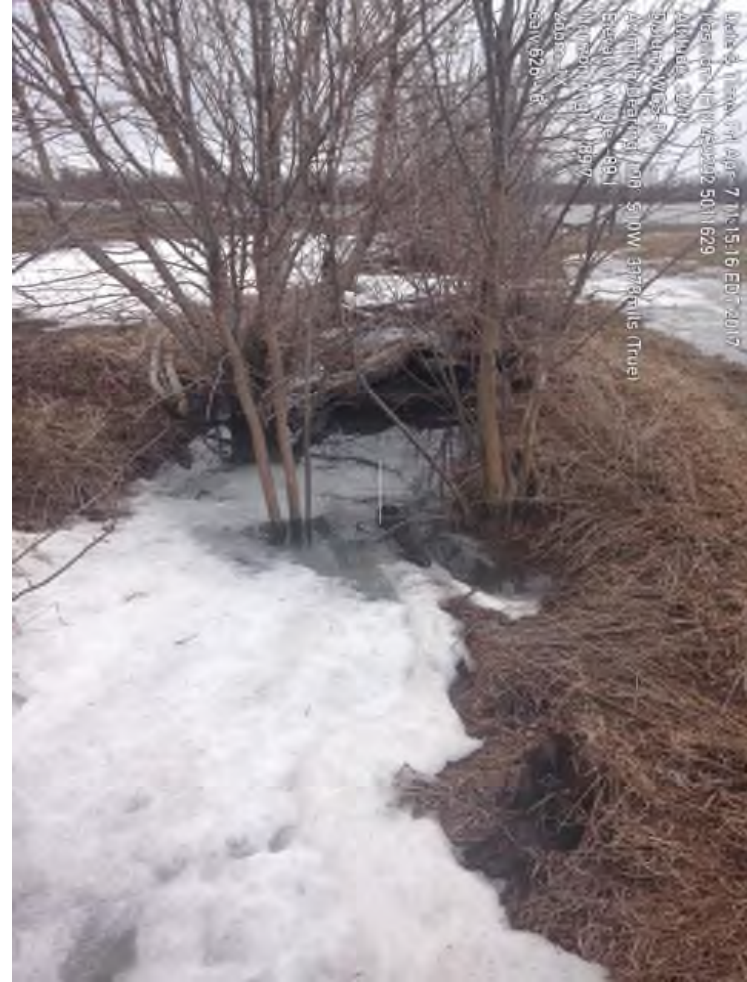
The substrate in this reach consists of a mixture of clay and silt. Woody debris was highly abundant downstream. Submergent vegetation was not present. Reach 6 maintained some standing water through April, May and July, through a combination of spring runoff, heavy rains and poor drainage/infiltration. No fish or turtles were observed in this reach. No frogs were heard here either, though American Toads and Gray Treefrogs were heard calling from the SWM pond to the north.

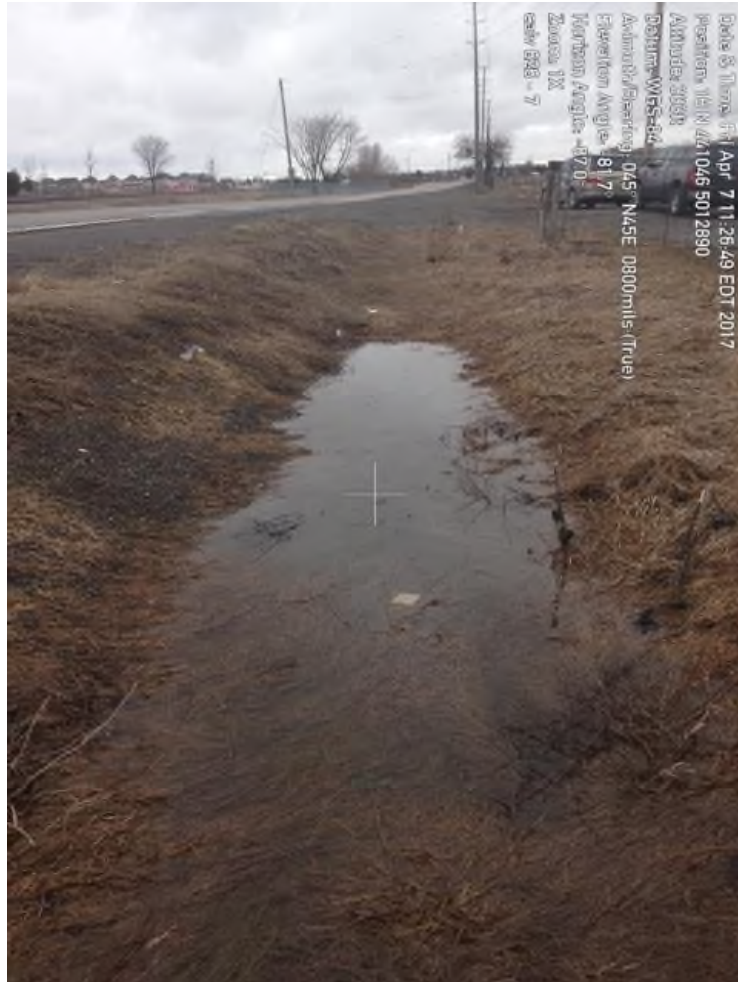
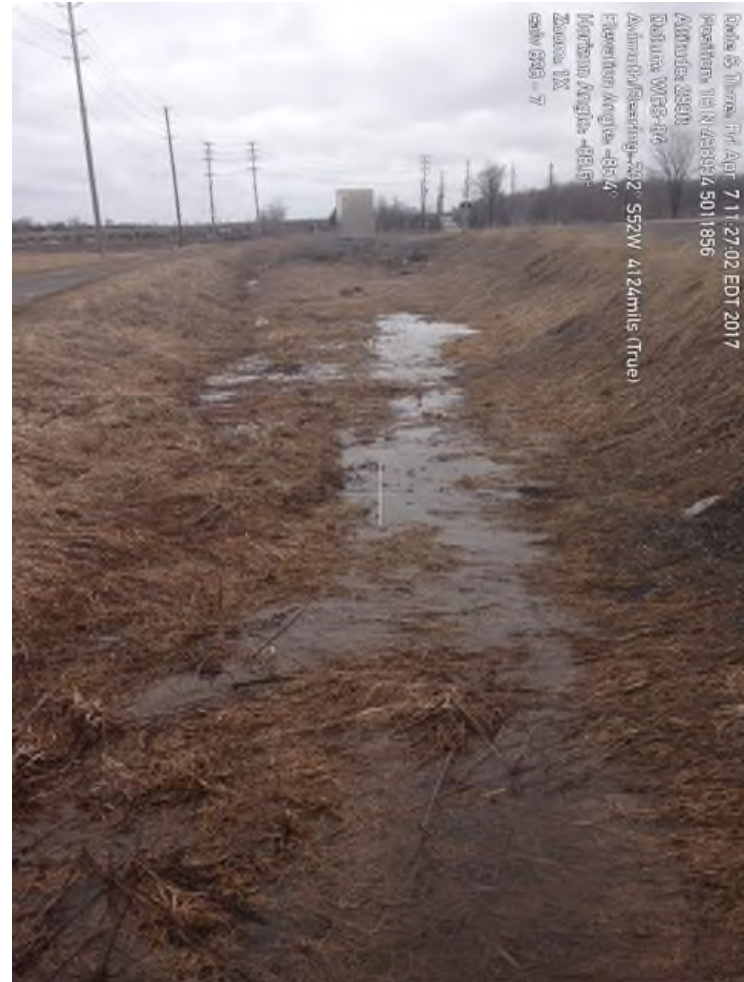
The substrate consisted of a mixture of clay and silt. Woody debris and submergent vegetation was absent. Reach 7 consisted of standing water in April, May, and July, being blocked by higher ground downstream. No fish, frogs, or turtles were observed in this reach.

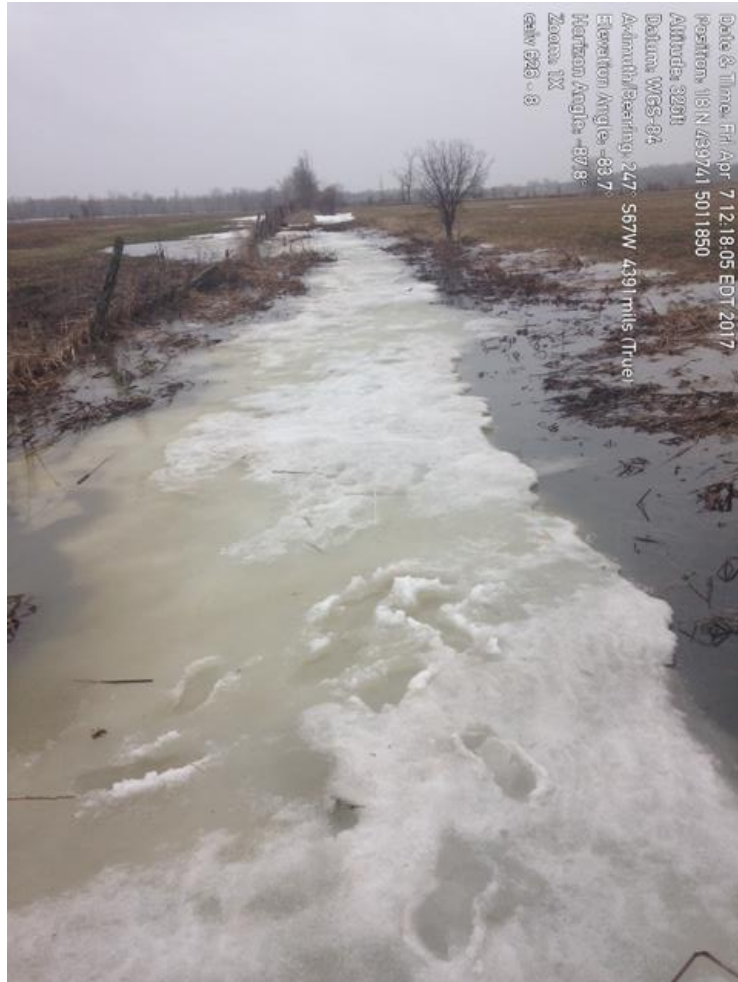
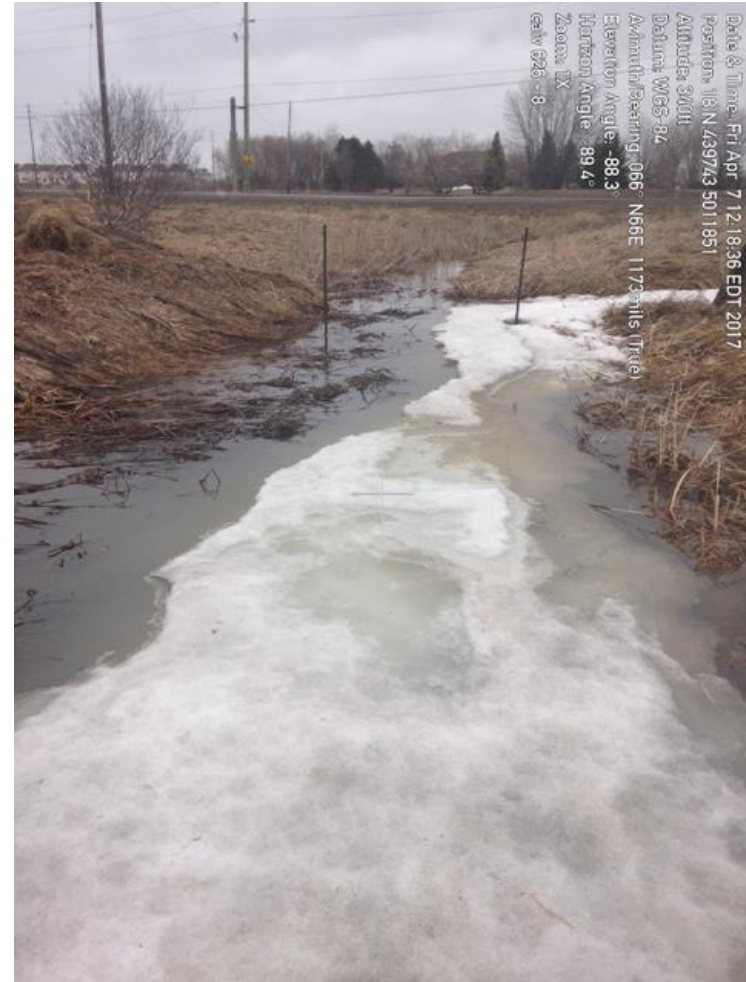
Reach 8 is the upstream-most section of the Fraser Clarke Municipal Drain. Reach 8 is a 165 m channel running just beyond the north edge of the property to Borrisokane Rd. The channel then passes under Borrisokane through a culvert, and crosses neighbouring properties to the north before reaching the east-side development area (Reach 14 there). The substrate consisted of silt and clay. It was flooded in April with slow flow. In May and July, Reach 8 contained small amounts of standing water. No fish, frogs or turtles were observed there.

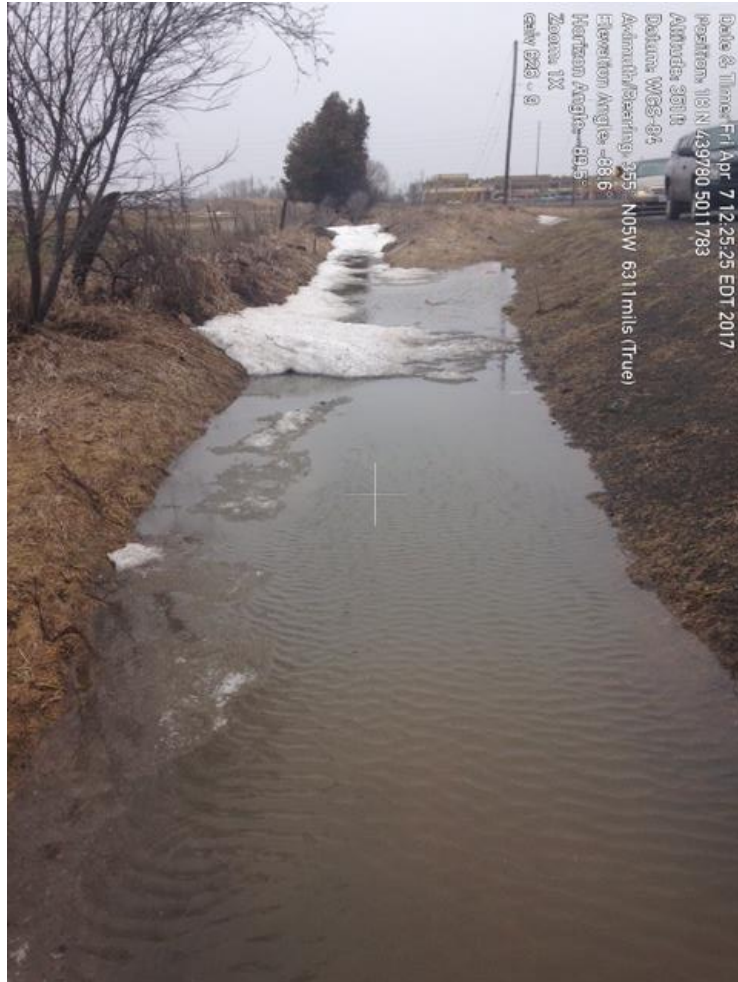
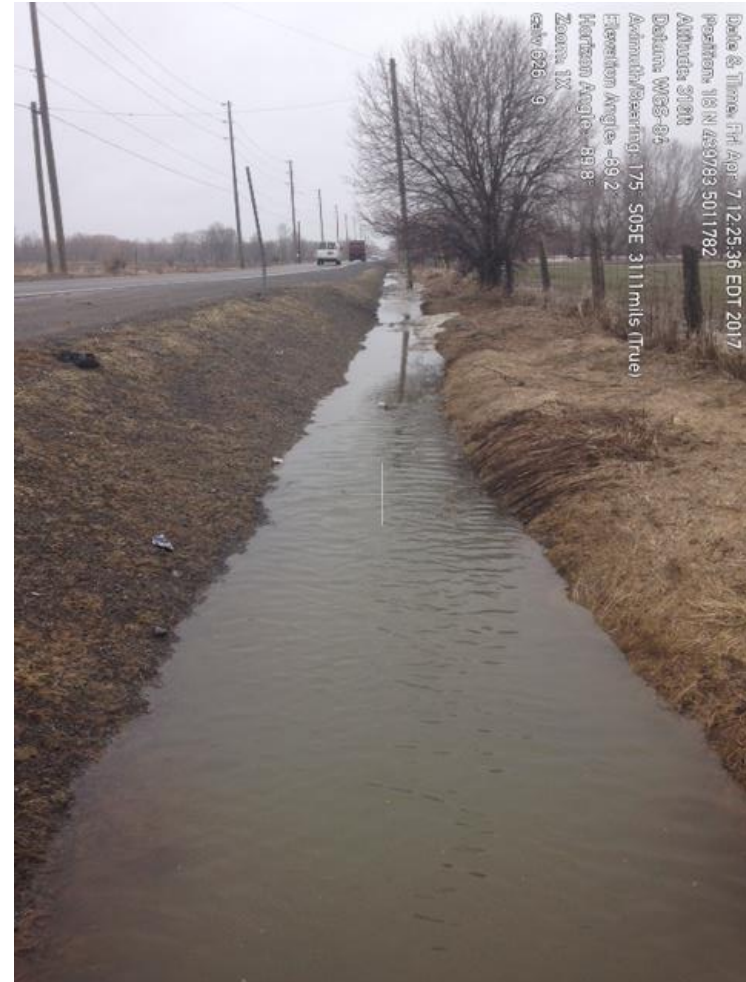
Reach 9

The substrates both reaches consisted of silt and clay. Woody debris and submergent vegetation are absent. In Reach 9, two fish were observed; one Creek Chub and one undetermined fish (fish was observed but was not captured). No fish were observed in Reach 10 and no frogs or turtles were observed in either reach.

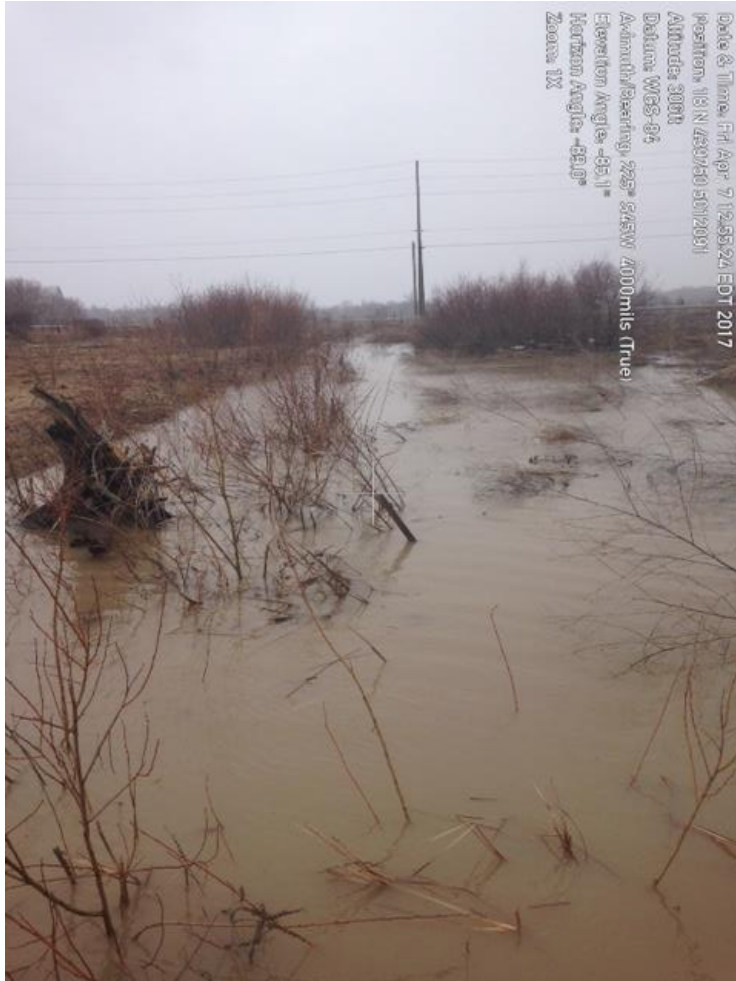
The substrate consisted of silt and clay. Woody debris and submergent vegetation are absent. Reach 11 had negligible flow in April with some standing water in May and July. No fish or turtles were observed in this reach. A few American Toads, Gray Treefrogs, and Northern Leopard frogs were heard calling from scattered points along Reach 11.

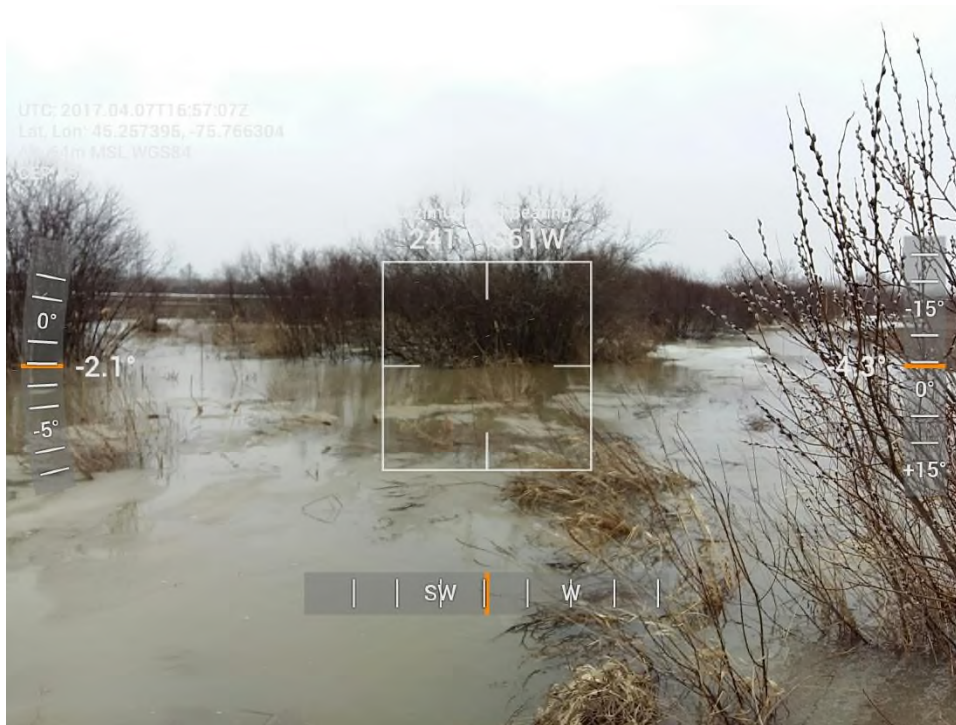
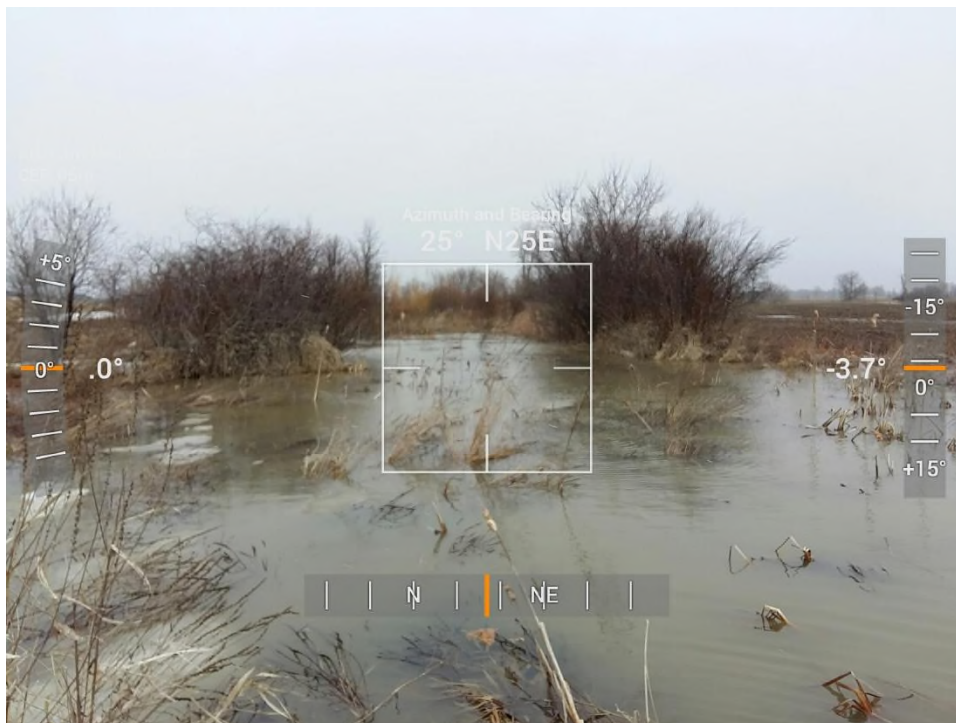
Reach 12

The substrate consisted of silt and clay. Woody debris and submergent vegetation is mostly absent from this reach. In April, this reach was characterized by barely detectable flow. There were limited patches of standing water in May and July. No fish, frogs, or turtles were observed in this reach.

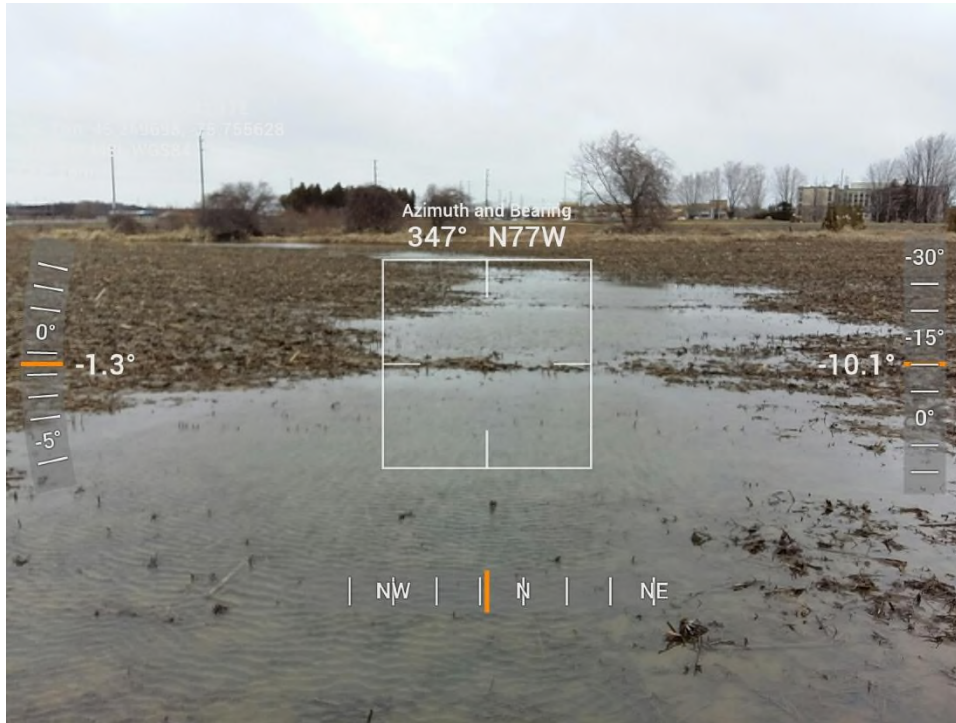
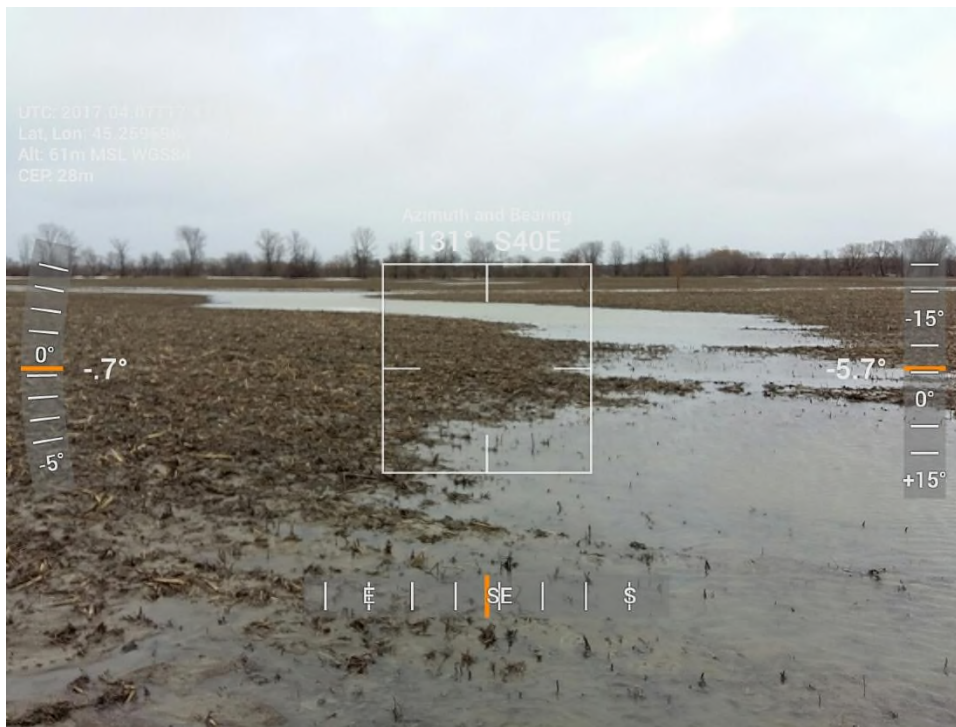
Reach 15

The substrate consisted of clay. Woody debris and submergent vegetation was absent. Reach 13 was characterized by standing water in April and was completely dry in May and July. No fish, frogs, or turtles were observed in this reach.
