Kanata West

Headwaters Report

December 2016
(Revised May 2018)

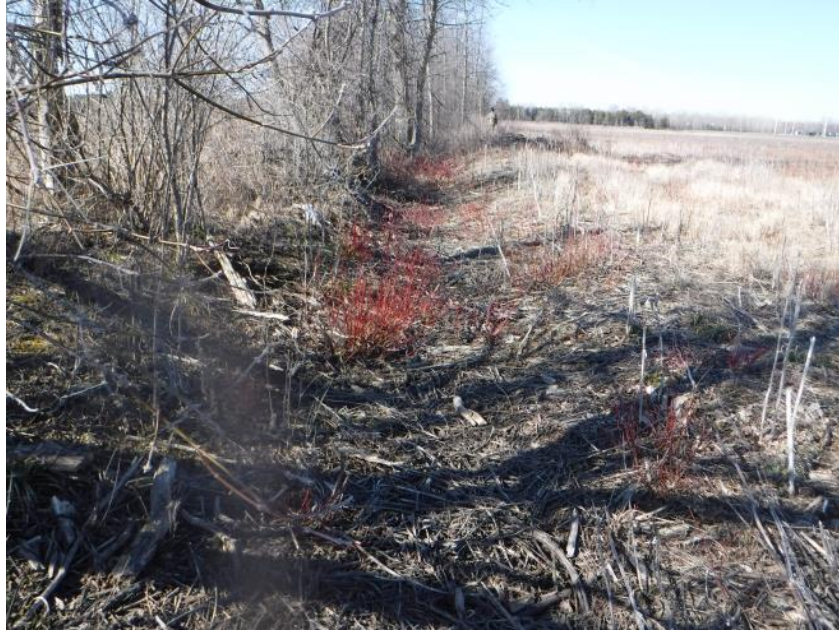
The substrate consisted of fines. Small woody debris was in the channel (Photo 1). No signs of erosion were noted.

Photo 1 Station 1a looking upstream from the downstream end (April 15, 2016)

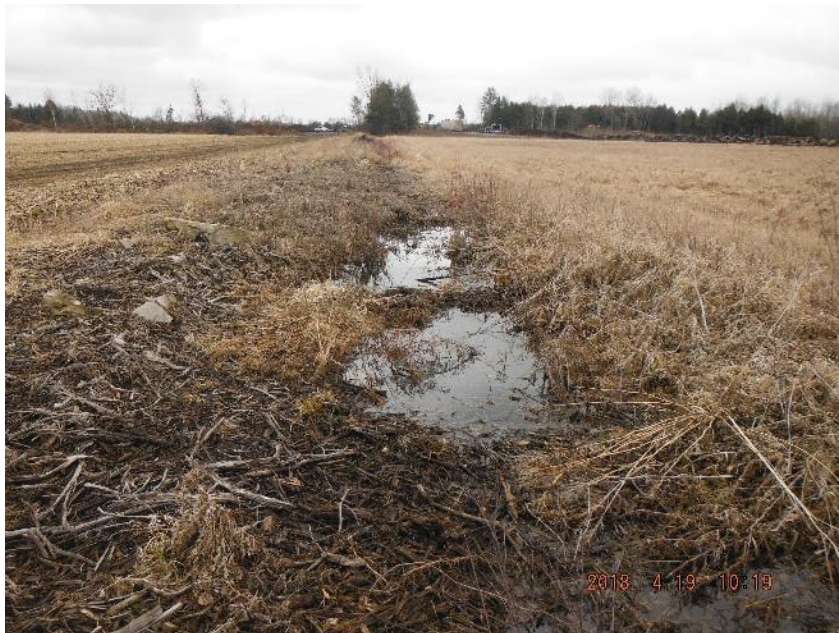
Photo 2 Station 1a looking upstream (April 13, 2018)

In 2018, the stations were revisited in mid-April. As in 2016, Station 1b contained substantial flow in 2018. The channel between the two stations was heavily vegetated with reed canary grass (change in conditions following tree removal in 2016) and within the reed canary grass the flow was recorded as minimal (grass was pulled out to facilitate evaluating the flow). In Station 1b and further downstream, the flow was measured as standing water despite the regular rainfall during the 7 days prior to the visit (48.2 mm). Where standing water was present, the channel was full of wood chips from the previous tree clearing by the adjacent landowner.

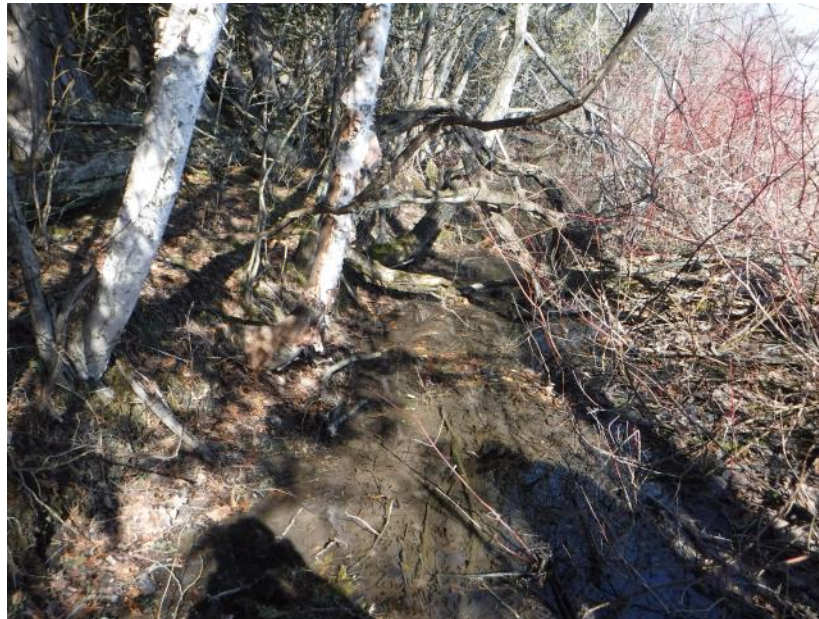
The substrate consisted of fines. The in-water cover consisted of aquatic vegetation which included: reed canary grass. Some small woody debris was noted within the station. No signs of erosion were noted.

Photo 3 Station 1b looking downstream from upstream end (April 15, 2016)

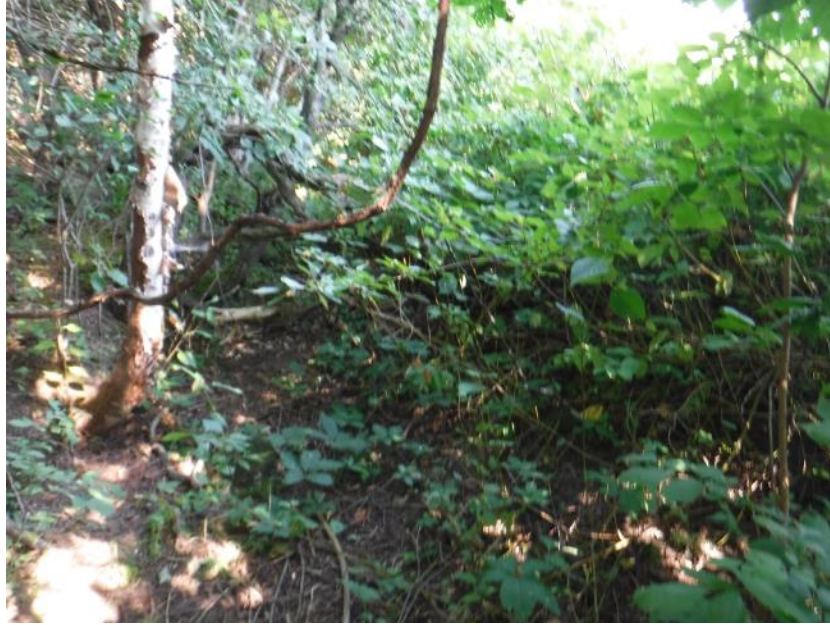
Photo 4 Station 1b looking downstream from upstream end (August 11, 2016)

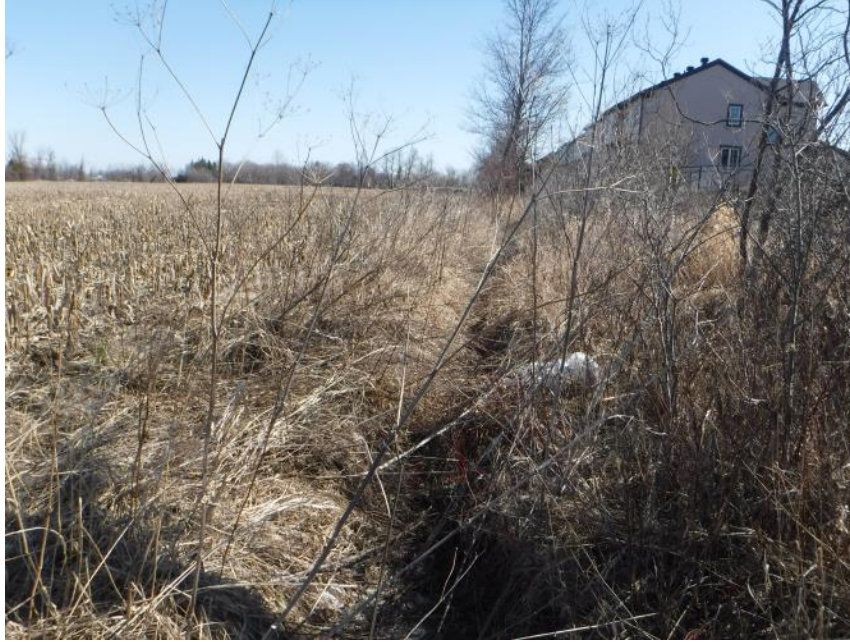
The substrate consisted of fines. The channel contained terrestrial vegetation: ragweed, thistle, white clover common buckthorn, white cedar and American elm. No signs of erosion were noted.

Photo 5 Station 2 looking upstream from the downstream end (April 15, 2016)

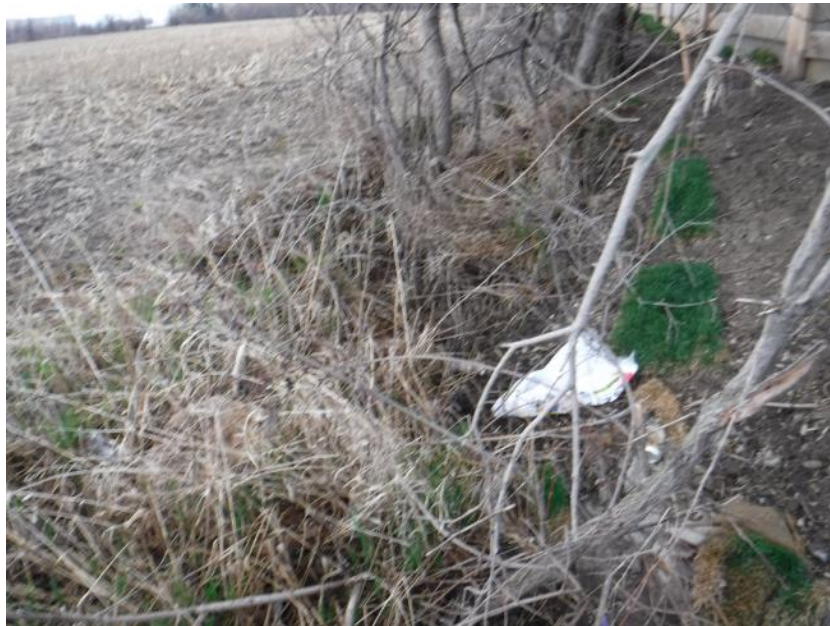
Photo 6 Station 2 looking upstream from the downstream end (May 2, 2016)

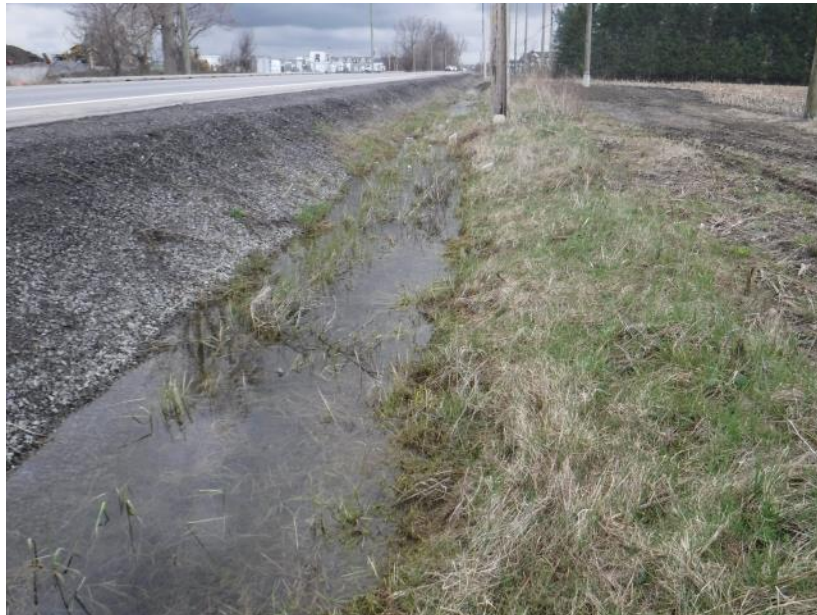
The substrate consisted of fines. In-water cover was provided by aquatic vegetation. These species included: purple loosestrife, reed canary grass and great water dock.

Photo 7 Station 3 looking upstream from the downstream end (May 2, 2016)

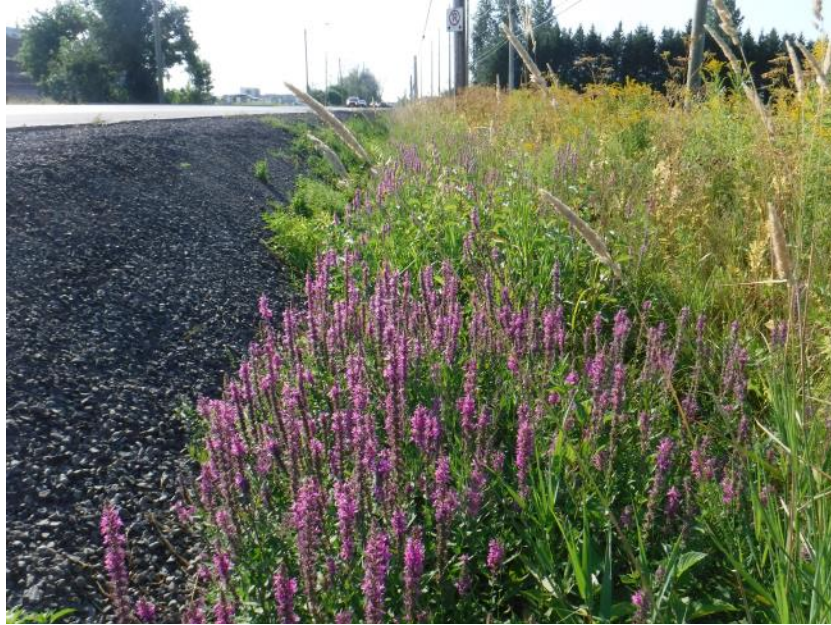
Photo 8 Station 3 looking upstream from the downstream end (August 15, 2016)

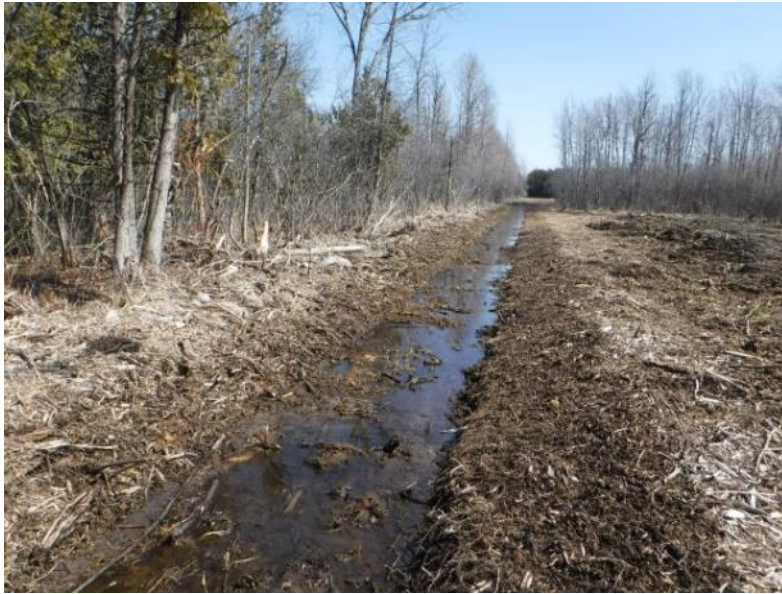
The substrate consisted of fines. In-water cover was provided by aquatic vegetation. These species included: reed canary grass, purple loosestrife and water smartweed. No signs of erosion were noted.

Photo 9 Station 4 looking downstream from upstream end (April 15, 2016)

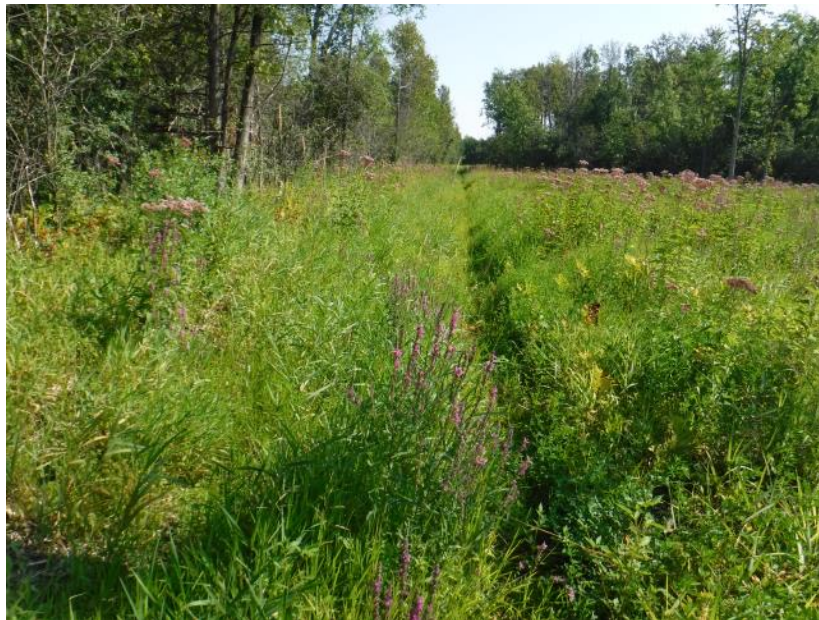
Photo 10 Station 4 looking downstream from upstream end (August 15, 2016)

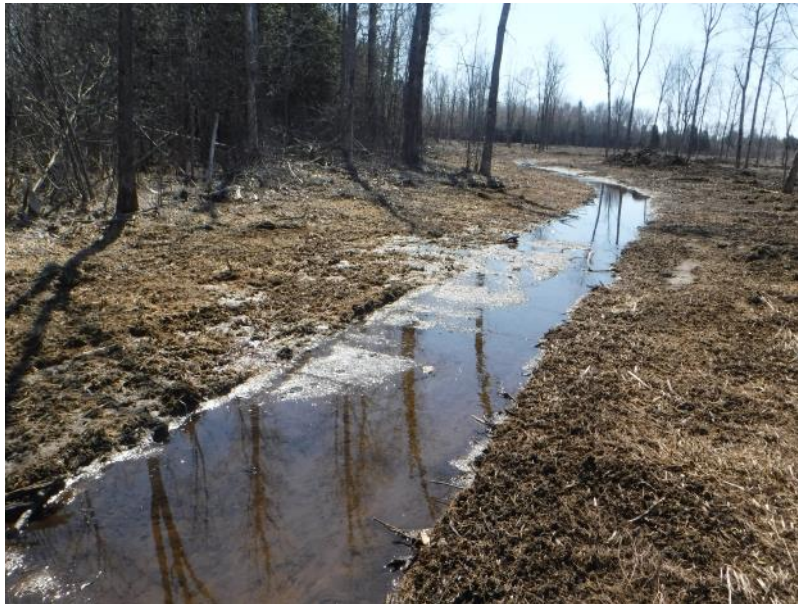
The substrate consisted of fines. In-water cover was provided by aquatic vegetation. These species included: reed canary grass, purple loosestrife and water smartweed. No signs of erosion were noted.

Photo 11 Station 5 looking upstream from downstream end (April 15, 2016)

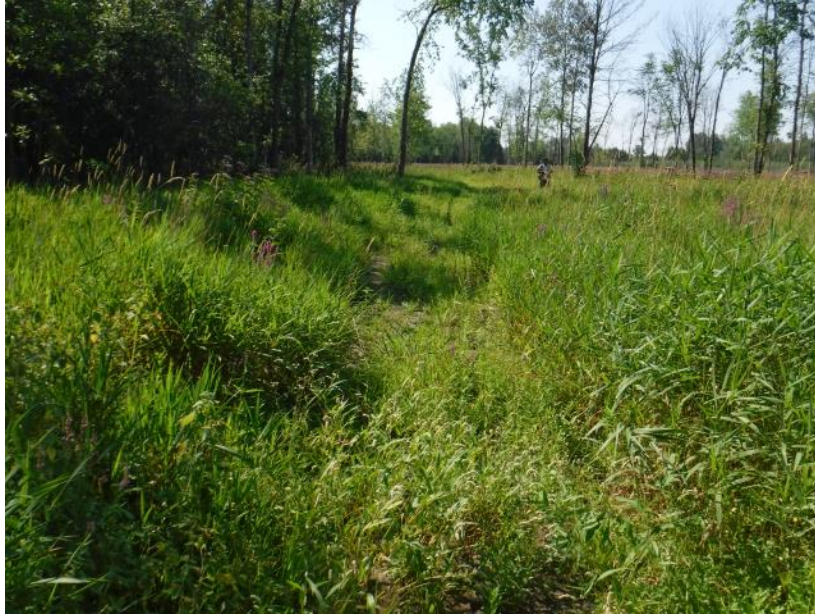
Photo 12 Station 5 looking upstream from downstream end (August 11, 2016)

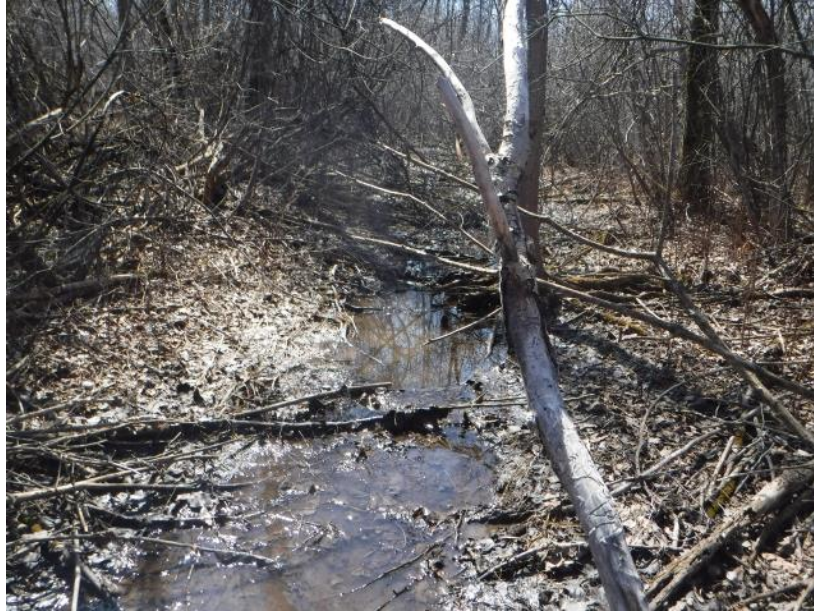
The substrate consisted of fines. No in-water cover was observed during the early spring when water was present. Later in the season the channel was vegetated with species such as: spotted joe-pye weed, false wood nettle and sensitive fern. No signs of erosion were noted.

Photo 13 Station 6 looking upstream from downstream end (April 15, 2016)

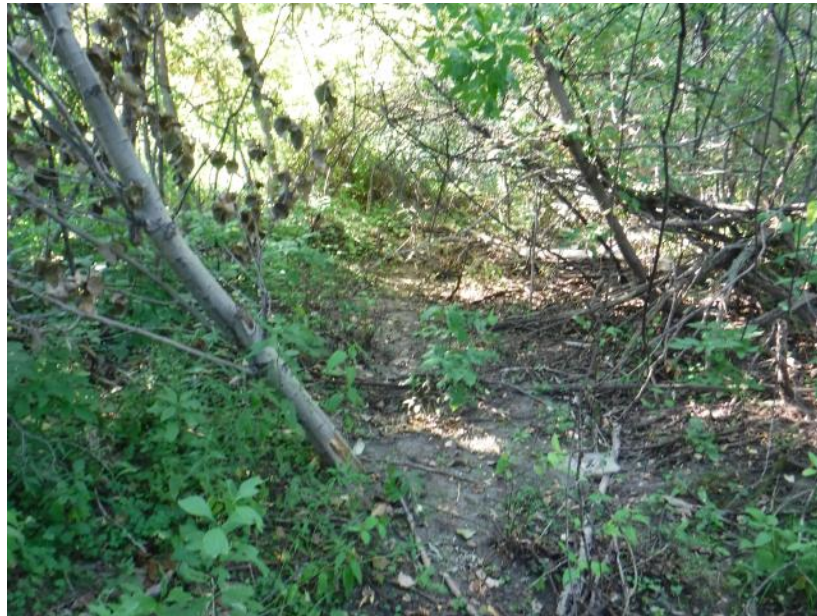
Photo 14 Station 6 looking upstream from the downstream end (August 11, 2016)
