RURAL RESIDENTIAL DEVELOPMENT

**2727 CARP ROAD
CITY of OTTAWA**

Headwaters Report

June 2018

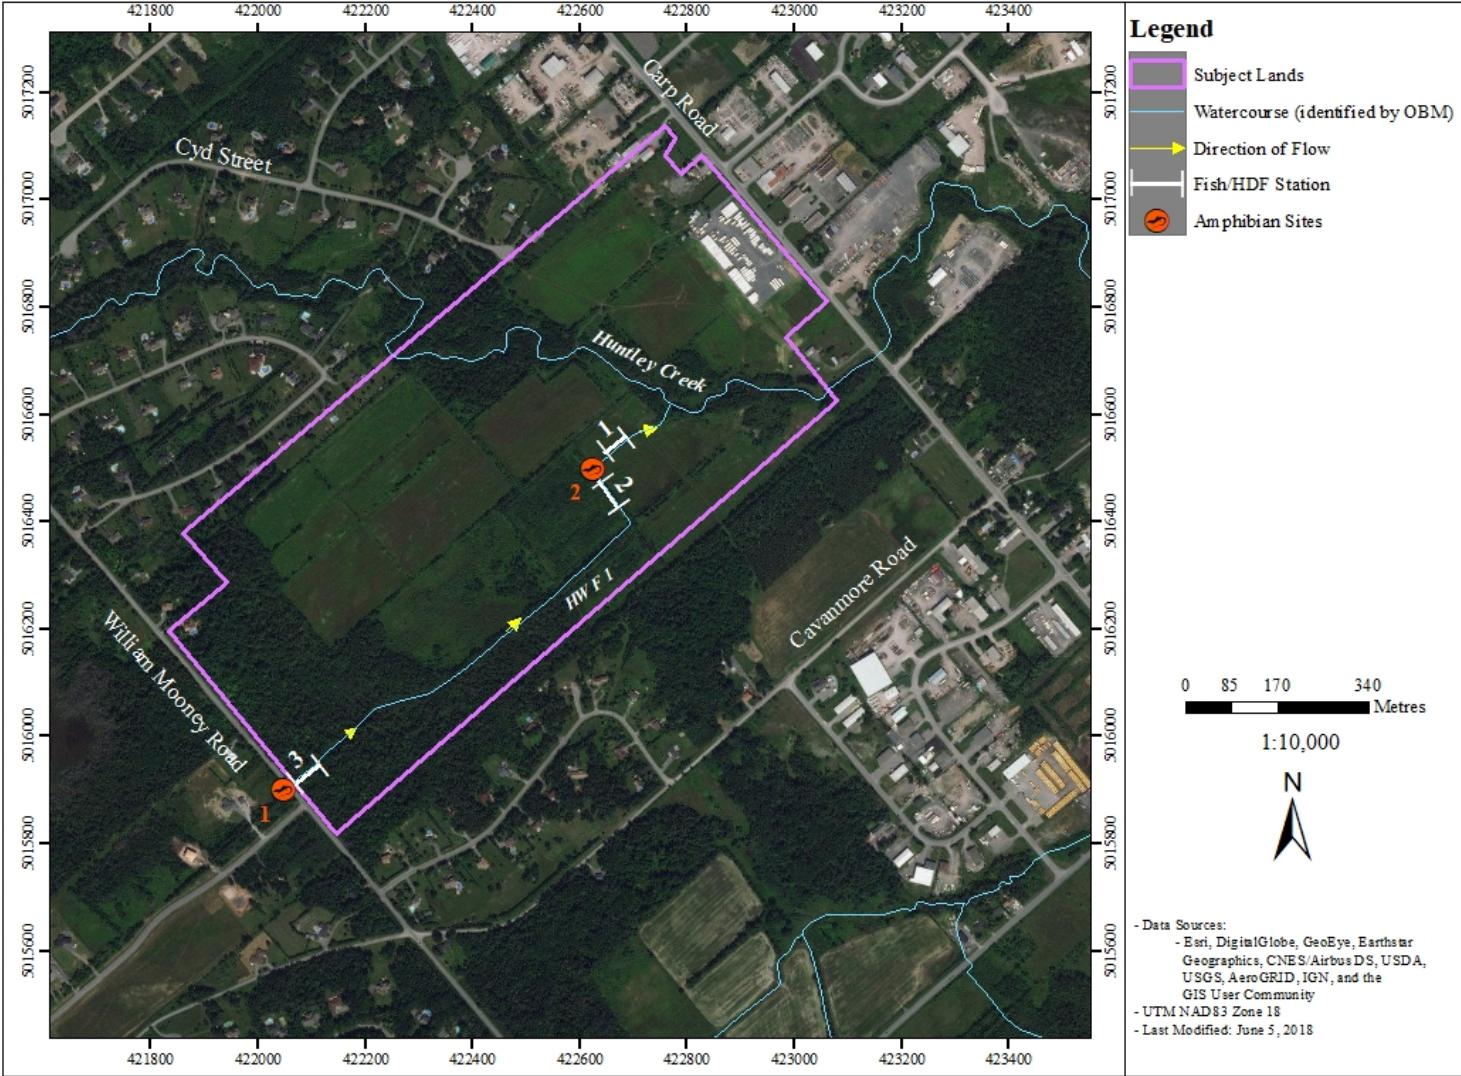
Figure 2 Location of Headwater Features and Survey Stations

The fish habitat features within the study area was described based on the *Ontario Stream Assessment Protocol*. Information on the channel morphology was collected (channel width, wetted width, bankfull and wetted depths, cover type and abundance, and substrate type). The location of specific features mentioned in the text is shown on Figure 2.

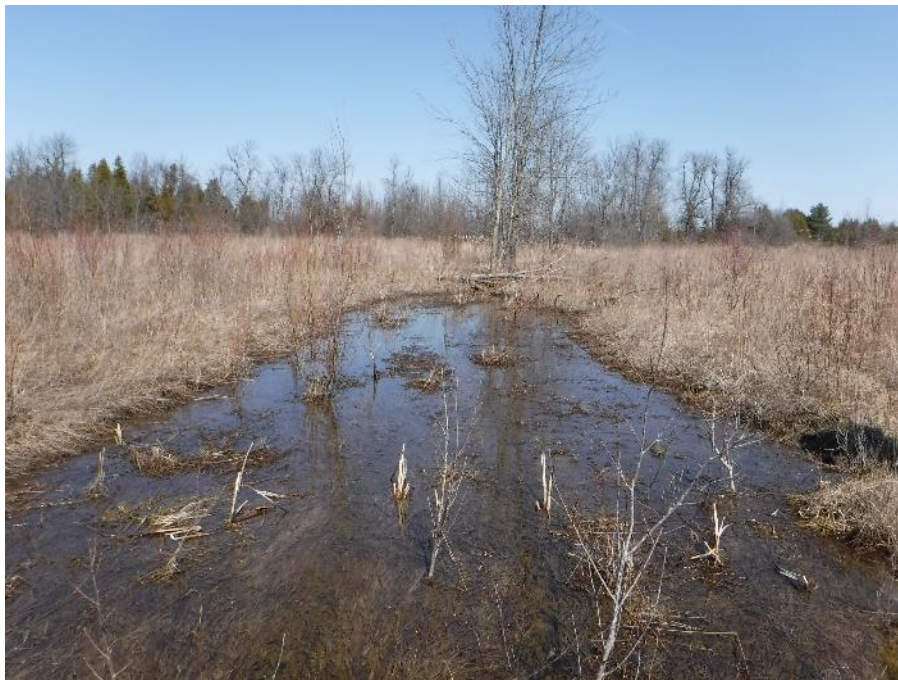
Station 1, flowing southwest to northeast, started 108 m upstream from confluence of Tributary 1 and was 50 m in length. The average channel width was 4.8 m and the headwater feature was dry during the August visit. The average wetted widths during the two spring flow visits were: 5.7 m and 3.6 m. The average water depths during these same visits were: 6.7 cm and 7.8 cm.

The substrate consisted of fines. In-water cover was provided by aquatic vegetation. These species included: purple loosestrife, grass-leaved goldenrod and scouring rush. A few areas containing large woody debris were noted. This station had no canopy cover. No signs of erosion were noted.

Photo 1 Station 1 looking downstream from the upstream end (April 15, 2016)

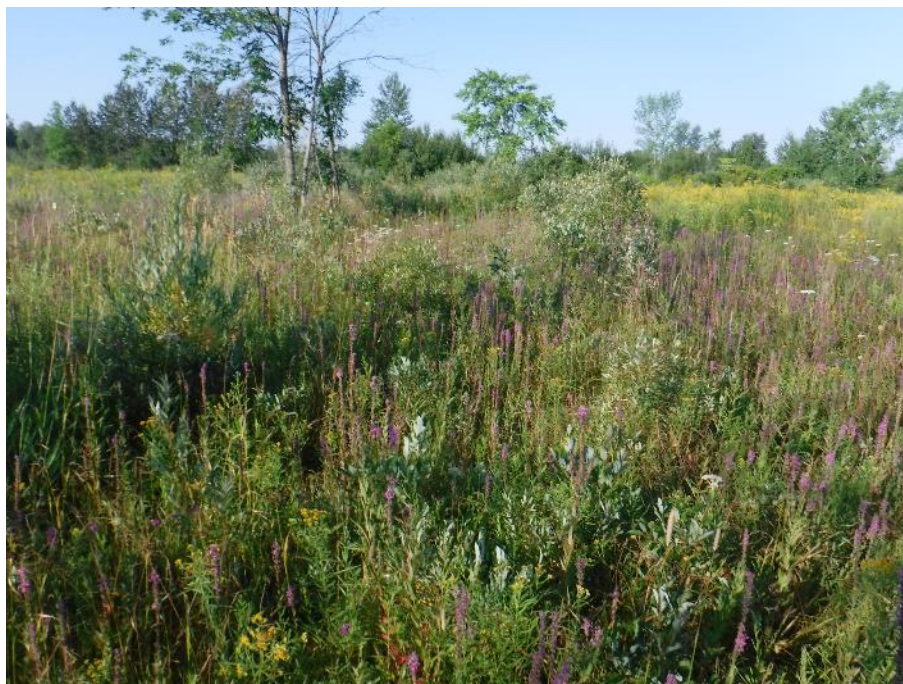
No sampling was completed during the summer of 2016 due to lack of water.

Photo 2 Station 1 looking downstream from the upstream end (August 11, 2016)

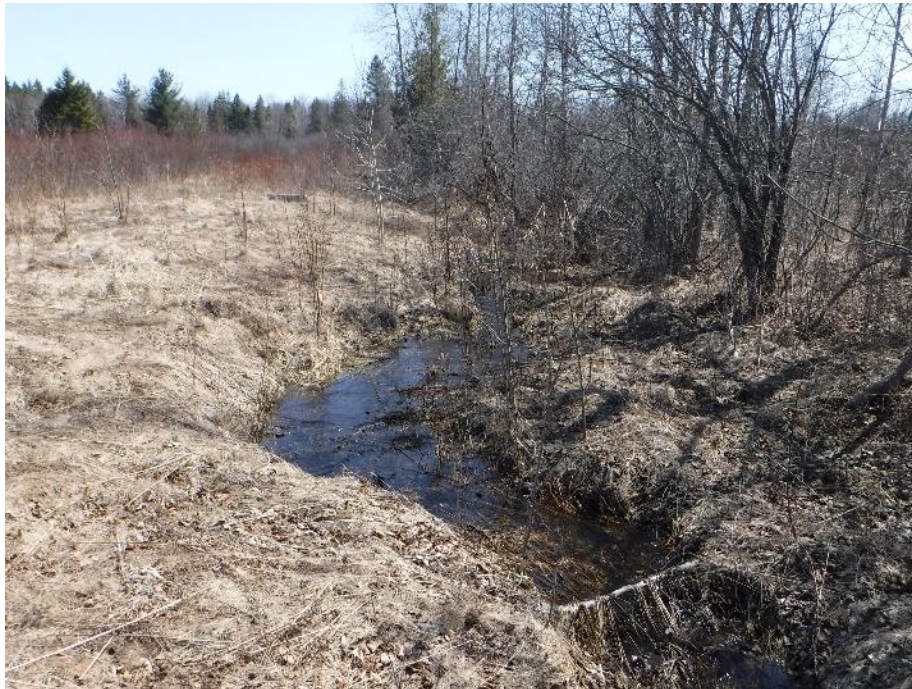
Station 2, flowing southeast to northwest, started 47 m upstream of Station 1 and was 63 m in length. The average channel width was 2.5 m and the headwater feature was dry during the summer. The average wetted widths during the two spring flow visits were: 1.1 m and 0.8 m. The average water depths during these same visits were: 9.6 cm and 8.3 cm.

The substrate consisted of fines. In-water cover was provided by aquatic vegetation. These species included: purple loosestrife, grass-leaved goldenrod and scouring rush. This station had poor canopy cover. No signs of erosion were noted.

Photo 3 Station 2 looking upstream from the downstream end (April 15, 2016)

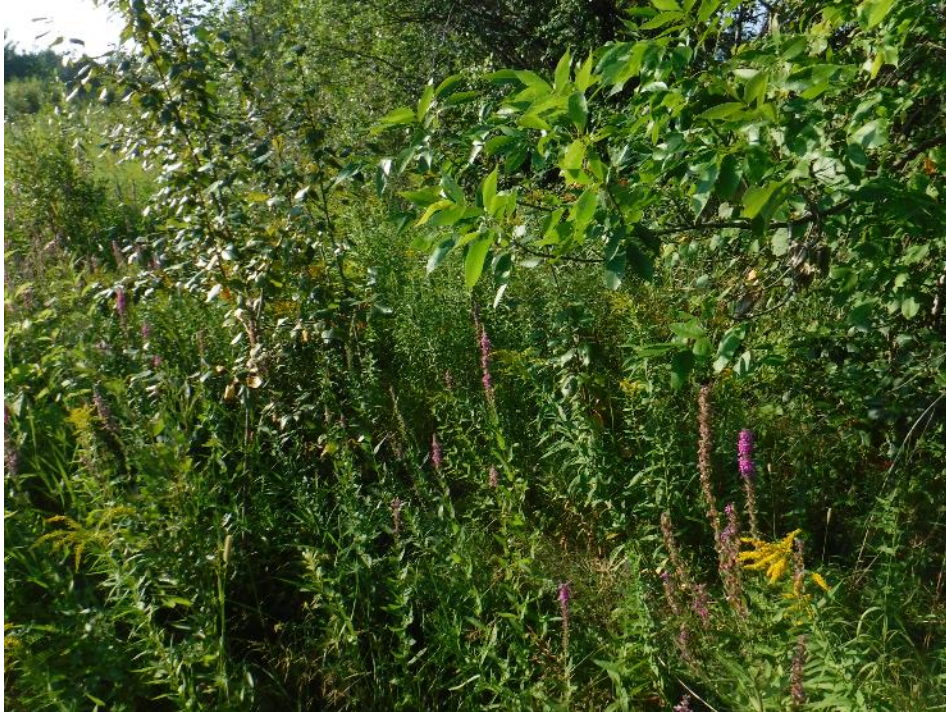
No sampling was completed during the summer of 2016 due to lack of water.

Photo 4 **Station 2 looking upstream from the downstream end (August 11, 2016)**

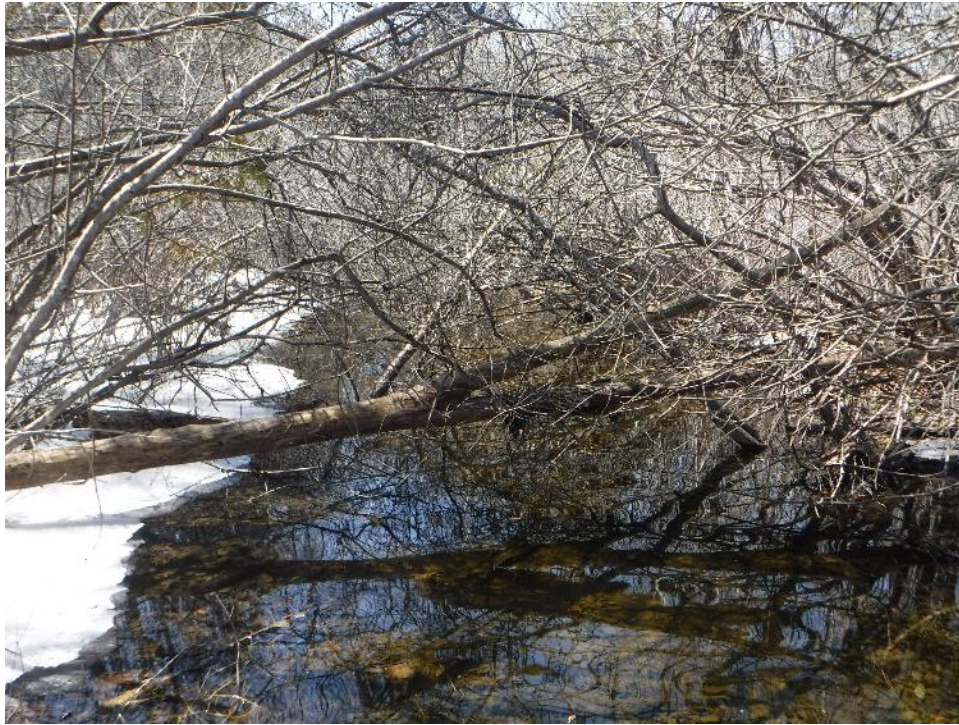
Station 3, flowing southwest to northeast, started 17 m from William Mooney Road and was 55 m in length. The average channel width was 2.5 m and the headwater feature was dry during the summer visit. The average wetted widths during the two spring flow visits were: 2.0 m and 1.7 m. The average water depths during these same visits were: 6.3 cm and 5.0 cm.

The substrate consisted of fines. The in-water cover consisted of aquatic vegetation with a section containing no in-water cover. These species included: spotted joe-pye weed, bittersweet nightshade and common water plantain. Areas of large and small woody debris were noted. This station had moderate to full canopy cover. There were no signs of erosion.

Photo 5 Station 3 looking downstream from upstream end (April 15, 2016)

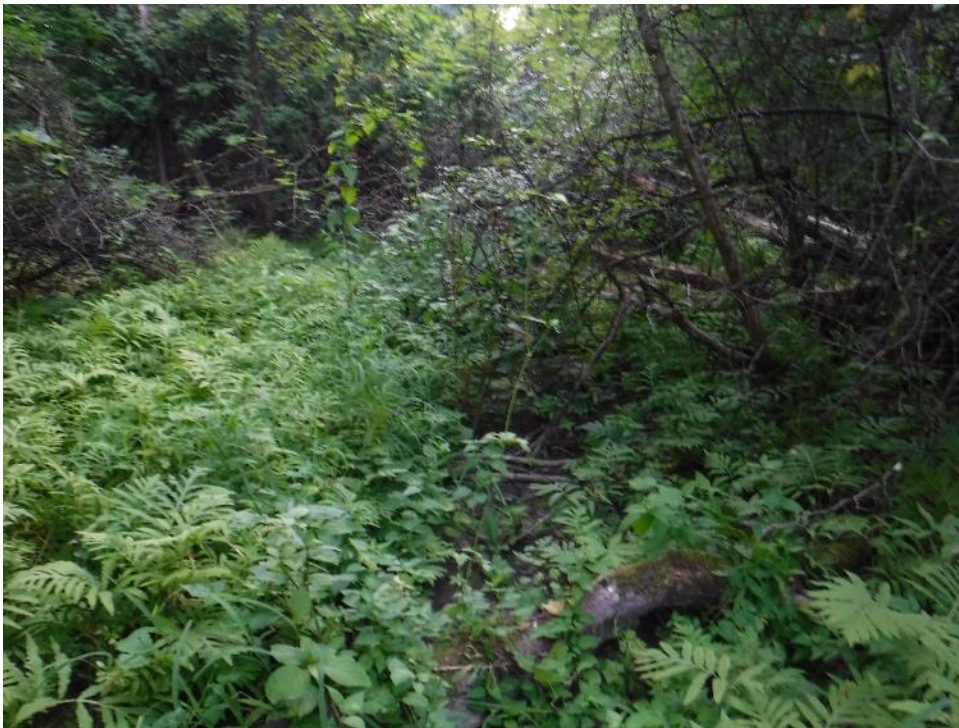
No sampling was completed during the summer of 2016 due to lack of water.

Photo 6 Station 3 looking upstream from the downstream end (August 11, 2016)

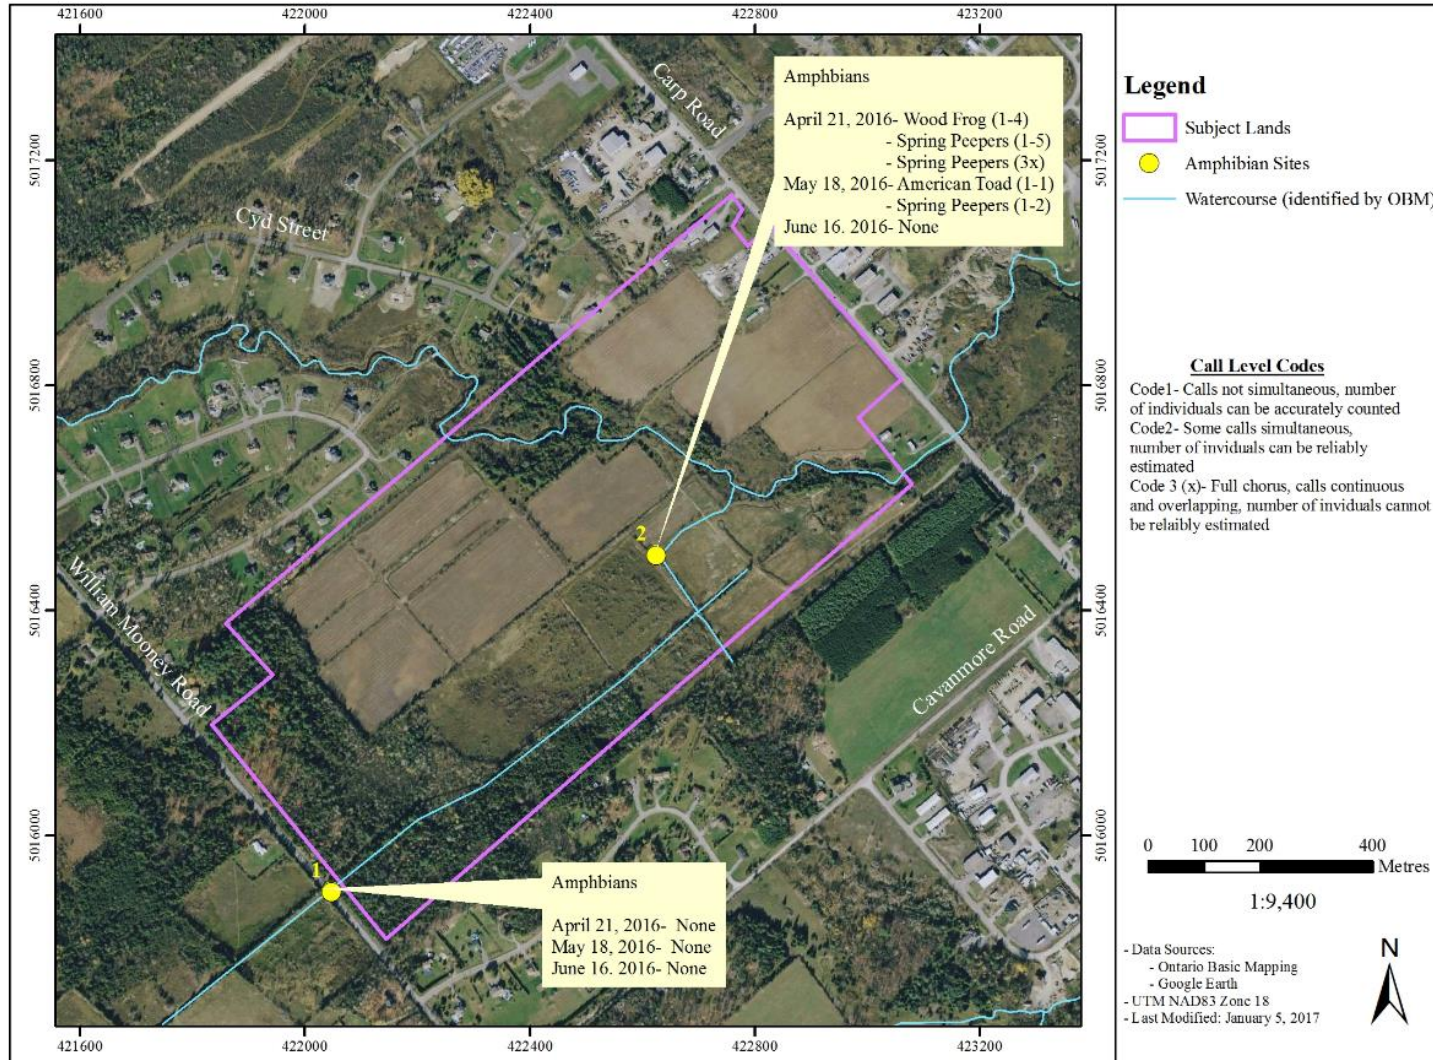
Figure 3 Amphibian Results

HWF	Site	Visit 1 (Species, #) April 21, 2016			Visit 2 (Species, #) May 18, 2016			Visit 3 (Species, #) June 16, 2016		
		Distance from Site								
		50m	50-100m	>100m	50m	50-100m	>100m	50m	50-100m	>100m
HWF 1	A2	WOFR 4 SPPE 5	none	SPPE -FC	none	AMTO 1	SPPE 2	none	none	GRTR 3
HWF 1	A1	none	none	WOFR -FC SPPE -FC	none	none	AMTO 1 SPPE -FC	none	none	none

Green - In Feature
 Red - Out of Feature
 FC – Full Chorus

AMTO - American Toad
 GRTR – Gray Treefrog
 SPPE - Spring Peeper
 WOFR - Wood Frog
