MINTO COMMUNITIES CANADA

# Quinn's Pointe Stage 2-4

## Environmental Impact Statement

August 2018

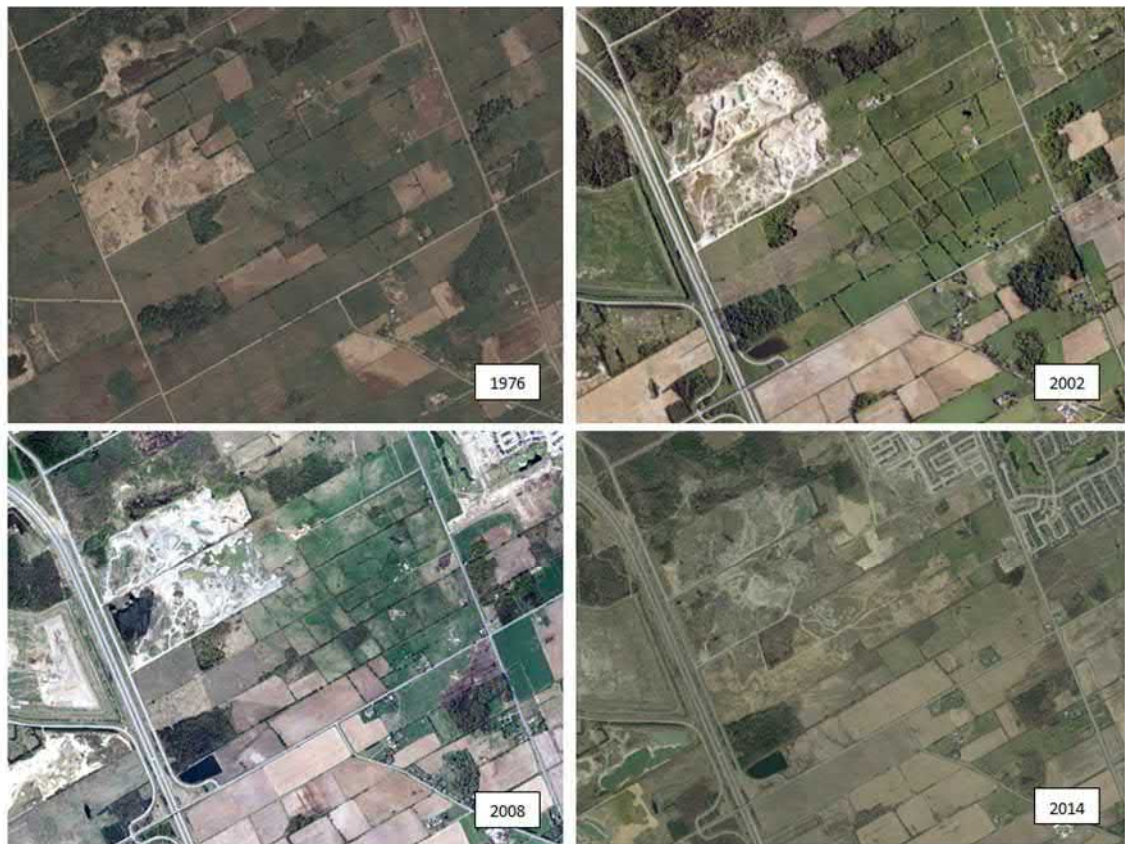
Figure 2: Land Use Changes Over Time

A desktop review of the area indicates that the Property is primarily comprised of agricultural lands with recent development to the north along Greenbank Road. There are a few woodlands and fencerows evident in aerial photos within the Property. A review of available historic aerial photos indicates that the land use within the Property has remained the same since at least 1976 (Figure 2).

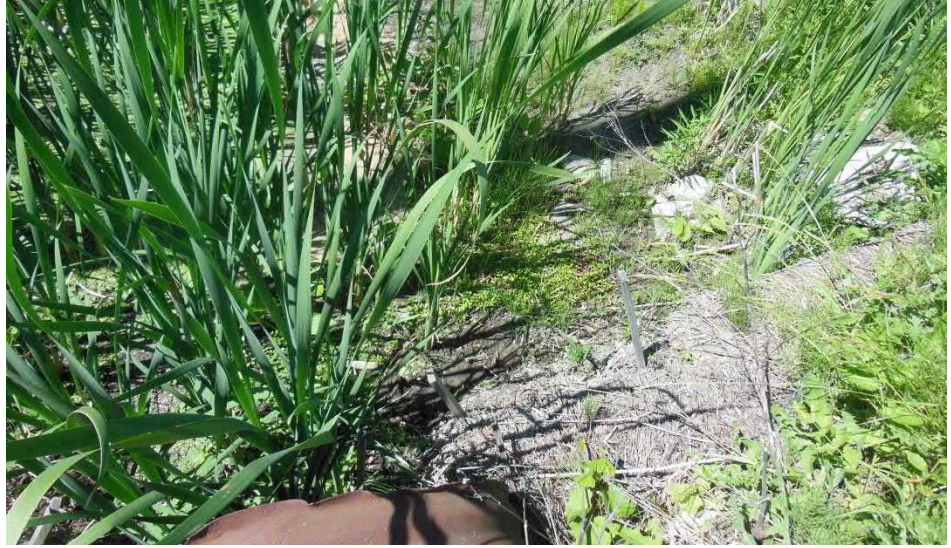
**Photo 38**

Upstream side of  
laneway culvert  
(straw bales visible)

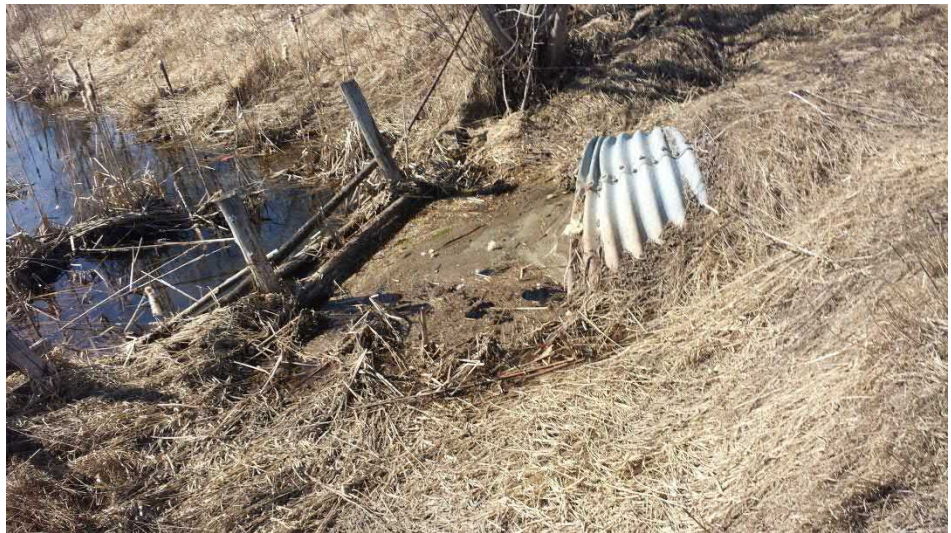
**Photo 39**

Upstream side of  
culvert (caved in and  
blocked up)

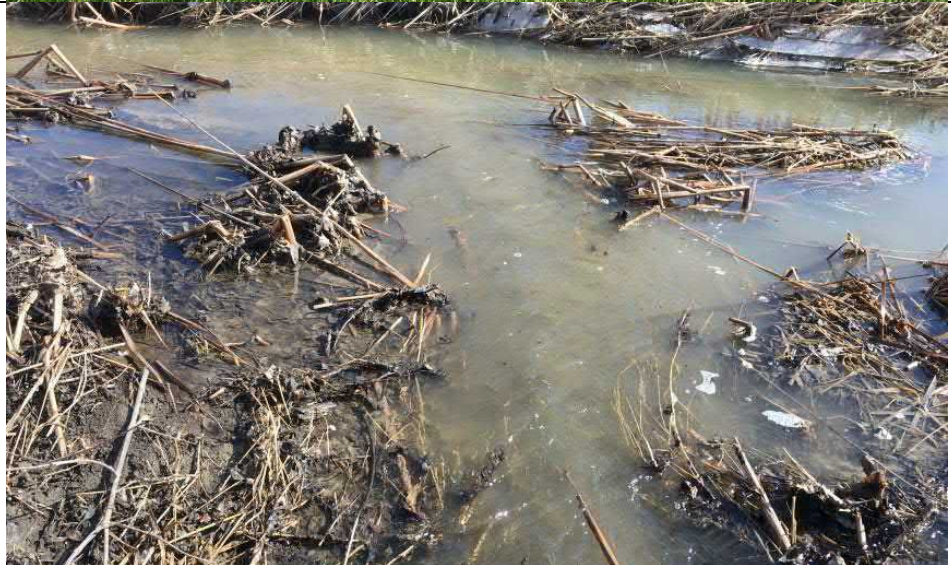
**Photo 53**

Convergence of  
tributaries, erosion  
and sedimentation,  
looking south toward  
Bankfield Road

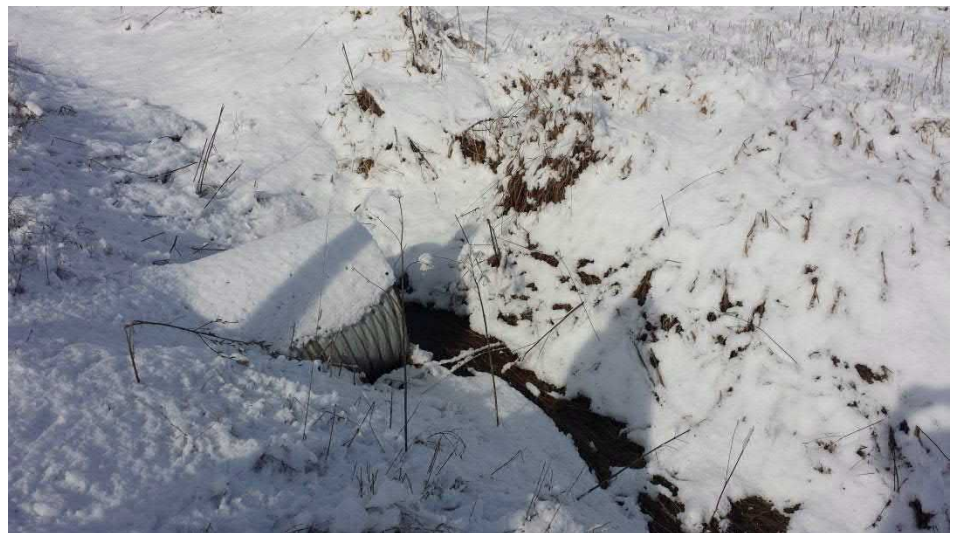
**Photo 63**

Upstream (north)  
side of Barnsdale  
Road. Ditch flowing  
into perched culvert.

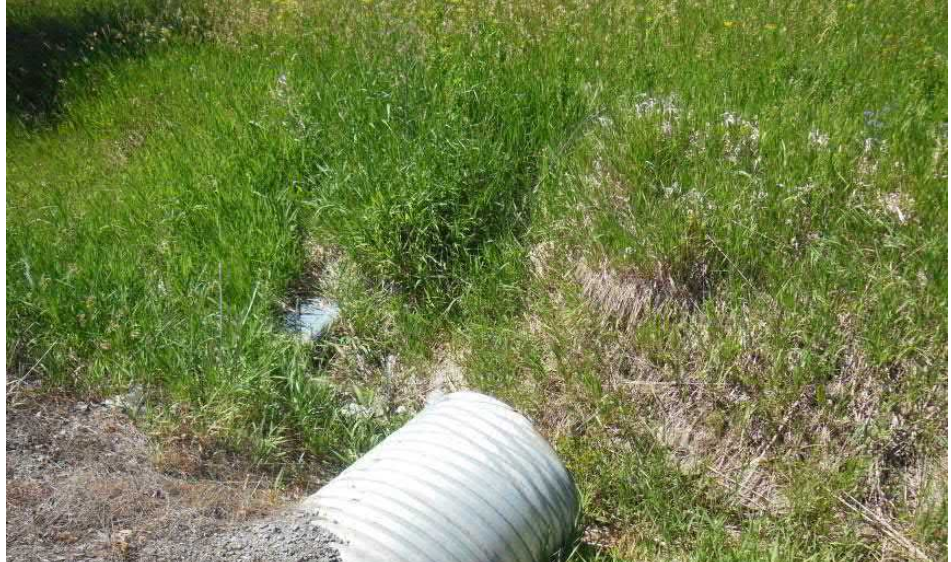
**Photo 64**

Upstream (north)  
side of Barnsdale  
Road. Ditch flowing  
into perched culvert.
