McKINLEY
ENVIRONMENTAL
SOLUTIONS

Combined Environmental Impact Statement &
Tree Conservation Report
1053/1075/1145 March Road

June 2018
Prepared for CU Developments Inc.

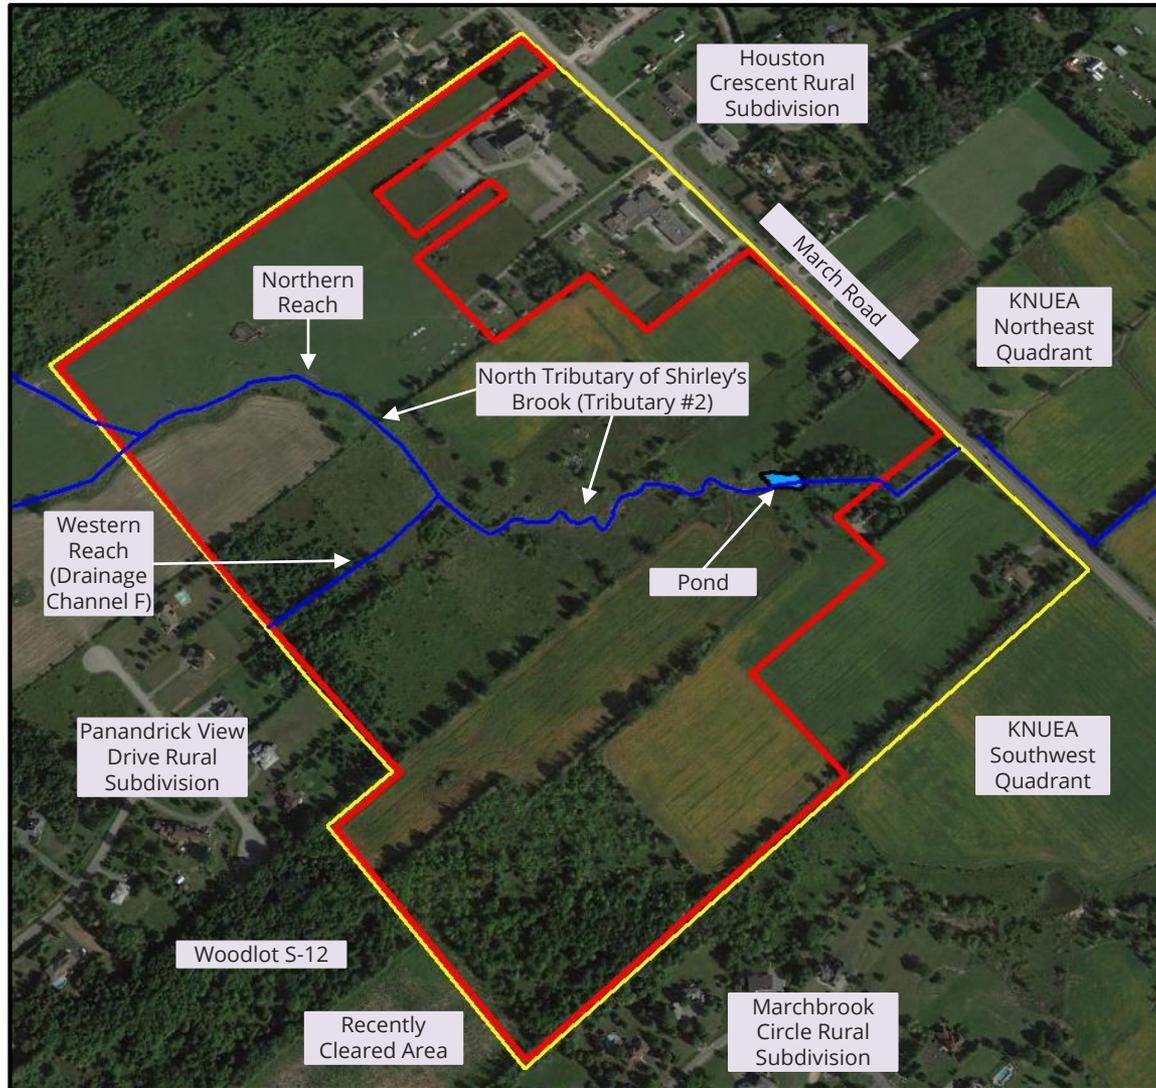
FIGURE 1: SITE OVERVIEW

- Study Area (Northwest Quadrant)
 - Development Limits

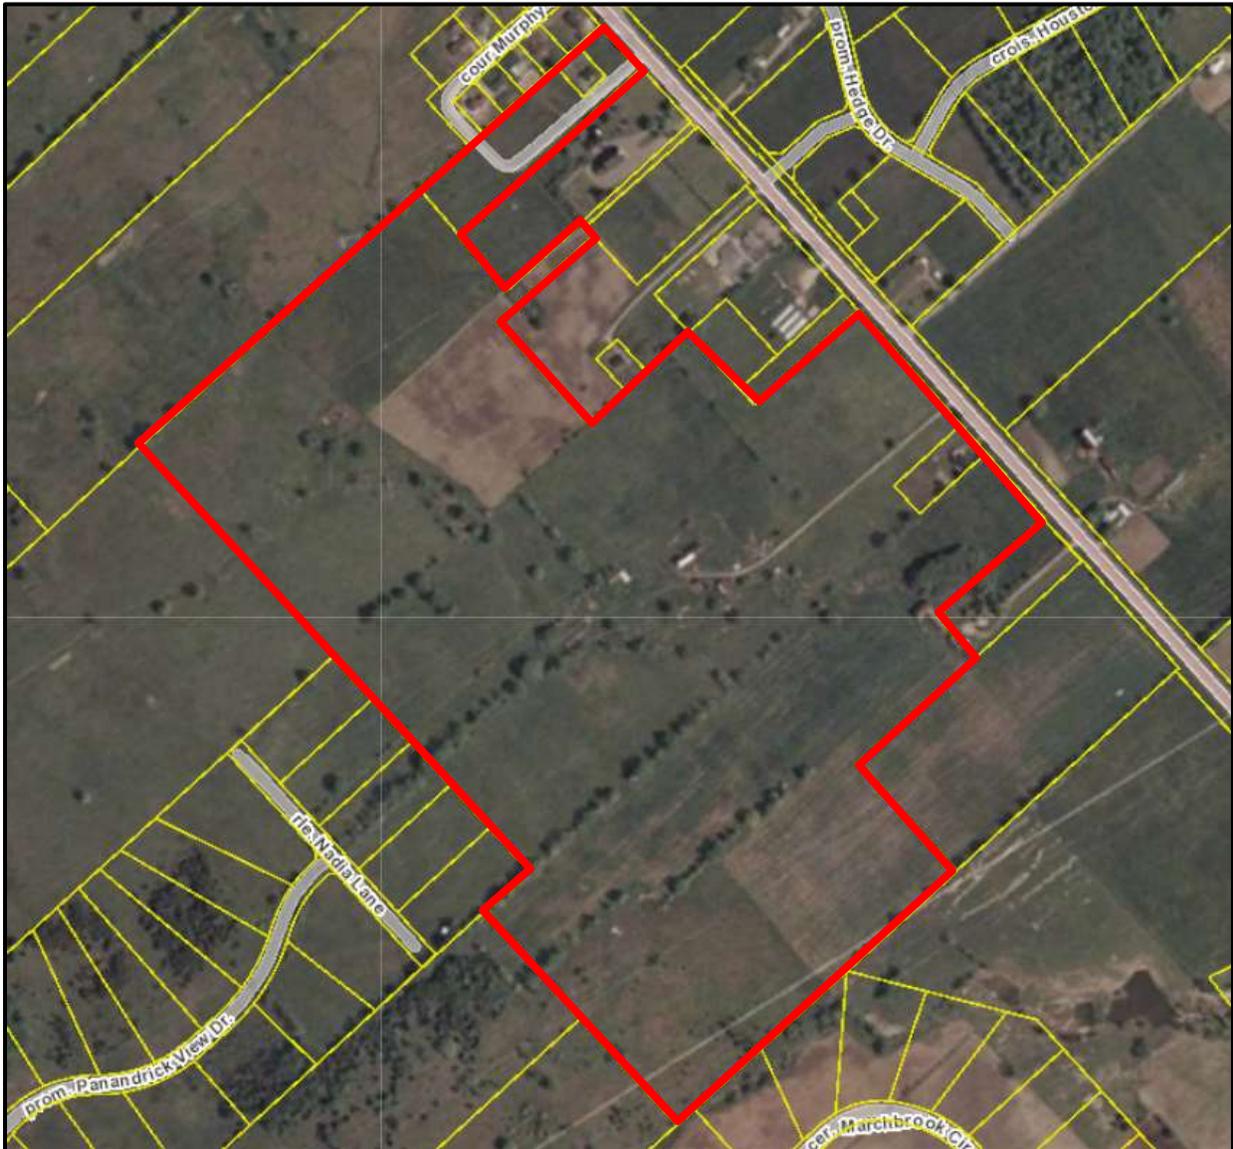
Historic Air Photograph 1: Historic Air Photo from 1976 (Site development limits shown in red). Note the Study Area was intensively farmed and tree cover was limited to the hedgerows in 1976. Regeneration of trees and shrubs in the southwestern part of the Study Area was not yet underway in 1976 (Photos from City of Ottawa 2018).

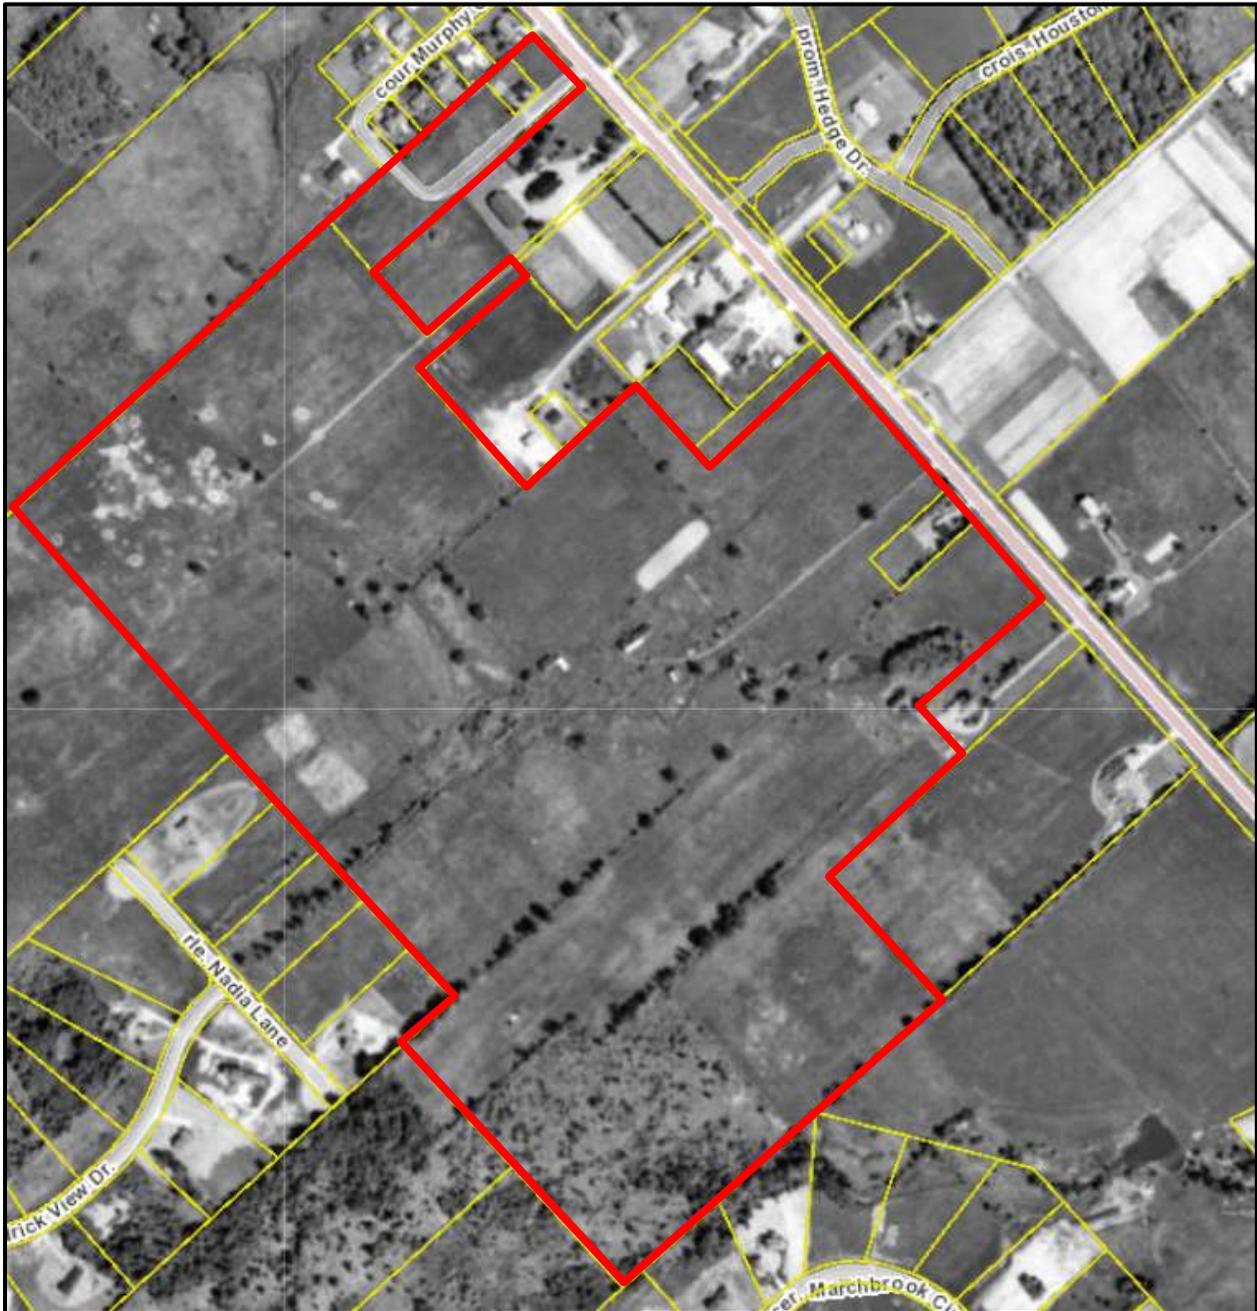
Historic Air Photograph 2: Historic Air Photo from 1991 (Site development limits shown in red). Note the majority of the Study Area continued to be intensively farmed in 1991, and tree cover was predominantly limited to the hedgerows. However, regeneration of trees and shrubs in the southwestern corner of the Study Area and surrounding areas was underway by 1991 (Photos from City of Ottawa 2018).

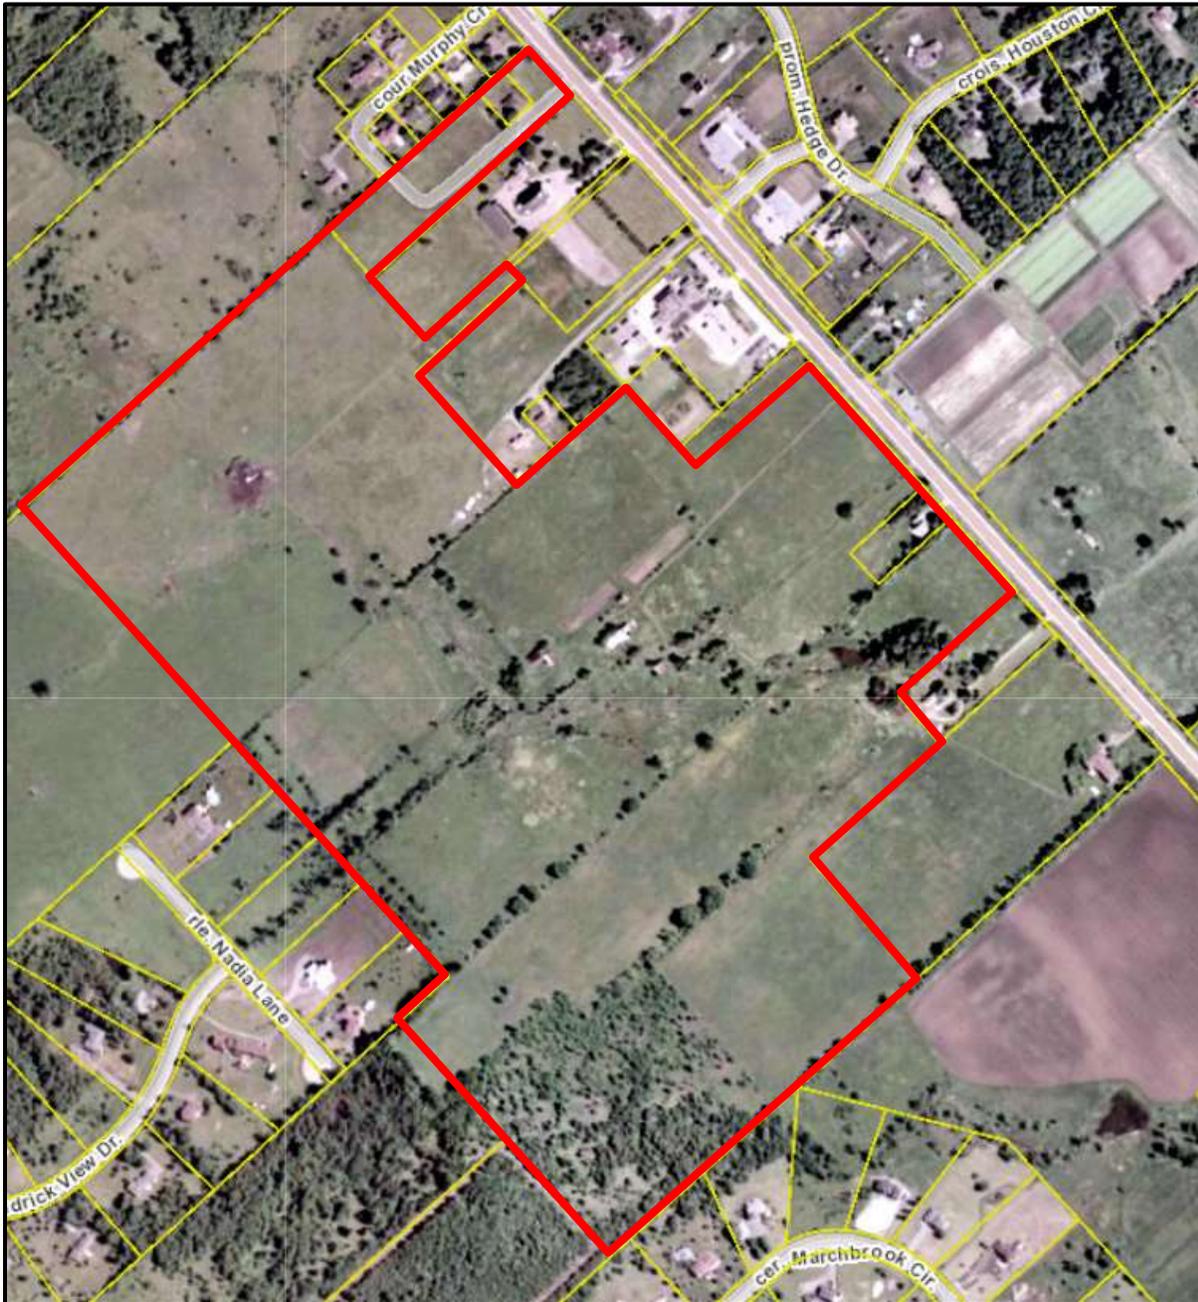
Historic Air Photograph 3: Historic Air Photo from 2005 (Site development limits shown in red). Note the majority of the Study Area continued to be intensively farmed. Tree cover was limited to the hedgerows and Cultural Woodlot F and G in 2005. However, regeneration of trees and shrubs in the southwestern corner of the Study Area and surrounding areas had advanced significantly by 2005 (Photos from City of Ottawa 2018).

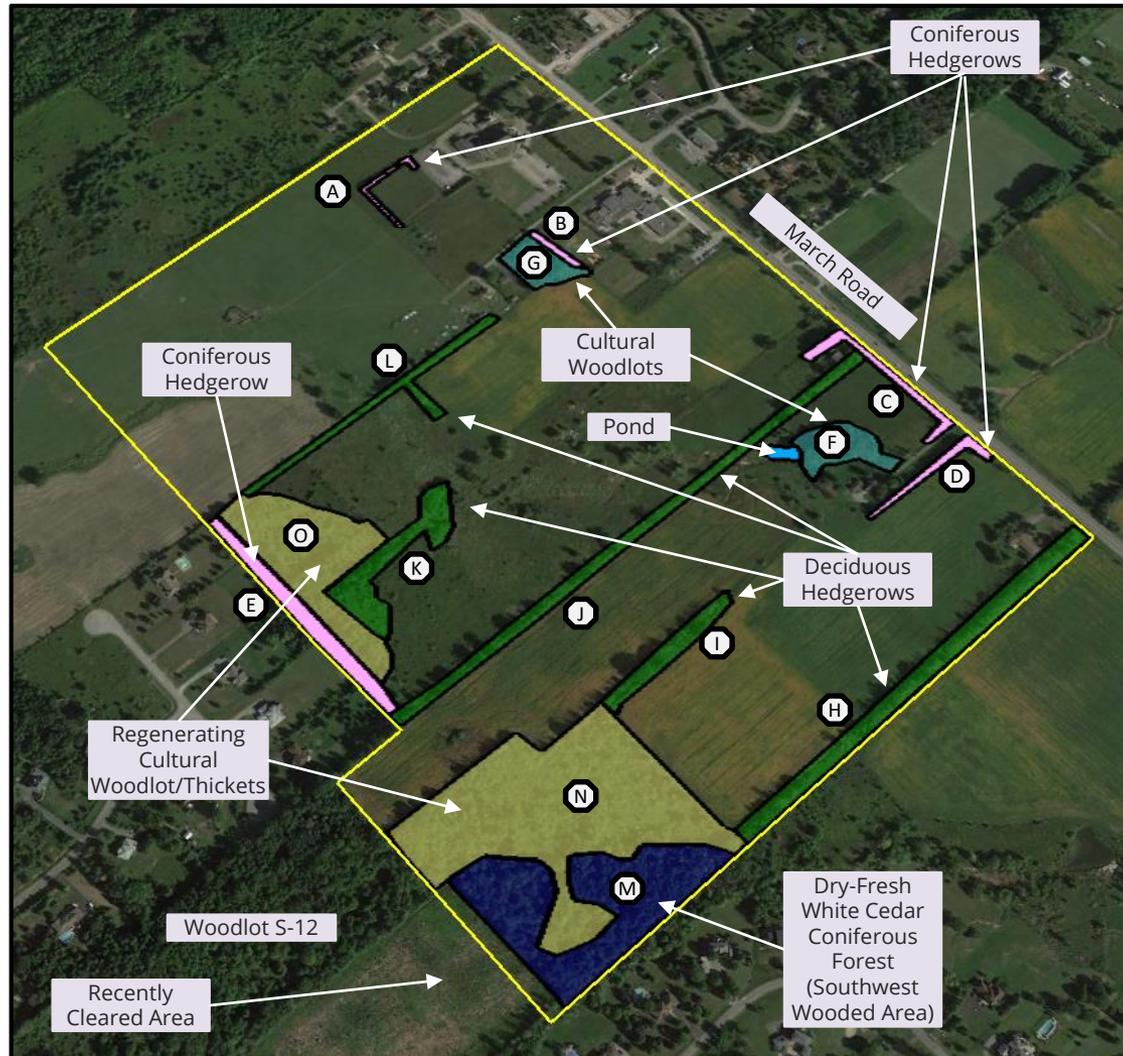
FIGURE 3: TREED HABITATS

- Study Area (Northwest Quadrant) H - Vegetation Feature Number

There are five (5) Deciduous Hedgerows within the Study Area. Deciduous Hedgerows are shown in Figure 3 and tree sizes are shown in Table C. The Deciduous Hedgerows throughout the Study Area all have similar species composition. Throughout the Study Area White/Green Ash are the dominant tree within the Deciduous Hedgerows. Virtually all White/Green Ash over 20 cm dbh in size are either dead or severely stressed as a result of the effects of the invasive Emerald Ash Borer. This die-off of large Ash trees has significantly degraded the hedgerows. Other trees that are common throughout the Deciduous Hedgerows include Bur Oak, Manitoba Maple, American Elm, American Basswood, Domestic Apple and Black Cherry. Trembling Aspen, White Cedar, White Birch, Sugar Maple, and White Pine are also present but are less common. All of the Deciduous Hedgerows include thick shrub cover including regenerating Ash stems, Common Buckthorn, Common Apple, Prickly Ash, Tartarian Honeysuckle, Choke Cherry, Hawthorn, Wild Red Raspberry, and Riverbank Grape. Groundcover is reflective of disturbed conditions and includes various grasses, Dandelion, Poison Ivy, Virginia Creeper, Common Milkweed, Canada Goldenrod, Common Strawberry, Common Ragweed, and Red and White Clover. Tree sizes vary within the hedgerows as follows:

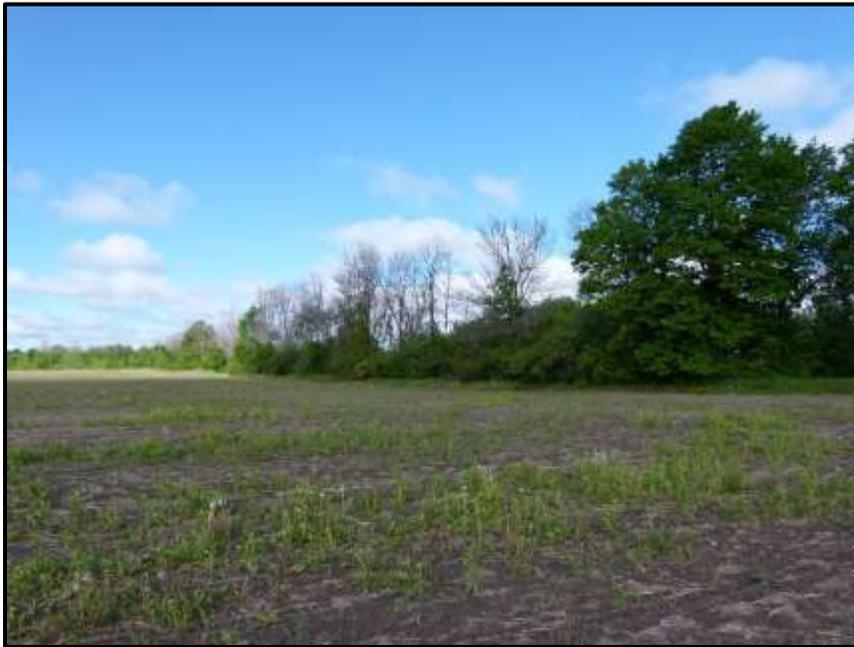
Photograph 9: Deciduous Hedgerow H looking northwest, a large Bur Oak (63 cm dbh) is shown on the right. Dead/stressed Ash stems are visible in the center of the photo (June 3rd, 2017).

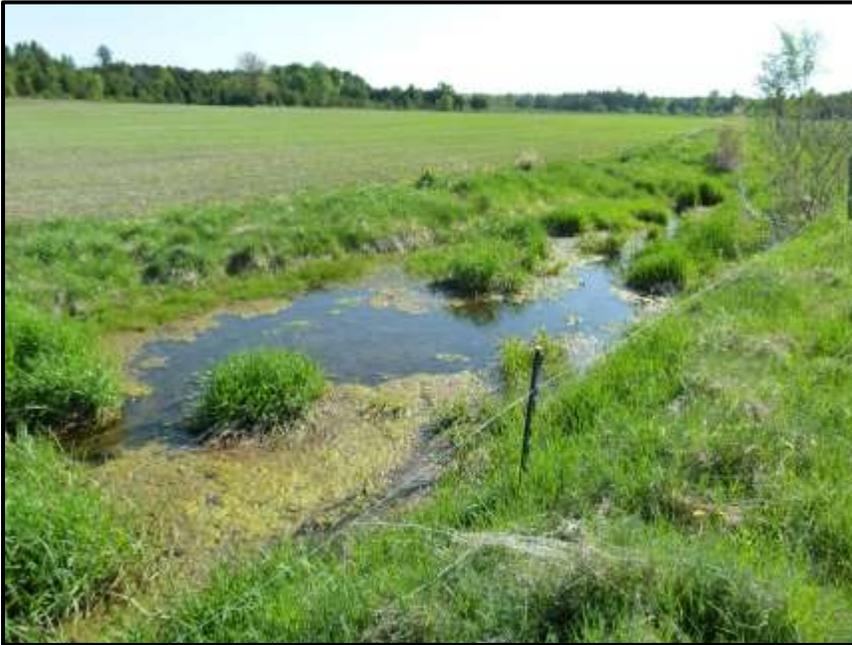
Photograph 24: Looking south at the northern reach of the North Tributary. The area shown is where the watercourse enters the Study Area (May 23rd, 2016).

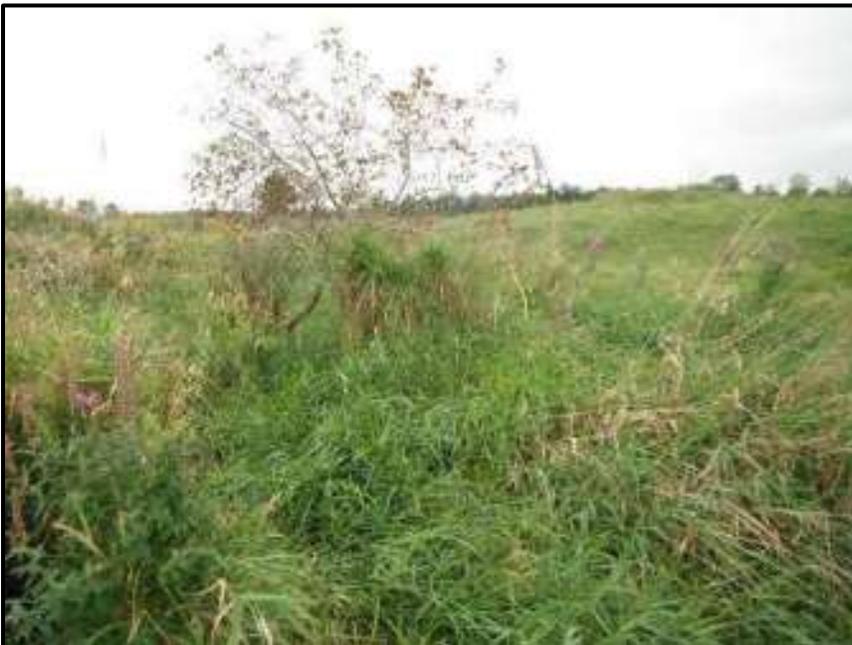
Photograph 25: The North Tributary during typical summer conditions. Note the channel is overgrown by terrestrial vegetation (September 3rd, 2013) (Photo from MEP 2016).

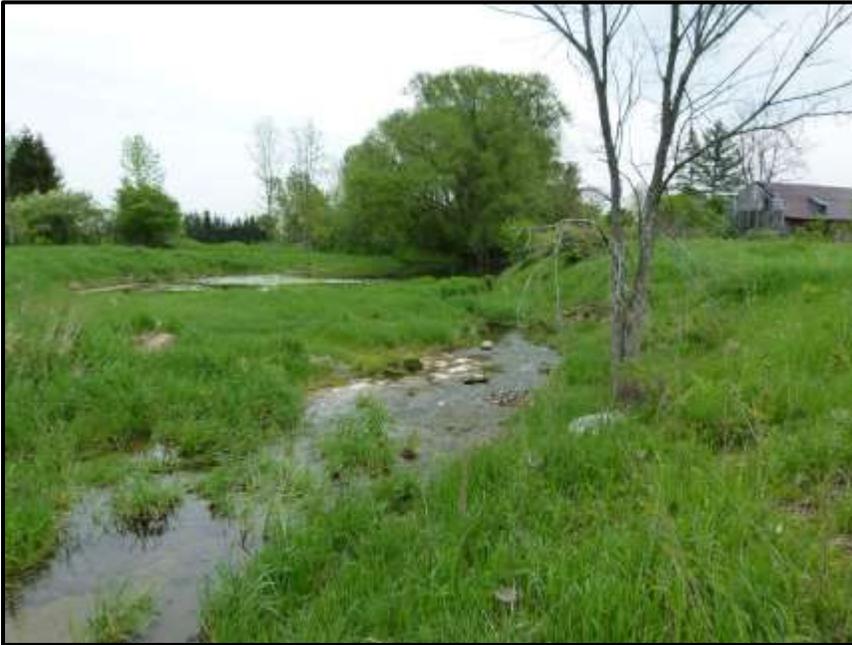
Photograph 26: Looking east along the North Tributary, with the pond in the background. Note that the channel is shallow, narrow, and mostly overgrown with terrestrial vegetation. The barn shown on the right was demolished during the winter of 2017-2018 (May 24th, 2017).

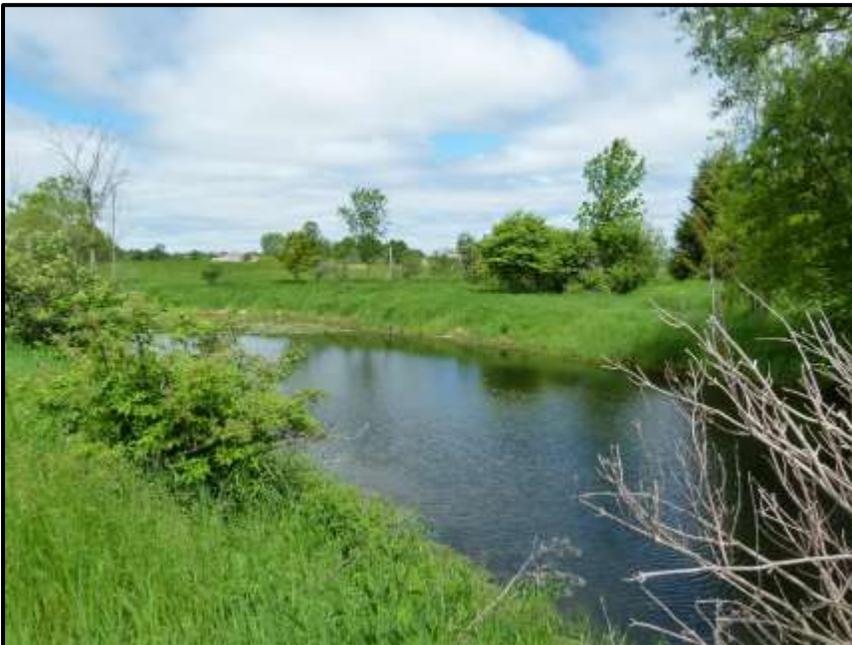
Photograph 27: Looking west at the pond. Note that the majority of the pond's surface area remains as open water, even in mid-summer (June 3rd, 2017).

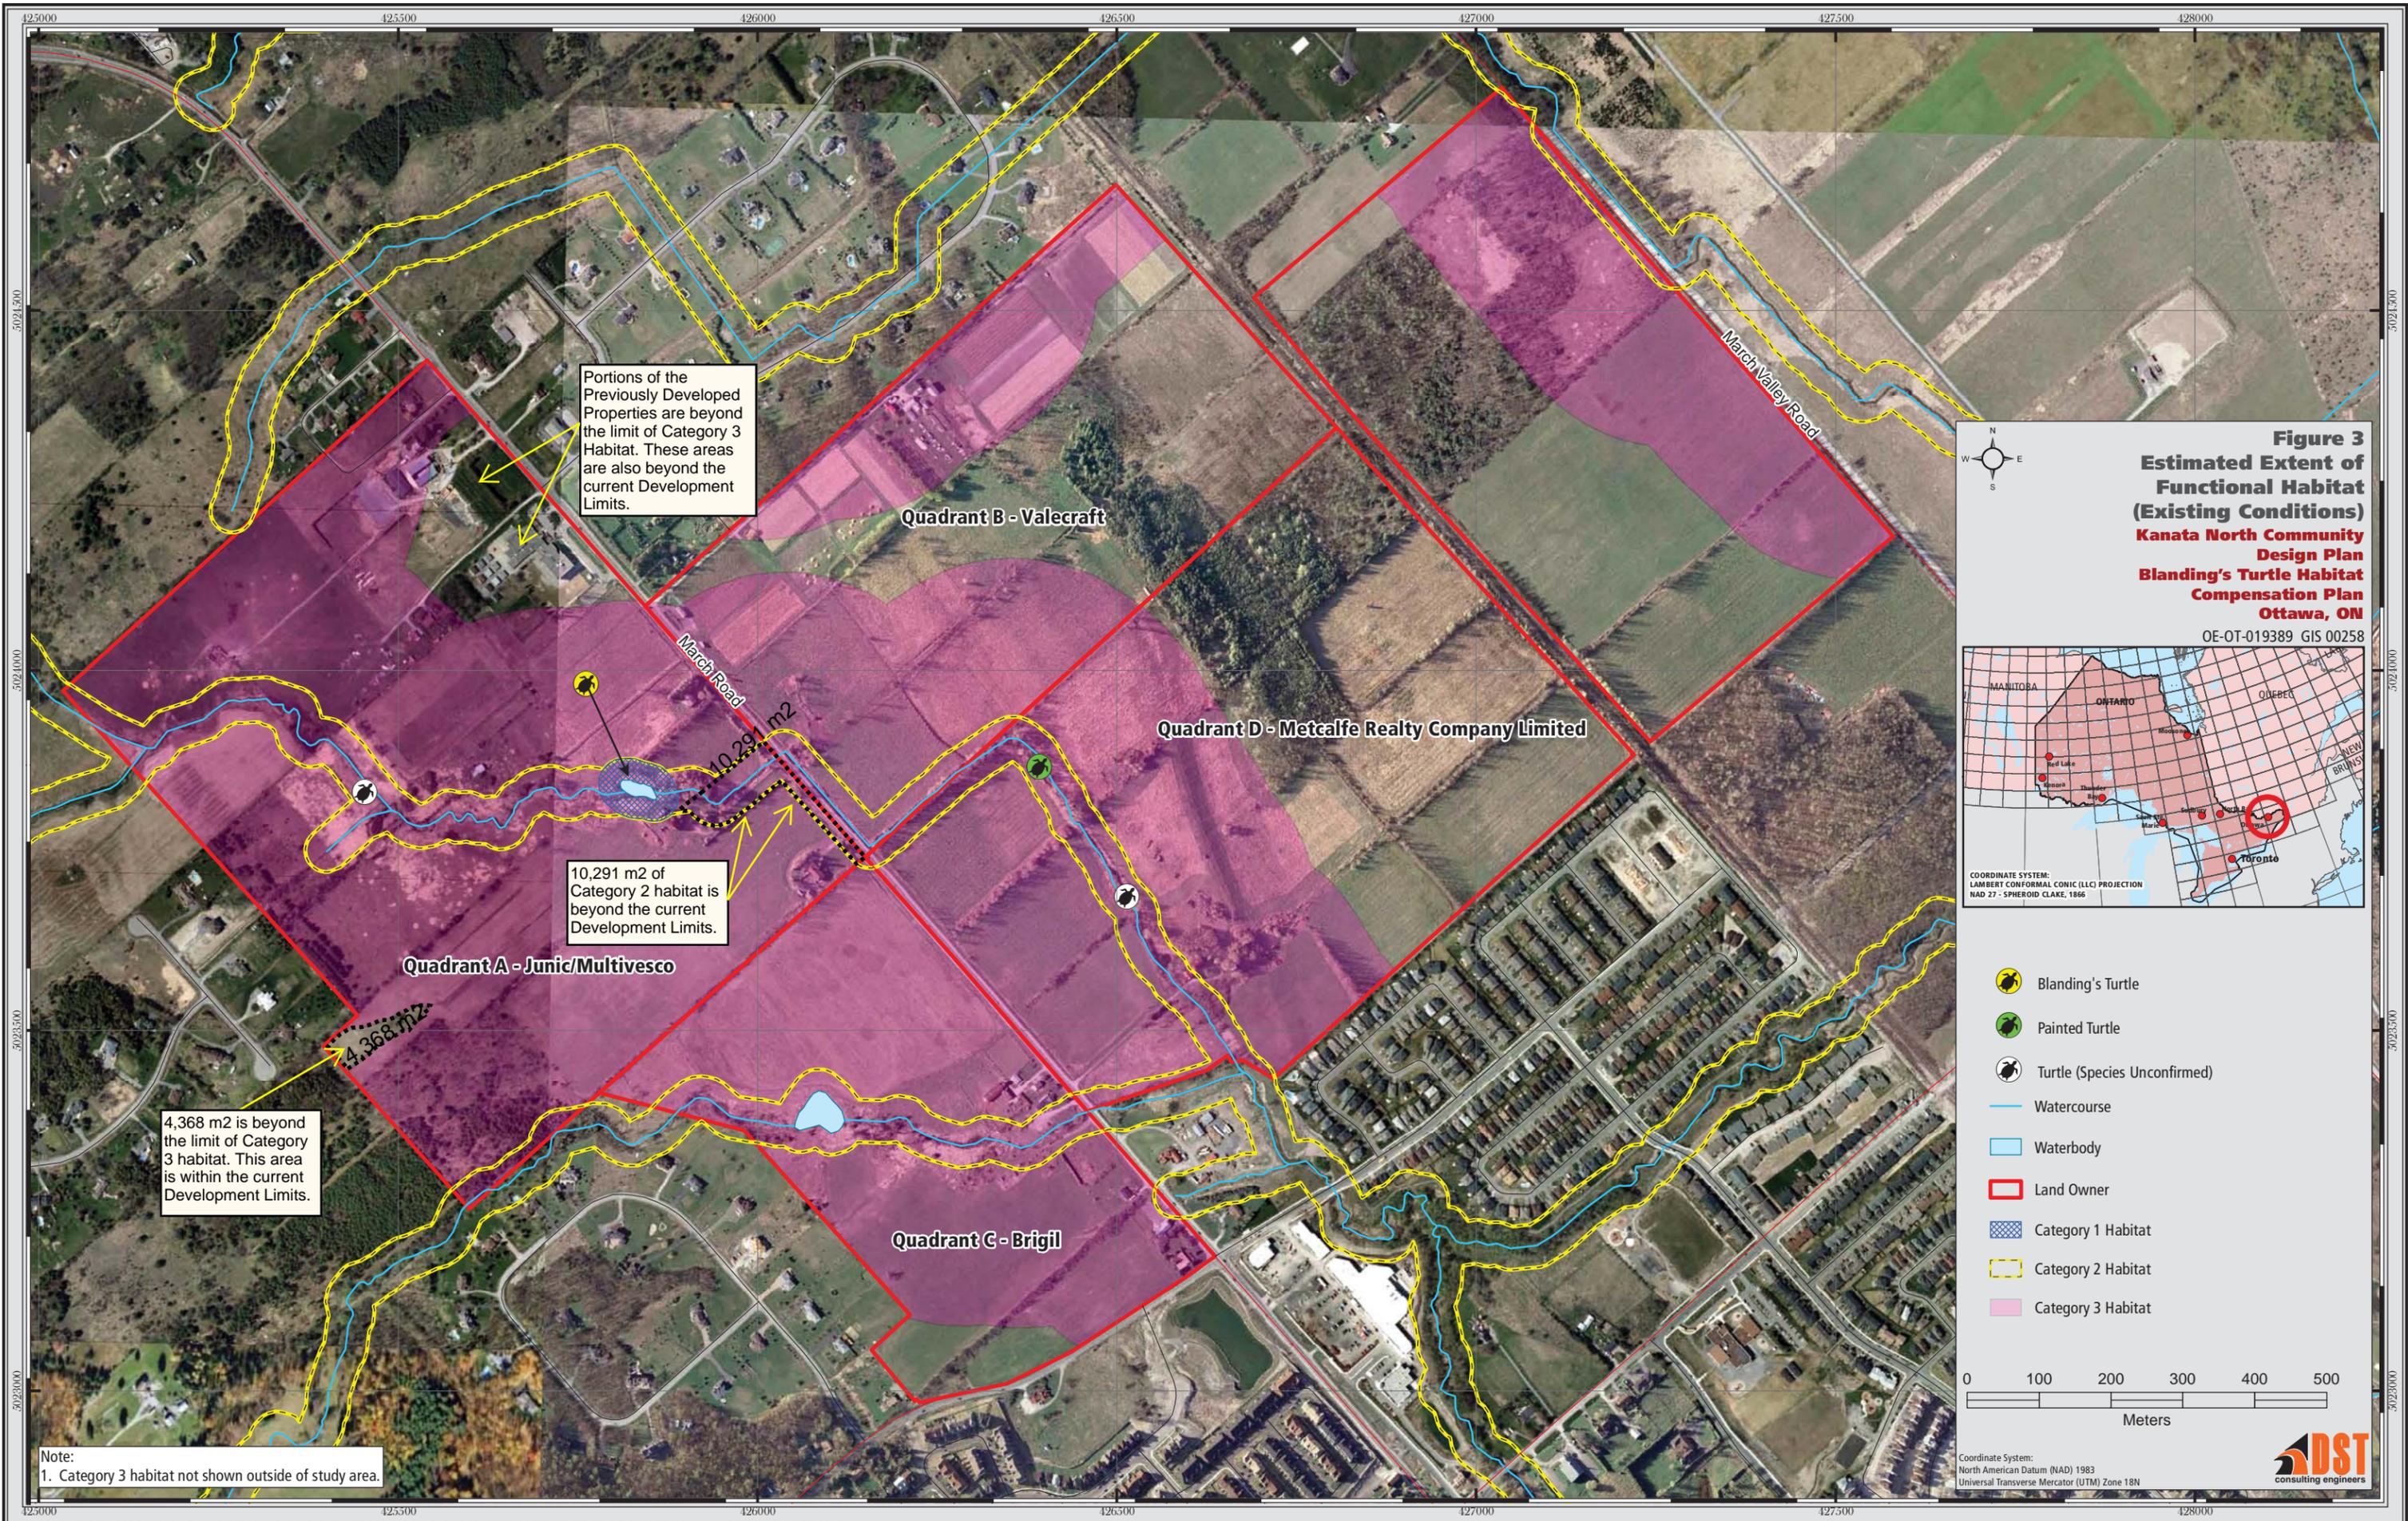
Figure 3
Estimated Extent of Functional Habitat (Existing Conditions)
Kanata North Community Design Plan
Blanding's Turtle Habitat Compensation Plan
Ottawa, ON

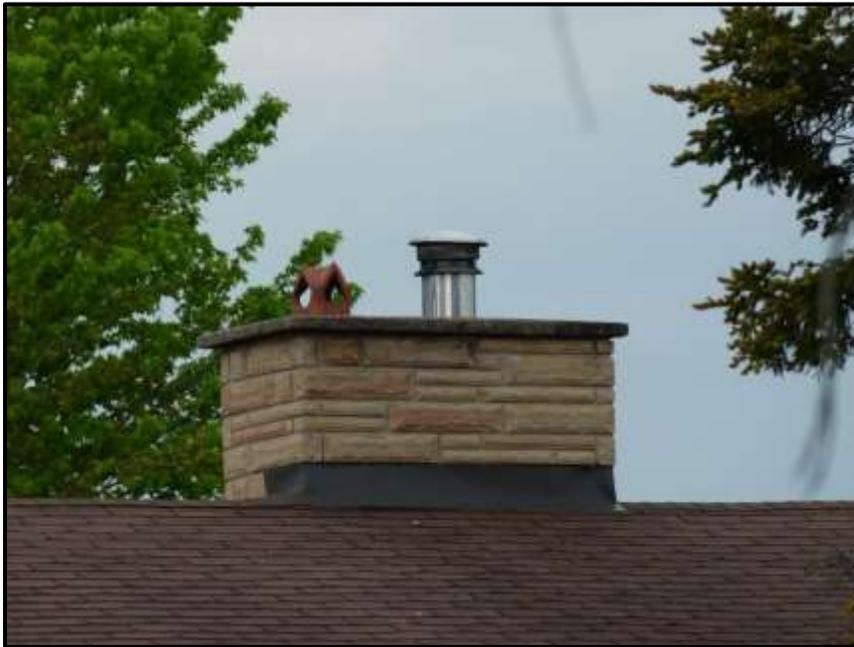
Photograph 31: Chimney at 1015 March Road. Note metal cap and ceramic liner (May 24th, 2017).

Photographs of the chimneys are included below. Chimney Swift will not typically nest in chimneys with ceramic liners, as they are unable to affix their nests to the smooth interior surface. Chimney Swift are unable to enter chimneys with wire mesh or metal caps. There are therefore no chimneys within the Study Area which may be suitable for Chimney Swift nesting. Due to the absence of potentially suitable chimneys within the Study Area, a survey for Chimney Swifts was not required.

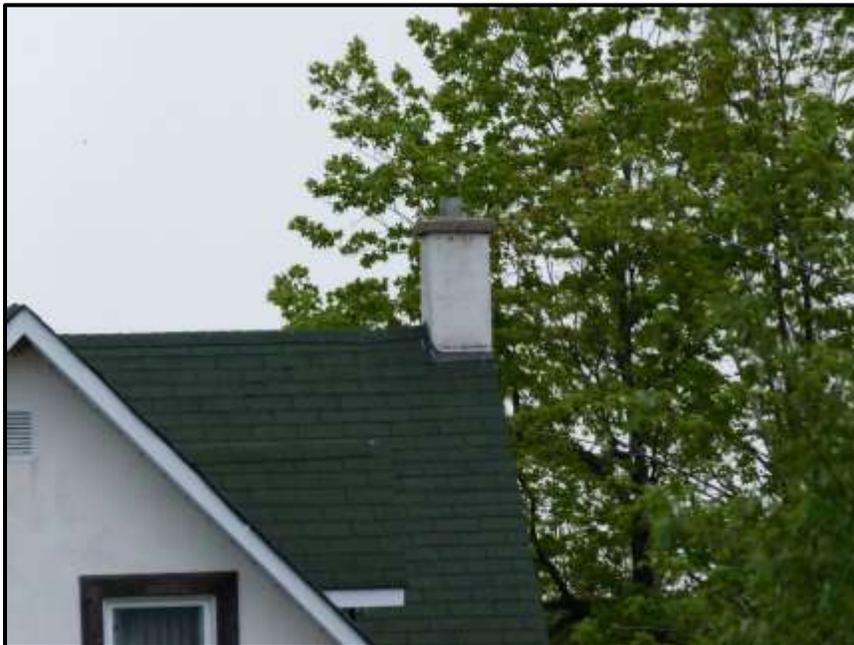
Photograph 32: Chimney at 1035 March Road. Note metal liner (May 24th, 2017).

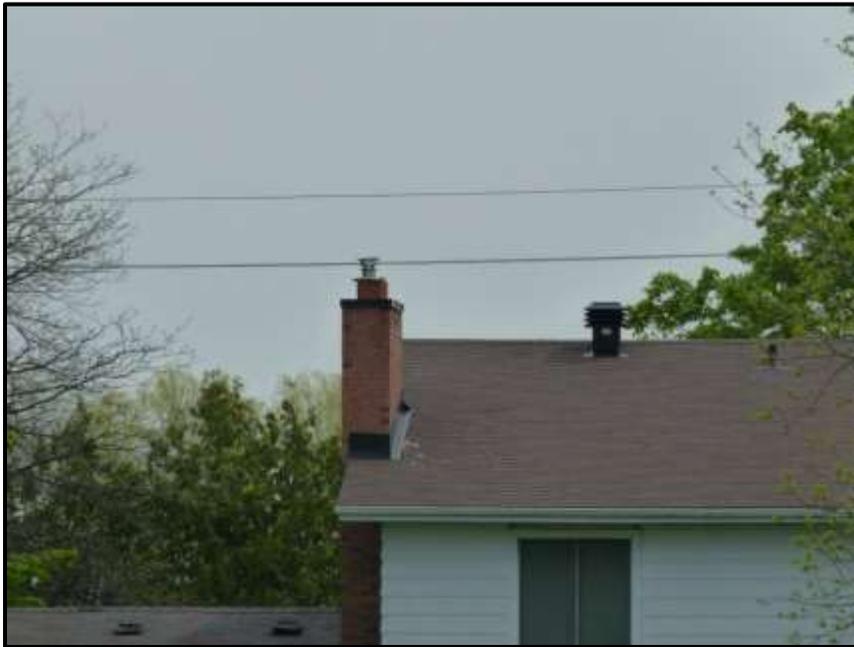
Photograph 33: Chimney at 1053 March Road. Note ceramic liner and metal cap (May 24th, 2017).

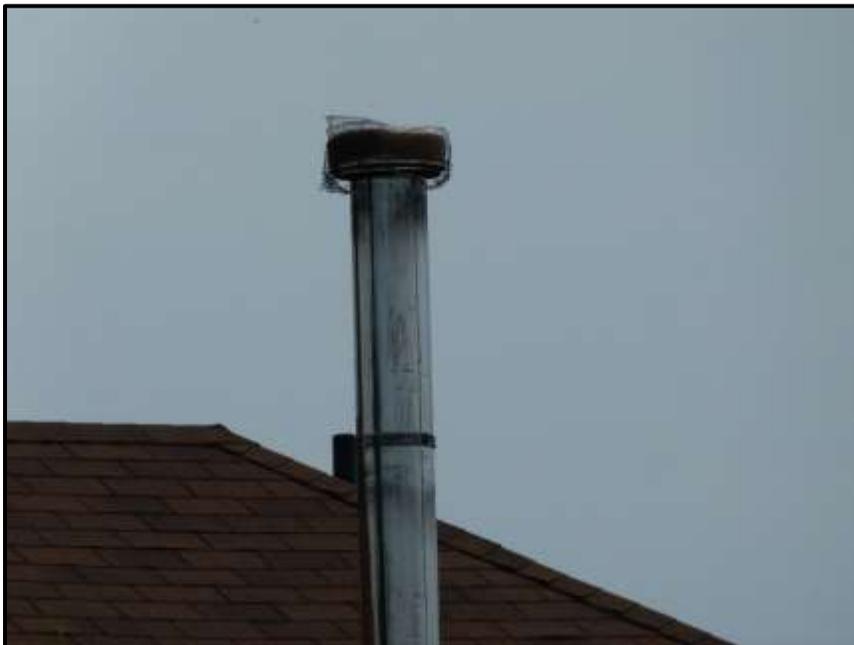
Photograph 34: Chimney at 1113 March Road. Note metal liner and wire mesh cap (May 24th, 2017).

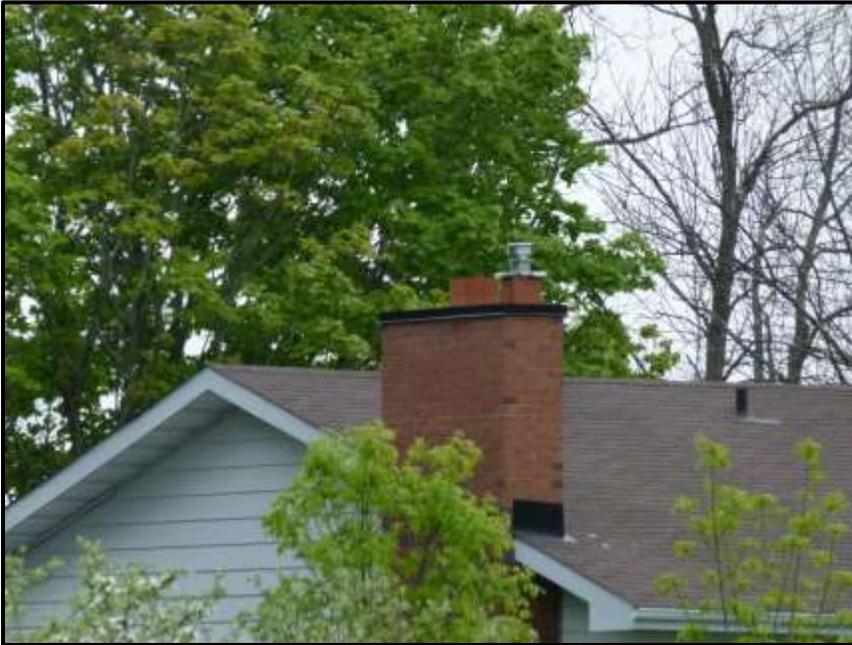
Photograph 35: Chimney at 1145 March Road. Note ceramic liner and metal cap (May 24th, 2017).

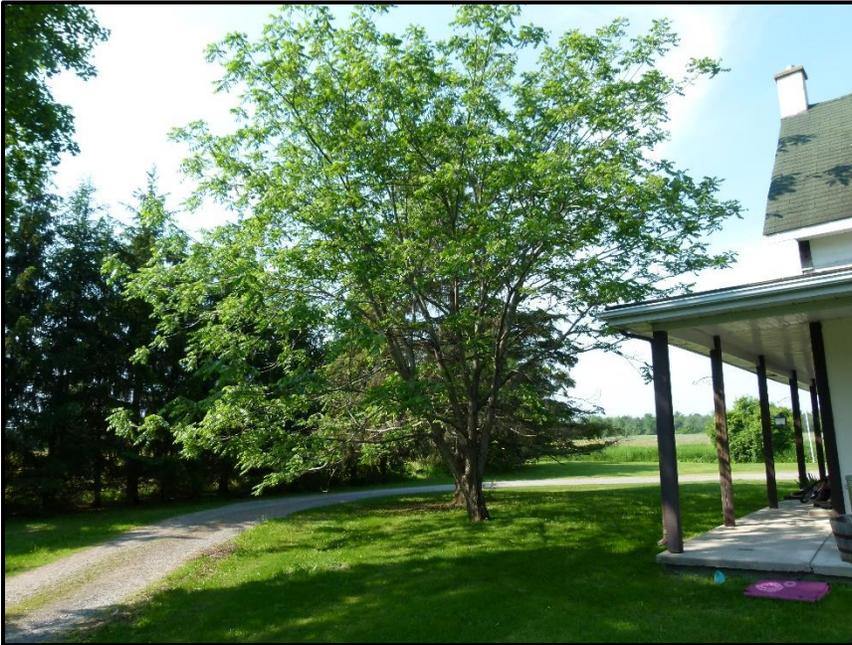
Photograph 1: Butternut Tree #1 (41 cm dbh) (June 12th, 2017).
