Combined Environmental Impact Statement &  
Tree Conservation Report  
Minto Communities and 2559688 Ontario Inc.  
Kanata North Development (936 March Road)

November 2018

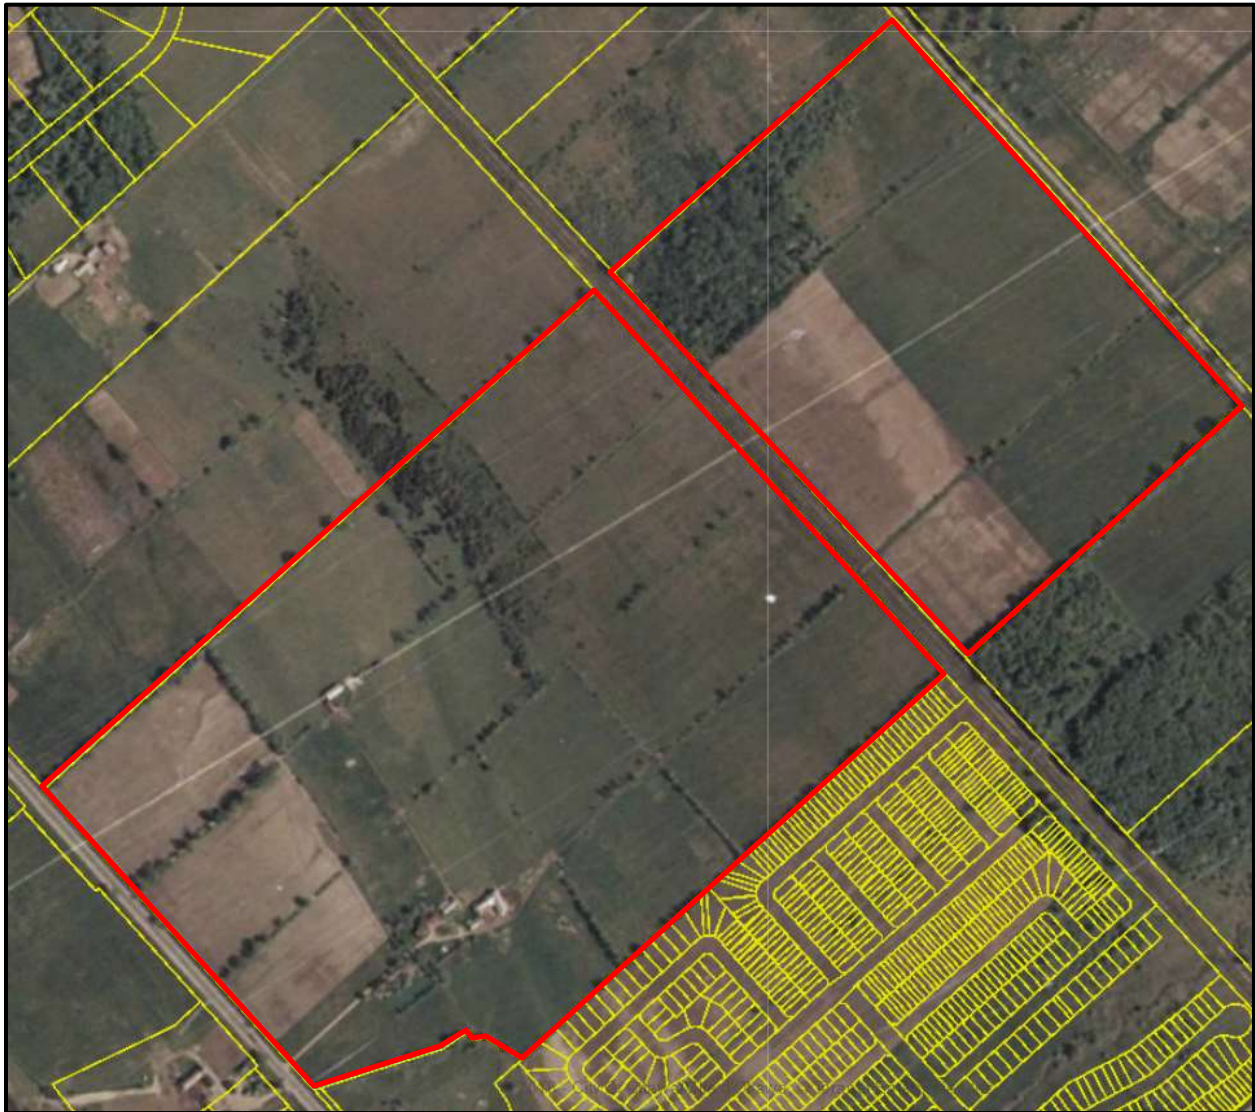
**Historic Air Photograph 1:** Historic Air Photo from 1976 (Study Area limits shown in red). Note the overall composition of the Study Area was similar in 1976, with most of the Study Area intensively farmed. The western portions of both Woodlot S-20 and Woodlot S-23 are present in 1976, however, the eastern portion of both features and the southern portion of Woodlot S-20 appear to be largely clear of tree cover. The Cultural Woodlot surrounding the farmhouse at 936 March Road is largely absent (Photos from City of Ottawa 2018).

Air photos from 1976, 1991 and 2005 are included below (Photos from City of Ottawa 2018). Recent air photos are included in the report figures. The oldest available historic air photo (from 1976), shows that the overall composition of the Study Area was similar in 1976, with most of the Study Area intensively farmed. In 1976, the western portions of both Woodlot S-20 and Woodlot S-23 are present, however, the eastern portion of both features and the southern portion of Woodlot S-20 appear to be largely clear of tree cover. The Cultural Woodlot surrounding the farmhouse at 936 March Road is also largely absent. This suggests that the western portions of both Woodlot S-20 and Woodlot S-23 are more than 40 years old (approximately), however, the remainder of these features and the Cultural Woodlot surrounding the farmhouse are younger than 40 years old (approximately). By 1991, the Study Area remained largely unchanged, although the Cultural Woodlot surrounding the farmhouse at 936 March Road expanded by 1991. This suggests that the oldest trees within the Cultural Woodlot are approximately 20 to 30 years old. By 2005, the eastern and southern portions of Woodlot S-20 are visibly regenerating. This suggests that much of the tree cover within the eastern and southern portions of Woodlot S-20 is approximately 10 to 20 years old. However, the area east of Woodlot S-23 remains largely clear of tree cover. The Cultural Woodlot surrounding the farmhouse at 936 March Road is similar to its current size in 2005.

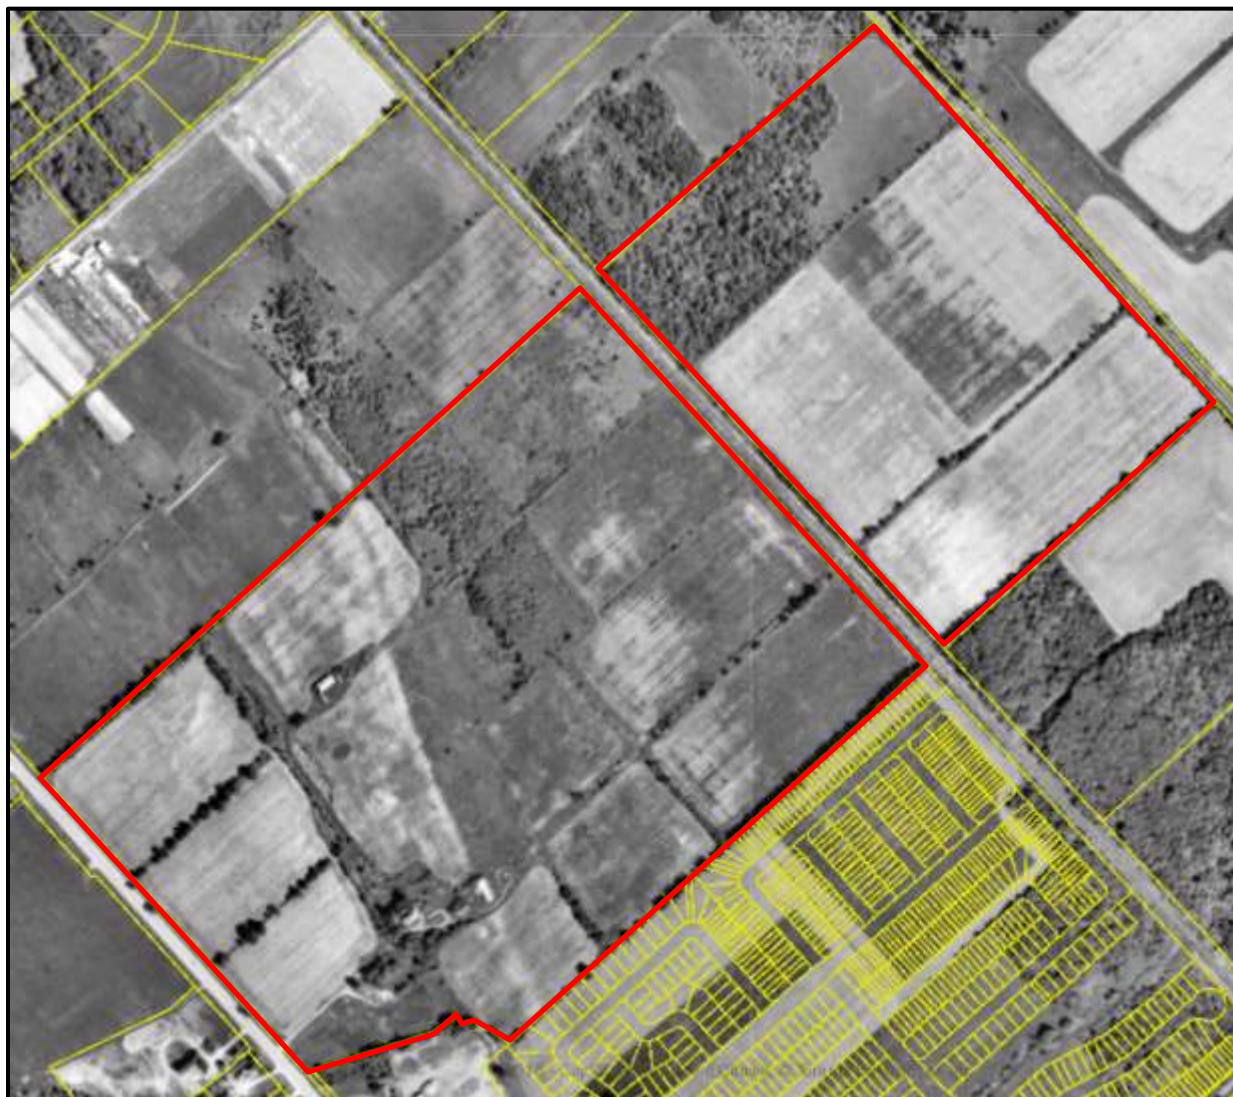
**Historic Air Photograph 2:** Historic Air Photo from 1991 (Study Area limits shown in red). Note the overall composition of the Study Area was similar in 1991, with most of the Study Area intensively farmed. The western portions of both Woodlot S-20 and Woodlot S-23 are present in 1991, however, the eastern portion of both features continues to be largely absent in 1991. The southern portion of Woodlot S-20 is also largely absent. The Cultural Woodlot surrounding the farmhouse at 936 March Road has expanded by 1991 (Photos from City of Ottawa 2018).

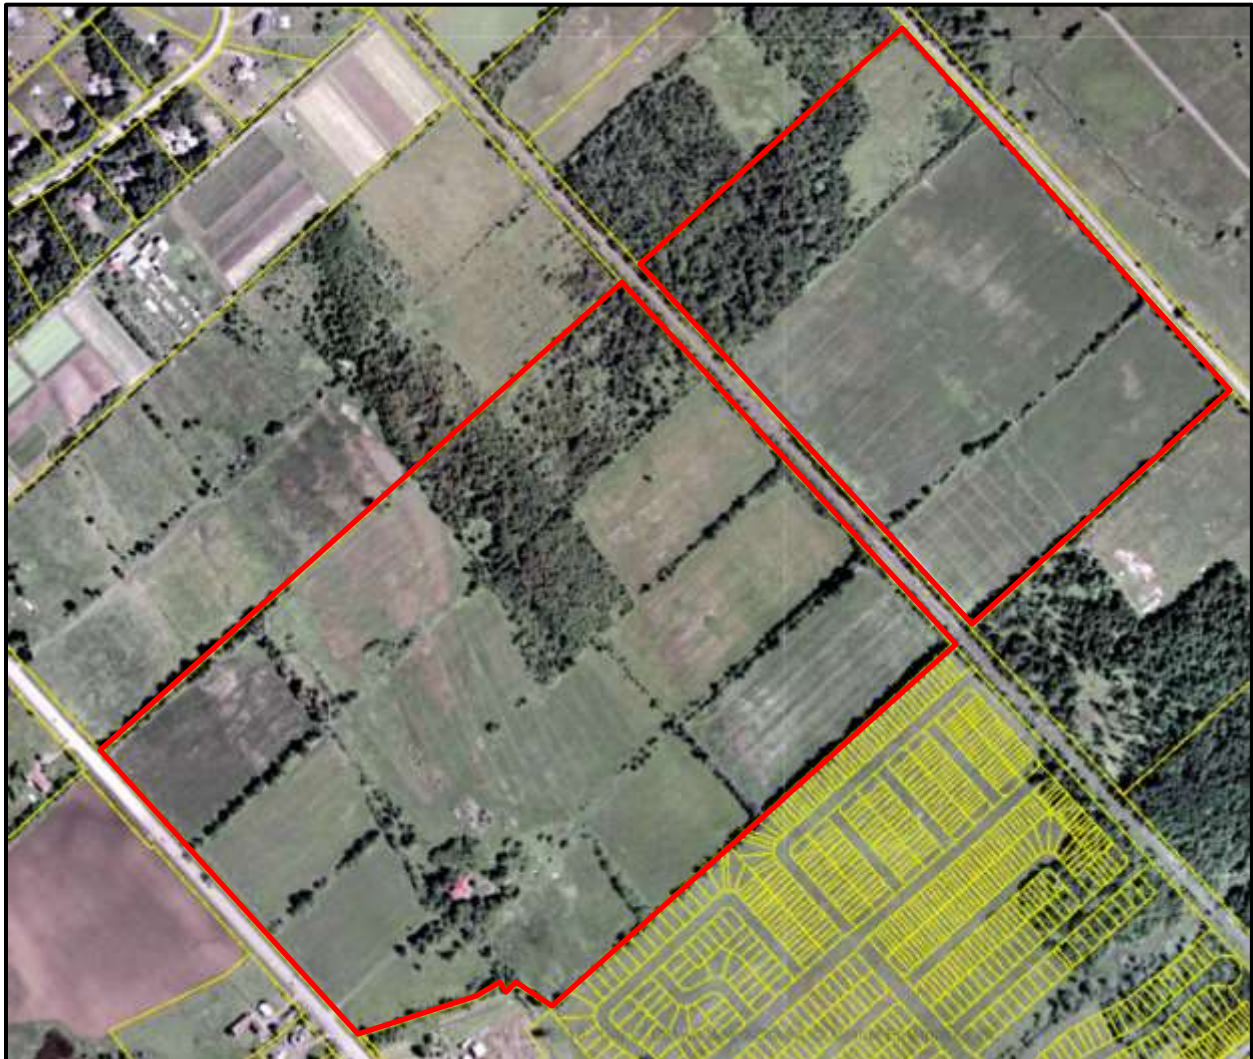
**Historic Air Photograph 3:** Historic Air Photo from 2005 (Study Area limits shown in red). Note the overall composition of the Study Area was similar in 2005, with most of the Study Area intensively farmed. The western portions of both Woodlot S-20 and Woodlot S-23 are present in 2005. By 2005, the eastern and southern portions of Woodlot S-20 are visibly regenerating. However, the area east of Woodlot S-23 remains largely clear of tree cover. The Cultural Woodlot surrounding the farmhouse at 936 March Road is similar to its current size in 2005 (Photos from City of Ottawa 2018).

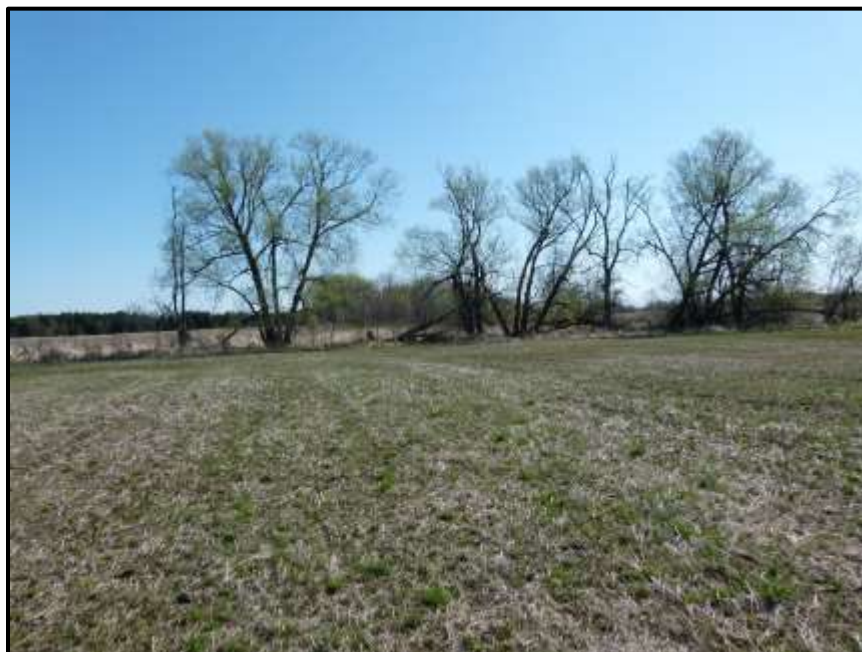
Photograph 18: Looking east at the large Crack Willows (60 cm to 80 cm dbh) present in the Riparian Community (Feature R) surrounding the North Tributary (May 8<sup>th</sup>, 2018).

A corridor of Riparian Vegetation (Feature R) exists surrounding the North Tributary. Tree cover is dominated by White/Green Ash and Manitoba Maples. However, several large Crack Willows are present, most of which are 60 cm to 80 cm dbh in size, although some specimens up to 150 cm dbh are also present. The Crack Willows are not native species, and were likely planted as landscaping features along the creek. Shrub cover includes Wild Red Raspberry, Common Buckthorn and Tartarian Honeysuckle. Groundcover is dominated by Reed Canary Grass with Purple Loosestrife, Spotted Touch Me Not, and Common Cattail present.

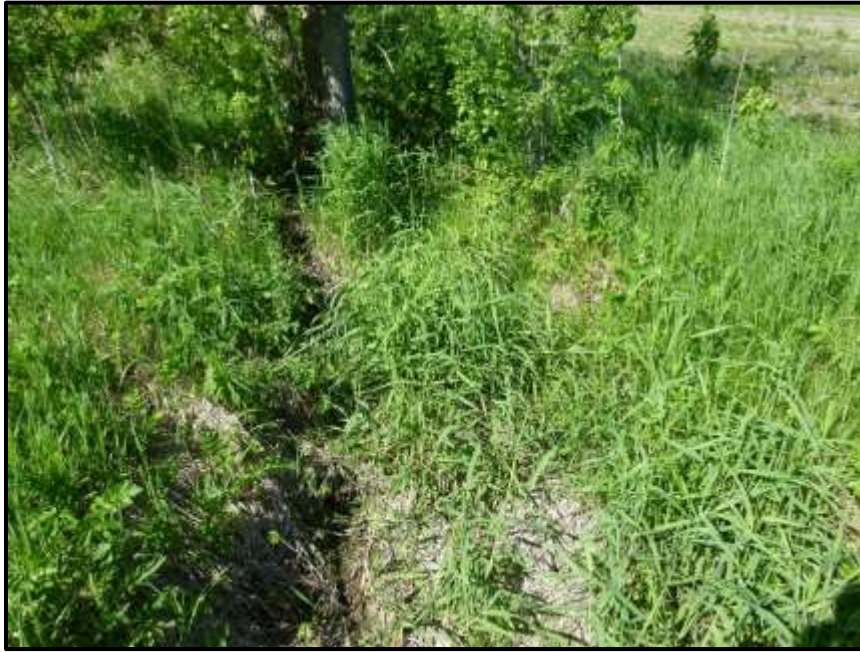
**Photograph 38:** Ephemeral Farm Drainage Channel in the southeastern part of the Study Area, east of the Former CN Railway Corridor. Note the channel is entirely dry by late May (May 29<sup>th</sup>, 2016).

All of the Ephemeral Farm Drainage Channels are fed by surface drainage from the surrounding fields, and none of these features include direct upstream connection to any adjacent watercourses. The Ephemeral Farm Drainage Channels generally have a limited hydro-period that is confined to the early spring and/or immediately following storm events, during which the drains are fed by surface runoff from the surrounding fields (MEP 2015). As a result, the Ephemeral Farm Drainage Channels are dry for the majority of the growing season. In 2018, all of these features were observed to be completely surface dry by early June. The features are generally overgrown with terrestrial vegetation throughout the majority of the growing season. Terrestrial vegetation coverage varies, but is essentially the same as the adjacent terrestrial vegetation communities within which the Ephemeral Farm Drainage Channels occur (e.g. Deciduous Hedgerows, Forest, and/or Fallow Agricultural Fields). As discussed below, fish habitat functionality was found to be very limited. Due to their limited hydro-period and general lack of aquatic habitat, the Ephemeral Farm Drainage Channels were not shown to provide Category 2 Blanding's Turtle habitat (DST 2015). The CDP and EMP did not recommend retention of any of the Ephemeral Farm Drainage Channels, unless those channels fall within other designated retained areas (e.g. the retained portion of Woodlot S-23). Overall, the Ephemeral Farm Drainage Channels are not considered significant ecological features. Refer to MEP (2015) for a discussion of management and mitigation recommendations for the Ephemeral Farm Drainage Channels.

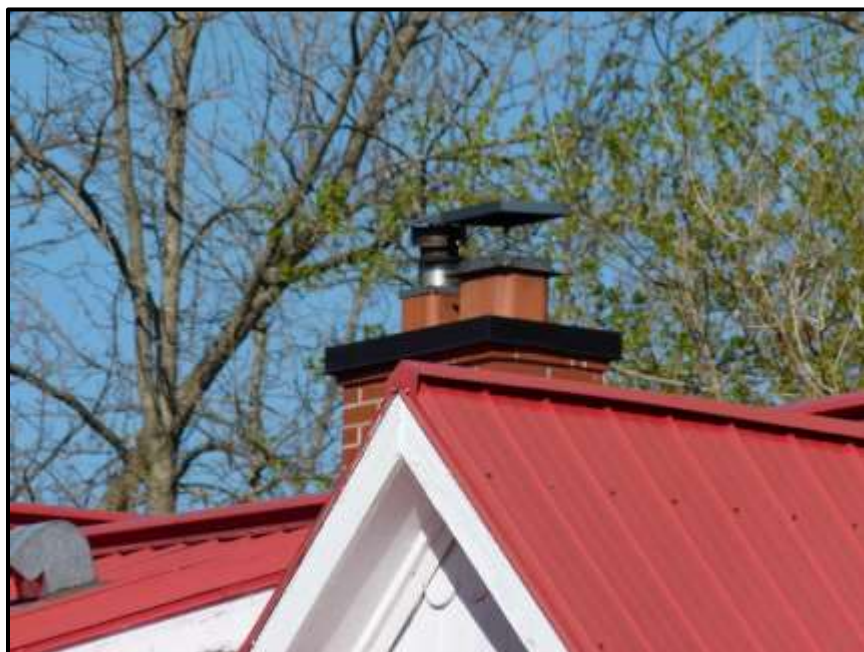
Photograph 42: The capped chimney on the farmhouse at 936 March Road (May 8<sup>th</sup>, 2018).

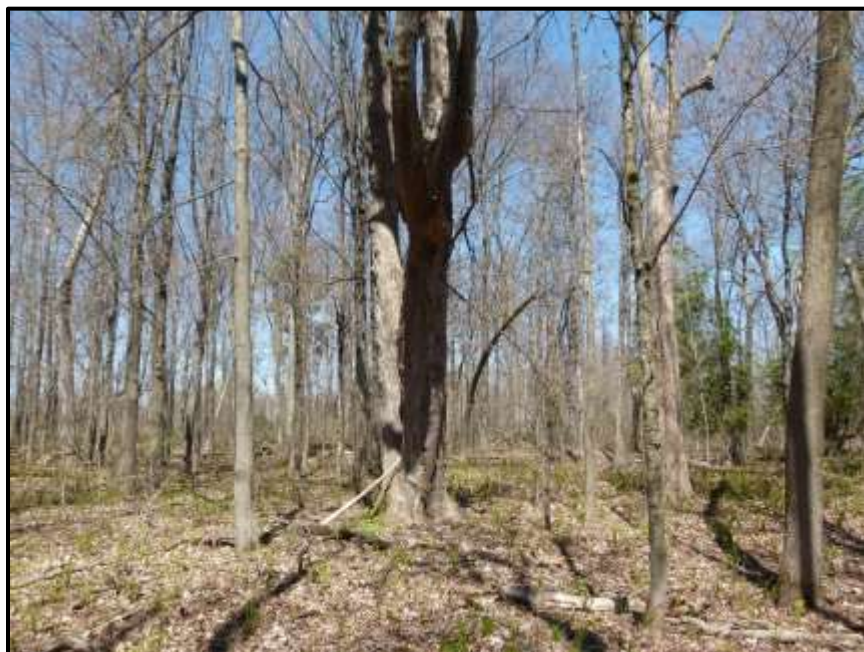
**Photograph 49:** Example of a cavity tree (111 cm dbh Sugar Maple) – found within the Dry-Fresh Sugar Maple – White Ash Deciduous Forest (Feature Y). Note that the large tree is surrounded mostly by smaller stems, and hence the density of trees over 25 cm dbh is inherently low (May 8<sup>th</sup>, 2018).

- **Dry – Fresh Sugar Maple – Ash Deciduous Forest (Feature Y):** As noted in Section 3.3, Feature Y also includes comparatively more mature trees than elsewhere within the Study Area. However, the mature trees are generally surrounded by younger stems that make up the majority of the forest cover, and hence the density of mature trees over 25 cm dbh remains inherently low. A snag/cavity tree count was completed for Feature Y, and only two (2) cavity trees were noted. The density of snag/cavity trees is hence too low to support potential maternity roosting habitat.
